**Re: Site Assessment, Remediation, and Closure Report**  
**Allied 7 Federal #001**  
**API No. 30-015-25900**  
**GPS: Latitude 32.7638435 Longitude -103.9067764**  
**UL G, Section. 07, T18S, R31E**  
**Eddy County, NM**  
**NMOCD Ref. No. NAPP2312548979**

Pima Environmental Services, LLC. (Pima) has been contracted by Devon Energy Production, LLC. (Devon) to perform a spill assessment, remediation, and submit this closure report for a produced water release that occurred at the Allied 7 Federal #001 (Allied). The initial C-141 was submitted on August 24, 2023 (Appendix C). This incident was assigned Incident ID NAPP2312548979 by the New Mexico Oil Conservation Division (NMOCD).

**Allied 7 Federal #001**

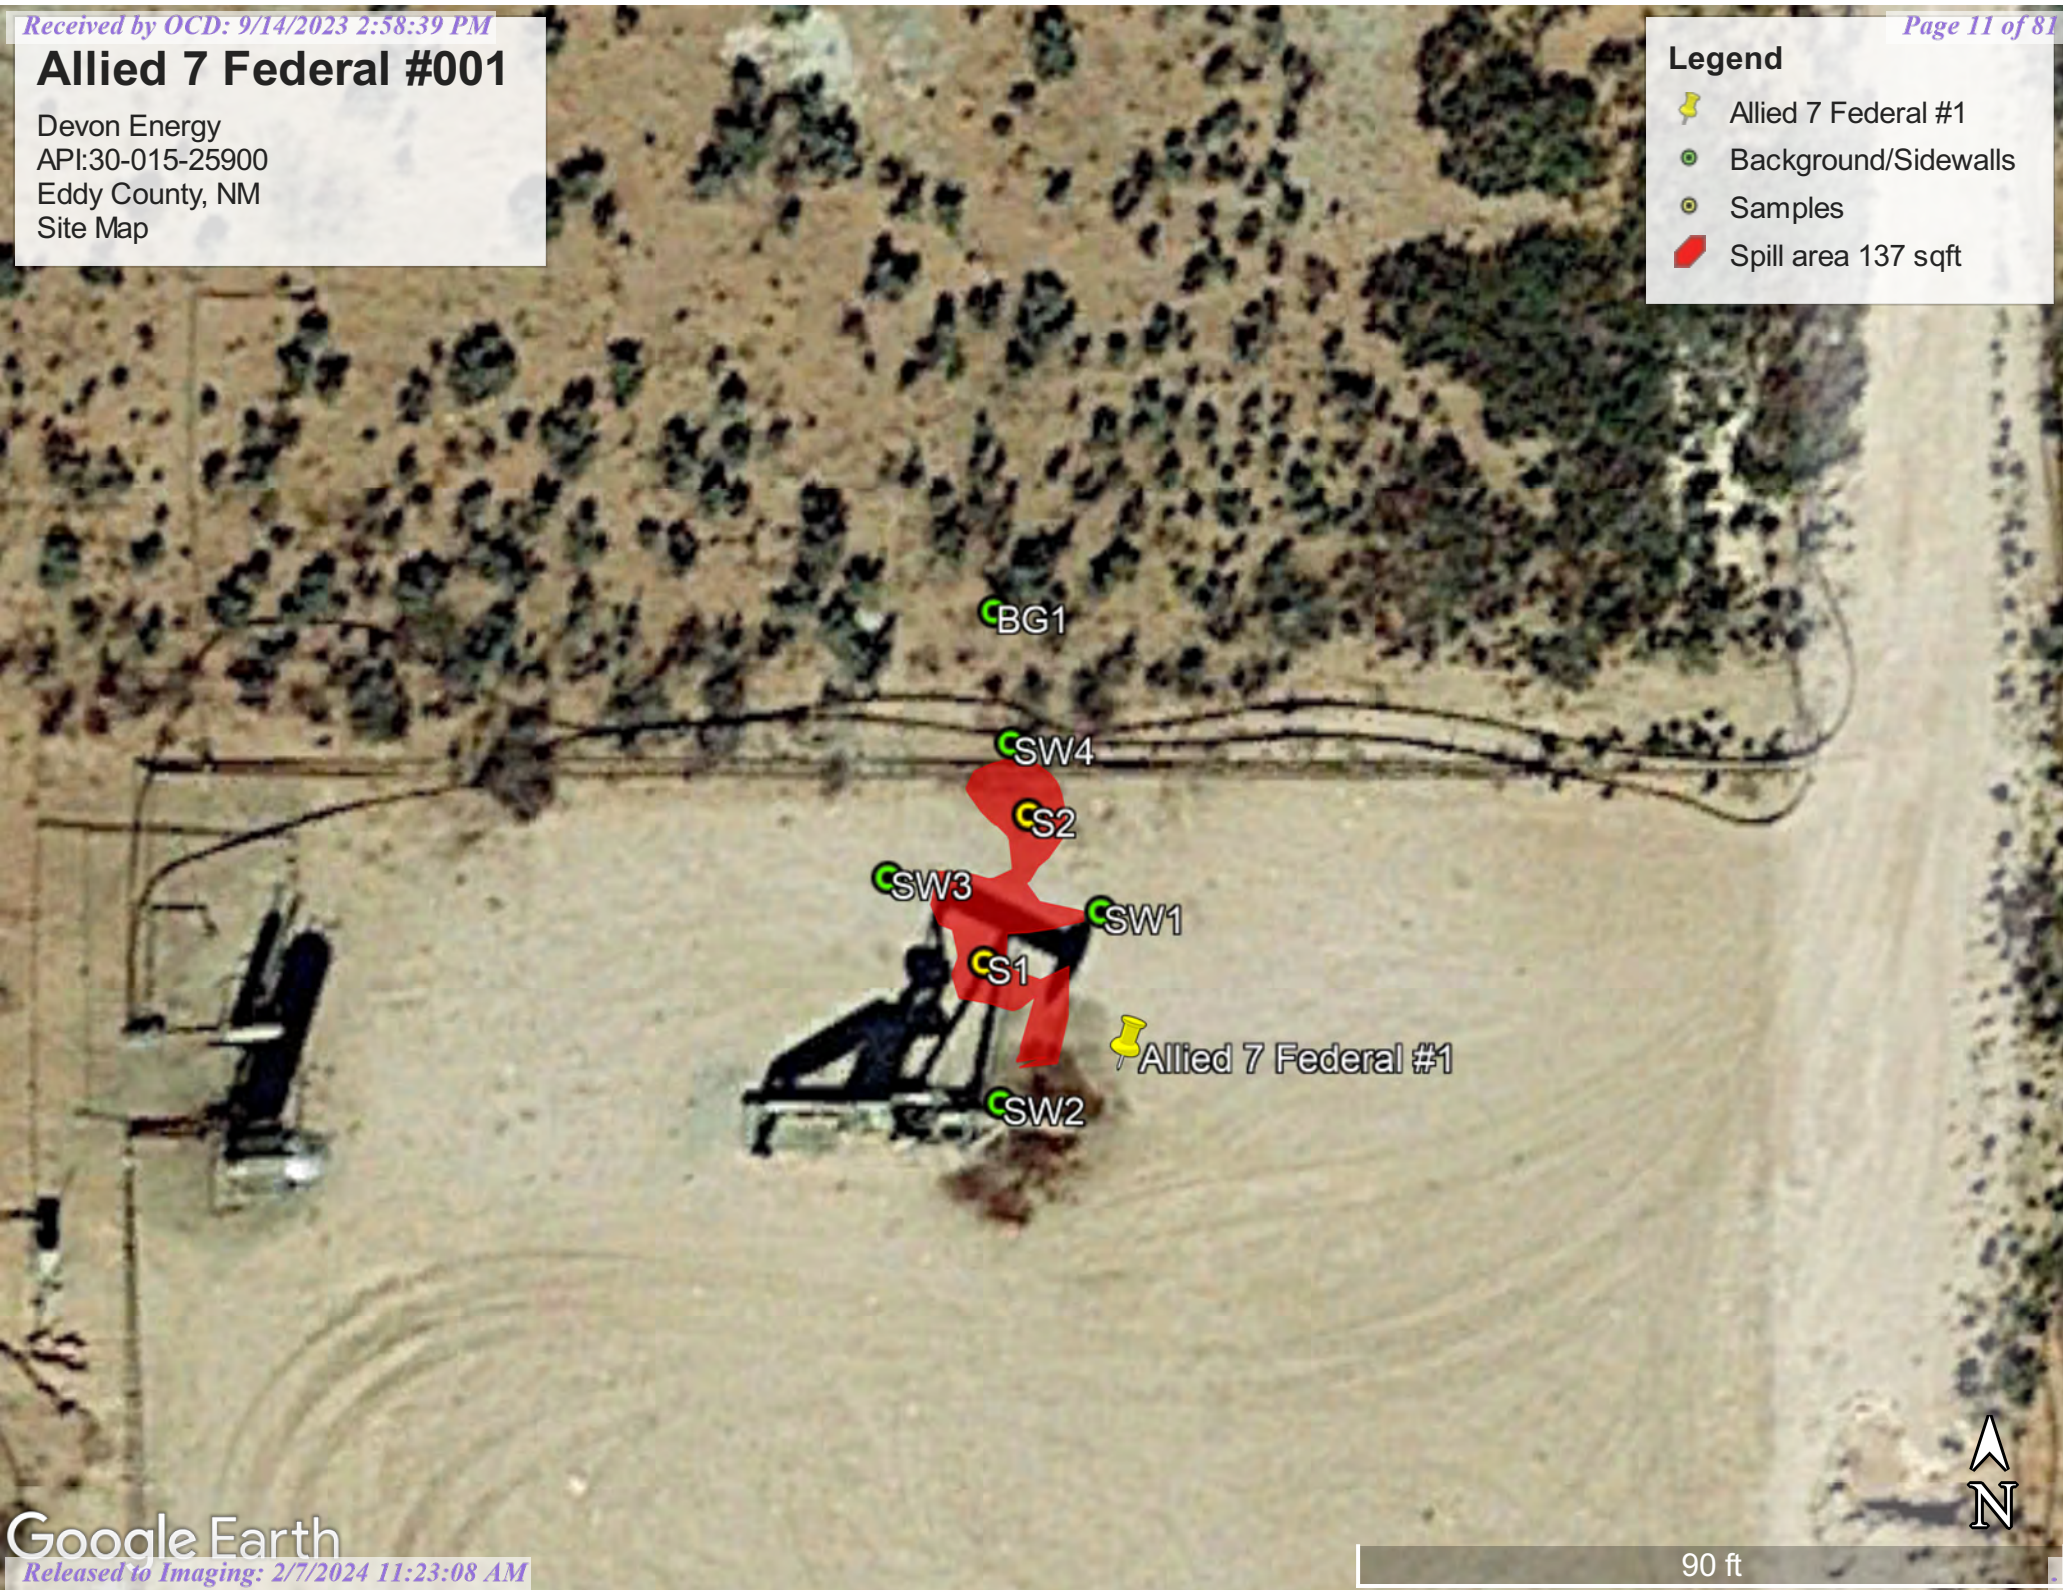
Devon Energy  
API:30-015-25900  
Eddy County, NM  
Site Map

On May 8, 2023, Pima mobilized personnel to the site to assess the area. We sampled the impacted area. Laboratory results of this sampling event can be found in the following data table. A Site Map can be found in Figure 4.

On June 21, 2023, Pima personnel returned to the site to further delineate S-2 area. Laboratory results of this sampling event can be found in the following data table. A Site Map can be found in Figure 4.

Spill area 137 sqft

On August 28, 2023, Devon Construction Department mobilized personnel and equipment to conduct remedial activities. They excavated the area to an average depth of 2' and 4' BGS. Pima personnel collected samples to verify all contaminated soil had been removed. The contaminated soil, which was approximately 14 cubic yards, was hauled to an approved, lined disposal facility and clean backfill material was brought in.

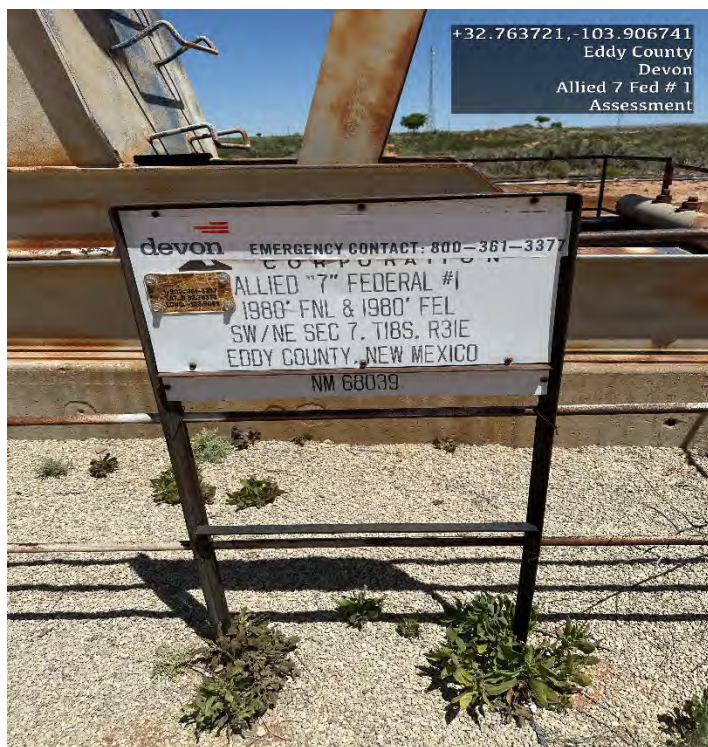
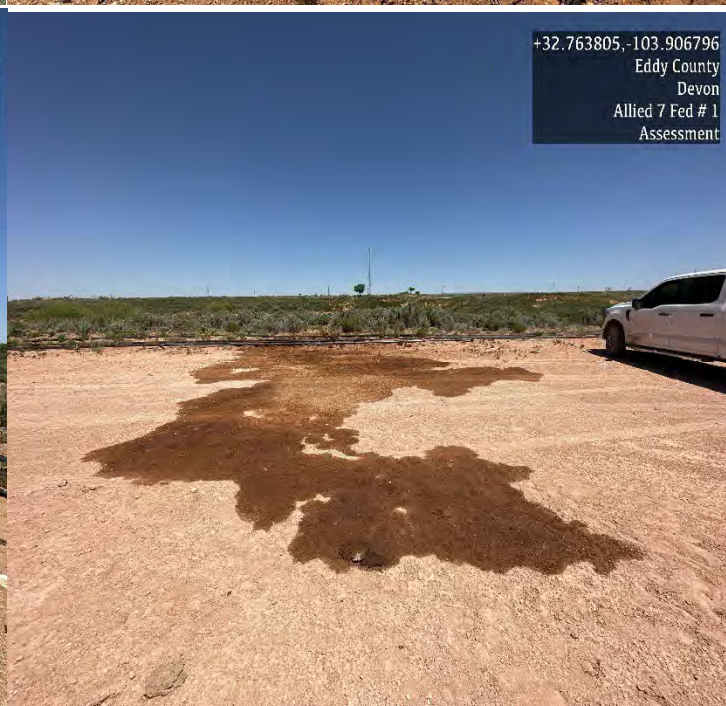
**Site Assessment**

**NAPP2312548979:** On May 4, 2023, a pinhole leak on a 2" flowline from the wellhead was discovered by a LO. The leak caused fluid to release on the pad. The released fluids were calculated to be approximately 0.5 of a barrel (bbls) of produced water. No fluids were able to be recovered due to being soaked into the ground.

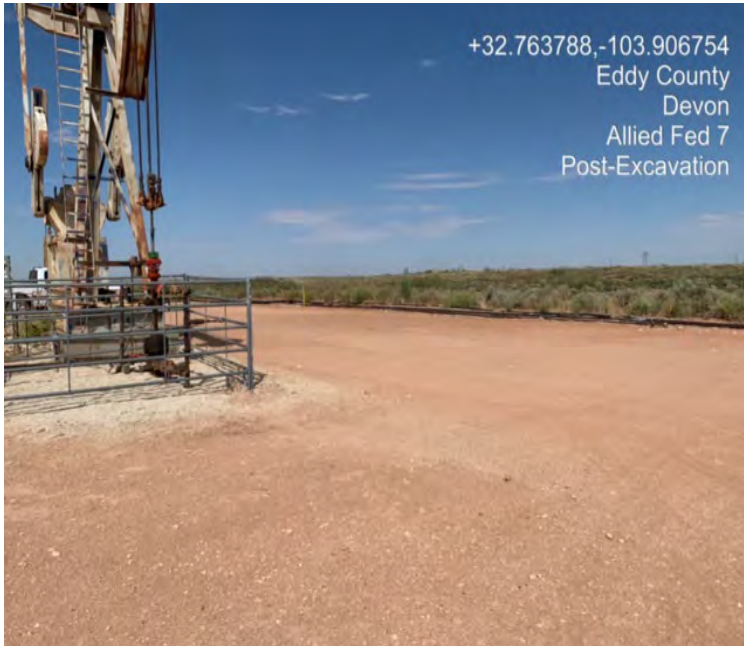
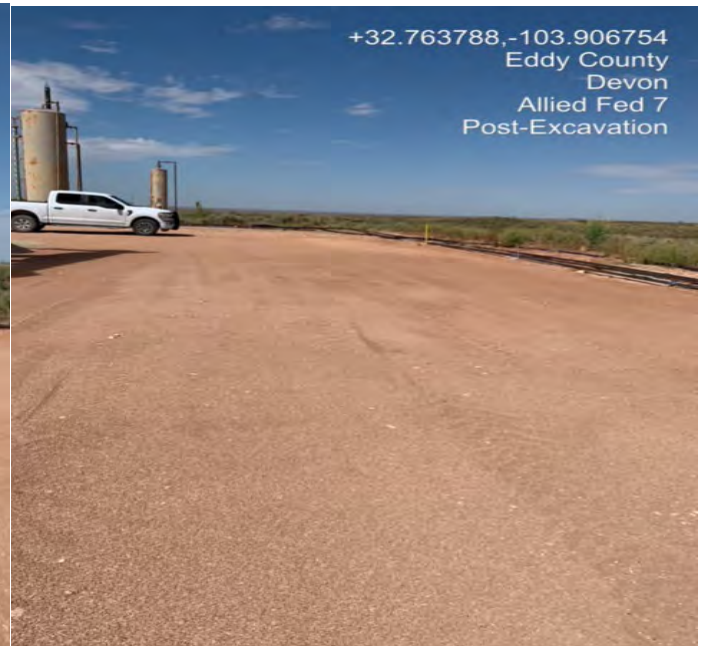
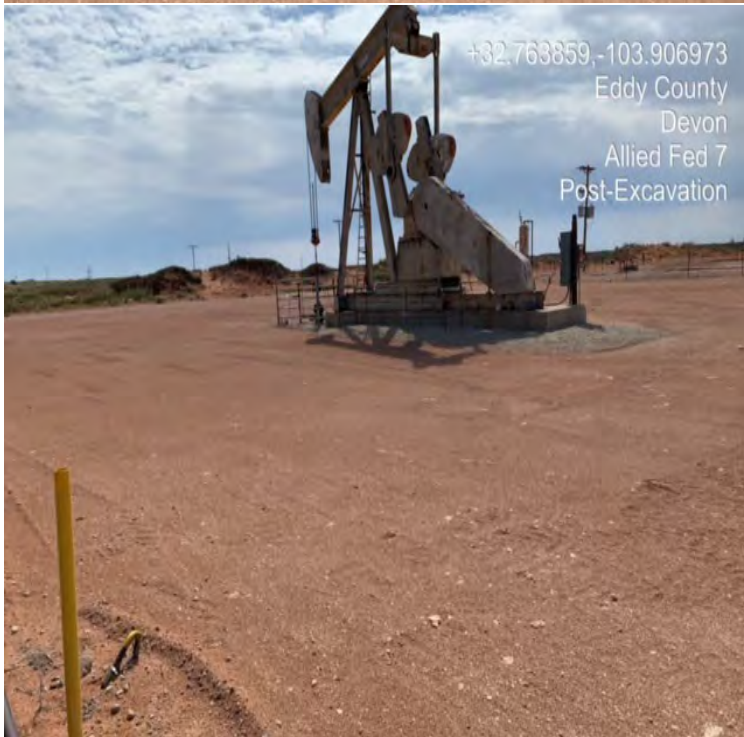
Post Excavation

Based on the sample results, the bottom and sidewalls were below NMOCD Closure Criteria 19.15.29 NMAC. The contaminated material was transported to Lea Land, an NMOCD approved disposal site. The excavation was then backfilled with clean like material, machine compacted and contoured to match the surrounding terrain. See Appendix D for Photographic Documentation.
