Closure Report
SRO State Com 064H (05.03.23)
Incident #NAPP2316652713
Eddy County, New Mexico
Unit E Sec 10 T26S R28E
32.0574°, -104.0808°

Crude Oil Release
Point of Release: Equipment Failure
Release Date: 05.03.2023
Volume Released: 0.2849 Barrels of Crude Oil
Volume Recovered: 0 Barrels of Crude Oil

Re: Closure Report
SRO State Com 064H (05.03.23)
Concho Operating, LLC
Site Location: Unit E, S10, T26S, R28E
(Lat 32.0574°, Long -104.0808°)
Eddy County, New Mexico

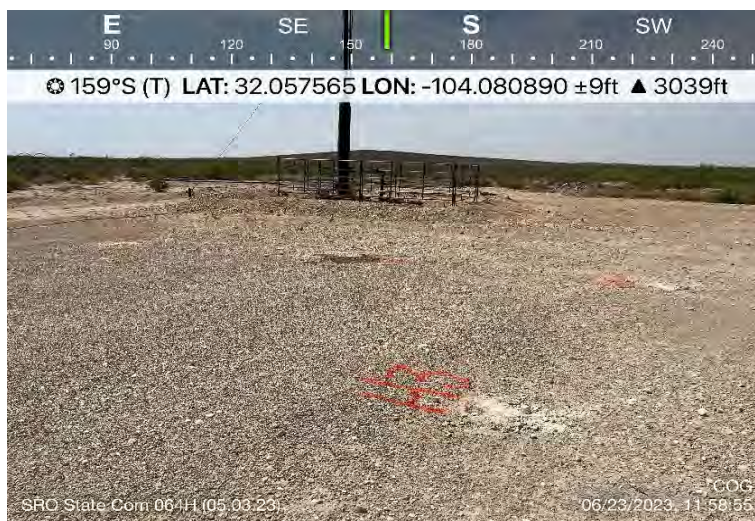
PHOTOGRAPHIC LOG**Concho Operating, LLC****Photograph No. 1****Facility:** SRO State Com 064H (05.03.23)**County:** Eddy County, New Mexico**Description:**

View South, area of H-3 through H-1.

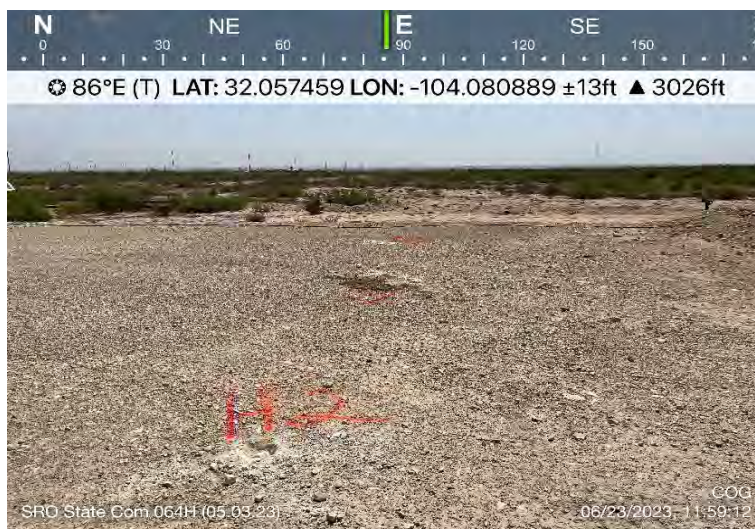
**Photograph No. 2****Facility:** SRO State Com 064H (05.03.23)**County:** Eddy County, New Mexico**Description:**

View East, area of H-2 through H-4.

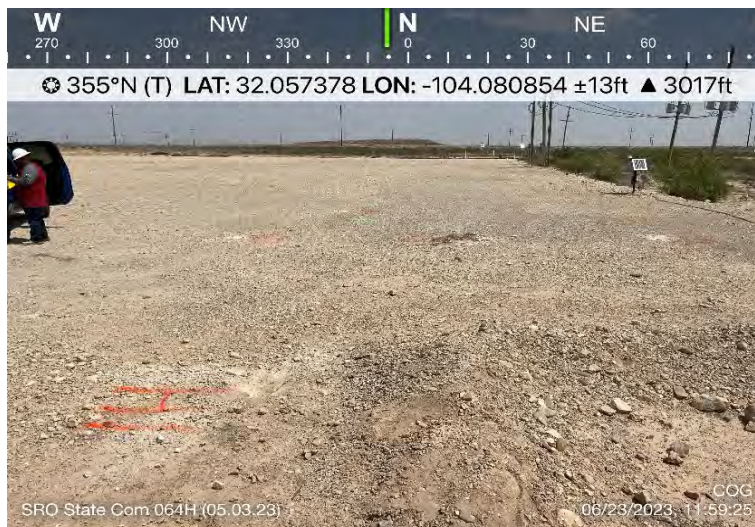
**Photograph No. 3****Facility:** SRO State Com 064H (05.03.23)**County:** Eddy County, New Mexico**Description:**

View North, area of H-1 through H-4.

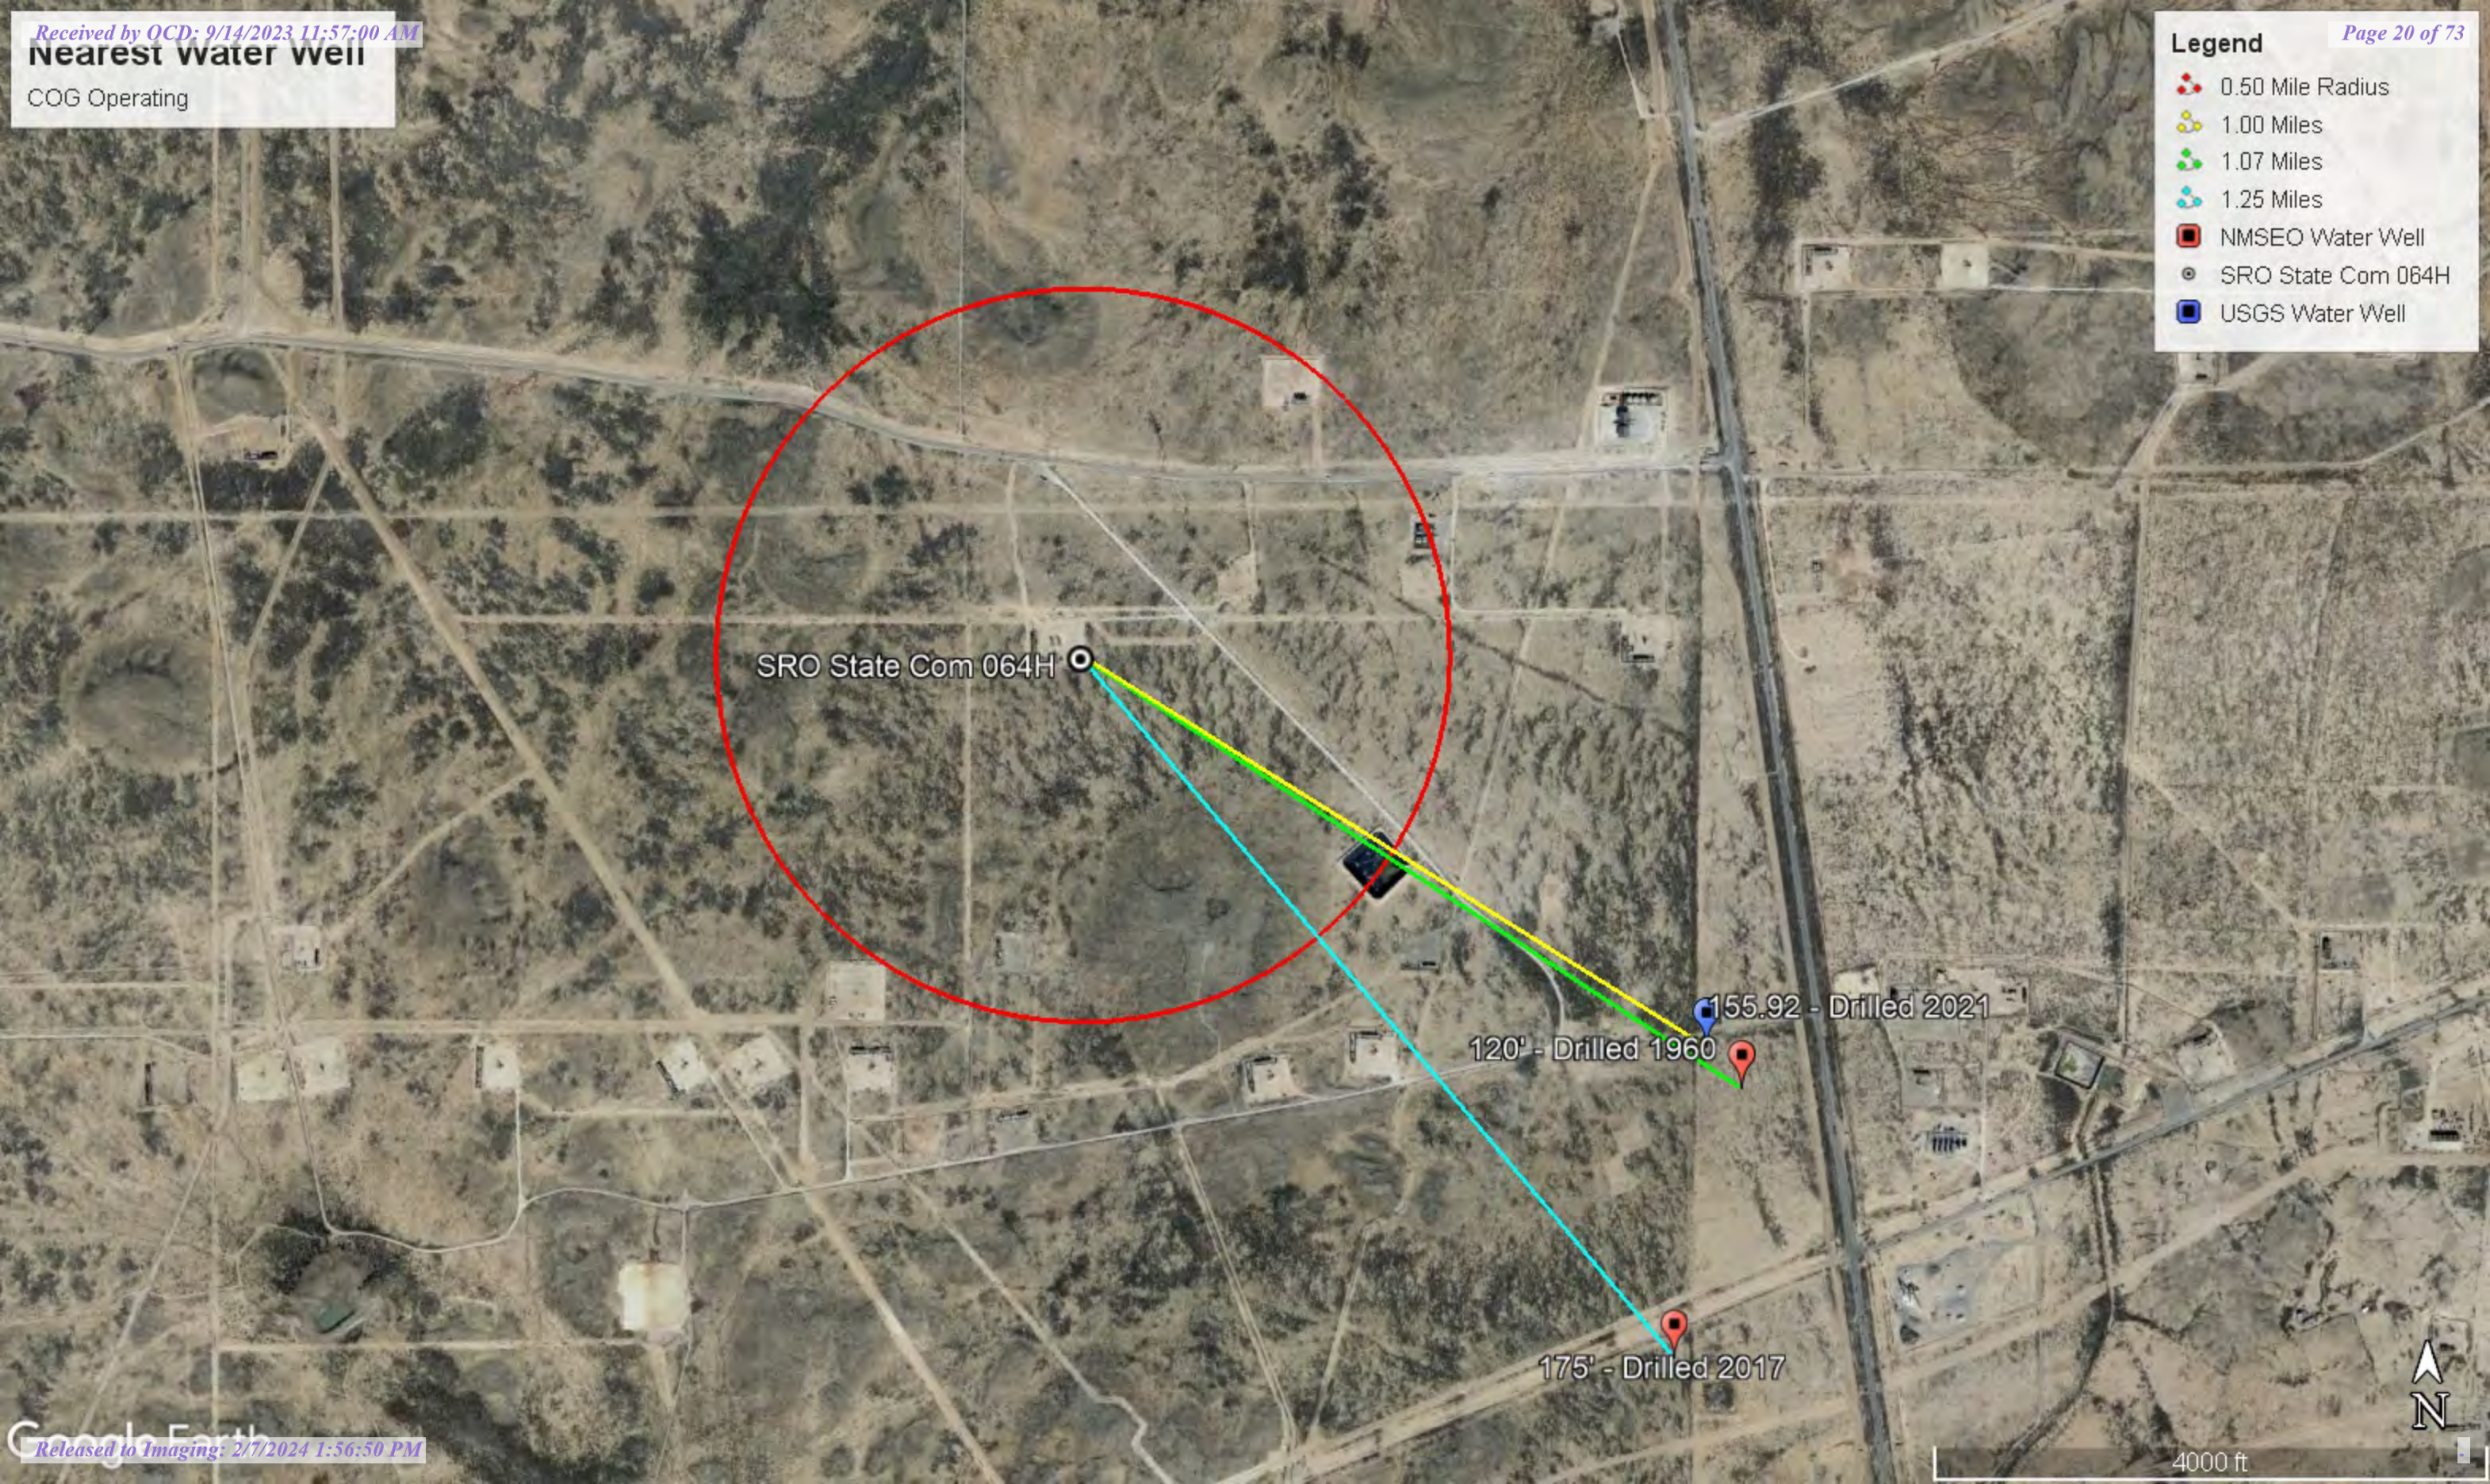
Nearest water well

- 0.50 Mile Radius
- 1.00 Miles
- 1.07 Miles
- 1.25 Miles
- NMSEO Water Well
- SRO State Com 064H
- USGS Water Well

The site is located within a medium karst area. Based on a review of the New Mexico Office of State Engineers and USGS databases, no known water sources are within a 0.50-mile radius of the location. The nearest identified well is approximately 1.00 miles Southeast of the site in S14, T26S, R28E and was drilled in 2021. The well has a reported depth to groundwater of 155.92 feet below the ground surface (ft bgs). A copy of the associated Summary Report is attached in Appendix D.
