**Re: Closure Request  
Rojo 14-17 Tank Battery  
Incident Number NAPP2106927983  
Lea County, New Mexico**

Ensolum, LLC (Ensolum), on behalf of BTA Oil Producers, LLC (BTA), has prepared this *Closure Request* to document assessment, delineation, and soil sampling activities performed at the Rojo 14-17 Tank Battery (Site). The purpose of the Site assessment, delineation, and soil sampling activities was to assess for the presence or absence of impacts to soil resulting from a historical produced water release at the Site. Based on field observations, field screening activities, and soil sample laboratory analytical results, BTA is submitting this *Closure Request*, describing Site assessment and delineation activities that have occurred and requesting closure for Incident Number NAPP2106927983.

BTA Oil Producers, LLC  
Closure Request  
Rojo 14-17 Tank Battery

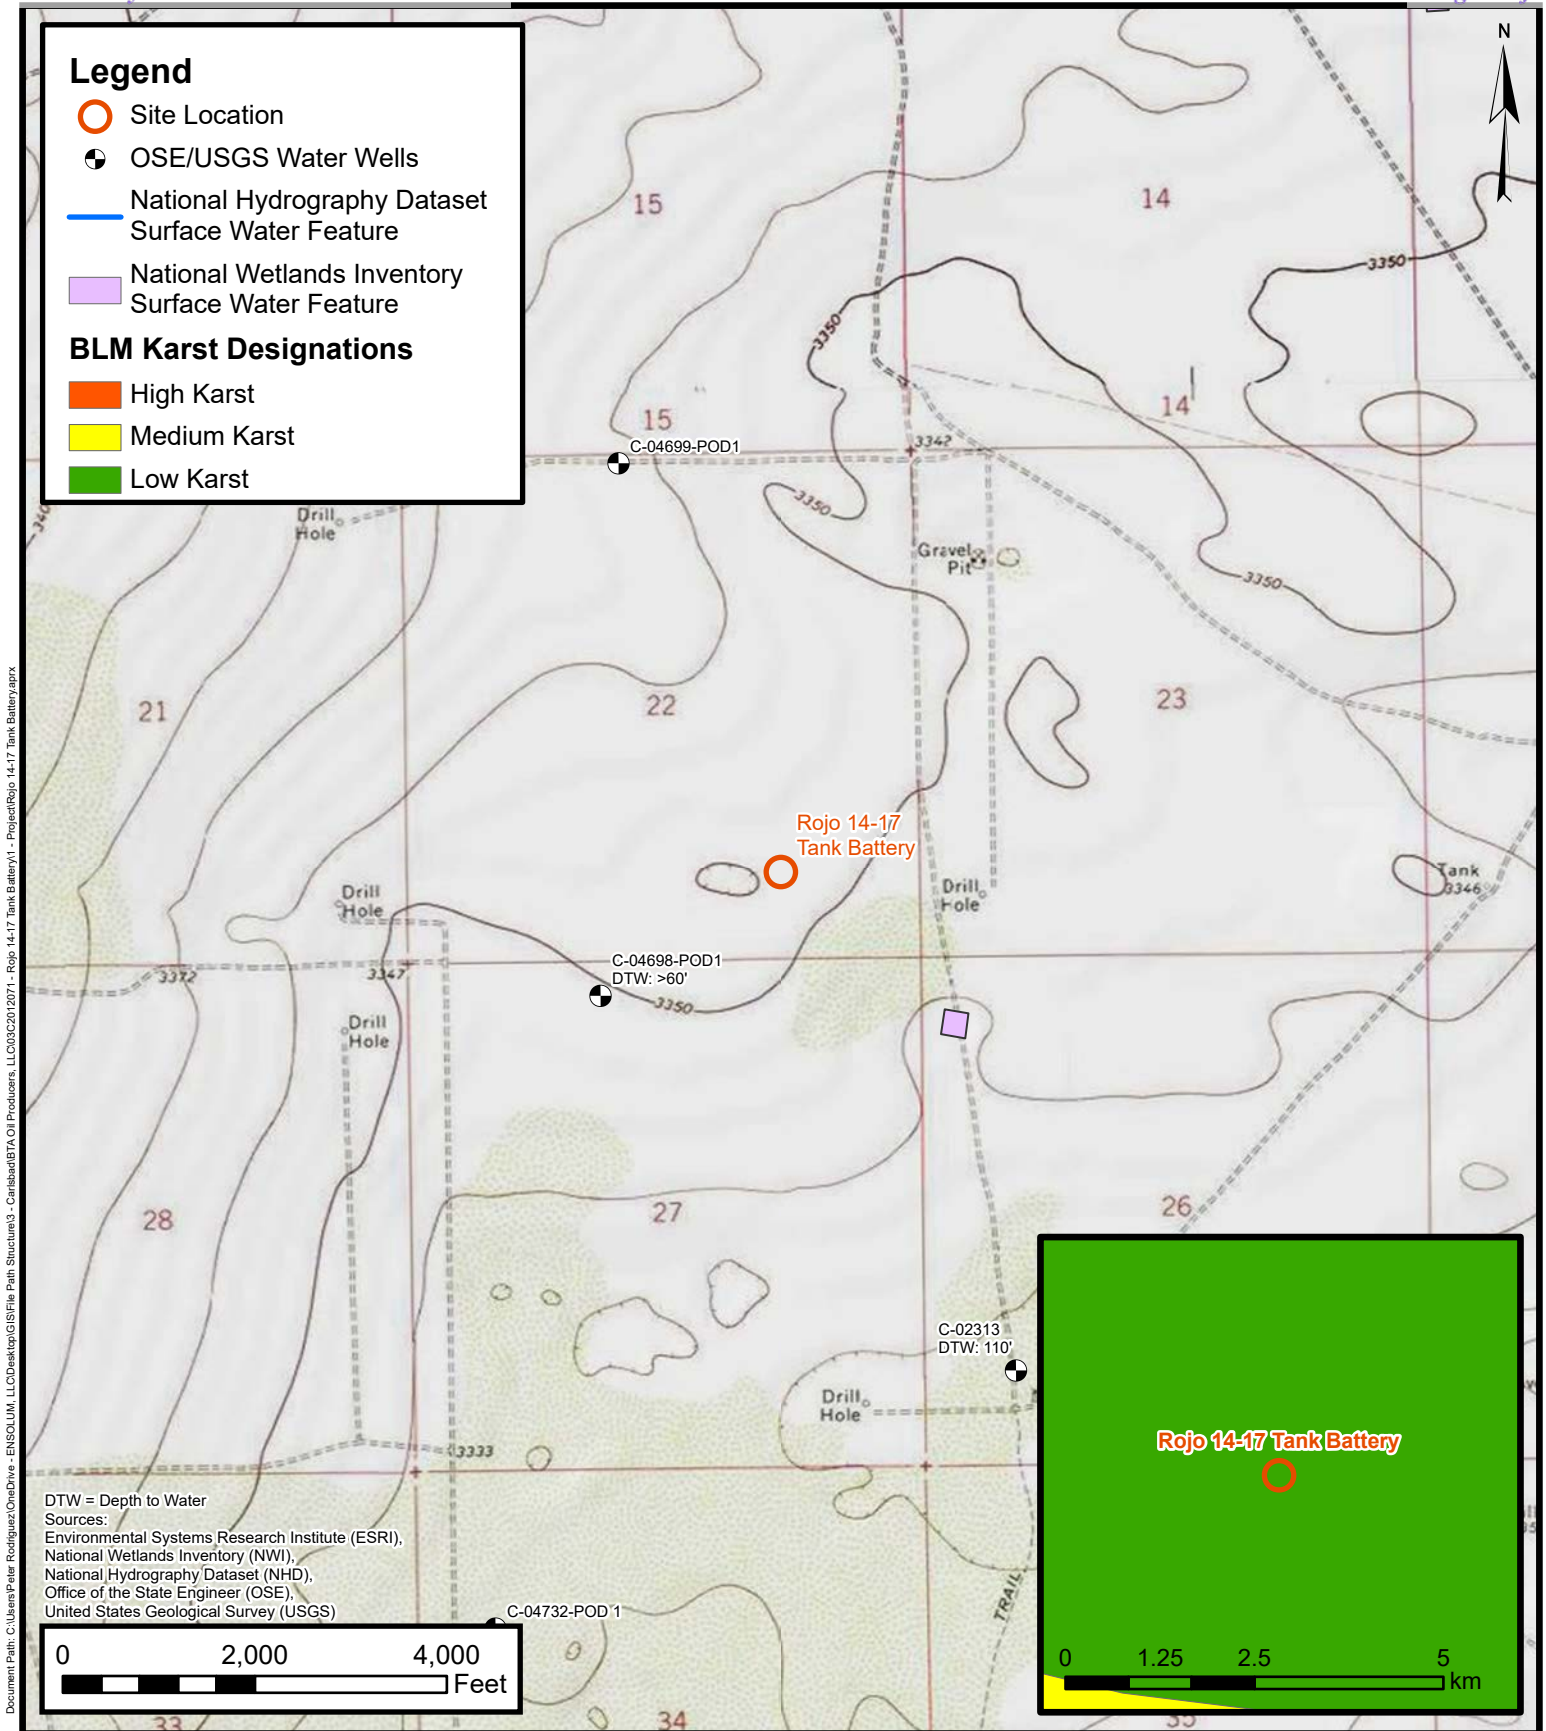
1

## Site Receptor Map

BTA Oil Producers  
Rojo 14-17 Tank Battery  
Incident Number: NAPP2106927983  
Unit P, Sec 22, T25S R33E  
Lea County, New Mexico

The Site was characterized to assess the applicability of Table I, Closure Criteria for Soils Impacted by a Release, of Title 19, Chapter 15, Part 29 (19.15.29) of the New Mexico Administrative Code (NMAC). Results from the characterization desktop review are presented on page 3 of the Form C-141, Site Assessment/Characterization. Potential Site receptors are identified on Figure 1.

groundwater determination are presented on Figure 1. The associated well records are included in Appendix A.

The closest continuously flowing or significant watercourse is greater than 300 feet from the Site. The Site is greater than 200 feet from a lakebed, sinkhole, or playa lake and greater than 300 feet from an occupied residence, school, hospital, institution, church, or wetland. The Site is greater than 1,000 feet to a freshwater well or spring and is not within a 100-year floodplain or overlying a subsurface mine. The Site is not underlain by unstable geology (low potential karst designation area). Site receptors are identified on Figure 1.

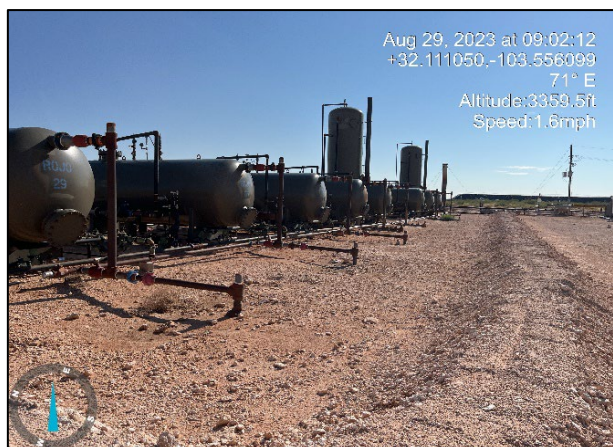
Photograph: 1 Date: 8/29/2023  
Description: Release area during initial assessment  
View: East

On August 29, 2023, Ensolum personnel were at the Site to evaluate the historical release area based on information provided on the Form C-141 and visual observations. No visible indications of the historical release were observed during the Site visit. Eight assessment soil samples (SS01 through SS08) were collected within and around the inferred release area, at a depth of approximately 0.5 feet bgs, to assess for the presence or absence of impacted soil resulting from the historical release. The soil samples were field screened for volatile organic compounds (VOCs) utilizing a calibrated photoionization detector (PID) and chloride using Hach® chloride QuanTab® test strips. The soil sample locations were mapped utilizing a handheld Global Positioning System (GPS) unit and are depicted on Figure 2. Photographic documentation was completed during the Site visit and a photographic log is included as Appendix B.

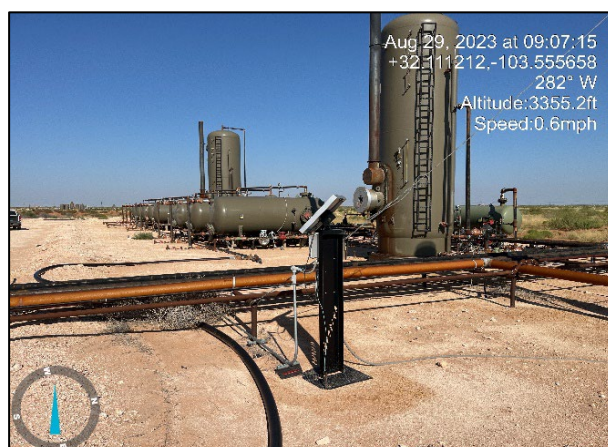
Photograph: 2 Date: 8/29/2023  
Description: Release area during initial assessment  
View: West

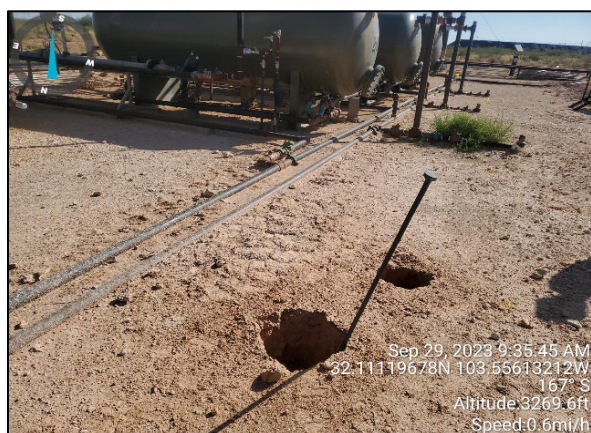
Photograph: 3 Date: 9/29/2023  
Description: Delineation activities  
View: South

On September 29, 2023, Ensolum personnel returned to the Site to complete vertical delineation activities to confirm the absence of impacted soil within the historical release area. Boreholes were advanced via hydrovac at the location of assessment samples SS01 through SS04. The boreholes were advanced to depths ranging from 2 feet to 4 feet bgs. Soil from the boreholes was field screened at 1-foot intervals for VOCs and chloride. Final depth of the boreholes was determined by field screening results indicating compliance with the most stringent Table I Closure Criteria or refusal (SS01). Field screening results and observations were logged on lithologic/soil sampling logs, which are included in Appendix C. Discrete delineation soil samples SS01A through SS04A were collected from the boreholes at depths ranging from 2 feet to 4 feet bgs. The delineation soil samples were collected, handled, and analyzed following the same procedures previously described. The delineation soil sample locations were mapped utilizing a handheld GPS unit and are depicted on Figure 2. Photographic documentation was completed during the Site visit and a photographic log is included in Appendix B.

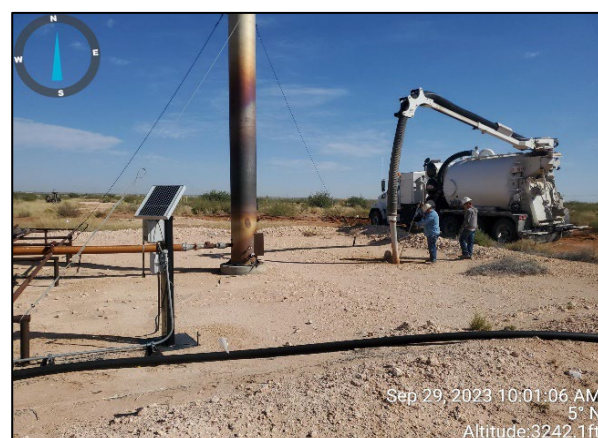
Photograph: 4 Date: 9/29/2023  
Description: Delineation activities  
View: North
