**Re: Closure Request  
Margarita 13 Federal Com #005H  
Incident Number nAPP2306635043  
Lea County, New Mexico**

Ensolum, LLC (Ensolum), on behalf of Matador Production Company (Matador), has prepared this *Closure Request* to document assessment, excavation, and soil sampling activities at the Margarita 13 Federal Com #005H (Site). The purpose of the Site assessment and soil sampling activities was to assess for the presence or absence of impacts to soil following a release of produced water onto the well pad. Based on field observations, field screening activities, and soil sample laboratory analytical results, Matador is submitting this *Closure Request*, describing Site assessment, excavation, and delineation activities that have occurred and requesting no further action for Incident Number nAPP2306635043.

## Site Receptor Map

Matador Production Company  
Margarita 13 Federal #005H  
Incident Number: nAPP2306635043  
Unit G, Section 13, T 21S, R 32E  
New Mexico

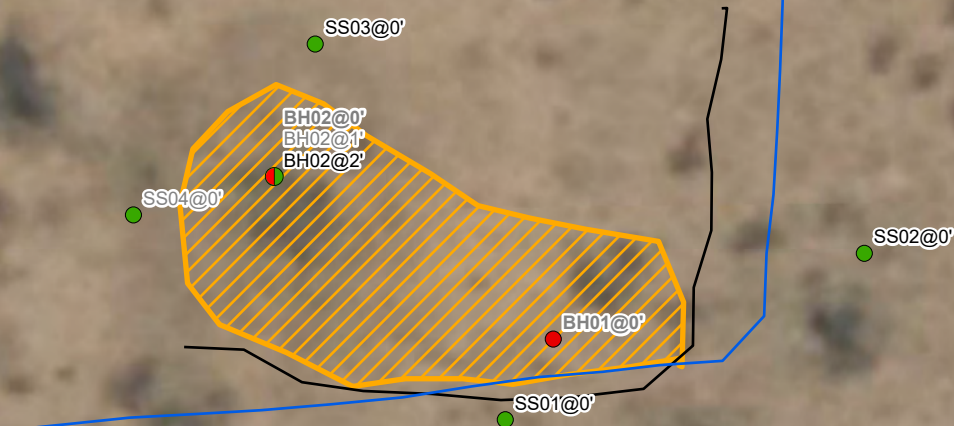
**FIGURE**  
**2**

On August 24, 2023, Ensolum personnel were at the Site to oversee vertical delineation activities. Boreholes were advanced via hand auger within the release extent to assess the vertical extent of the release. Borehole (BH01) was advanced to a depth of 0.5 feet bgs and borehole BH02 was advanced to a depth of 2 feet bgs. Borehole (BH01) hit refusal at a depth of 0.5 feet bgs due to a layer of indurated

caliche. Delineation soil samples were collected from each borehole at depths ranging from 0 feet to 2 feet bgs. Soil from the delineation boreholes were field screened for chloride utilizing the MOHR titration method. Field screening results and observations for the boreholes were logged on lithologic/soil sampling logs, which are included in Appendix D. The potholes and delineation soil sample locations are depicted on Figure 2.

Laboratory analytical results for all delineation soil samples indicated all COC concentrations were compliant with the Closure Criteria; however, laboratory analytical results for delineation soil samples BH01 and BH02 at 0-foot bgs indicated the chloride concentrations exceeded the reclamation requirement. While these two soil samples are on pad in an active production area, the proximity of the soil to the pasture and the ability to access the soil for reclaiming was taken into consideration. Laboratory analytical results are summarized in Table 1 and laboratory analytical reports are included in Appendix E.

Sample ID @ Depth Below Ground Surface.  
 Samples in bold indicate sample exceeded applicable closure criteria.  
 Grey text indicate soil sample was removed during excavation activities.

**Delineation Soil Sample Locations**

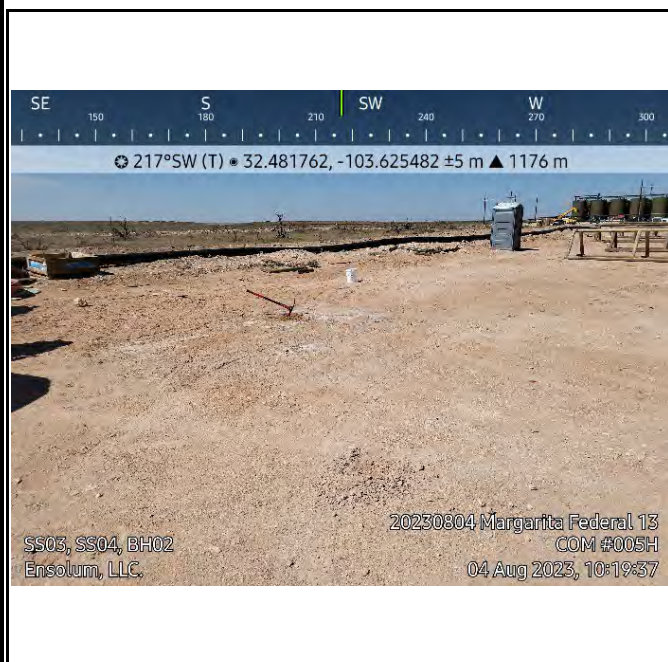
Photograph 1 Date: 08/04/2023  
Description: Site Assessment / Delineation Sampling  
View: Southwest

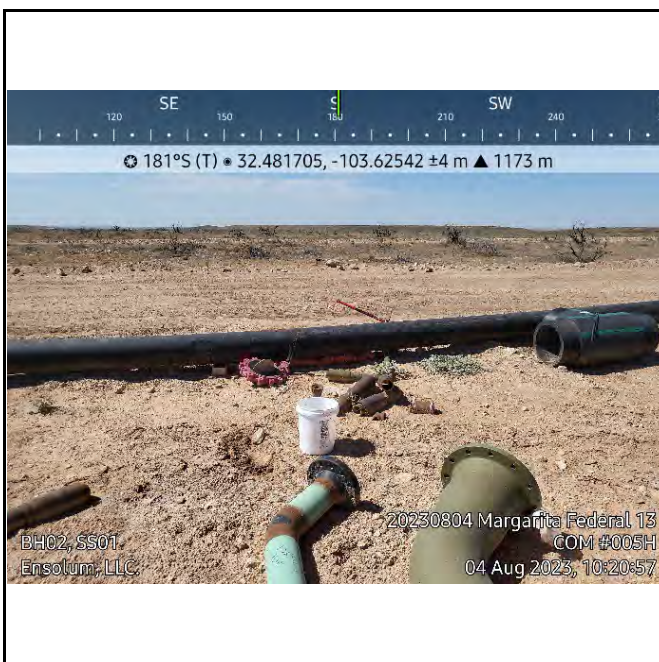
Photograph 2 Date: 08/04/2023  
Description: Site Assessment / Delineation Sampling  
View: South

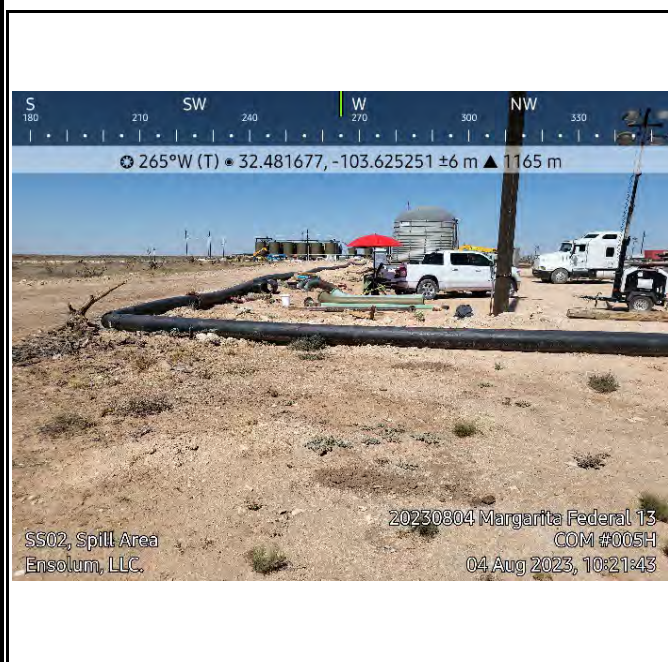
Photograph 3 Date: 08/04/2023  
Description: Site Assessment / Delineation Sampling  
View: West

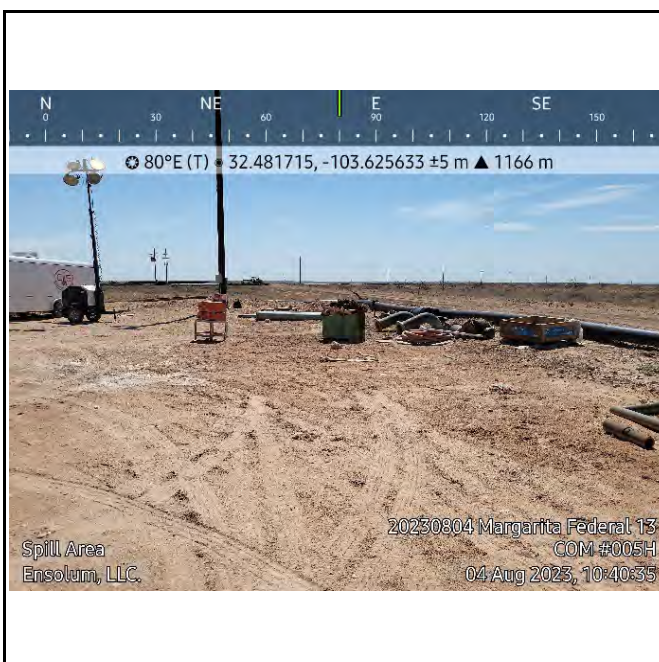
Photograph 4 Date: 08/04/2023  
Description: Site Assessment / Delineation Sampling  
View: Northeast

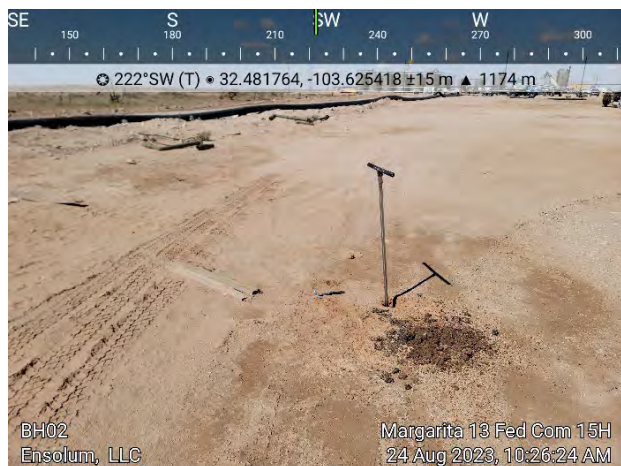
Photograph 5 Date: 08/24/2023  
Description: Vertical Delineation Sampling  
View: Southwest

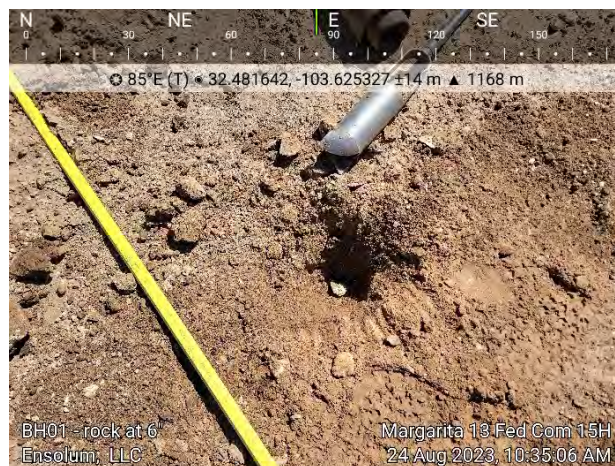
Photograph 6 Date: 08/24/2023  
Description: Vertical Delineation Sampling  
View: East

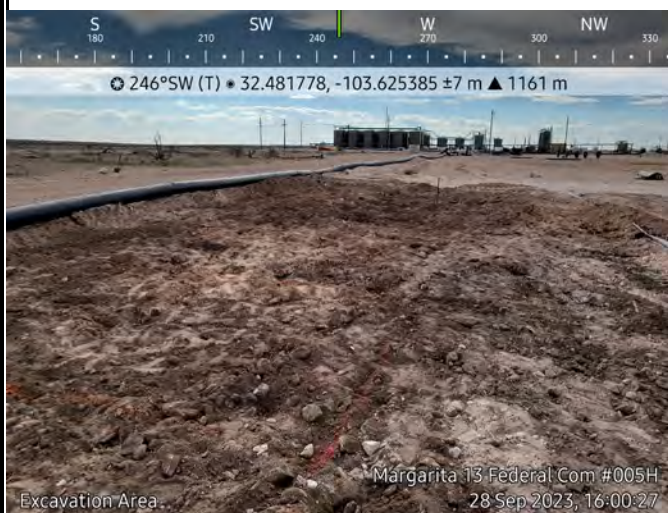
Photograph 7 Date: 09/28/2023  
Description: Excavation  
View: West

Starting on September 28, 2023, waste-containing soil was excavated from the release area as indicated by visible staining, field screening activities, and laboratory analytical results for delineation soil samples. Excavation activities were performed using a backhoe and belly dump trucks. The excavation occurred on the well pad near a transfer poly line. To direct excavation activities, Ensolum personnel screened soil for TPH and chloride utilizing a PetroFLAG® and Hach® chloride QuanTab® test strips, respectively.

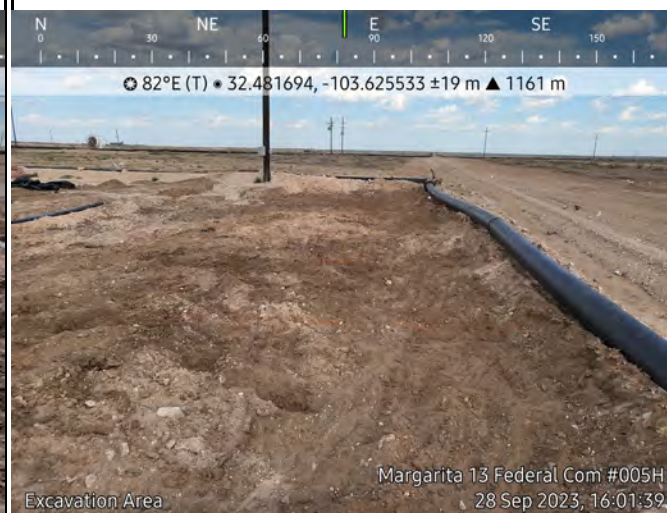
Photograph 8 Date: 09/28/2023  
Description: Excavation  
View: East

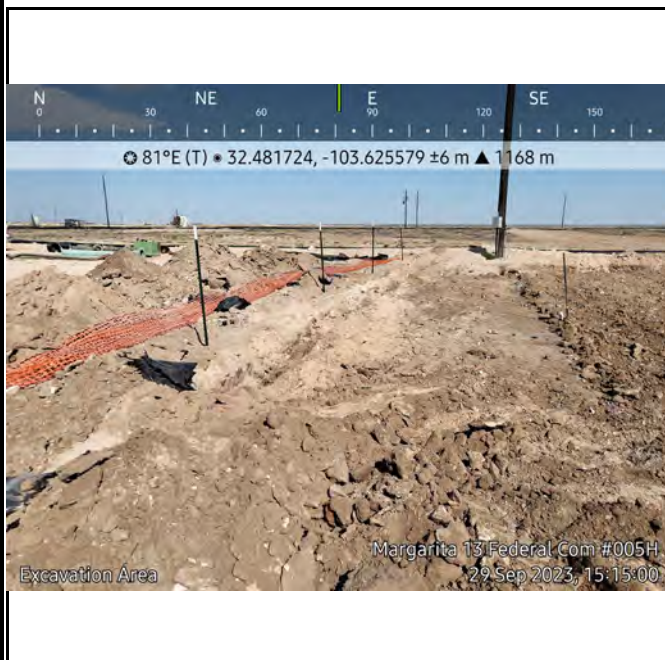
Photograph 9

Description: Excavation

View: East

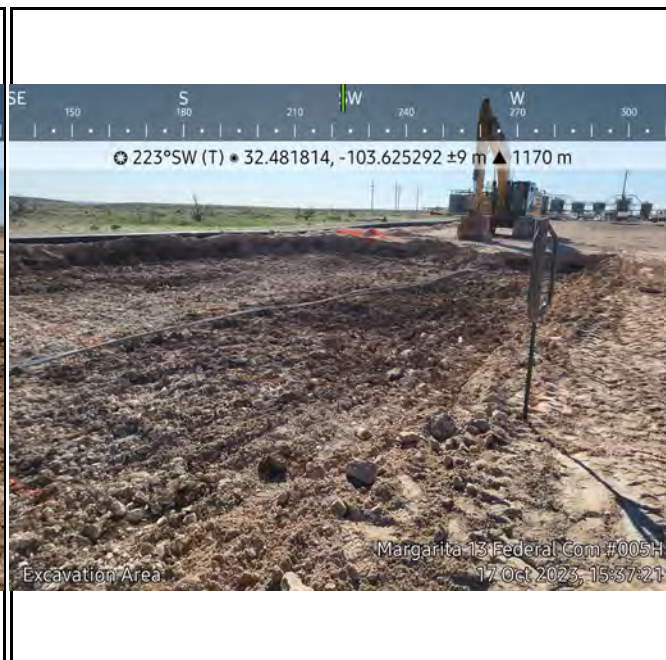
Photograph 10

Description: Excavation

View: West

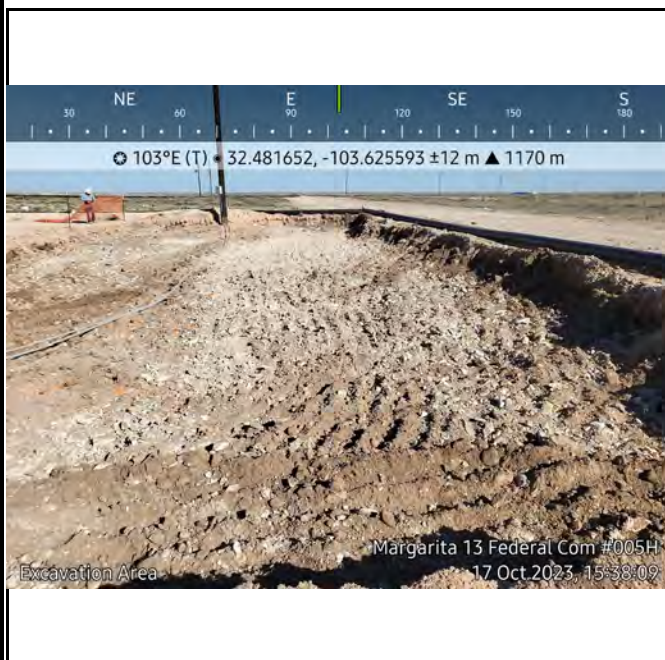
Photograph 11

Description: Excavation

View: East
