Incident ID	nAPP2316042324
District RP	
Facility ID	
Application ID

Site Assessment/Characterization

Based on laboratory analytical results and field activities conducted to date, Etech recommends Mewbourne Oil Company provide copies of this *Remediation Summary & Soil Closure Request* to the appropriate agencies and request closure be granted to the Santo Nino SWD Riser release site.

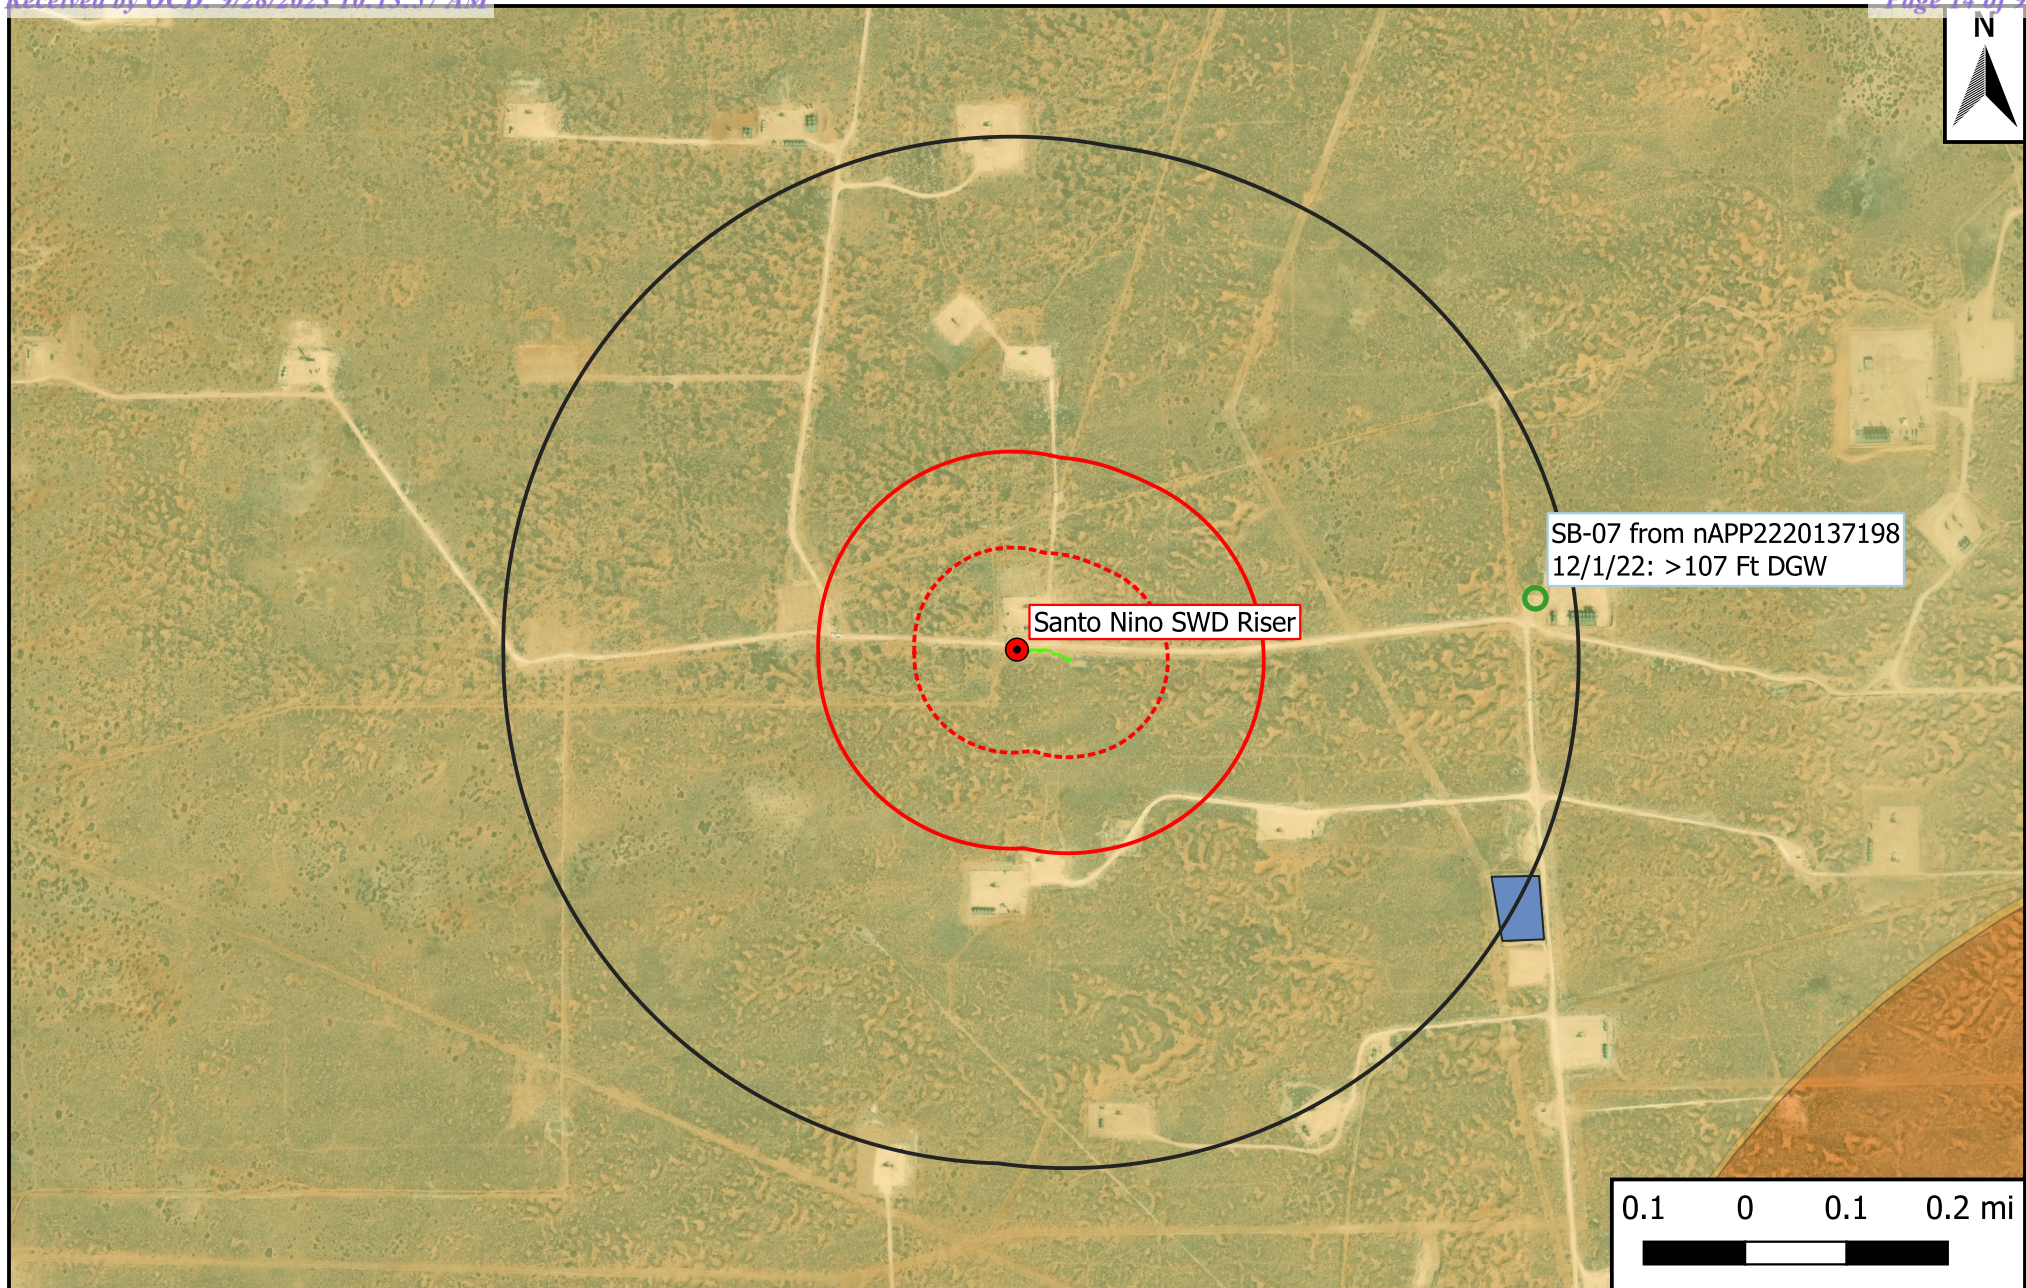
Figure 2

Site Characterization Map

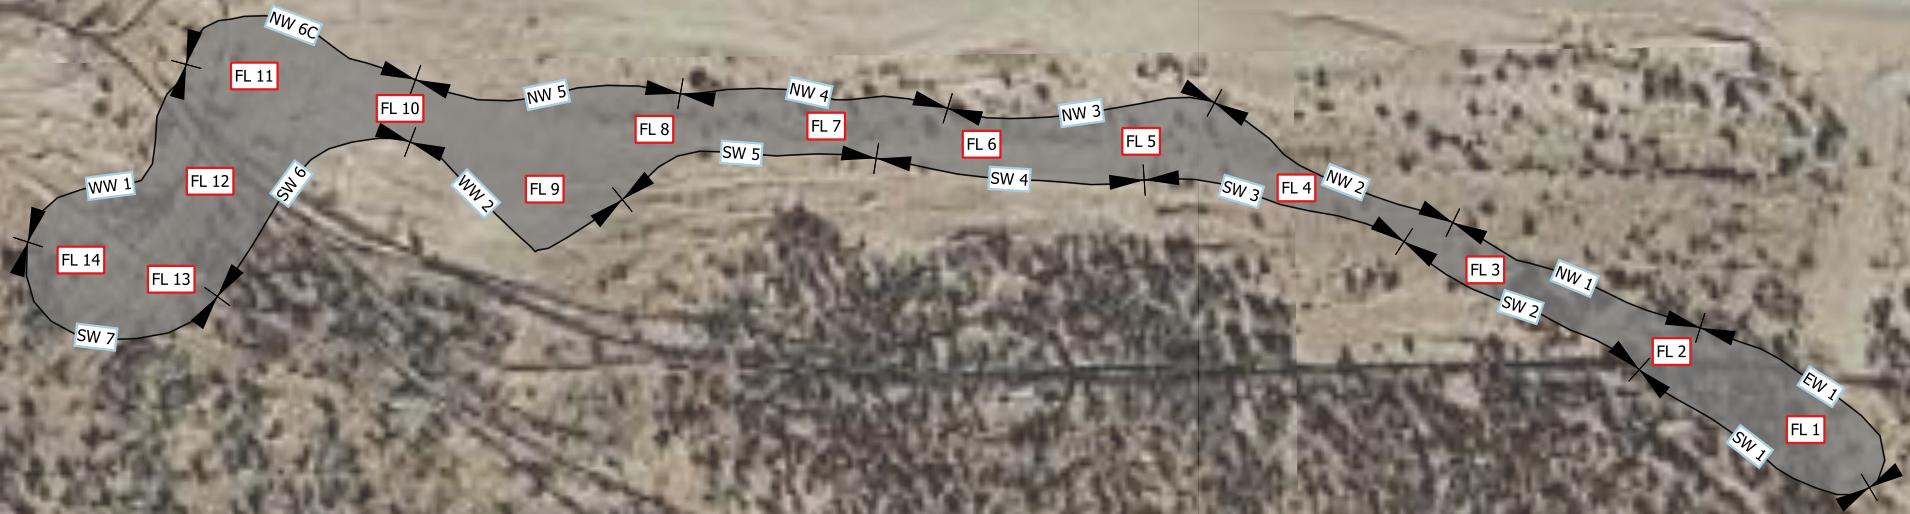
Figure 3

Site & Sample Location Map

- Excavation Extent
- Composite Floor Sample
- Composite Wall Sample

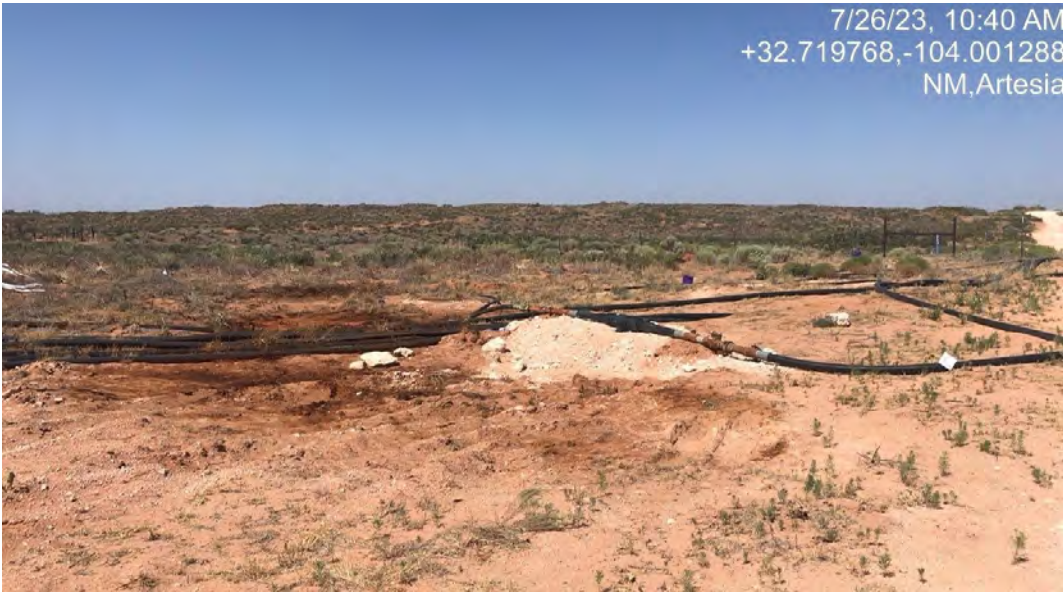
Photo Number: 1

Photo Direction: Southwest	
Photo Description: View of the affected area.

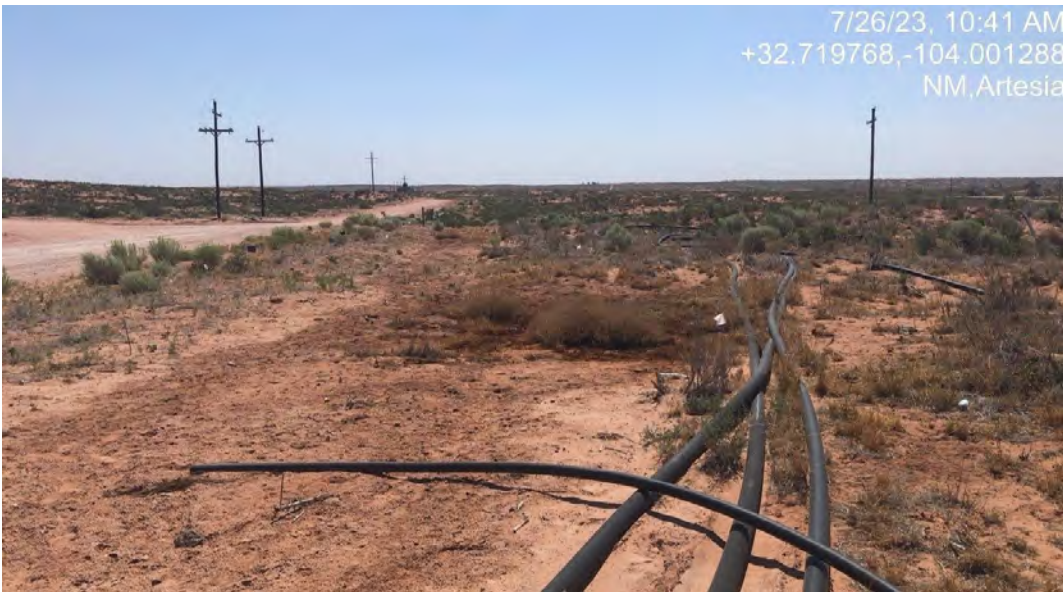
Photo Number: 2

Photo Direction: East	
Photo Description: View of the affected area.

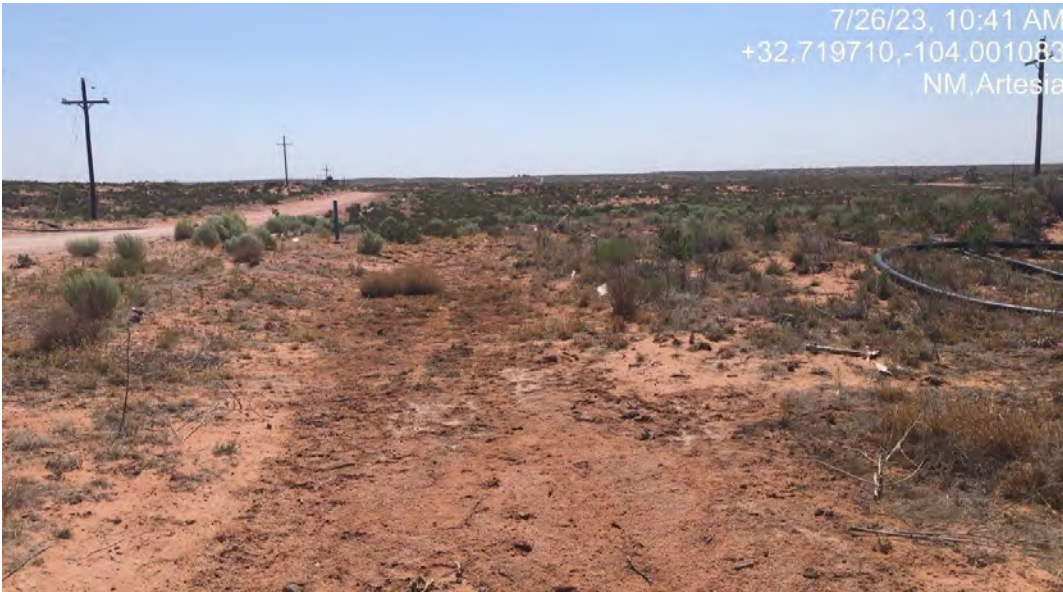
Photo Number: 3

Photo Direction: East	
Photo Description: View of the affected area.

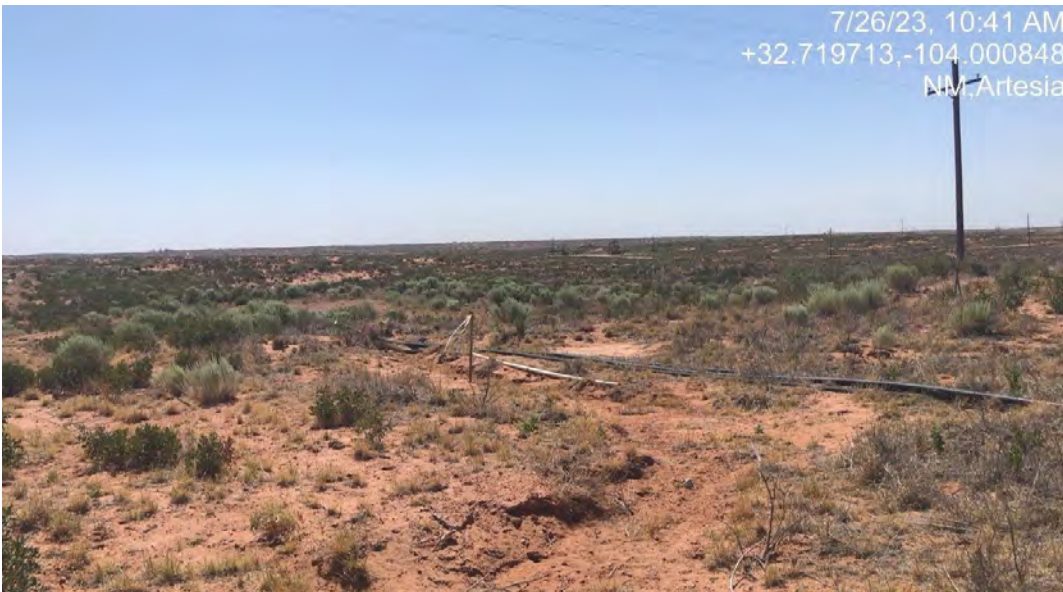
Photo Number: 4

Photo Direction: Southeast	
Photo Description: View of the affected area.

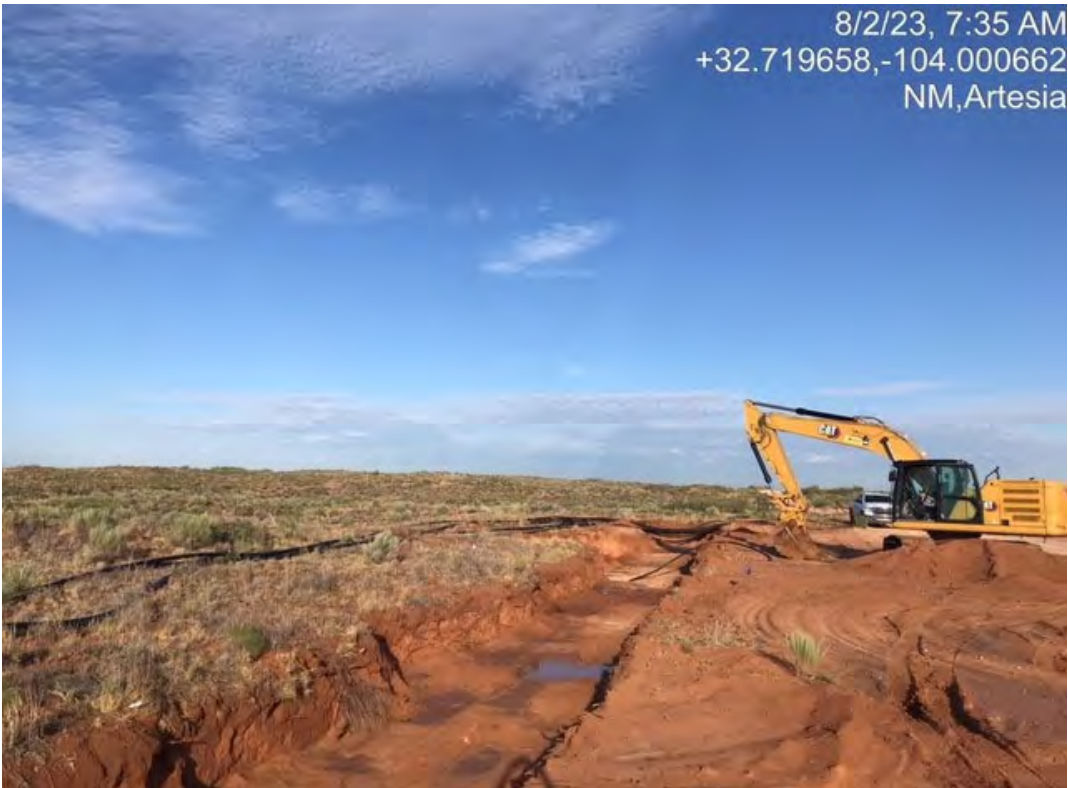
Photo Number: 8

<p>8/2/23, 7:35 AM +32.719658,-104.000662 NM,Artesia</p>
Photo Direction: West	
Photo Description: View of the excavated area.

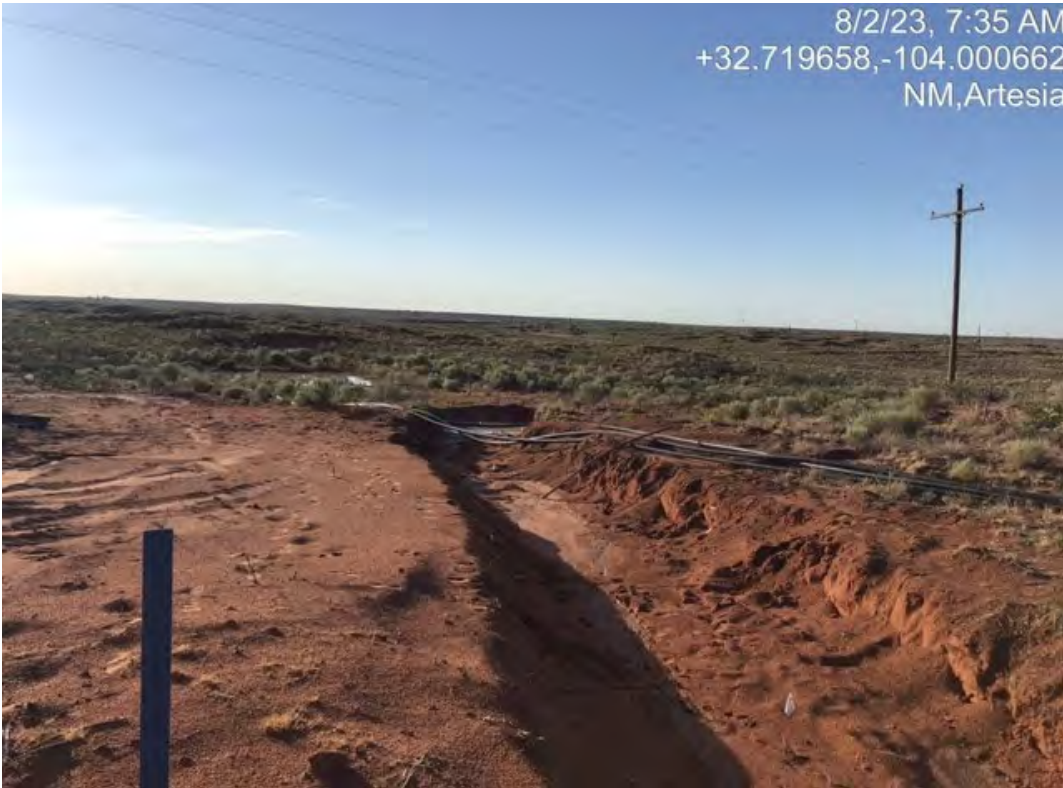
Photo Number: 9

<p>8/2/23, 7:35 AM +32.719658,-104.000662 NM,Artesia</p>
Photo Direction: Southeast	
Photo Description: View of the excavated area.

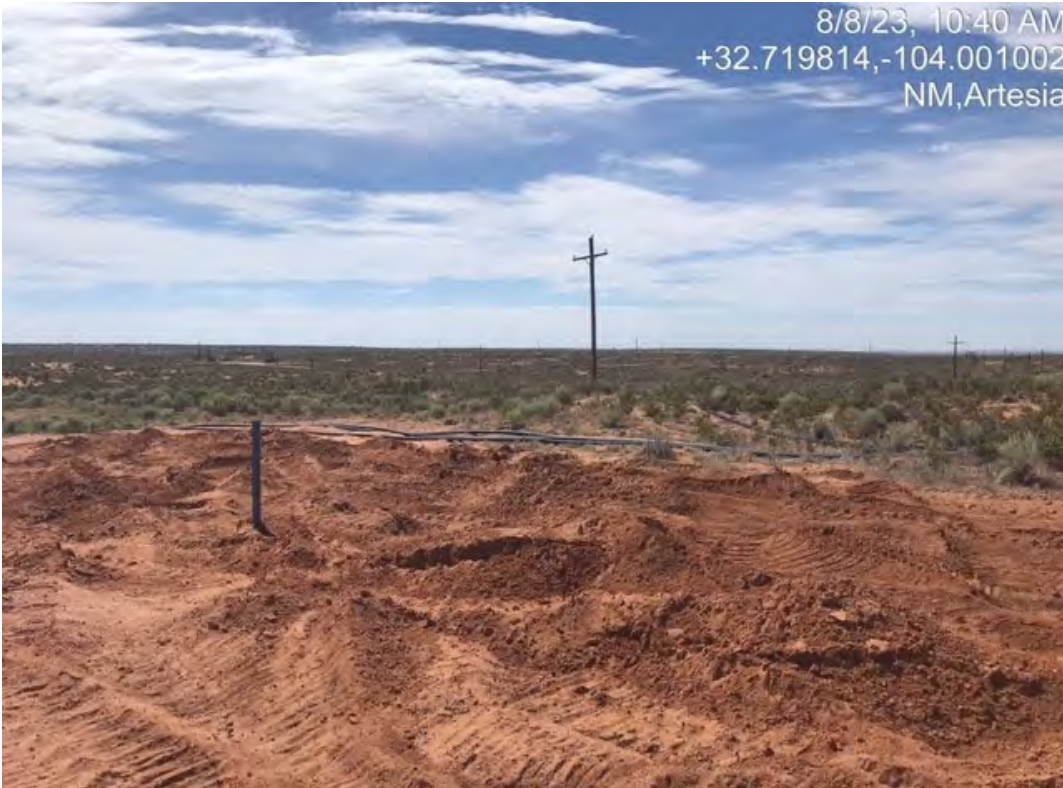
Photo Number: 10

<p>8/8/23, 10:40 AM +32.719814,-104.001002 NM,Artesia</p>
Photo Direction: Southeast	
Photo Description: View of the remediated area after backfill and regrading.

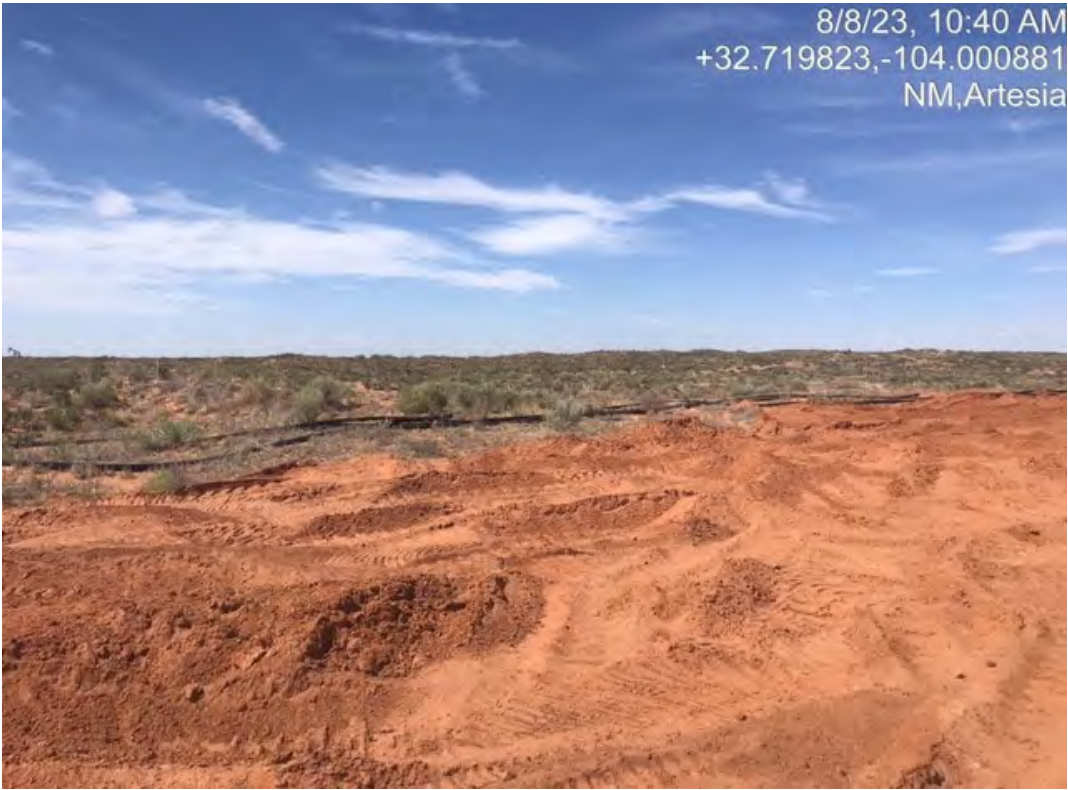
Photo Number: 11

Photo Direction: South	
Photo Description: View of the remediated area after backfill and regrading.

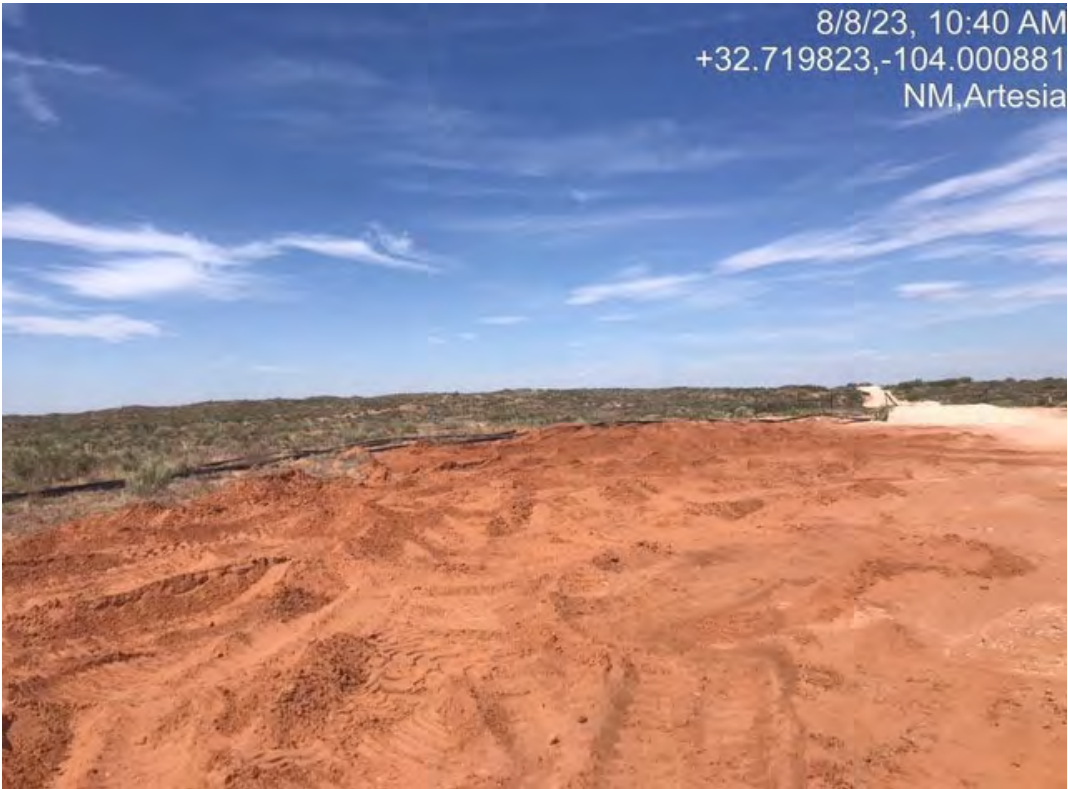
Photo Number: 12

Photo Direction: Southwest	
Photo Description: View of the remediated area after backfill and regrading.

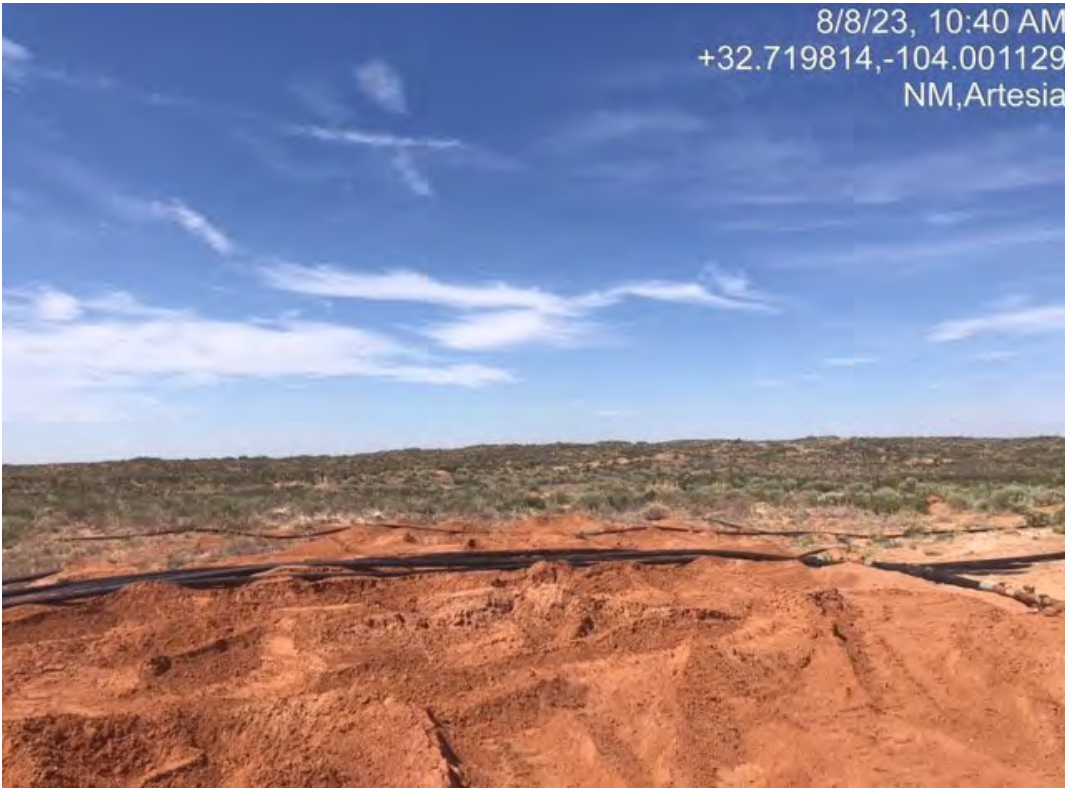
Photo Number: 13	<div>8/8/23, 10:40 AM +32.719814,-104.001129 NM,Artesia</div>

Photo Direction: South	
Photo Description: View of the remediated area after backfill and regrading.

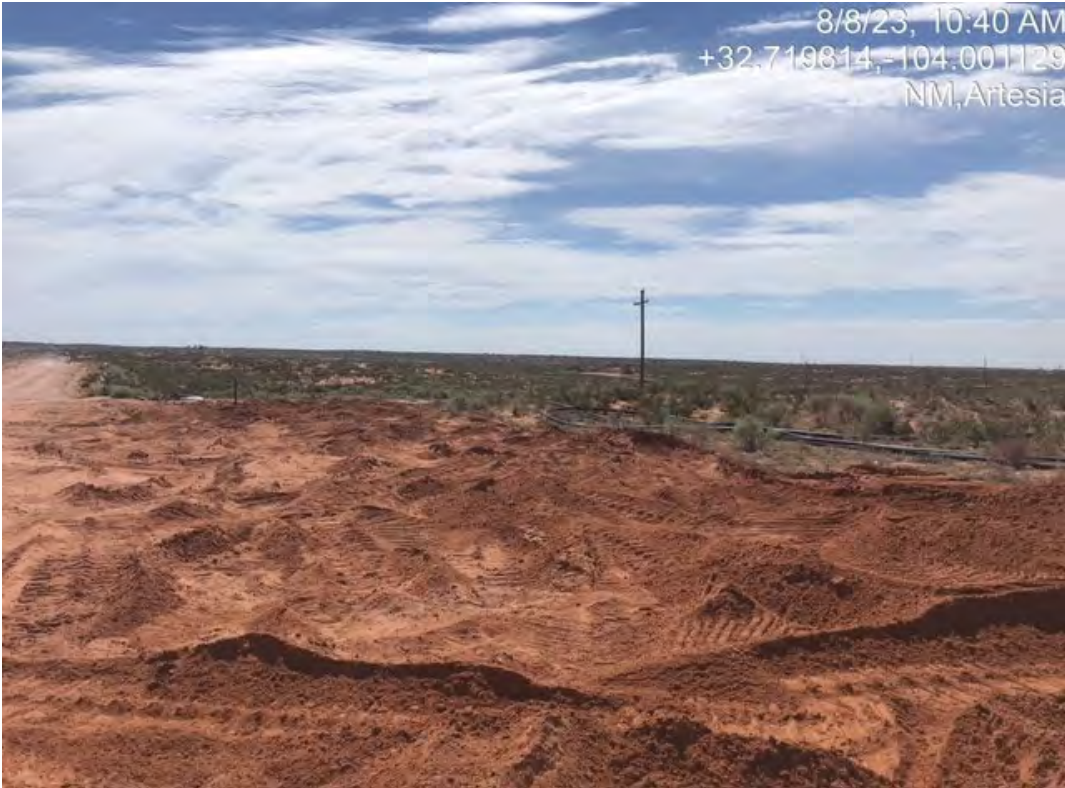
Photo Number: 14	<div>8/8/23, 10:40 AM +32.719814,-104.001129 NM,Artesia</div>

Photo Direction: Southeast	
Photo Description: View of the remediated area after backfill and regrading.
