CLOSURE REPORT

Lost Tank 3 Federal #005

**Eddy County, New Mexico
32.42244 N, 103.76144 W
Incident ID No. nAPP2323352221**

September 25, 2023
Ensolum Project No. 03B1417090

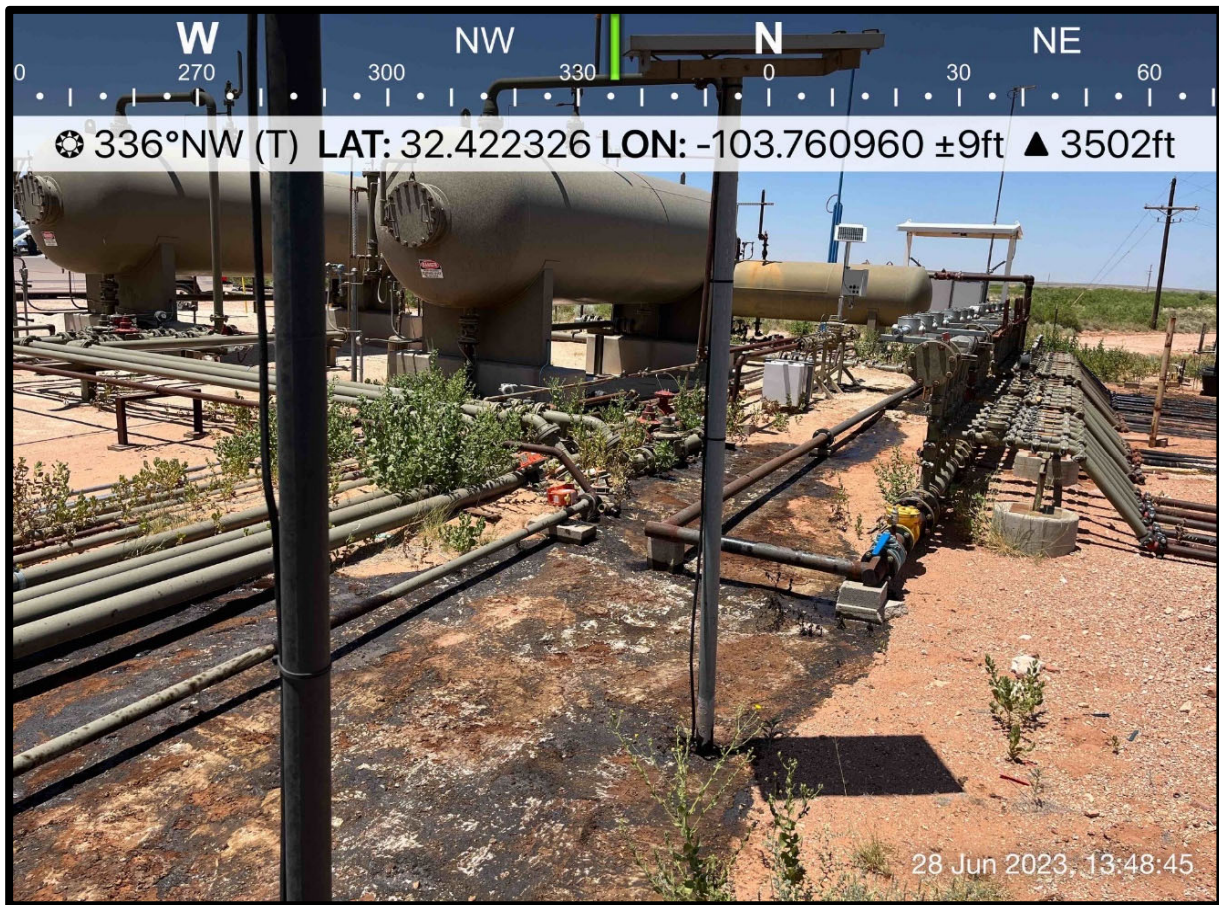
View of the initial release area, facing northwest (June 28, 2023).

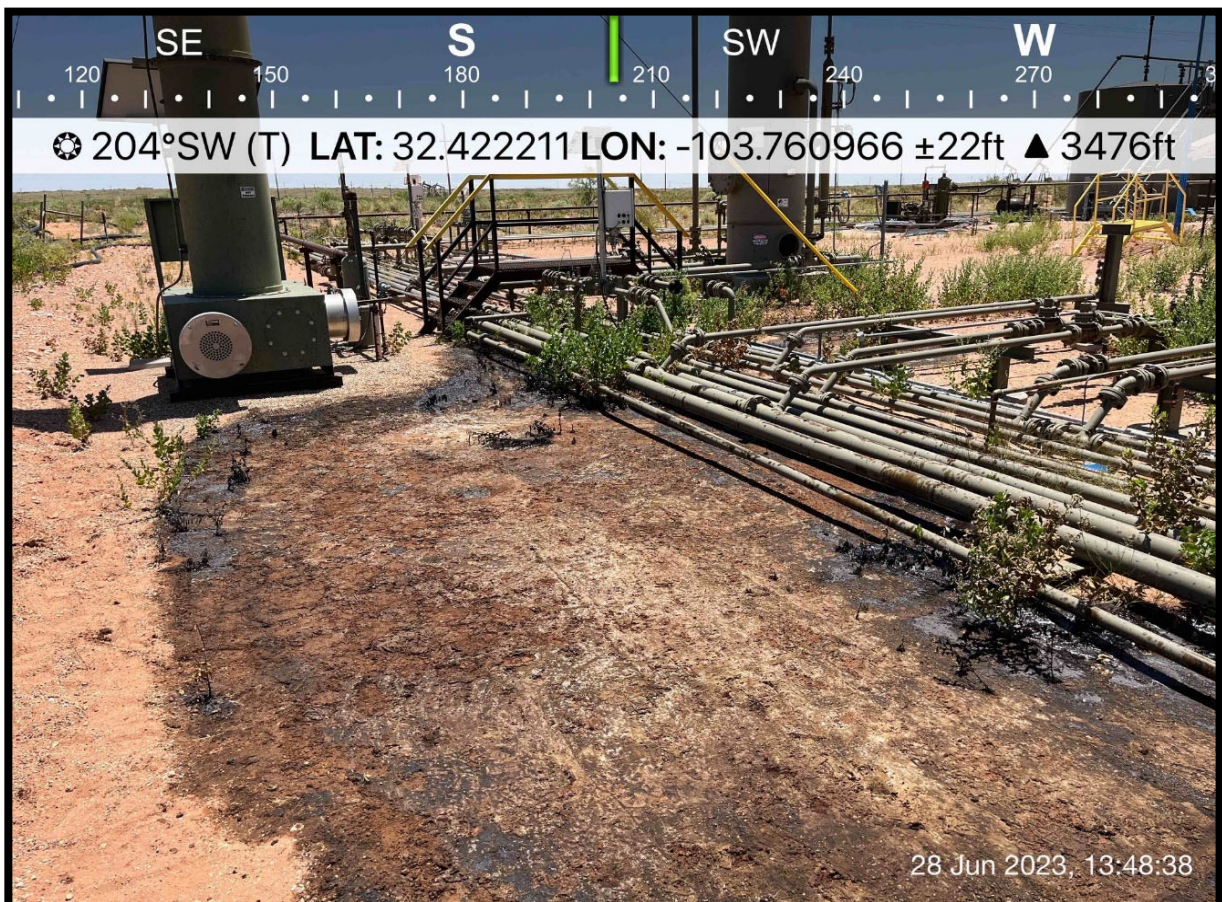
View of the initial release area, facing southwest (June 28, 2023).

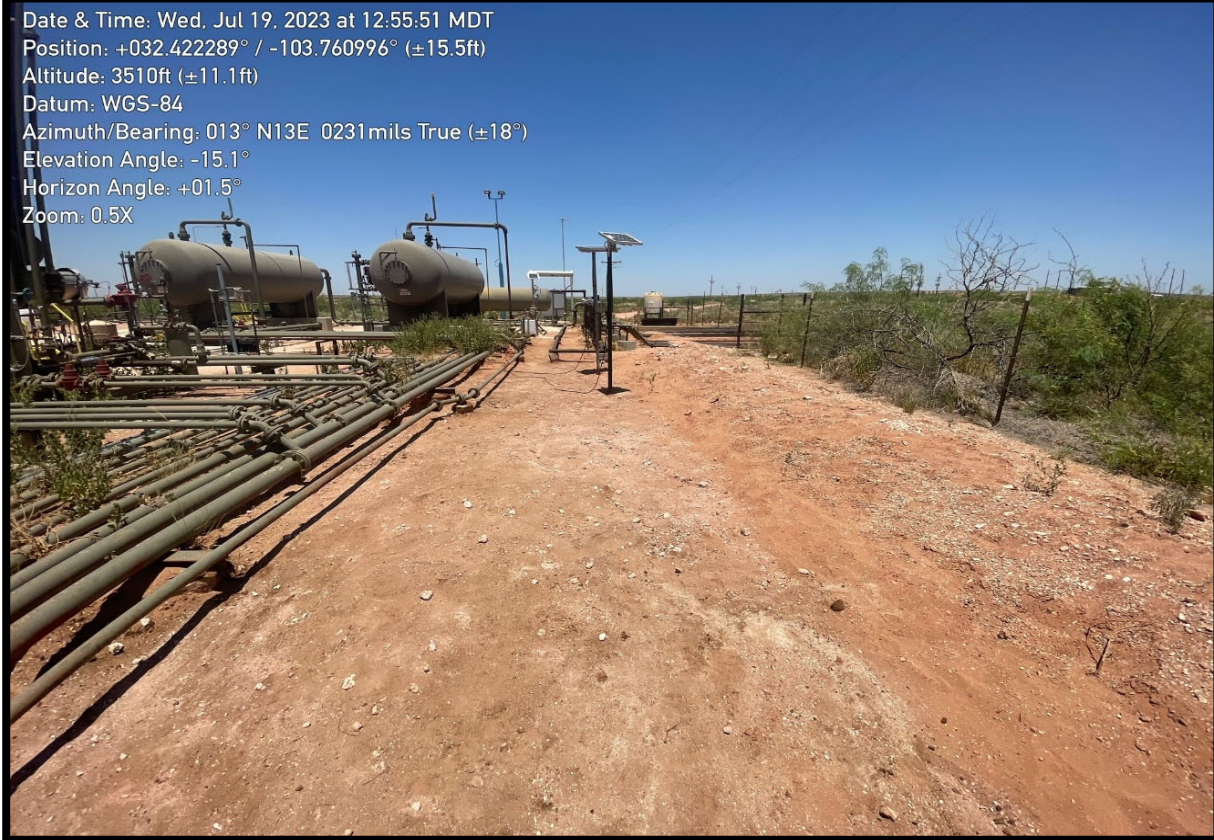
View of the excavation area, facing north (July 19, 2023).

The final excavation area measured approximately 152 feet long with a width that varied between five to 15 feet wide. The depth of the excavation measured approximately 0.25 to three feet bgs.

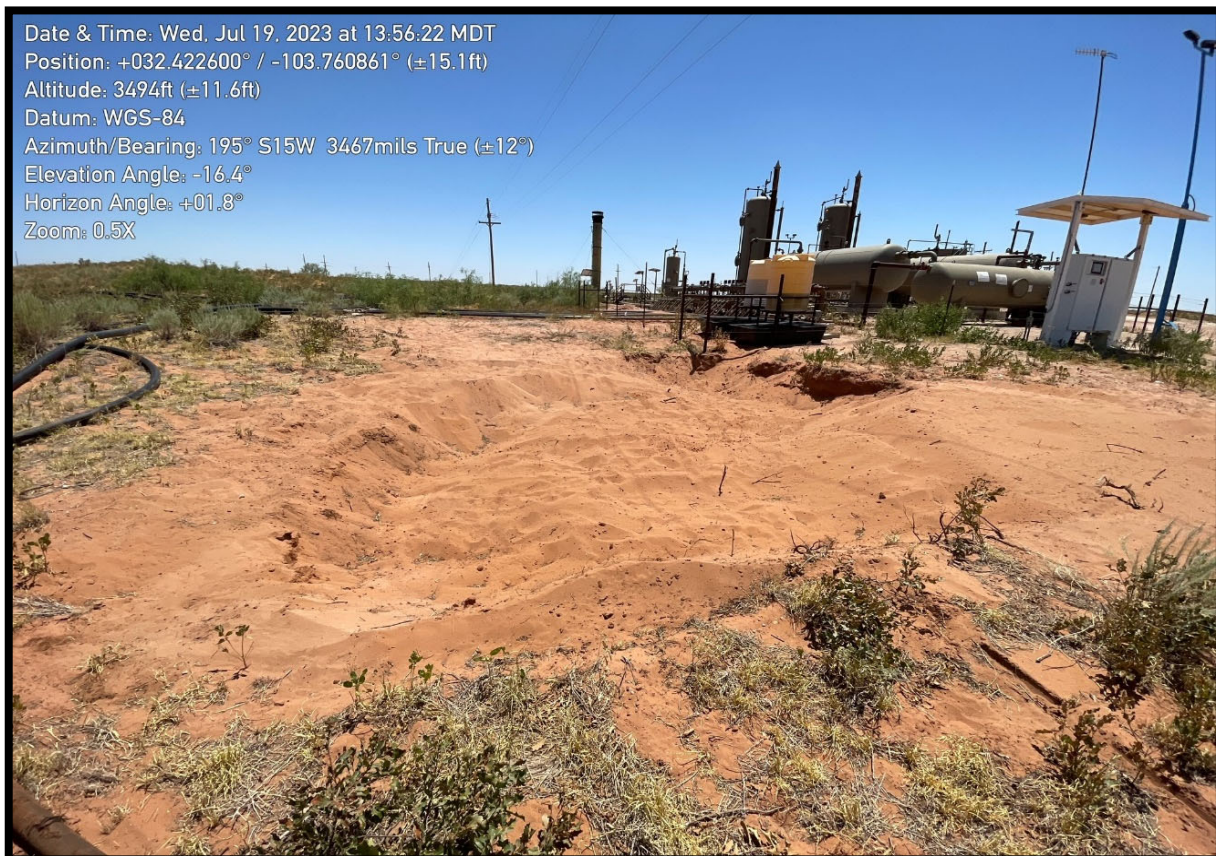
View of the excavation area, facing south (July 19, 2023).
