Closure Report

Cotton Draw Unit #089
Eddy County, New Mexico
API# 30-015-31381
Incident No. nMLB1128636288

Subject: **Closure Report**
 Cotton Draw Unit #089
 Eddy County, New Mexico
 API# 30-015-31381
 Incident No. nMLB1128636288

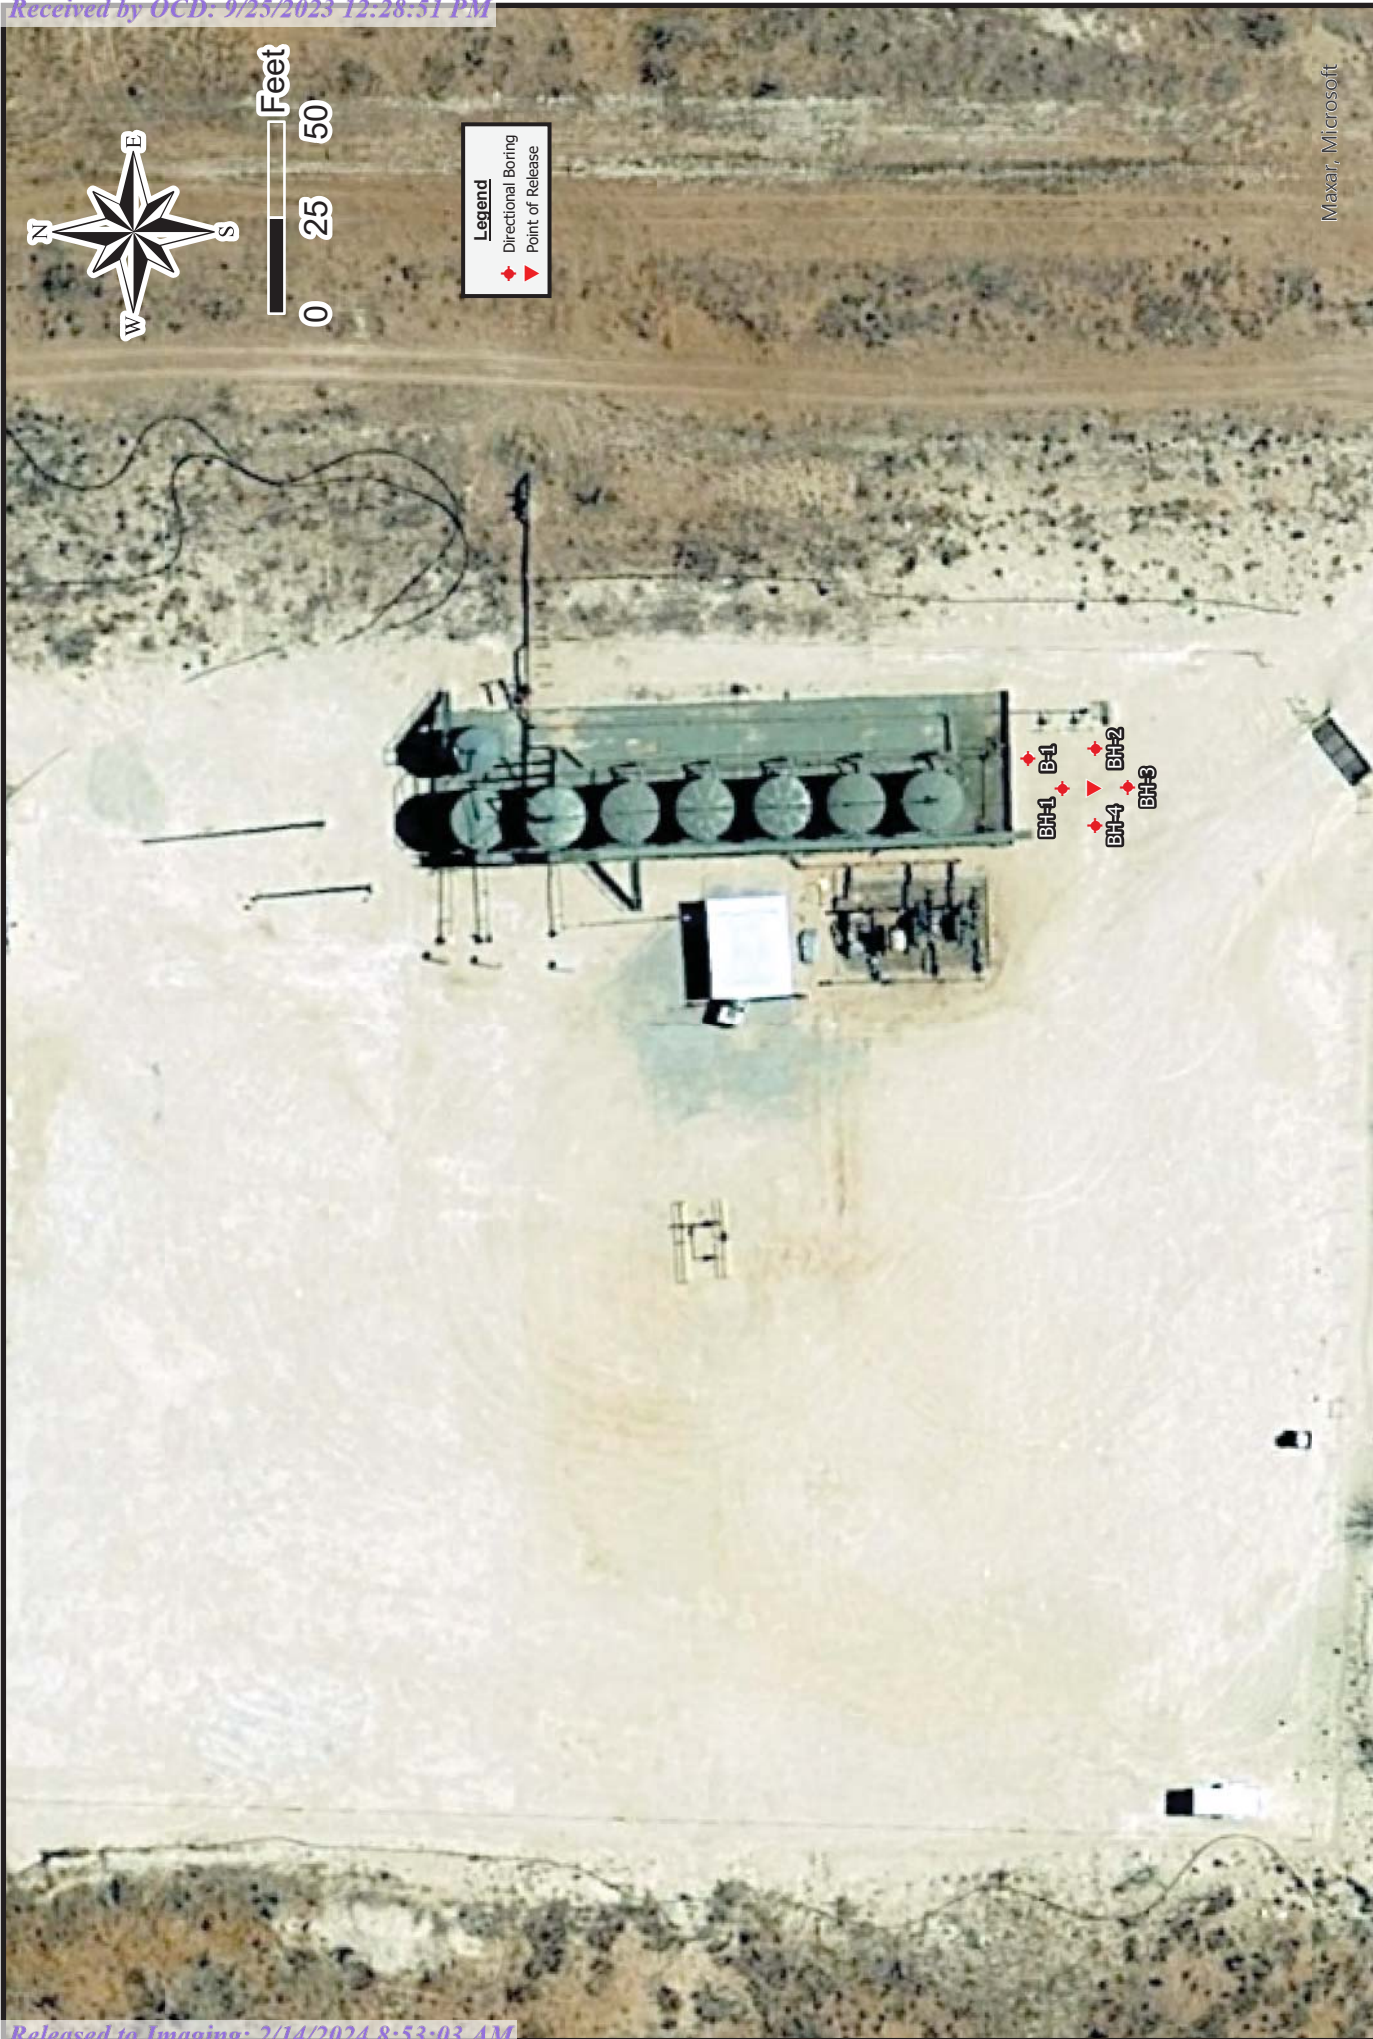
Devon Energy Corporation
Devon Energy Cotton Draw Unit #089
Eddy County, NM
Figure 1 - nMLB1128636288 Site Assessment

Results from the assessment sampling events are presented in the prior data tables and the complete laboratory reports can be found in [Appendix IV](#). Sample locations are shown on the attached Figure 1 in [Appendix I](#).
