REVISED CLOSURE REPORT

Trunk A

**32.307411 N, 103.792007 W
Unit H, S17 T23S, R31E
Eddy County, New Mexico
Event Date: June 30, 2016
NMOCD Incident ID: nAB1618857227**

Ensolum Project No. 03B1226302

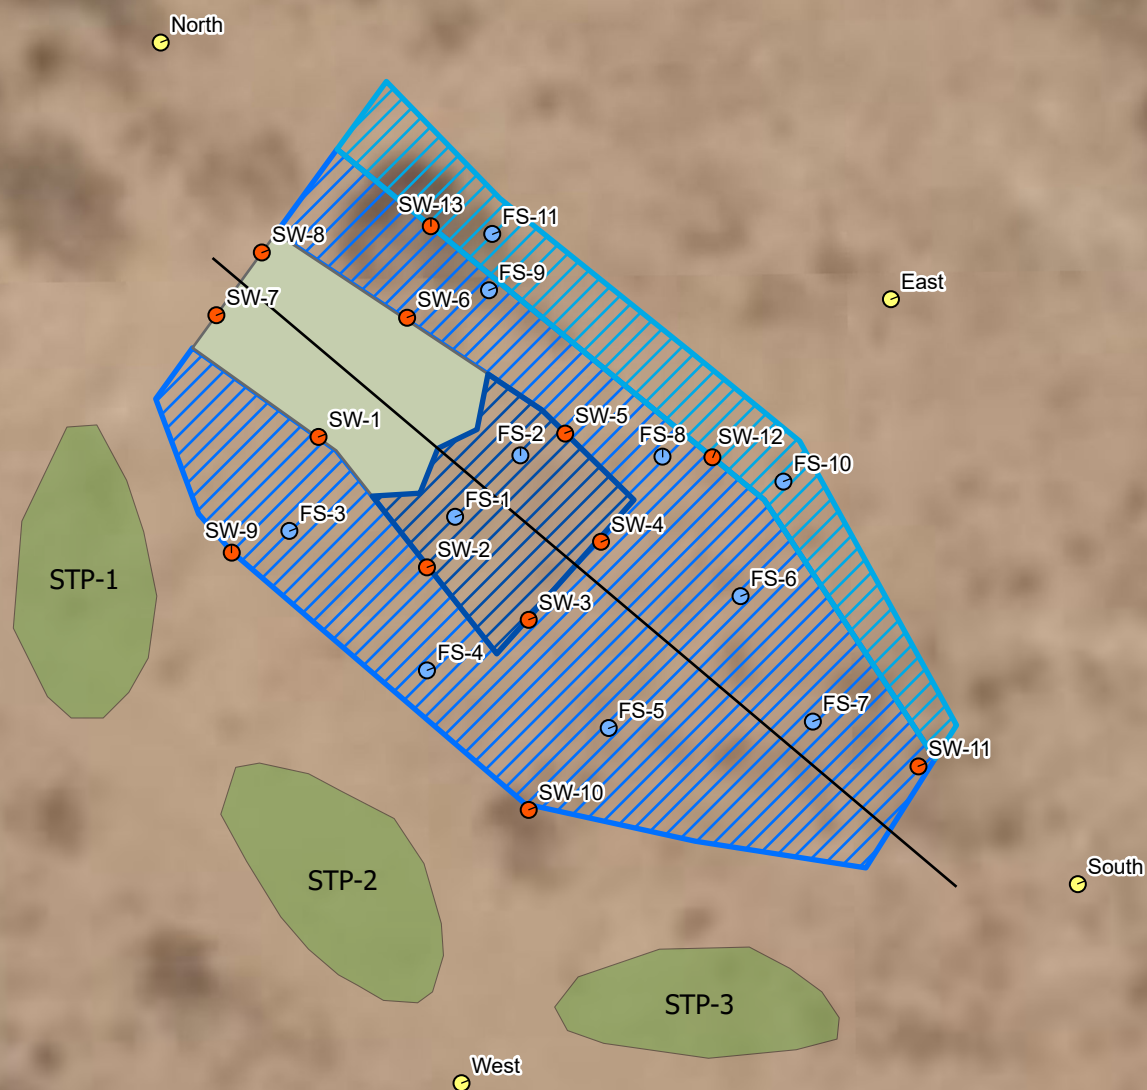
- Floor Sample
- Sample Outside Excavation
- Sidewall Sample
- Pipeline/Line/Utility
- Stockpile
- Deep Excavation Extent (0-20' BGS)
- Medium Excavation Extent (0-5')
- Shallow Excavation Extent (0-2')
- Ramp

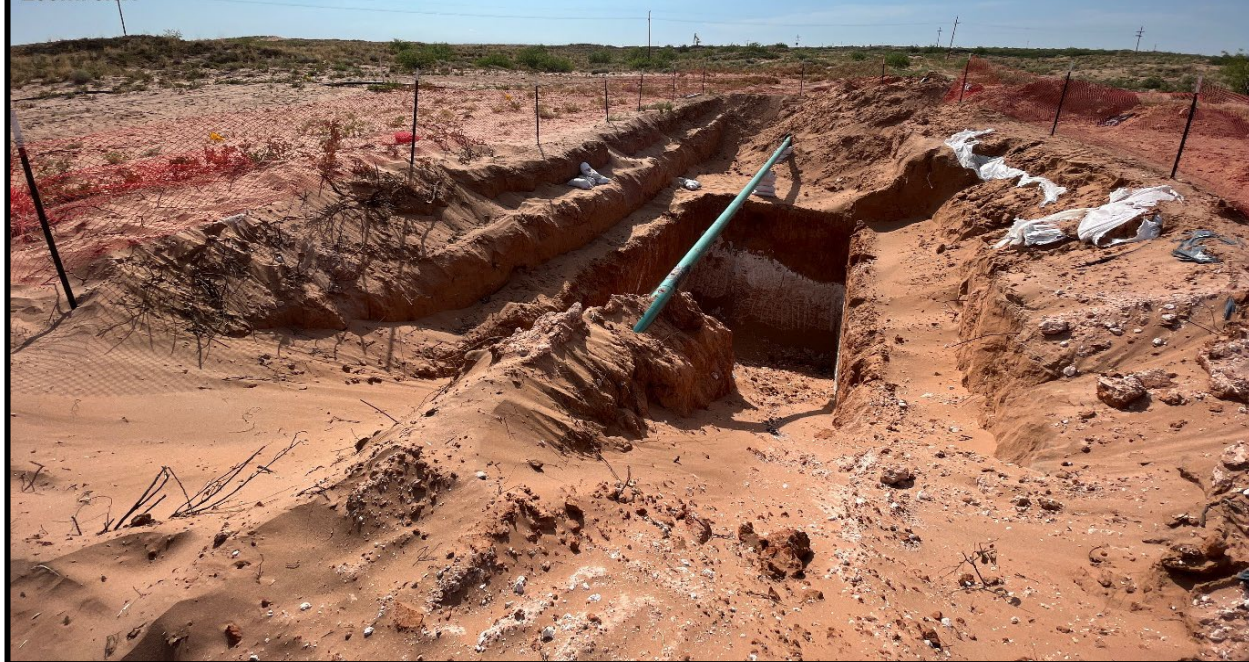
View of final excavation, facing east (August 14, 2023).

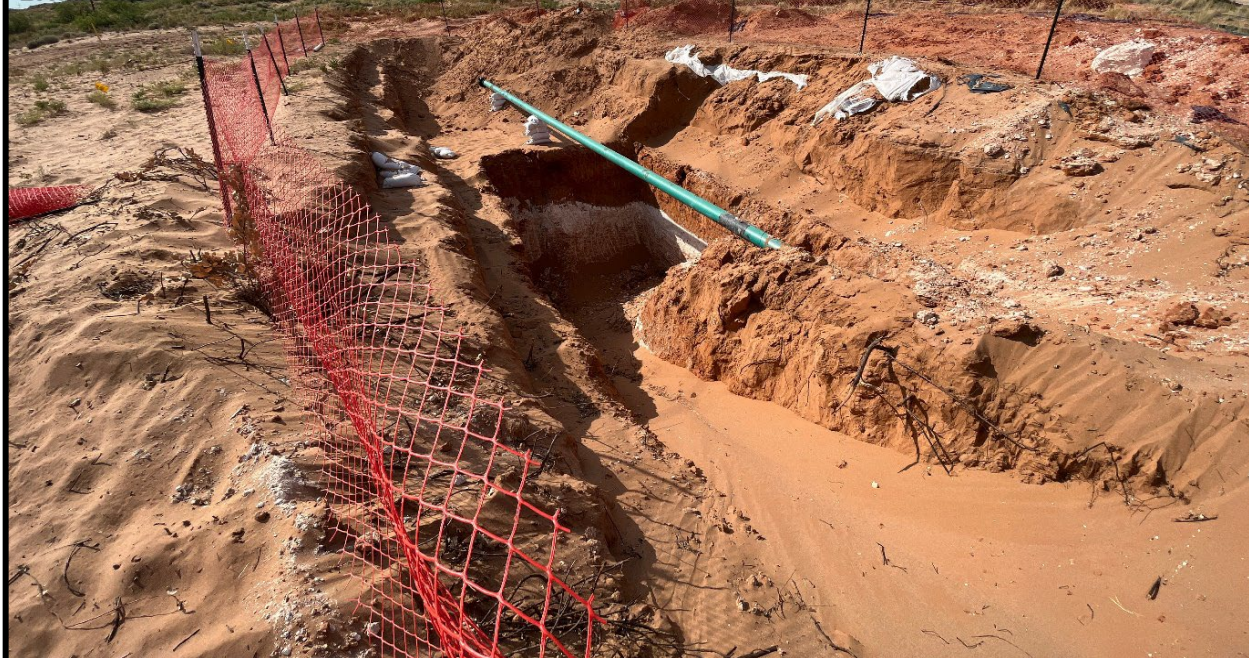
View of final excavation activities, facing southeast (August 14, 2023).

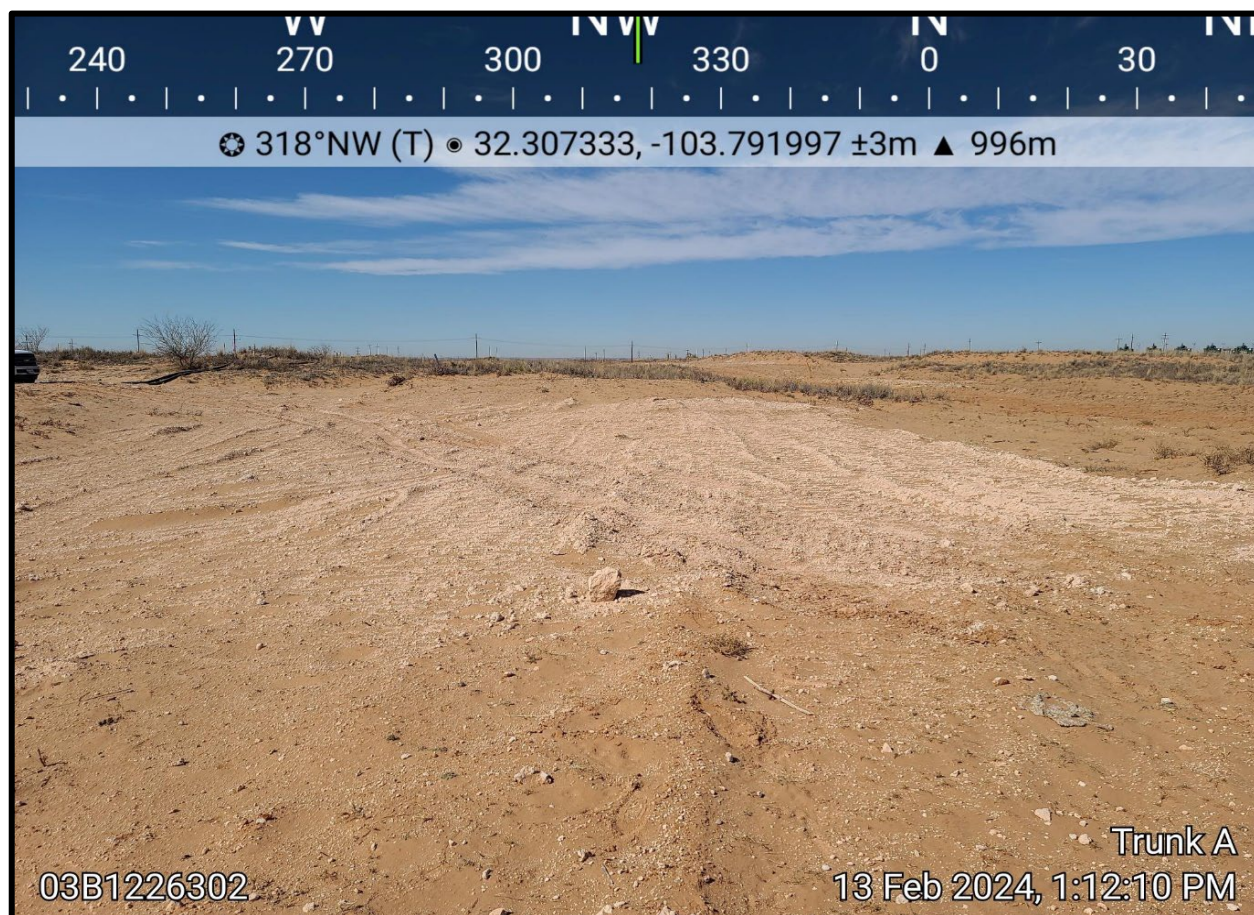
View of backfilled excavation extent, facing northwest (February 13, 2024).

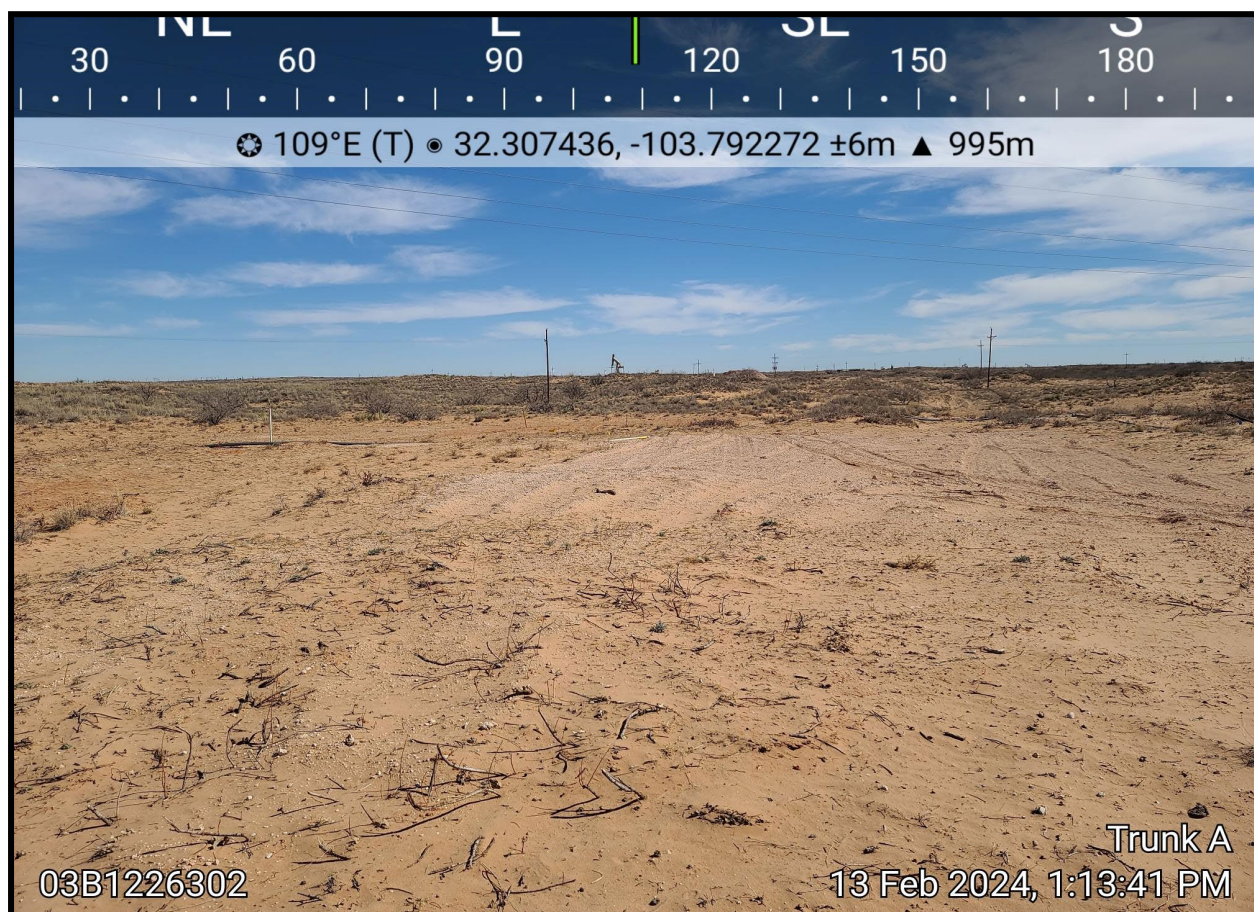
View of backfilled excavation extent, facing east (February 13, 2024).

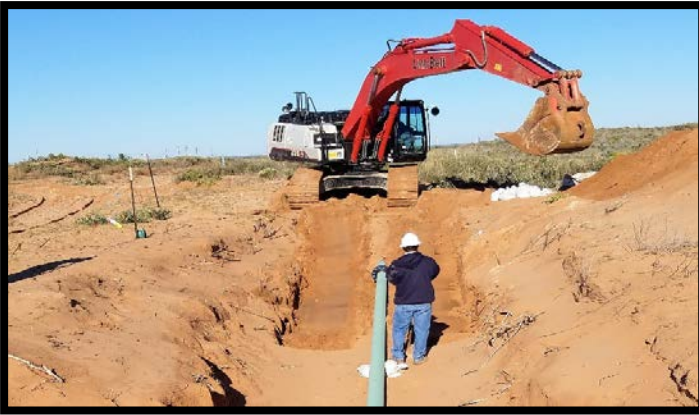
View of initial excavation activities, facing northwest.

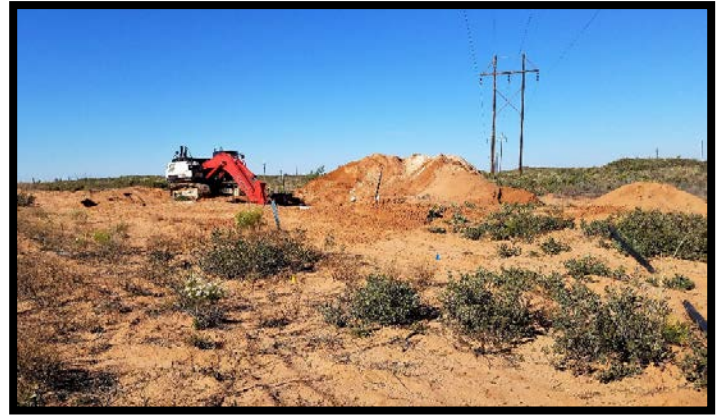
View of excavation and stockpiled soils, facing northwest.

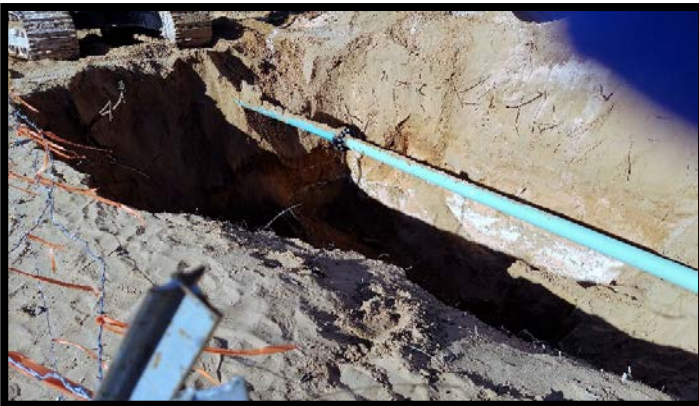
Close up view of potholed section of excavation, facing northwest.

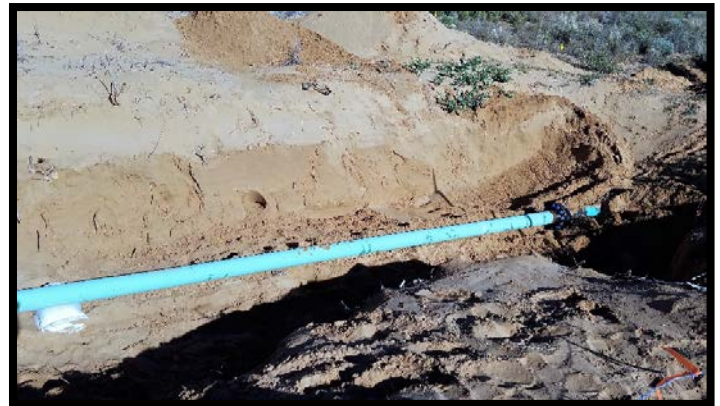
Close up view of pipeline in excavation, facing northeast.

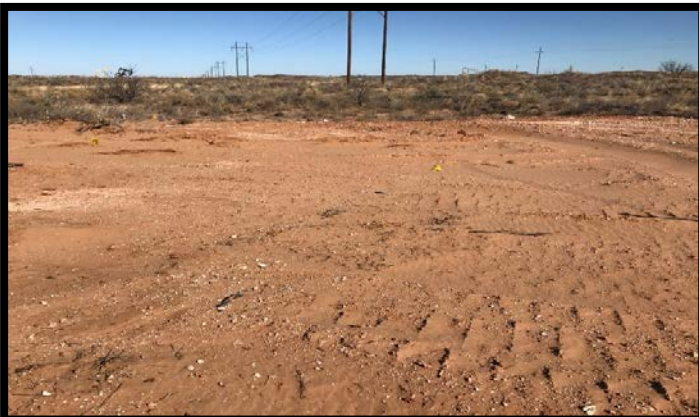
View of backfilled excavation prior to soil boring installation, facing northeast.

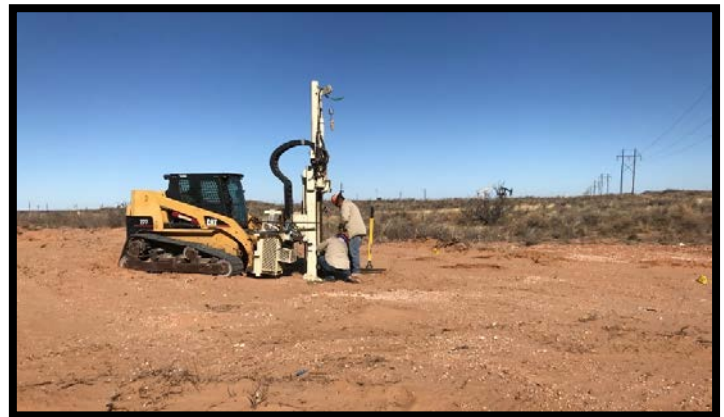
View of soil boring (SB-1) installation near release point on Enterprise Trunk A pipeline, facing northwest.
