**Re: Supplemental Closure Request
Big Sinks 2-24-30 State Battery
Incident Number NAB1913729531
Eddy County, New Mexico**

Ensolum, LLC (Ensolum), on behalf of XTO Energy, Inc. (XTO), has prepared this *Supplemental Closure Request* to document additional confirmation soil sampling results following the final excavation of residual soil impacts on top of a third-party pipeline at the Big Sinks 2-24-30 State Battery (Site). Based on removal of all residually impacted soil at the Site and confirmation soil samples documenting the absence of impacted soil, XTO is submitting this *Supplemental Closure Request*, summarizing confirmation soil sampling activities and results and requesting no further action for Incident Number NAB1913729531.

On April 25, 2019, an open valve on a circulating pump resulted in the release of approximately 70 barrels (bbls) of crude oil onto the caliche well pad at the Site and into the pasture area south of the well pad. The valve was closed to stop the release of fluid. No fluid was recovered. XTO reported the release to the New Mexico Oil Conservation Division (NMOCD) on a Release Notification and Corrective Action Form C-141 (Form C-141) on May 2, 2019.

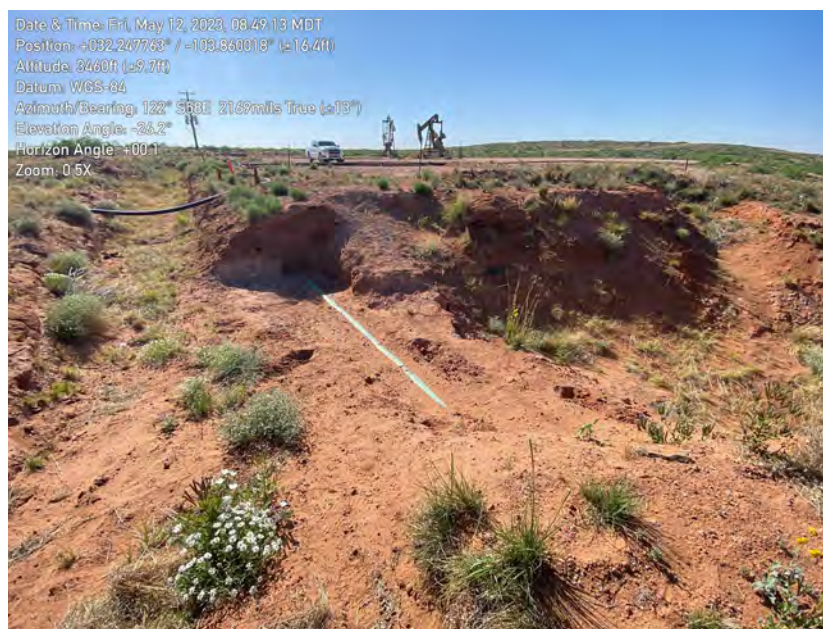
Photograph 1 – exposed pipeline and confirmation soil sample locations, view southeast.

Ensolum was on Site on May 12, 2023 to collect two confirmation floor soil samples, FS13 and FS14 (Figure 2) at depths of 4 feet below ground surface (bgs). The two 5-point composite soil samples represented up to 200 square feet from the of the previous excavation and included soil directly around the pipeline. The 5-point composite samples were collected by placing five equivalent aliquots of soil into a 1-gallon, resealable plastic bag and homogenizing the samples by thoroughly mixing.

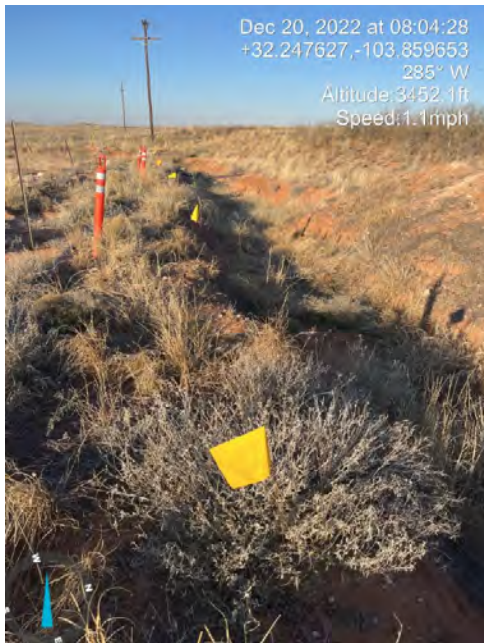
Photograph 1

Description: Marked deferral area to be excavated, view west.

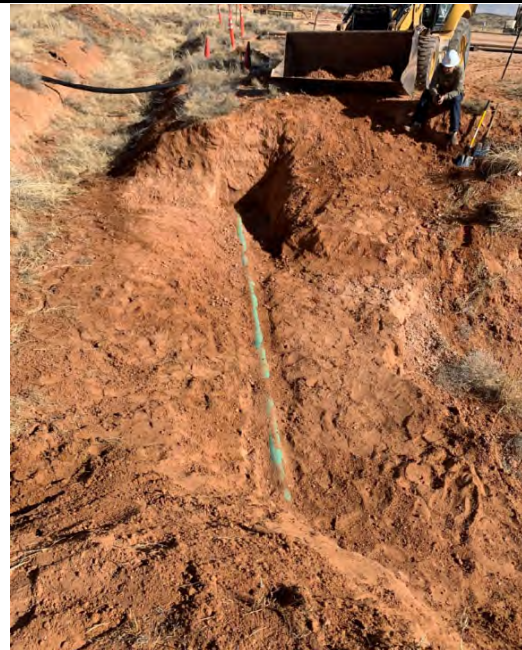
Photograph 2

Description: Excavation of impacted soil on top of Energy Transfer pipeline, view east.

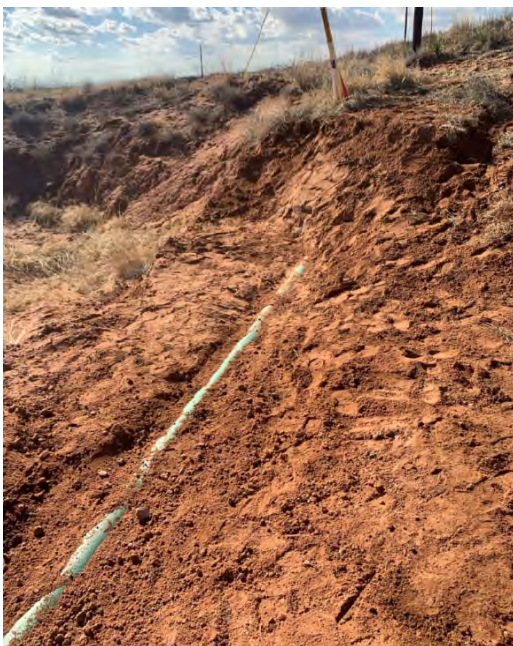
Photograph 3

Description: Exposed Energy pipeline, view west.
