Closure Report

Malaga SWD #004
Eddy County, New Mexico
API ID # 30-015-44514
Incident # NAPP2319477477

Subject: **Closure Report**
Malaga SWD #004
Eddy County, New Mexico
API # 30-015-44514
Incident # NAPP2319477477

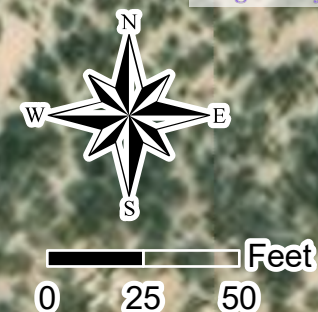
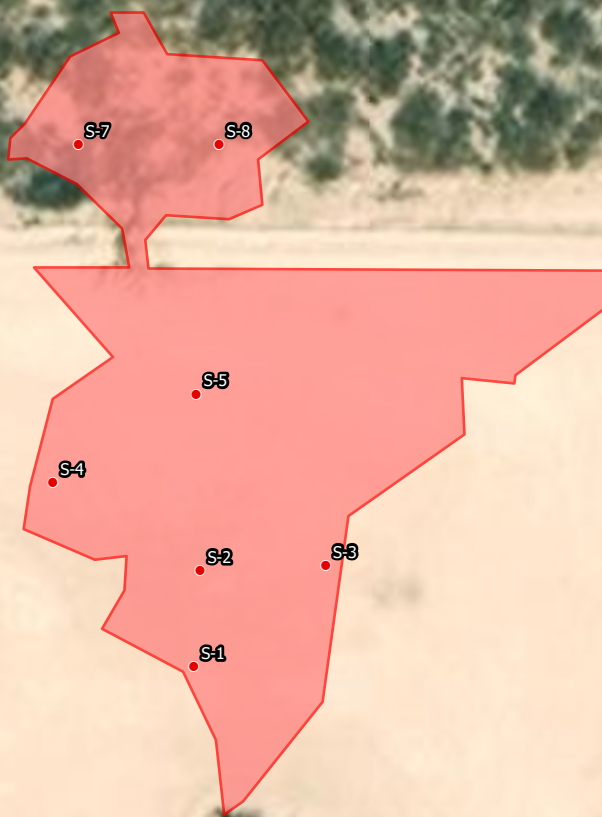
Matador Resources Company Malaga
SWD #04
Eddy County, NM
Figure 1 - Assessment Map

On August 8th, 2023, Talon personnel mobilized to the site to conduct an initial site assessment. The impacted area was photographed, sampled utilizing a hand auger, and mapped. All soil samples were properly packaged, preserved, and transported to Cardinal laboratories with the chain of custody for analysis of Total Chlorides (Method SM4500Cl-B), TPH (EPA Method 8015M), and volatile Organics (BTEX, EPA Method 8021B). Sample locations are shown on the attached Figure 1 ([Appendix I](#)) and the results of our sampling event are presented on the following data table.

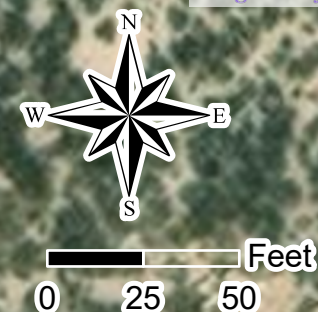
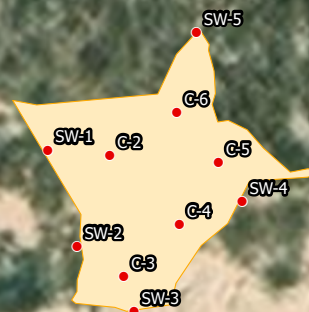
Figure 2 - Excavation Map

The soil sample results from the laboratory analytical are summarized in the data table below. Sample locations are illustrated on Figure 2 in [Appendix I](#) and complete laboratory analytical reports are presented in [Appendix V](#).

- The impacted areas in pasture were excavated to depth of 6 feet bgs. Talon field titrated soil samples for total chlorides to guide the vertical and horizontal extents of the excavation process.
- Pursuant to NMOCD guidance, confirmation soil samples were collected at 200 square foot intervals and analyzed for TPH, BTEX and Total Chlorides to insure all areas had reached NMOCD closure criteria.
- The excavated areas were backfilled with new like material (topsoil), machine compacted, and contoured to match the surrounding location.
- Copies of the Final C-141s are presented in [Appendix III](#).
- Photographic documentation is provided in [Appendix IV](#).

On August 31, 2023, Talon personnel returned to location to remove impacted soils. Backhoe was used to excavate 6 feet bgs. of contaminated soils and confirmation samples were collected. The samples were transported with the chain of custody to Envirotech Laboratories, for analysis of Total Chlorides (EPA 300.0/9056A), Total Petroleum Hydrocarbons (TPH, EPA Method 8015D) and Volatile Organics (BTEX, EPA Method 8021B).

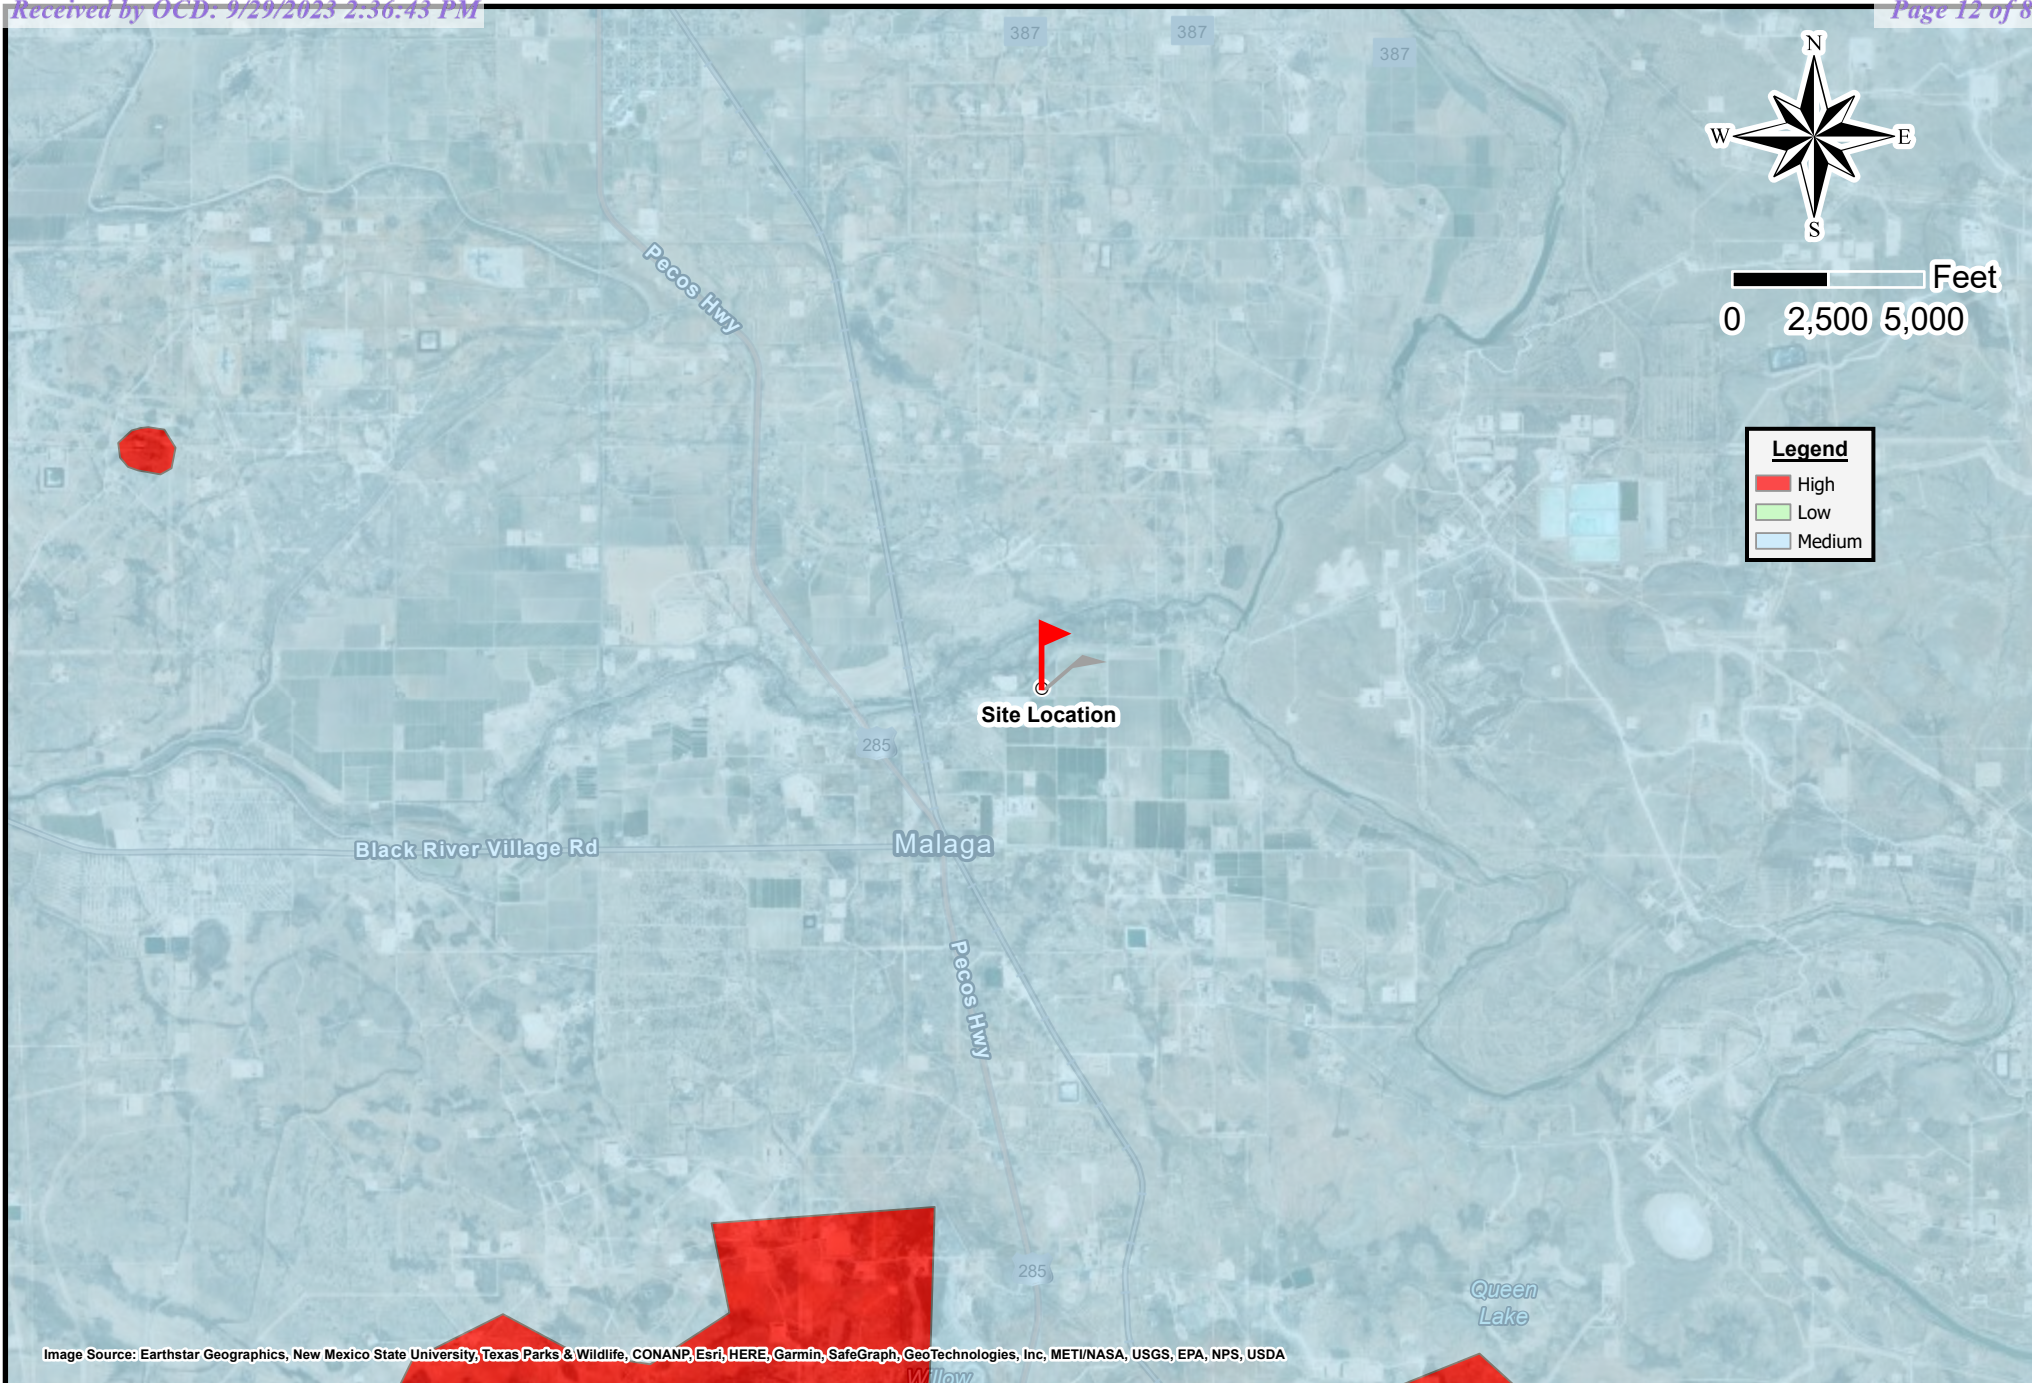
Matador Resources Company
Malaga SWD #04
Eddy County, NM
Karst Map

Based on the New Mexico Office of the State Engineer Database, the nearest reported groundwater depth is 20 feet below ground surface (bgs) but is located greater than 0.5 miles from the subject site. The FEMA Flood Service Center does not locate the site in a 100-year flood plain. Further research of the Bureau of Land Management Karst data indicates that this site is situated within a low potential Karst area. See [Appendix II](#) for the site characterization data.
