Closure Report
Hayduke 34 Federal Com 3H
Incident ID: NAPP2318426095
Eddy County, New Mexico
Unit I Sec 34 T25S R26E
32.08417°, -104.27296°

**Oil spilling out of oil tank due to water dump stuck in the closed position inside the
containment**

Prepared for:
Cimarex Energy Co. of Colorado
6001 Deauville Blvd.
Suite 300
Midland, Texas 79706

Prepared by:
Carmona Resources, LLC
310 West Wall Street
Suite 500
Midland, Texas 79701

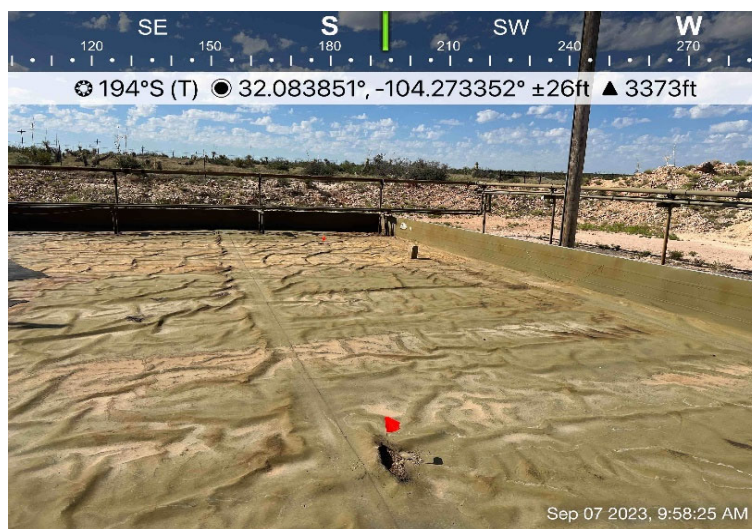
View South, area of S-1 and S-2 during tank battery down sizing.

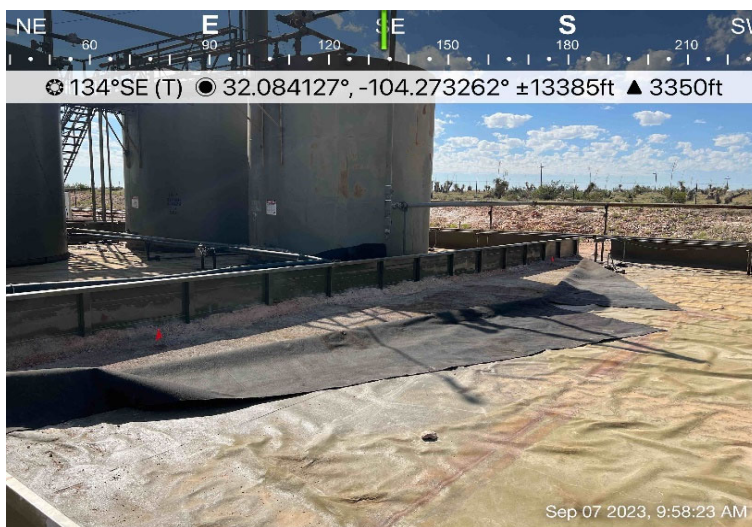
Photograph No. 2

View Southeast, area of S-3 and S-4 during tank battery down sizing.

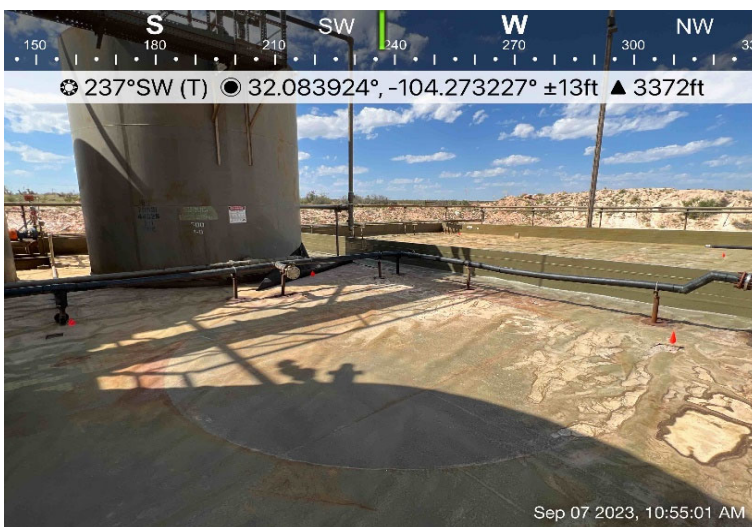
Photograph No. 3

View Southwest, area of S-5, S-6, and H-4.

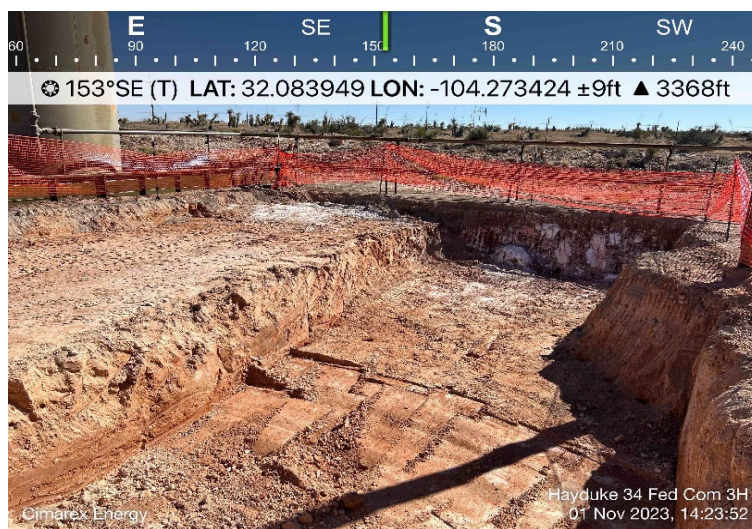
View Southeast, area of CS-1 through CS-9.

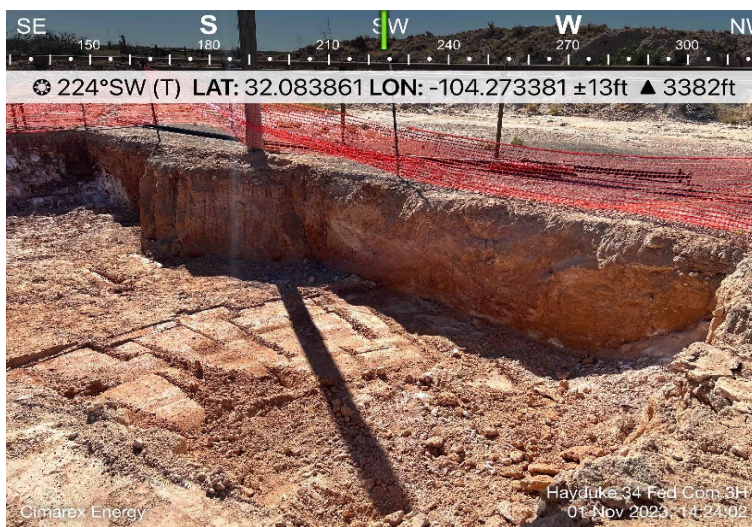
Photograph No. 5

View Southwest, area of CS-3 through CS-5.

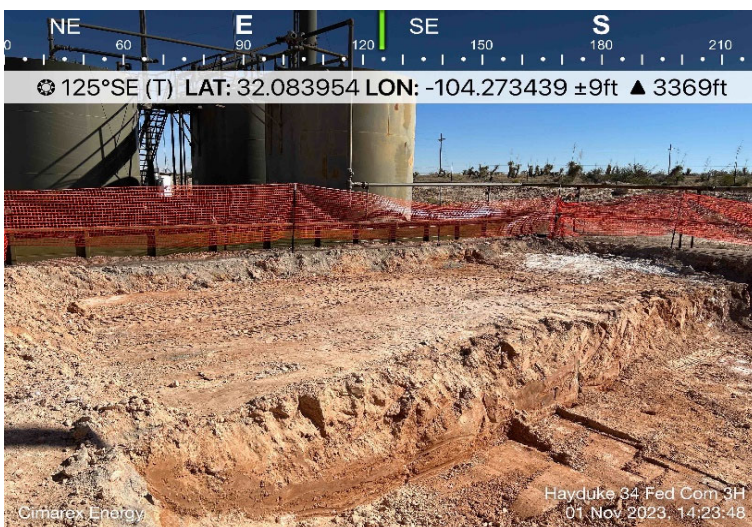
Photograph No. 6

View Southeast, area of CS-6 through CS-10.

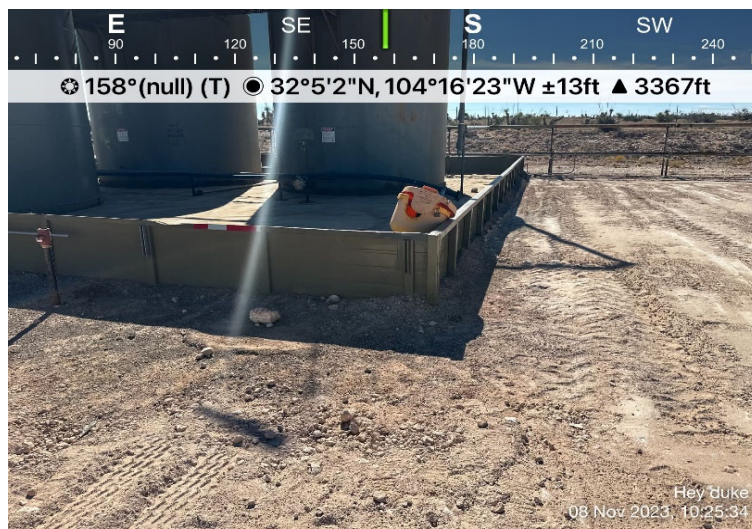
View Southeast, area of backfilled excavation and lined containment.

Based on the assessment results and the analytical data, no further actions are required at the site. The affected liner has been inspected and found to be in serviceable condition in accordance with 19.15.29.11 A.(5)(a)(i-ii) of the New Mexico Administrative Code. The final C-141 is attached, and Cimarex formally requests the closure of the spill. If you have any questions regarding this report or need additional information, please contact us at 432-813-1992.

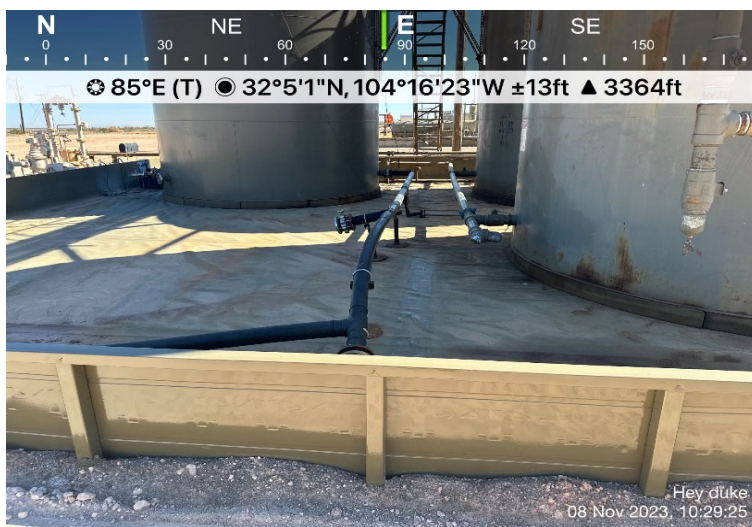
Photograph No. 8

View East, area of lined containment.

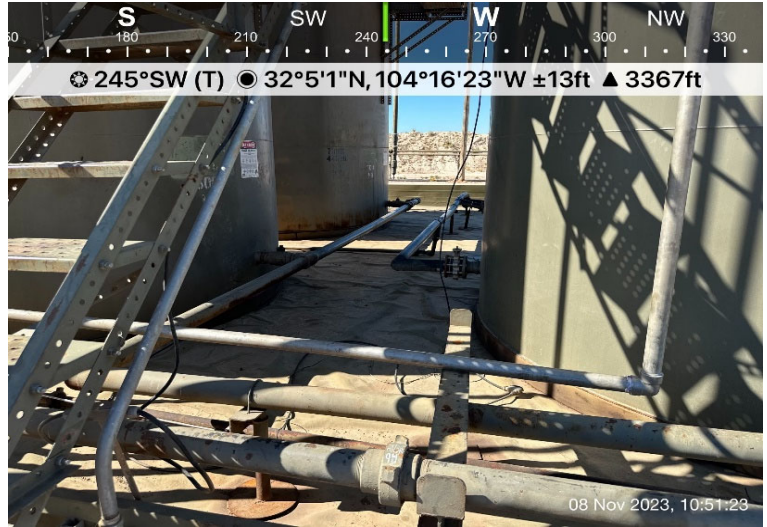
View Southwest, area of lined containment.
