August 22, 2023

**Re: REVISED  
Work Plan Addendum  
ConocoPhillips  
Heritage Concho  
Way South State Com 1H Tank Battery  
Unit Letter A, Section 30, Township 26 South, Range 28 East  
Eddy County, New Mexico  
Incident ID# NRM2008650013**

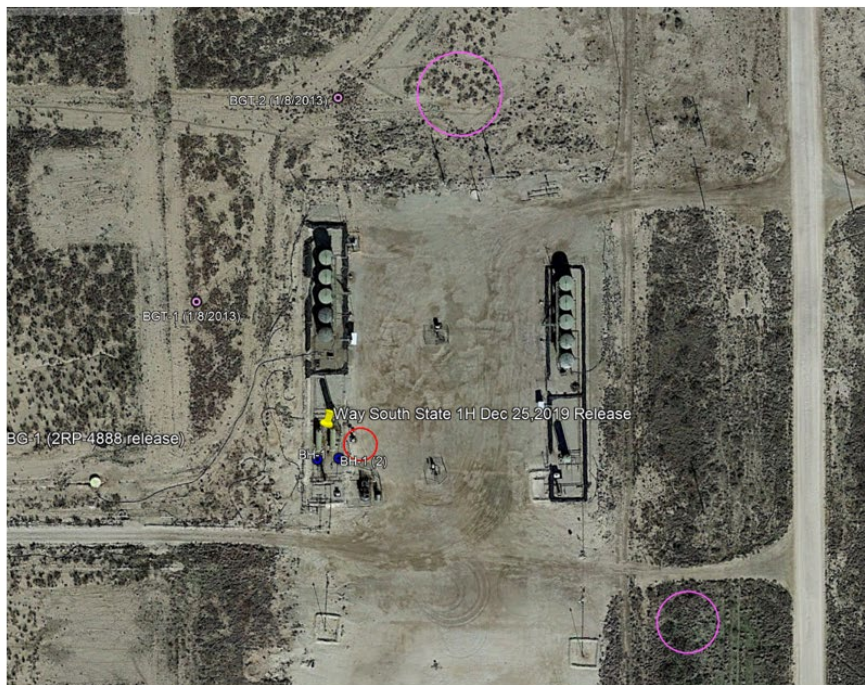
**Proposed MW Locations:**

Red Circle – proposed temp MW near BH-1 (2)

With your concurrence, we will move forward to obtain an NMOSE permit and then install this MW.

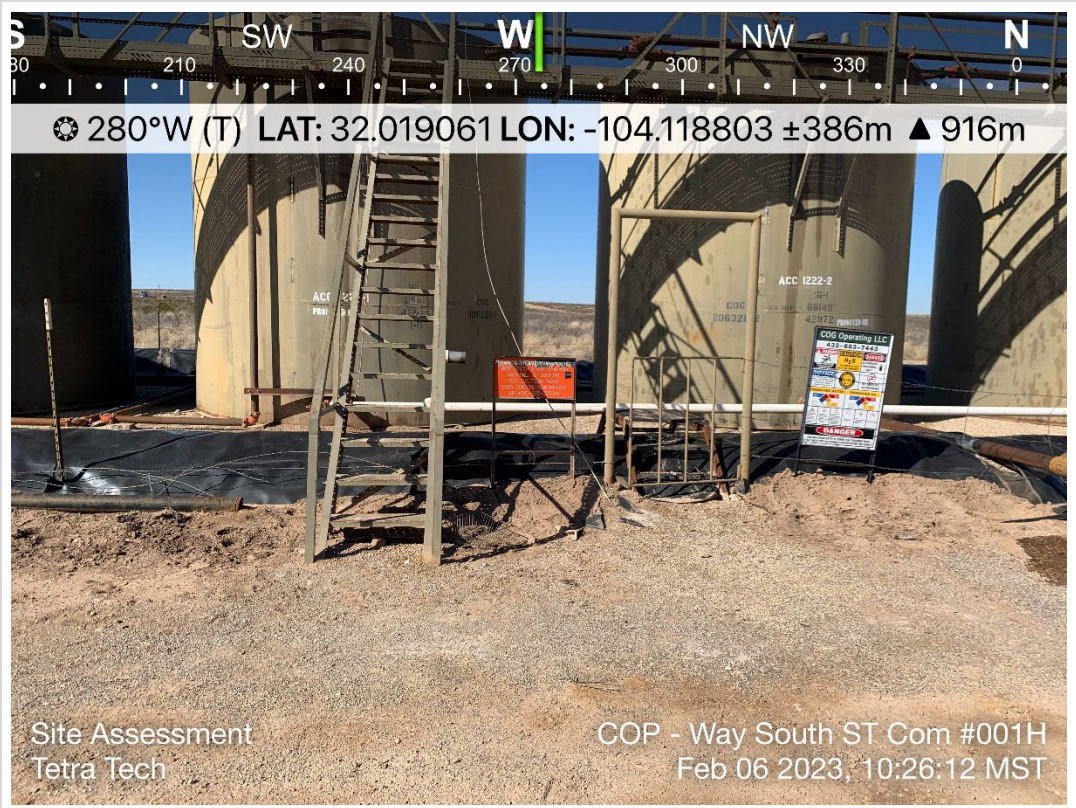
TETRA TECH, INC. PROJECT NO. 212C-MD-02839	DESCRIPTION	View west. View of site signage.	1
	SITE NAME	Way South State Com #001H Release	2/6/2023

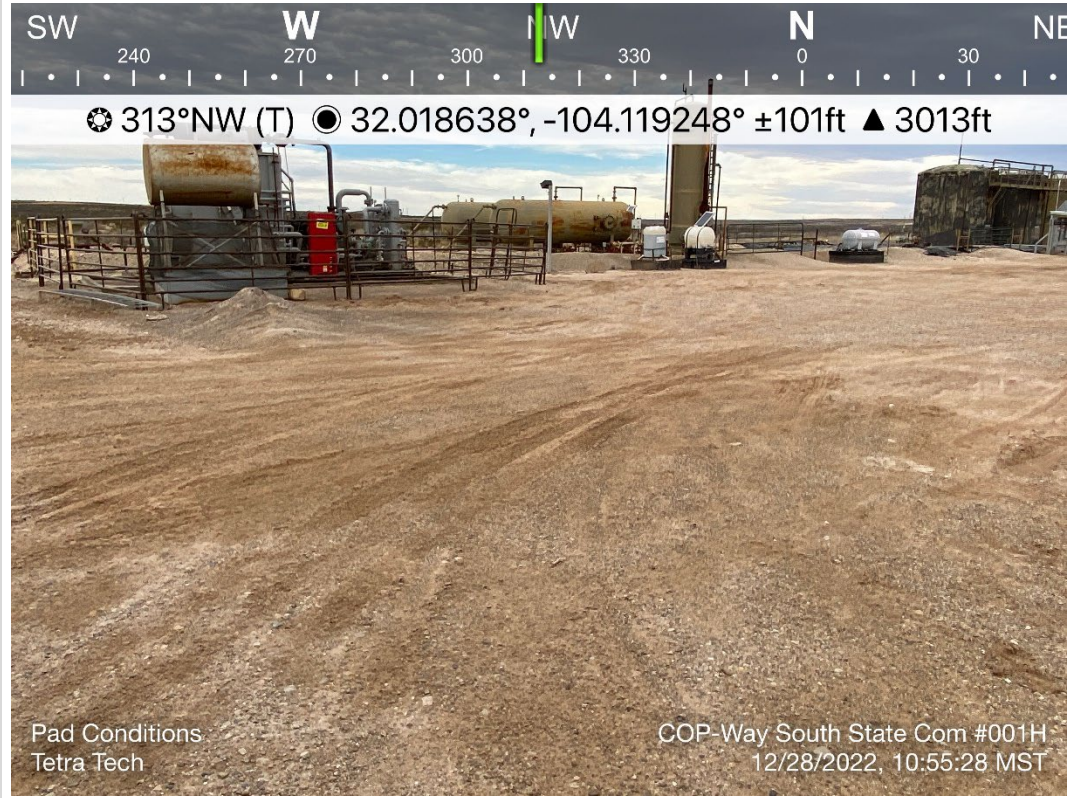
TETRA TECH, INC. PROJECT NO. 212C-MD-02839	DESCRIPTION	View northwest. View of pad conditions and current production equipment present on-site.	2
	SITE NAME	Way South State Com #001H Release	12/28/2022

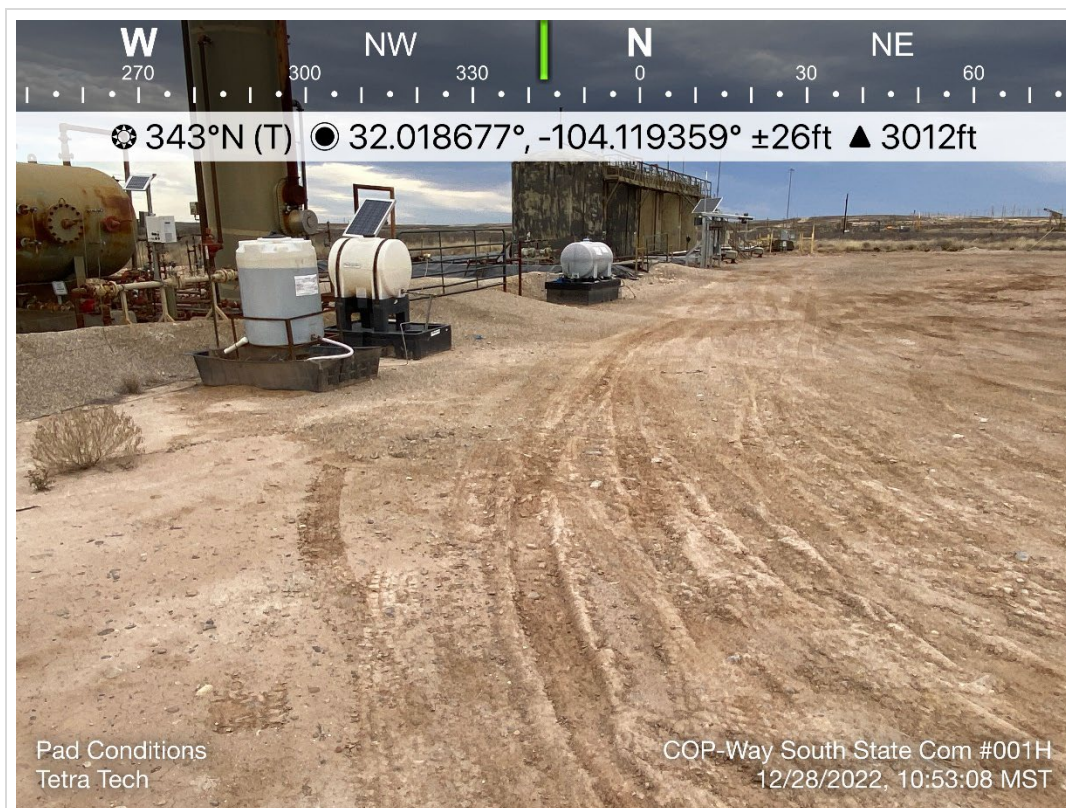
TETRA TECH, INC. PROJECT NO. 212C-MD--02839	DESCRIPTION	View northwest. View of approximate release extent. Production equipment present.	3
	SITE NAME	Way South State Com #001H Release	12/28/2022

The release area footprint occurred around the heater treater, horizontal FWKO's and multiple steel surface lines. The reported impacted area measured approximately 25' x 60' inside the facility walls. COG initially assessed the impacts at the Site with a Geoprobe (direct push) drilling rig on April 7, 2020 (BH-1). Assessment activities and a description of the site are documented in the initial rejected COG Work Plan (dated September 23, 2020). The rejected Work Plan also proposed additional evaluation within the facility firewalls to determine access; background trenches to evaluate chloride; and a follow up Work Plan or Deferral.

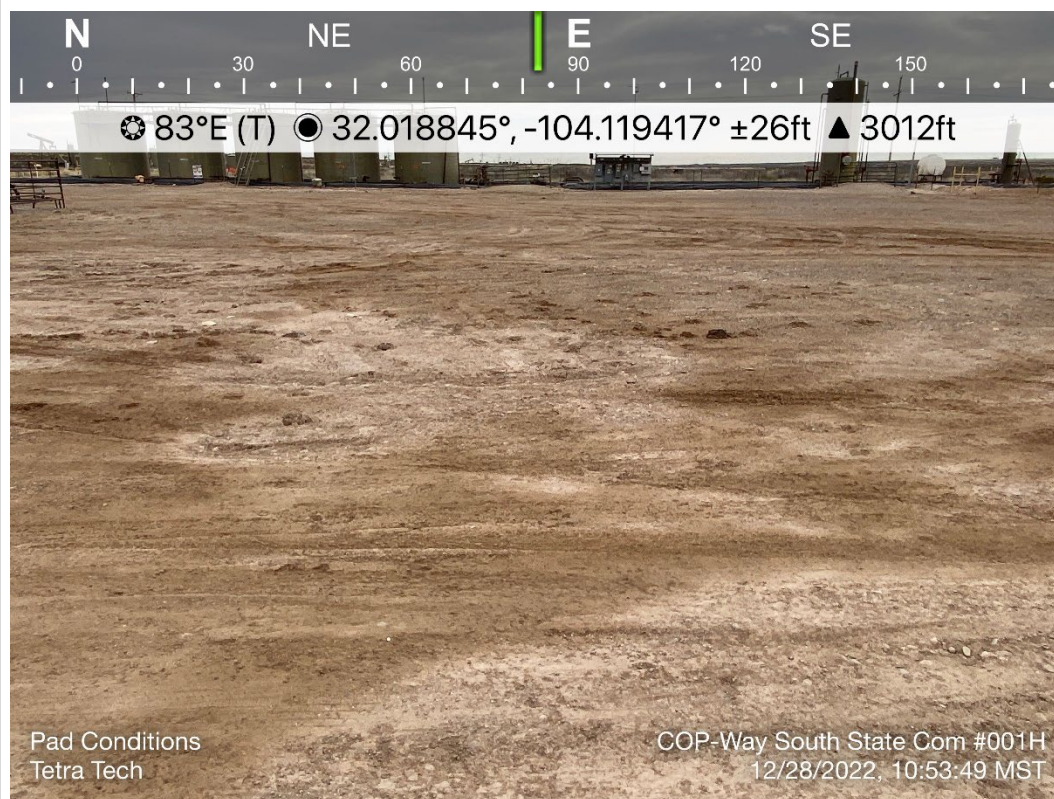
TETRA TECH, INC. PROJECT NO. 212C-MD--02839	DESCRIPTION	View east. View of pad conditions. Production equipment present.	4
	SITE NAME	Way South State Com #001H Release	12/28/2022

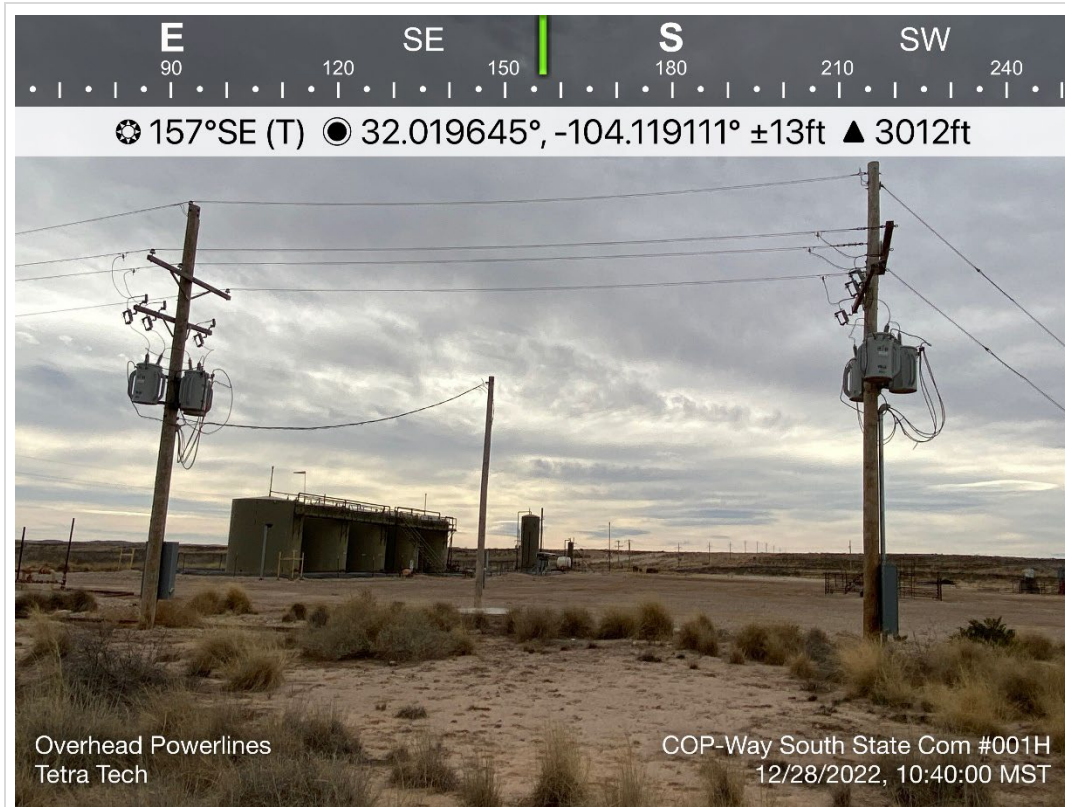
TETRA TECH, INC. PROJECT NO. 212C-MD--02839	DESCRIPTION	View southeast. View of overhead power lines and view of production equipment.	6
	SITE NAME	Way South State Com #001H Release	12/28/2022

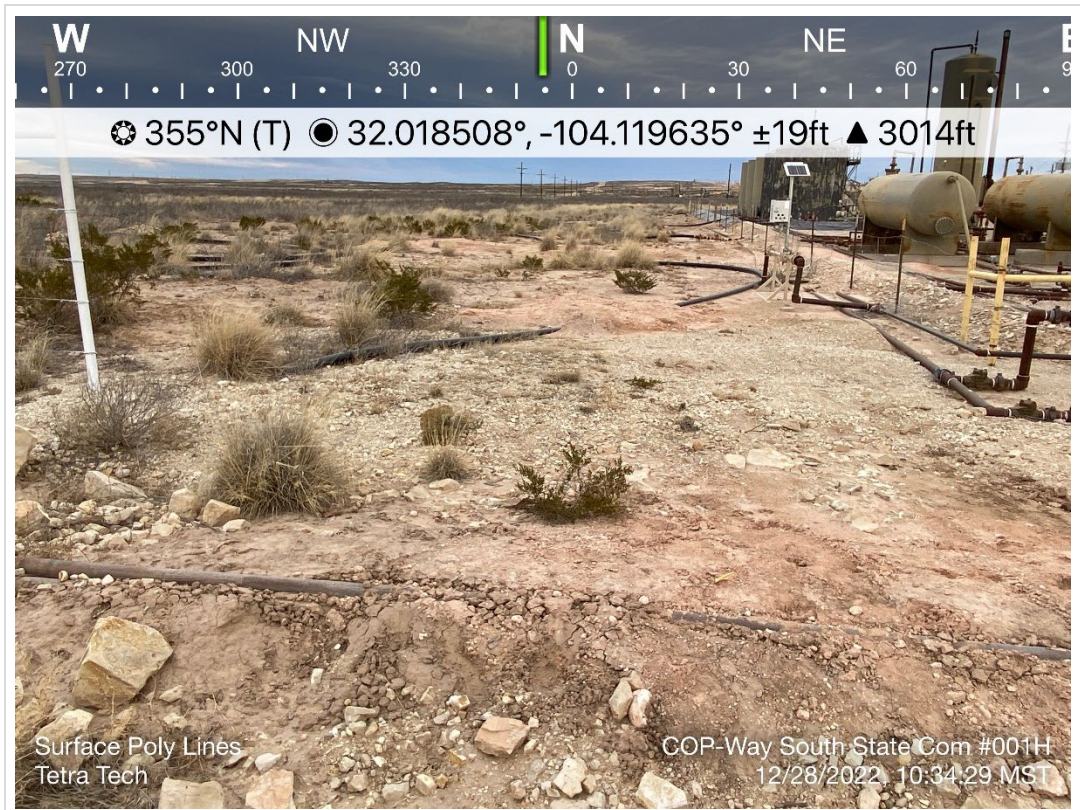
TETRA TECH, INC. PROJECT NO. 212C-MD--02839	DESCRIPTION	View north. View of production equipment and surface poly lines.	7
	SITE NAME	Way South State Com #001H Release	12/28/2022

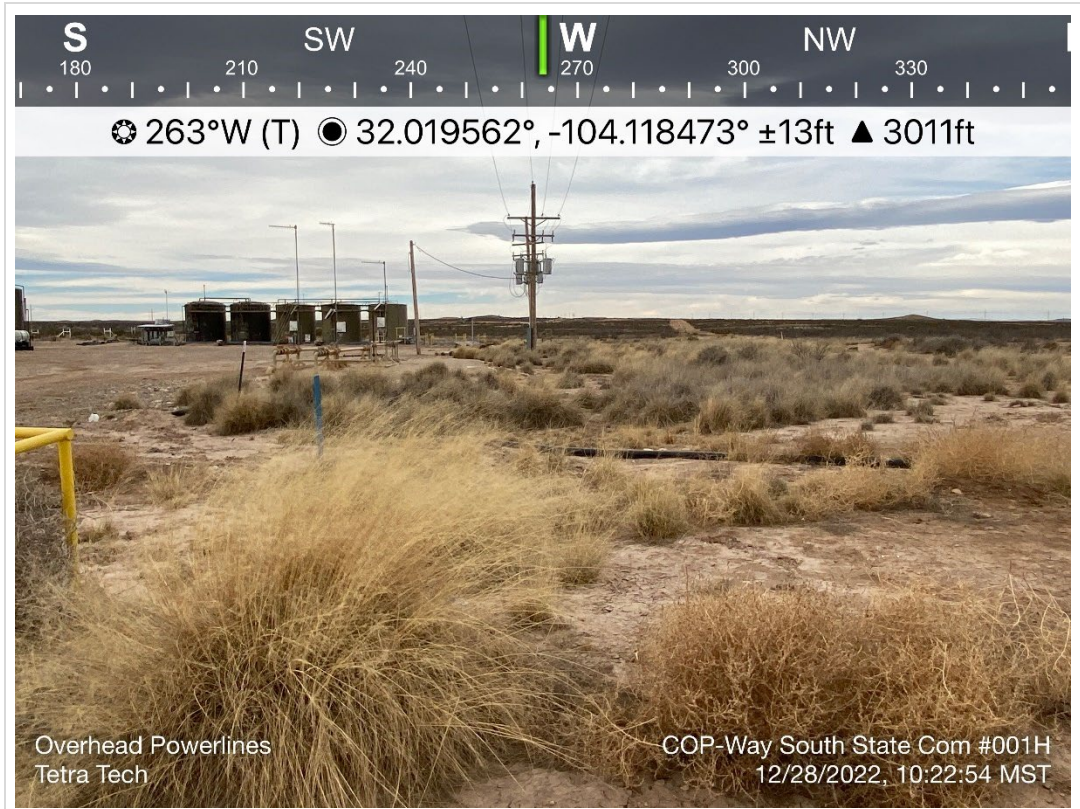
TETRA TECH, INC. PROJECT NO. 212C-MD--02839	DESCRIPTION	View west. View of over head powerlines, production equipment and surface polylines.	8
	SITE NAME	Way South State Com #001H Release	12/28/2022
