Release Notification

Site Name	Salado #002	Site Type	Brine Mining Well
Date Release Discovered	8/15/2019	API# (if applicable)	30-025-32394

**RE: Letter Report – Site Assessment Report, Remediation Plan, and Reclamation Plan
Salado No. 2 Brine Station, API No. 30-025-32394
Lat/Long: 32.118925, -103.176836
Lea County, New Mexico
SQE PN: 1180.002.001**

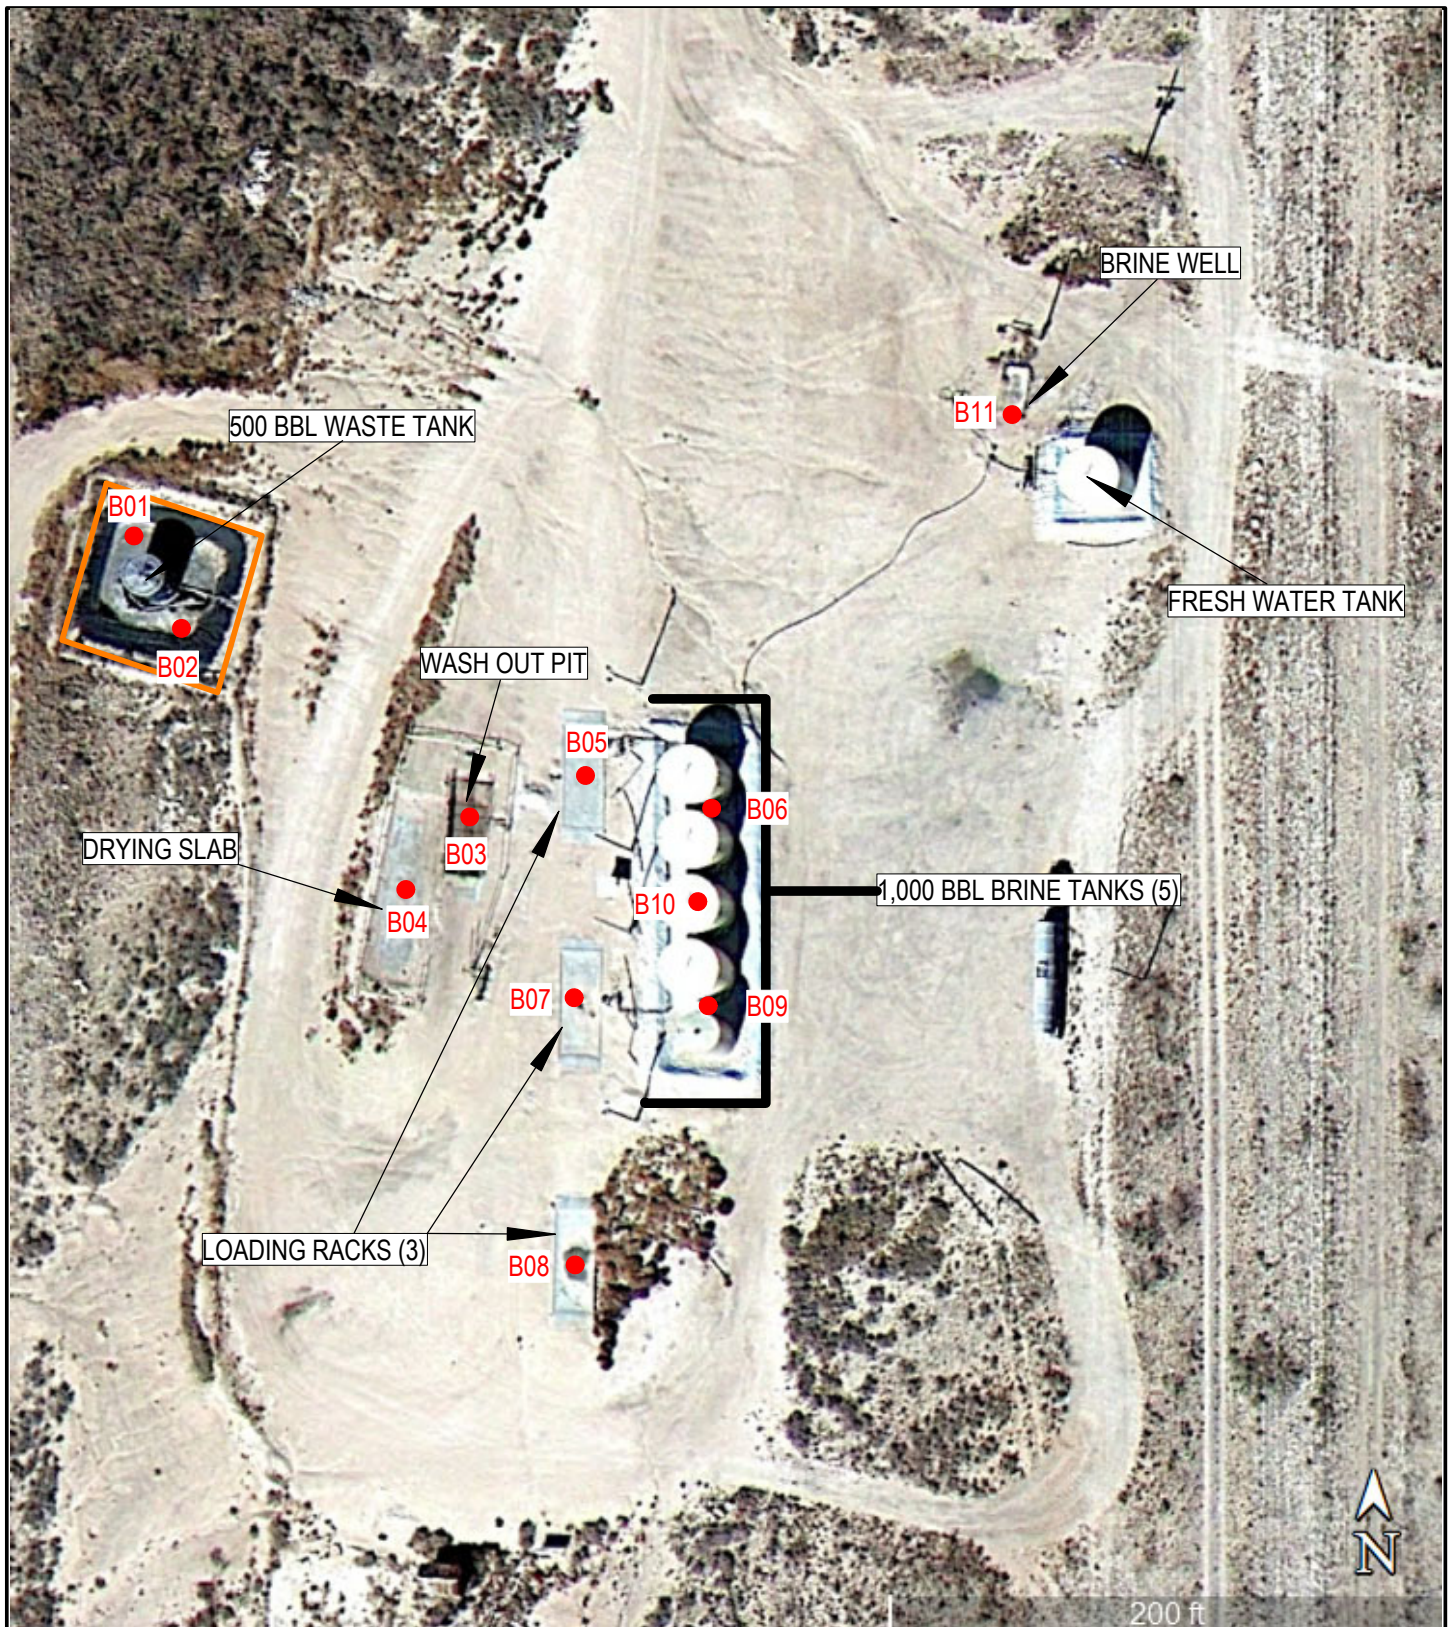
FIGURE 2**SAMPLE LOCATION MAP**

The soil sample locations are presented on **Figure 2**. It should be noted a historical aerial dated 7 February 2011 was used for Figure 2, and the surface equipment and features shown on the aerial (e.g., drying slab, washout pit, racks) are no longer present. The historical aerial was used to show the former layout of the Salado No. 2 for reference against the sample locations. A photographic log is included as **Attachment B**. Details regarding the work that was performed are provided below.

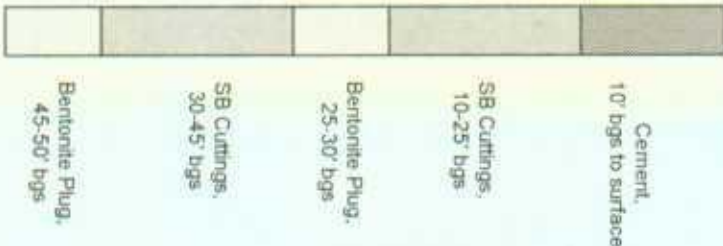
TITLE		DESCRIPTION				
Prather Salado Brine		SB-1				
DRAWN BY KAD		DATE 2 Aug 05

</div>
10			None	None	Soft Caliche , Dry	
15			None	None	Caliche and Sand, Dry	
20		TPH GRO/DRO: <10.0 ppm Chl: 160 ppm	None	None	Sand (SP) Red, Very Fine Grained, Well Sorted, Dry	
25			None	None	Sand (SP) Red, Very Fine Grained, Well Sorted, imbedded w/gravel, dry	
30			None	None	Sand (SP) Red, Very Fine Grained, Well Sorted, imbedded w/gravel and red clay, dry	
35			None	None	Sand (SP) Red, Very Fine Grained, Well Sorted, imbedded w/ red clay, damp	
40			None	None		
45			None	None		
50		TPH GRO/DRO: <10.0 ppm Chl: 24 ppm	None	None	Red Bed clay, dry	
<div>Prather Salado Brine SB-1 Lea County, New Mexico GPS: 32 07 07N 103 10 36W</div>

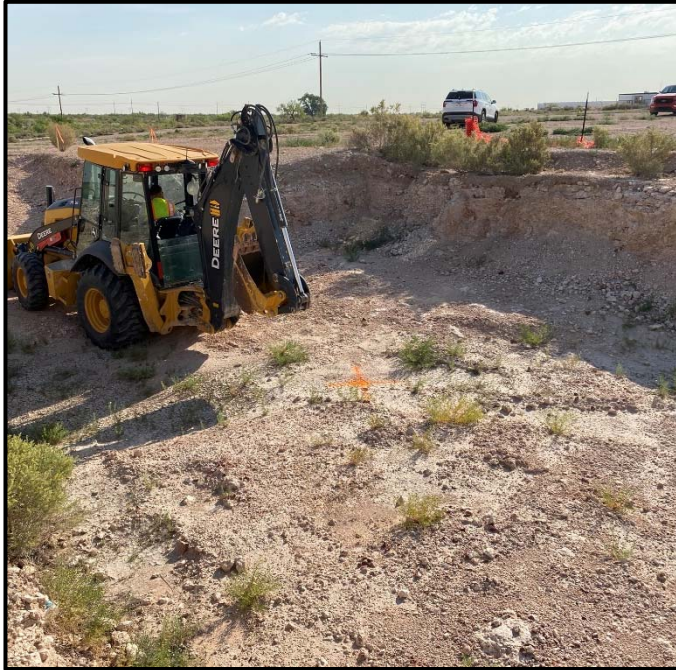
Photo 1: Setting up backhoe before advancing test pit at sample location B03. Note: Location is inside former pit, which is below the natural ground surface.
Direction: Northeast

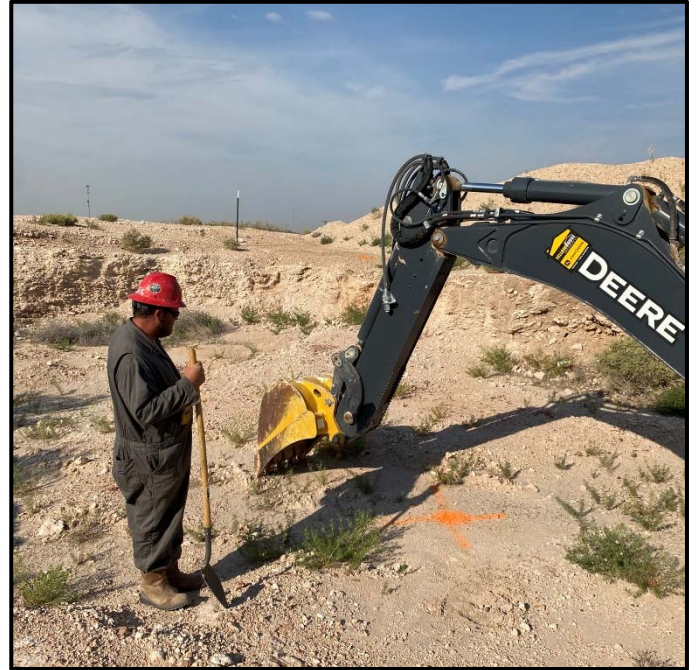
Photo 2: Preparing to advance test pit at sample location B03. Note: Location is inside former pit, which is below the natural ground surface.
Direction: Southwest

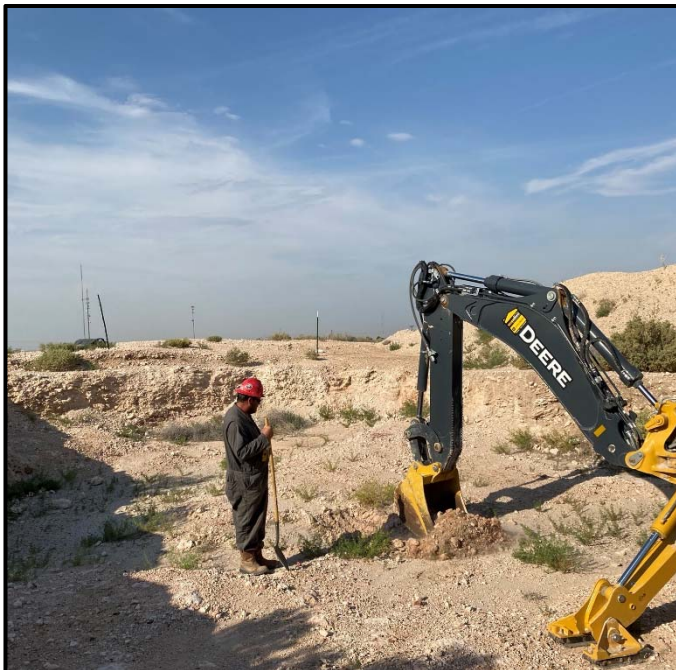
Photo 3: Advancing test pit at sample location B03. Note: Location is inside former pit, which is below the natural ground surface.
Direction: Southwest

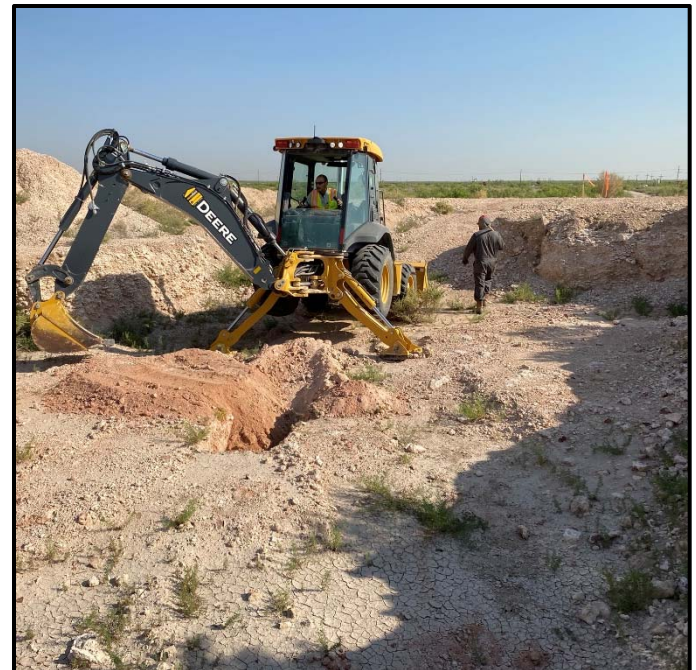
Photo 4: Advancing test pit at sample location B03. Note: Location is inside former pit, which is below the natural ground surface.
Direction: Southeast

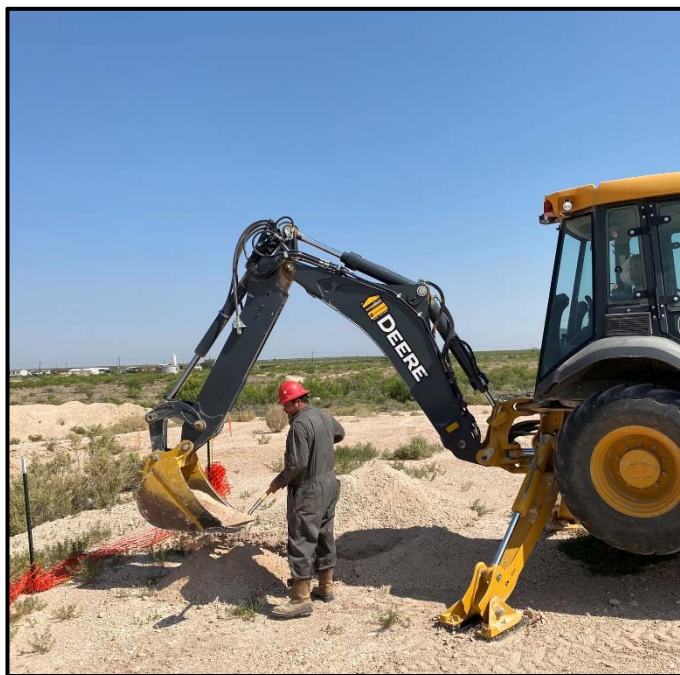
Photo 5: Advancing test pit at sample location B05.
Direction: Northwest

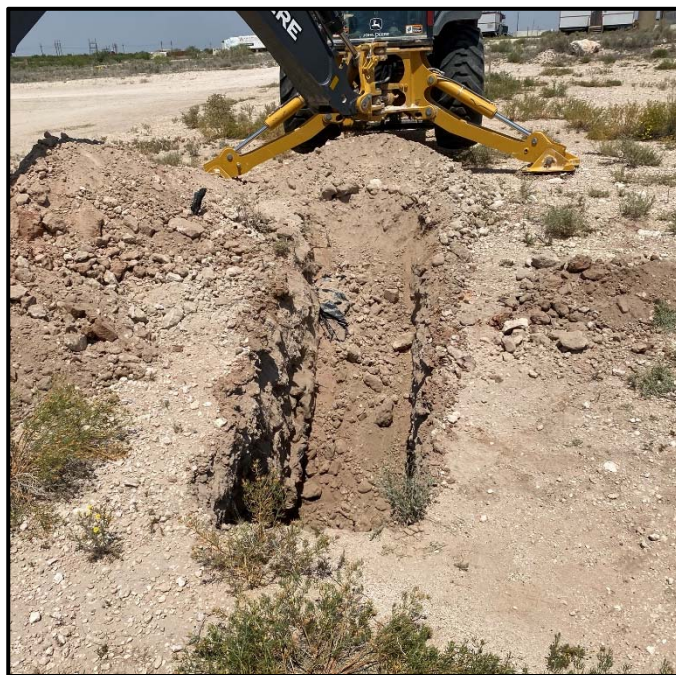
Photo 6: Advancing test pit at sample location B07.
Direction: South (down)

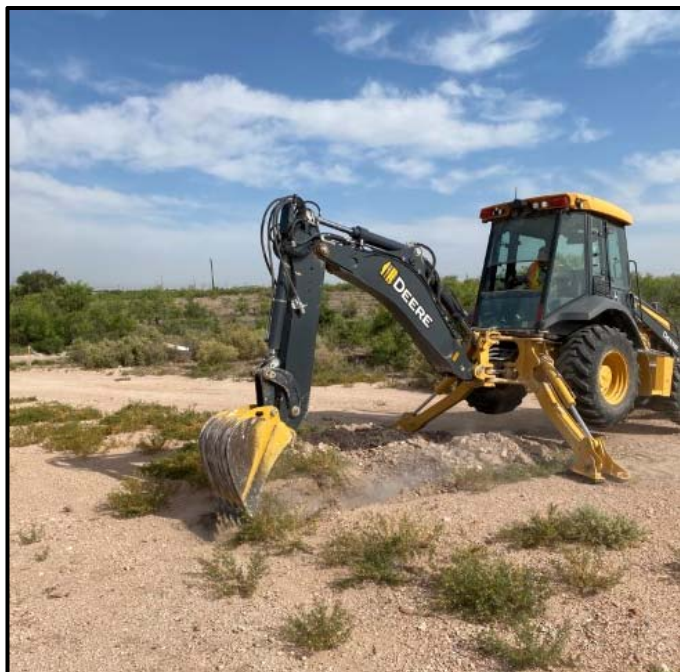
Photo 7: Advancing test pit at sample location B08.
Direction: Northeast

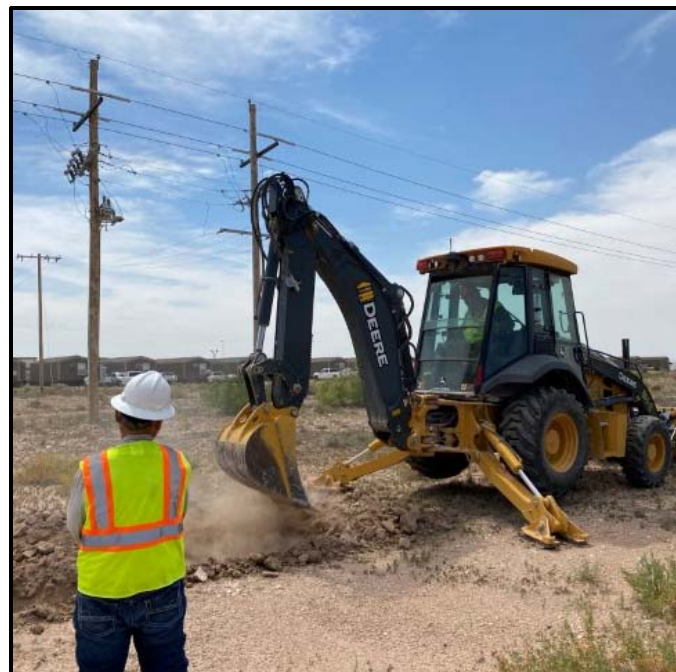
Photo 8: Backfilling the test pit at sample location B11 after sample collections and field measurements were performed.
Direction: East-Southeast
