Closure Report
Skelly to Lobo Inlet 18" Steel Line
Incident ID: nAPP2320236514
Eddy County, New Mexico
Unit E Sec 18 T17S R31E
32.837604°, -103.913854°

Crude Oil and Natural Gas Release
Point of Release: Interior and Exterior Deterioration of Pipe
Release Date: 07/19/23
Volume Released: 10 Barrels of Crude Oil
Volume Recovered: 0 Barrels of Crude Oil

**Re: Closure Report
Skelly to Lobo Inlet 18" Steel Line
Durango Midstream, LLC
Site Location: Unit E, S18, T17S, R31E
(Lat 32.837604°, Long -103.913854°)
Eddy County, New Mexico**

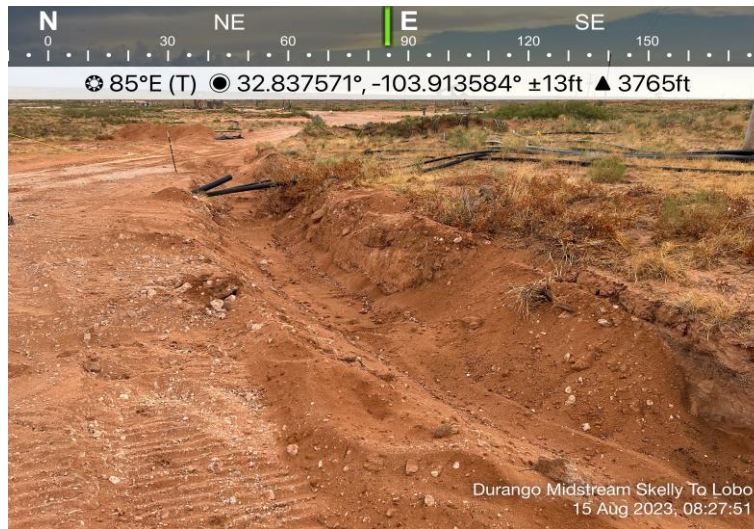
Photograph No. 2

View East, Area of CS-10 and CS-11.

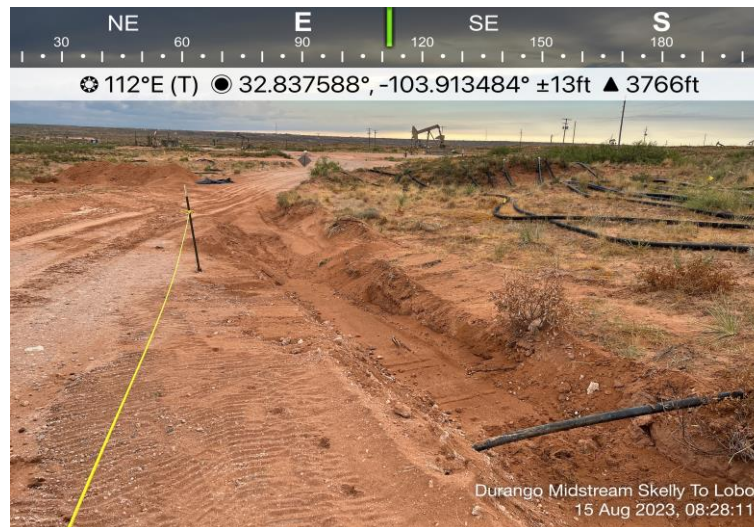
Photograph No. 3

View East, Area of CS-12 through CS-18.

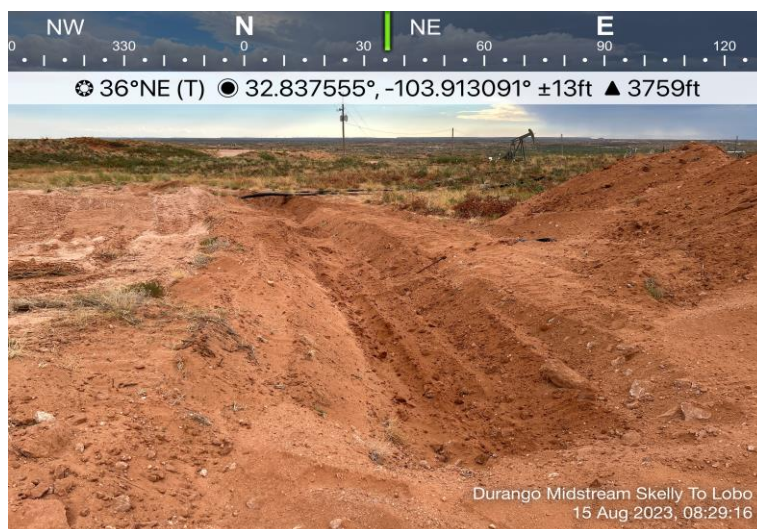
View Northeast, Area of CS-19 through CS-20.

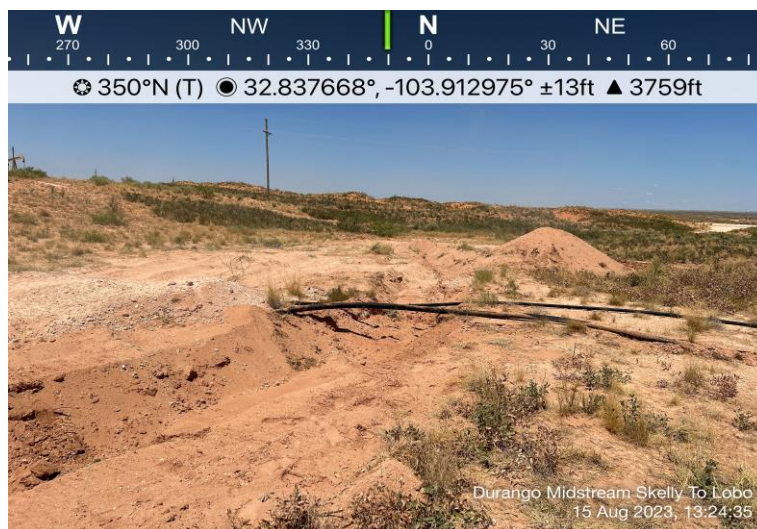
View North, Area of CS-21 through CS-23.

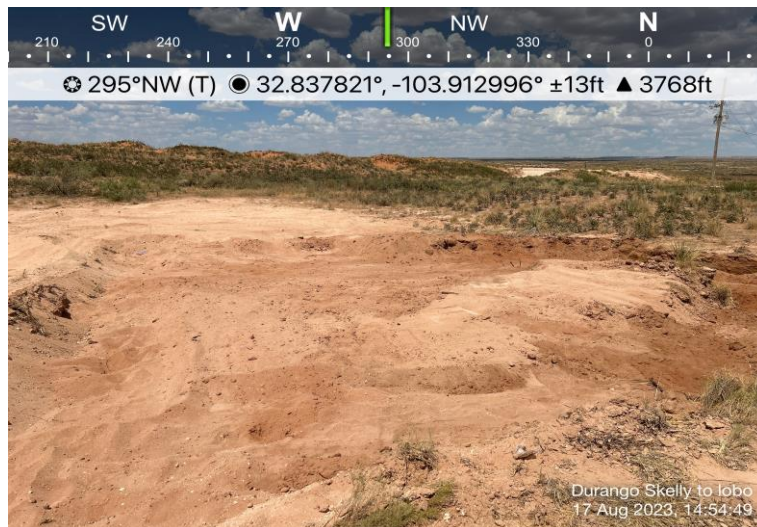
View Northwest, area of CS-24 through CS-30.
