Closure Report

Antelope Ridge 5 SWD Disposal (08.13.2023)

Incident #: NAPP2322844129

Produced Water Release

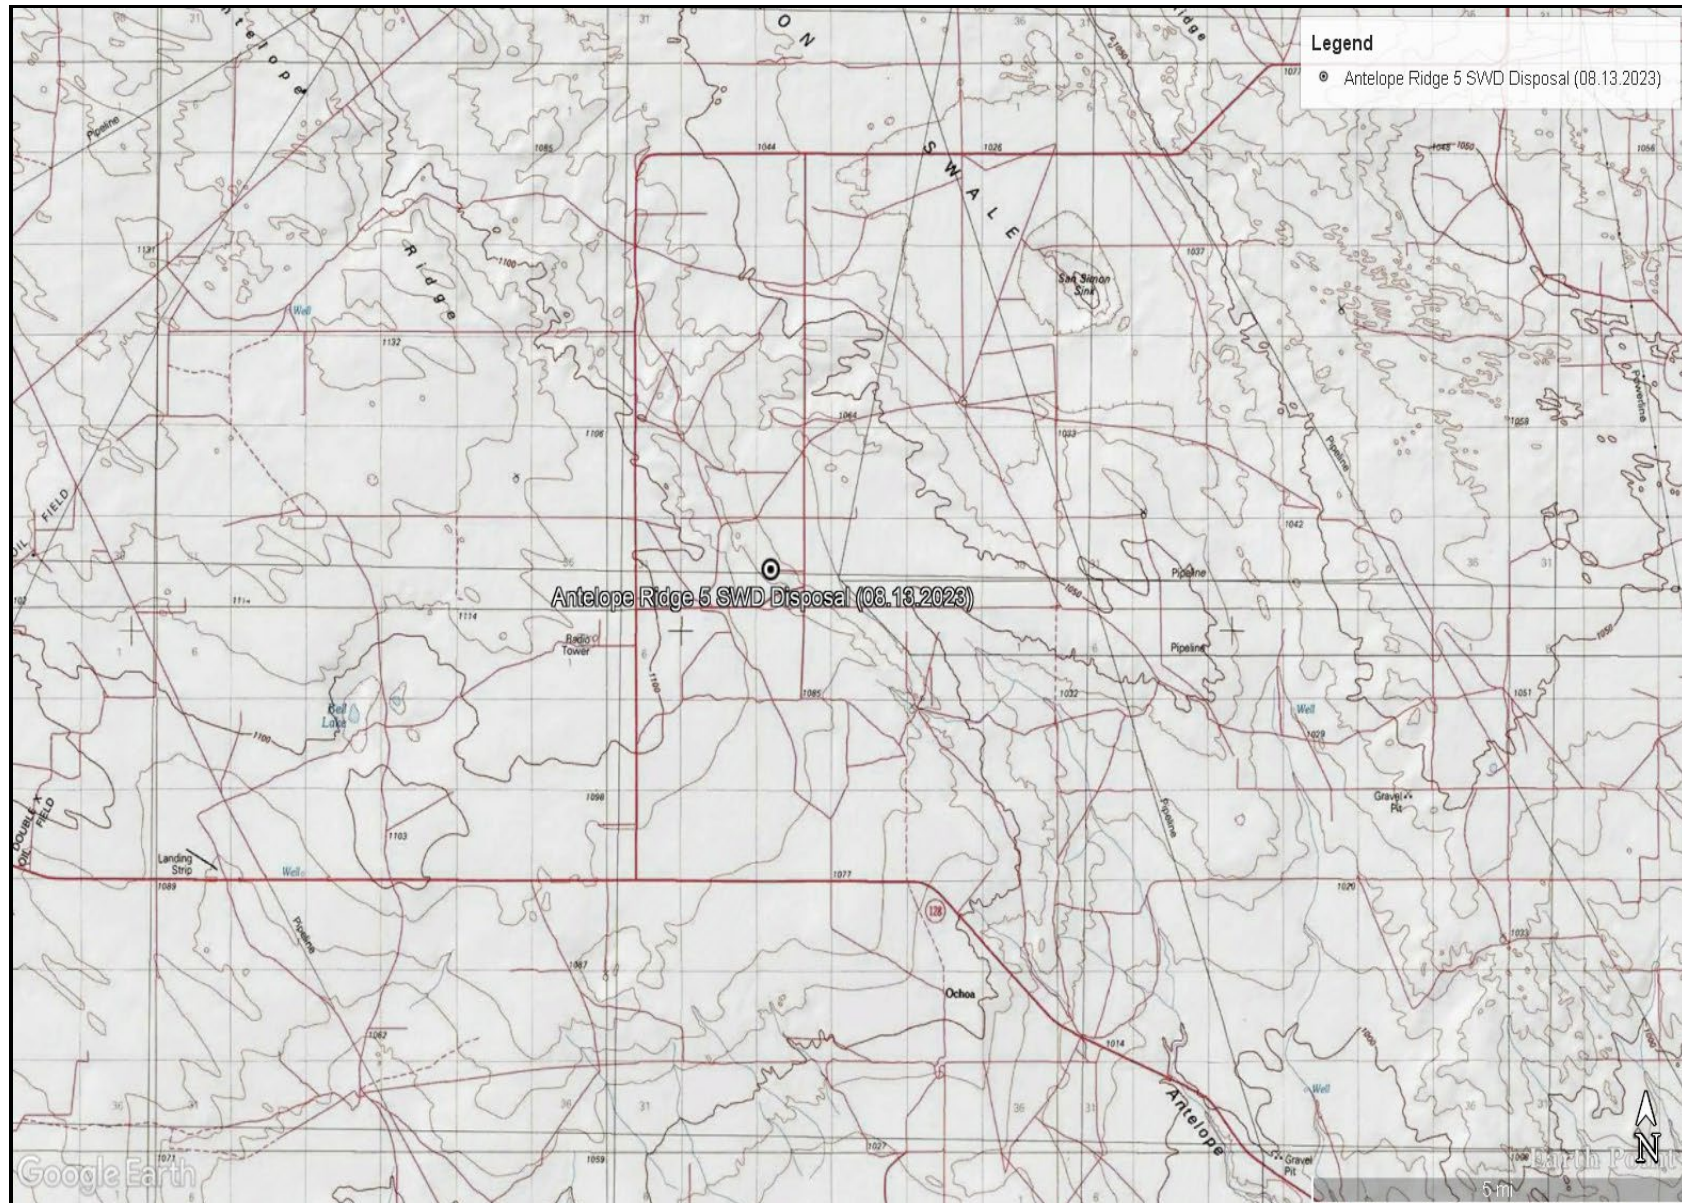
FIGURE 2

TOPOGRAPHIC MAP
CHEVRON U.S.A., INC.
ANTELOPE RIDGE 5 SWD DISPOSAL (08.13.2023)
LEA COUNTY, NEW MEXICO
32.260195°, 103.479899°

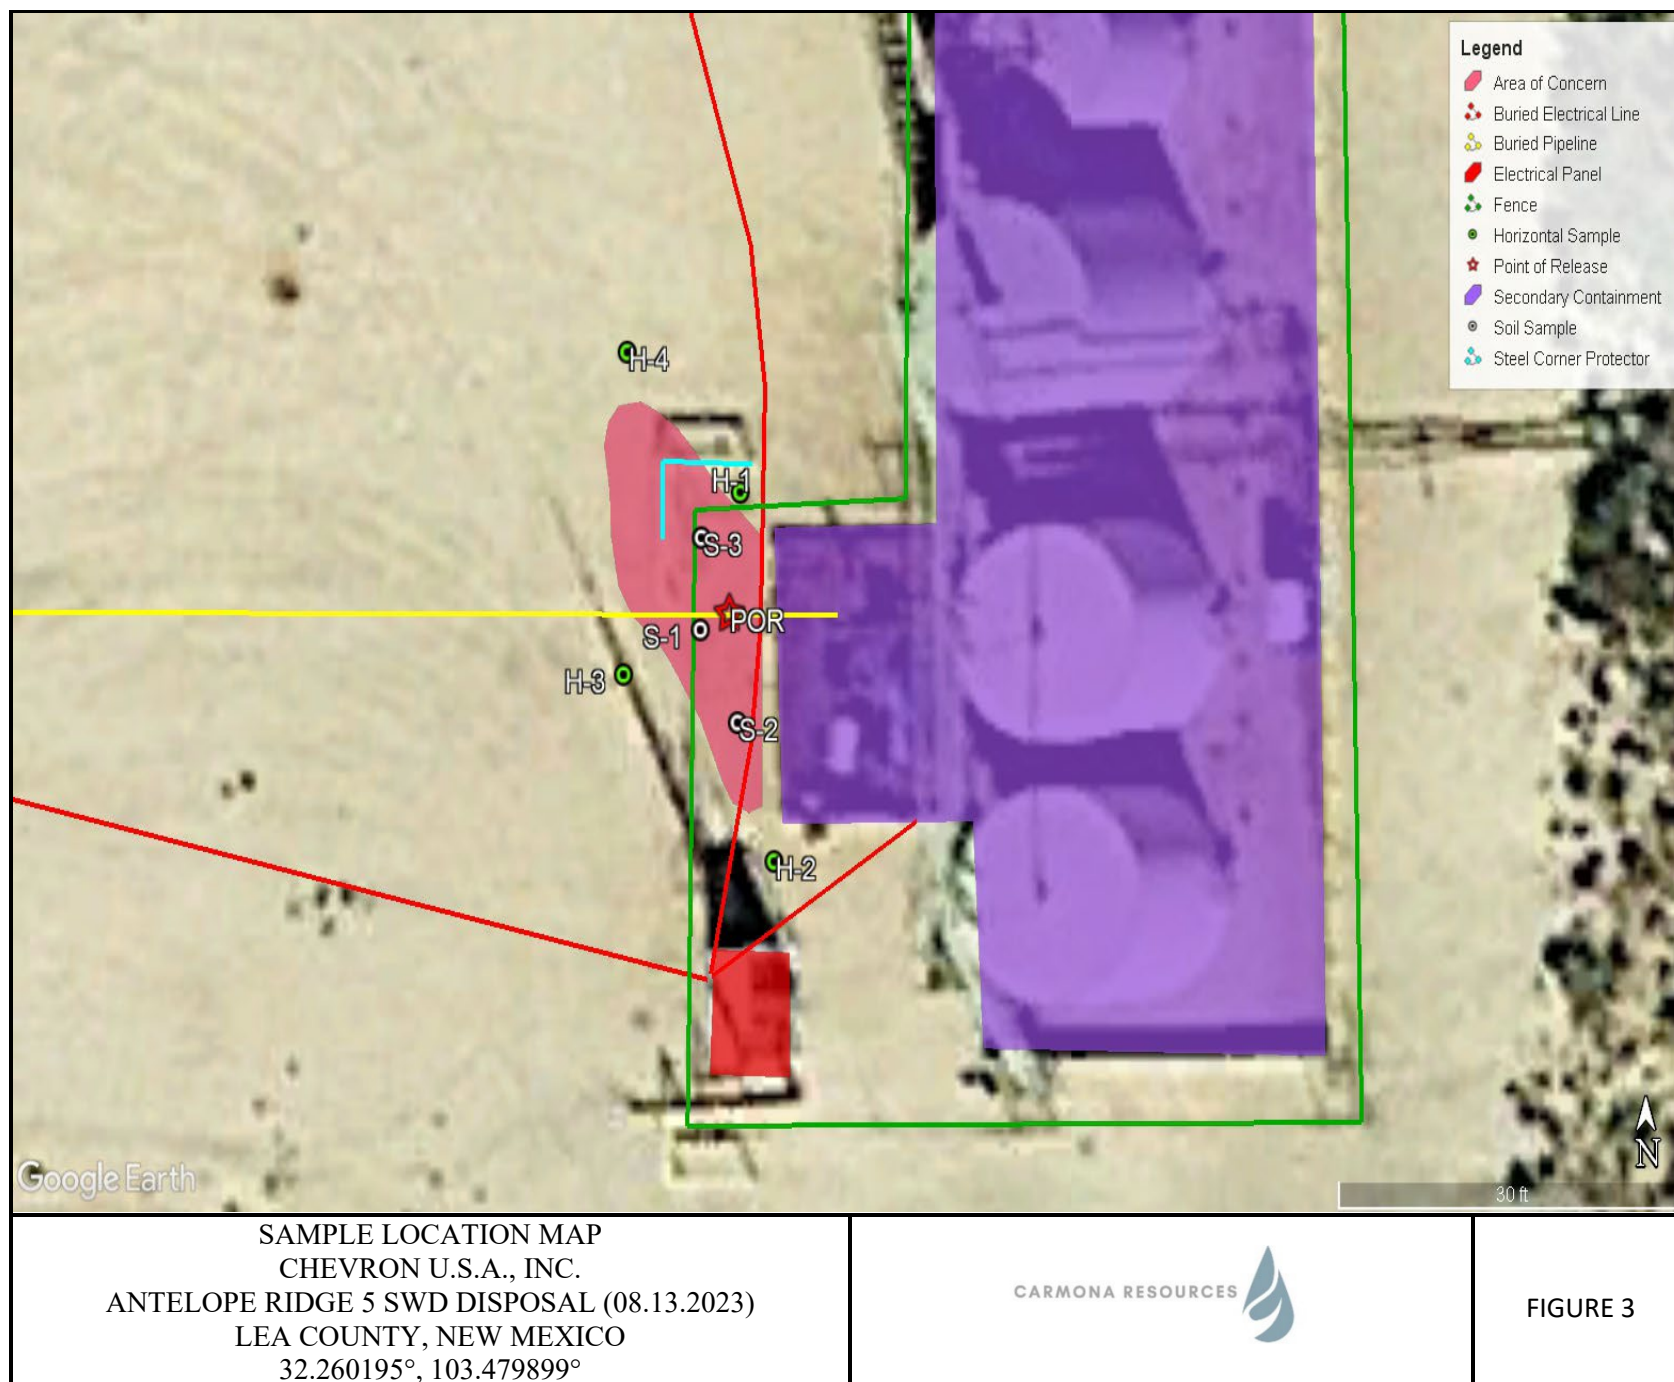
Based on the initial C-141 obtained from the New Mexico Oil Conservation Division (NMOCD), the release was discovered on August 13, 2023, caused by an underground leak on the discharge line of the flex pump. It resulted in approximately eleven (11) barrels of produced water being released and zero (0) barrels of produced water recovered. The impacted area was located on pad, shown in Figure 3. The initial C-141 form is attached in Appendix C.

On September 12, 2023, Carmona Resources, LLC performed site assessment activities to evaluate soil impacts stemming from the release. A total of three (3) sample points (S-1 through S-3) and four (4) horizontal sample points (H-1 through H-4) were installed to total depths ranging from surface to 3' below ground surface (bgs) inside and surrounding the release area. See Figure 3 for the sample locations. For chemical analysis, the soil samples were collected and placed directly into laboratory-provided sample containers, stored on ice, and transported under the proper chain-of-custody protocol to Cardinal Laboratories in Hobbs, New Mexico. The samples were analyzed for total petroleum hydrocarbons (TPH) by EPA method 8015, modified benzene, toluene, ethylbenzene, and xylenes (BTEX) by EPA Method 8021B, and chloride by EPA method 4500. The laboratory reports, including analytical methods, results, and chain-of-custody documents, are attached in Appendix E.

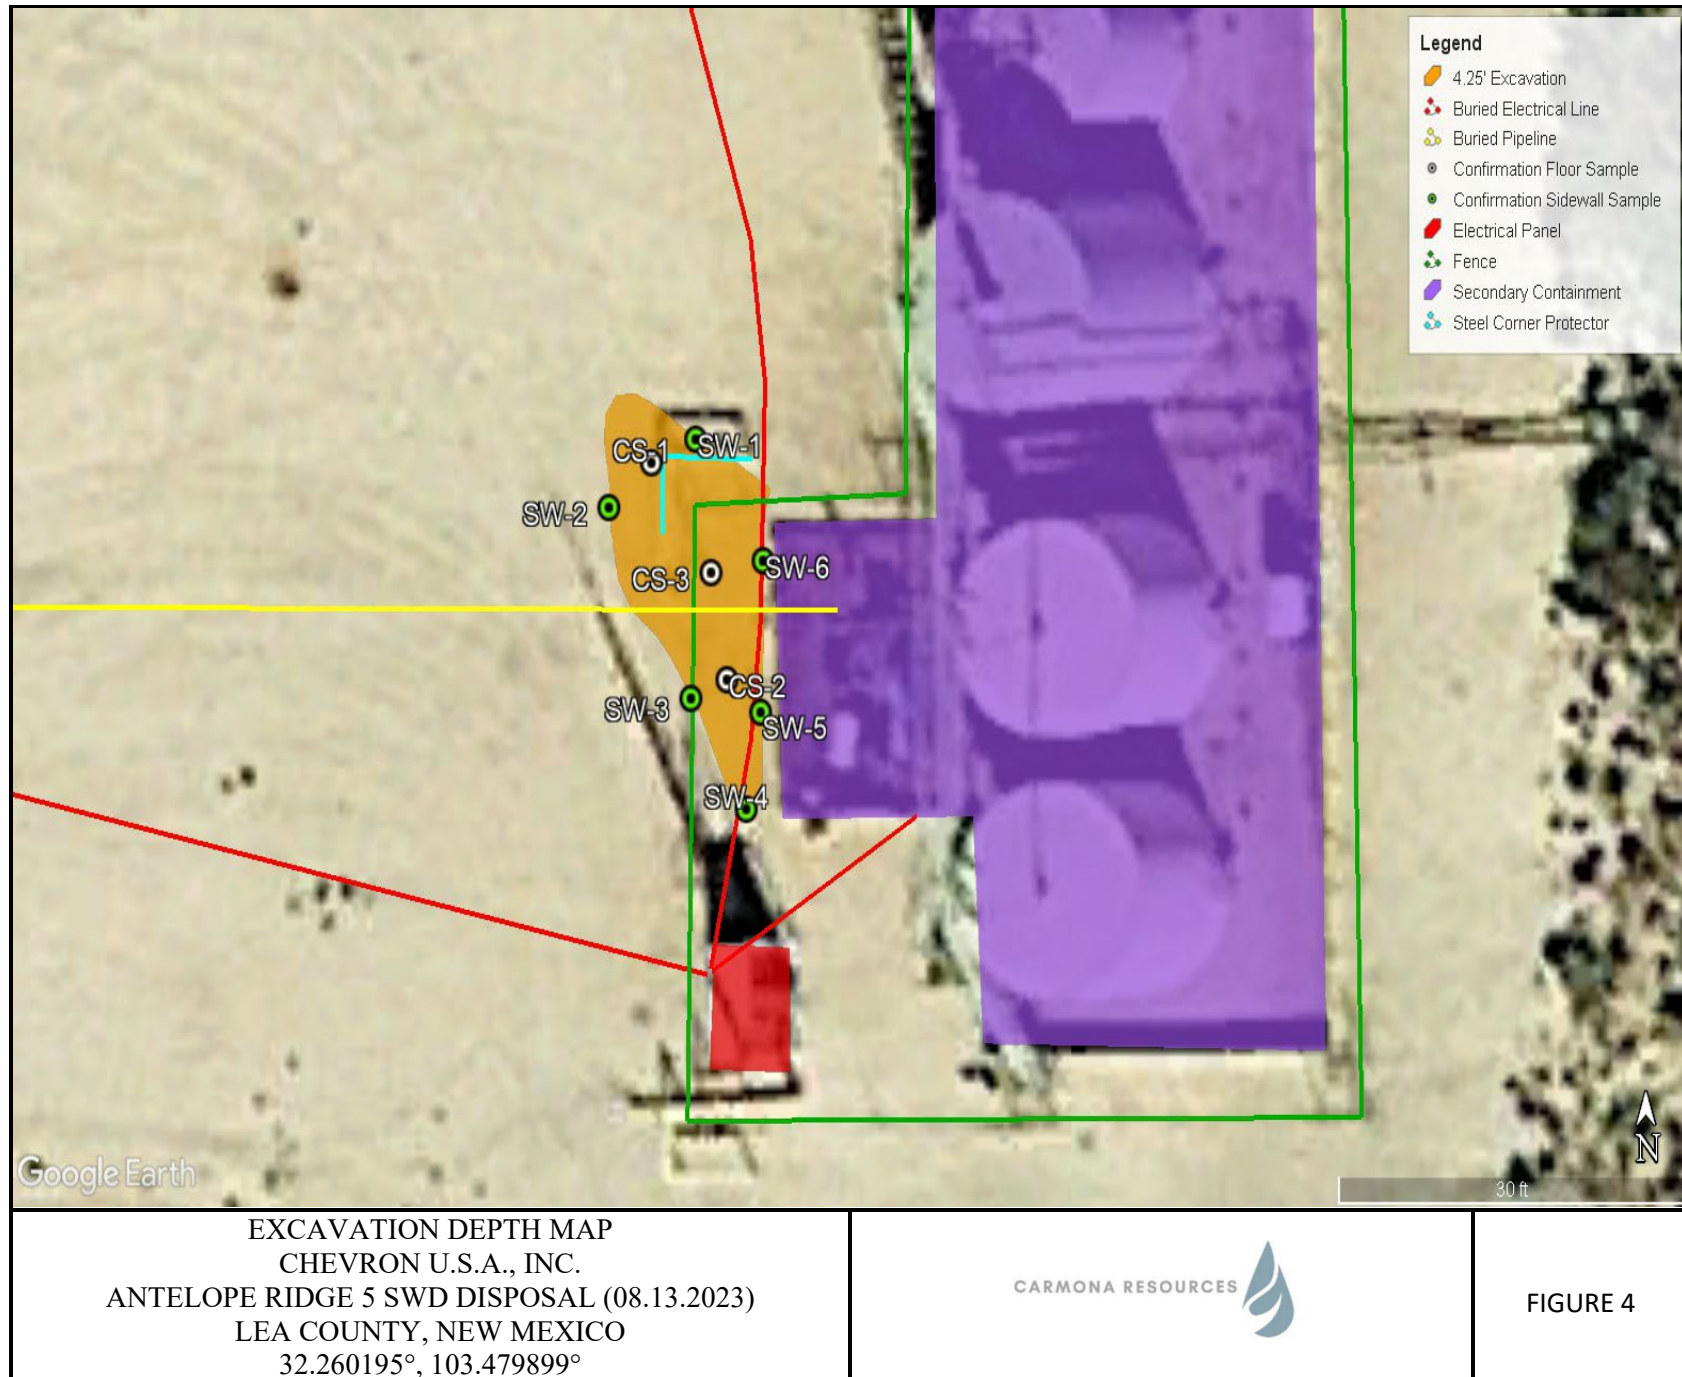
Carmona Resources personnel were onsite to supervise the remediation activities, collect confirmation samples, and document backfill activities. Before collecting composite confirmation samples, the NMOCD division office was notified via email on October 13, 2023, per Subsection D of 19.15.29.12 NMAC. See Appendix C. The area of S-1 through S-3 and H-1 was excavated to a depth of 4.25' bgs. A total of three (3) confirmation floor samples were collected (CS-1 through CS-3), and six (6) sidewall samples (SW-1 through SW-6) were collected every 200 square feet to ensure the proper removal of the contaminated soils. All collected samples were analyzed for TPH analysis by EPA method 8015 modified, BTEX by EPA Method 8021B, and chloride by EPA method 4500. Copies of laboratory analysis and chain-of-custody documentation are included in Appendix E. The excavation depths and confirmation sample locations are shown in Figure 4.

All final confirmation samples were below the regulatory requirements for TPH, BTEX, and chloride. Refer to Table 2.

Once the remediation activities were completed, the excavated areas were backfilled with clean material to surface grade. Approximately 70 cubic yards of material were excavated and transported offsite for proper disposal.

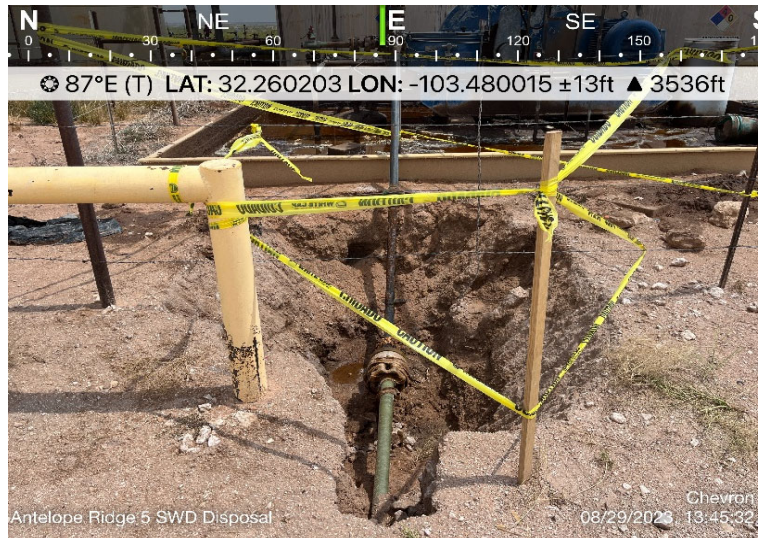
Photograph No. 1

Point of Release: Underground leak on the discharge line of the flex pump

Description:
View East, area of point of release.

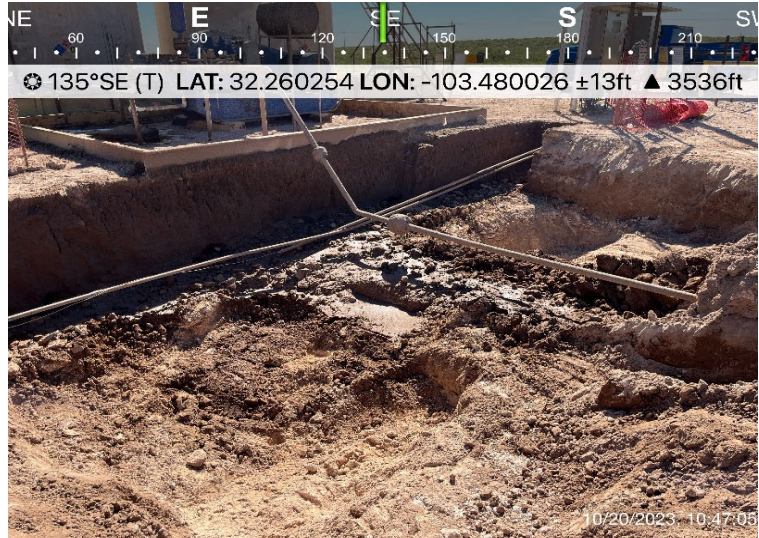
Photograph No. 2

Description:
View Southeast, area of CS-1 through CS-3.

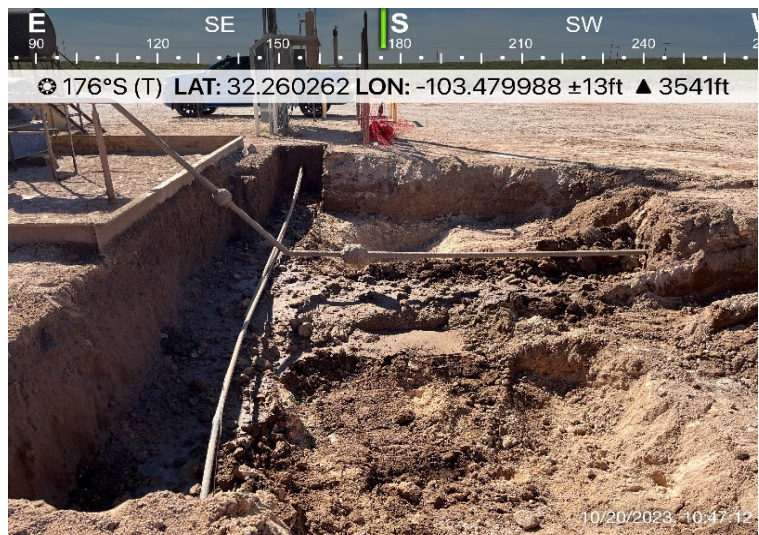
Photograph No. 3

Description:
View South, area of CS-1 through CS-3.

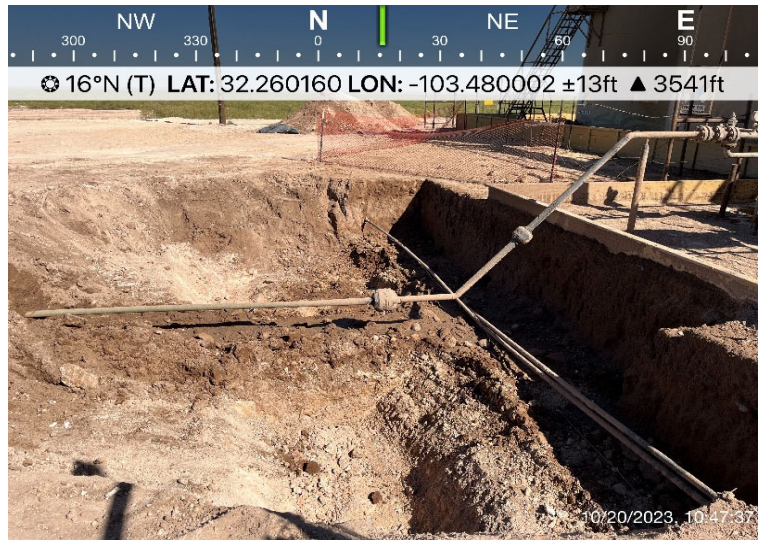
Photograph No. 4

Description:
View Northeast, area of CS-4.
