Incident ID	nAPP2325659451
District RP	
Facility ID	
Application ID

Site Assessment/Characterization

Based on laboratory analytical results and field activities conducted to date, Etech recommends Mewbourne Oil Company provide copies of this *Remediation Summary & Soil Closure Request* to the appropriate agencies and request closure be granted to the Delaware Ranch release site.

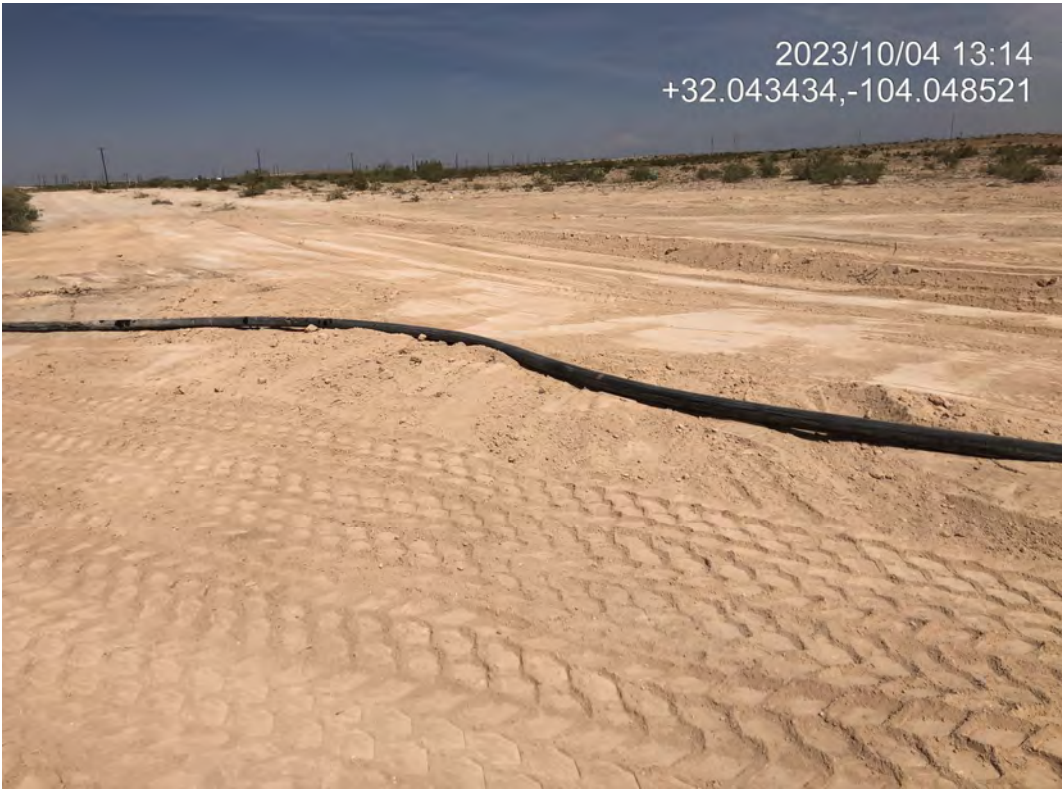
Photo Number: 7

Photo Direction: South	
Photo Description: View of the remediated area after backfill and regrading.

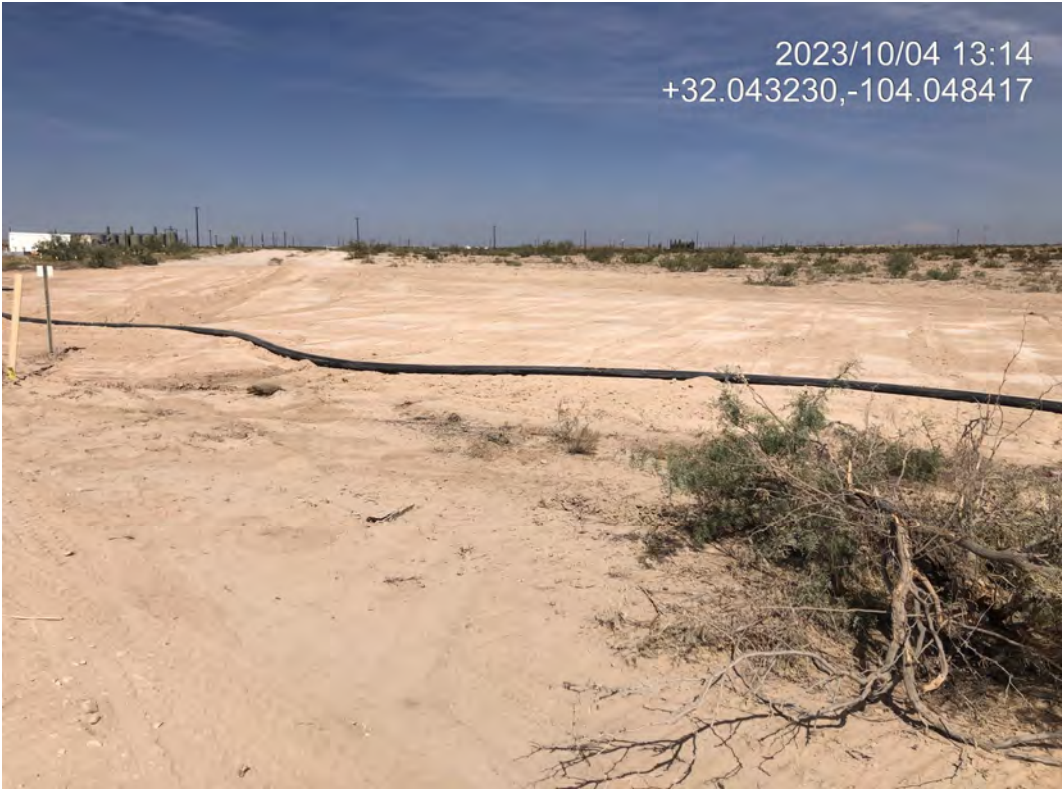
Photo Number: 8

Photo Direction: North	
Photo Description: View of the remediated area after backfill and regrading.
