**Re: REVISED Release Characterization and Remediation Work Plan  
ConocoPhillips  
On behalf of Solaris Water Midstream, LLC  
Pine Springs 2 State SWD #001 Release  
Unit Letter K, Section 2, Township 26 South, Range 25 East  
Eddy County, New Mexico  
Incident ID NAB1817955890  
2RP-4832**

Tetra Tech, Inc. (Tetra Tech) was contacted by ConocoPhillips to assess a release at the Pine Springs 2 State salt water disposal (SWD) #001 (API # 30-015-42348). The release footprint is located in Public Land Survey System (PLSS) Unit Letter K, Section 2, Township 26 South, Range 25 East, in Eddy County, New Mexico (Site). The approximate release point occurred at coordinates 32.071359°, -104.366918°, as shown on Figures 1 and 2. The Site is currently operated by Solaris Water Midstream, LLC (Solaris).

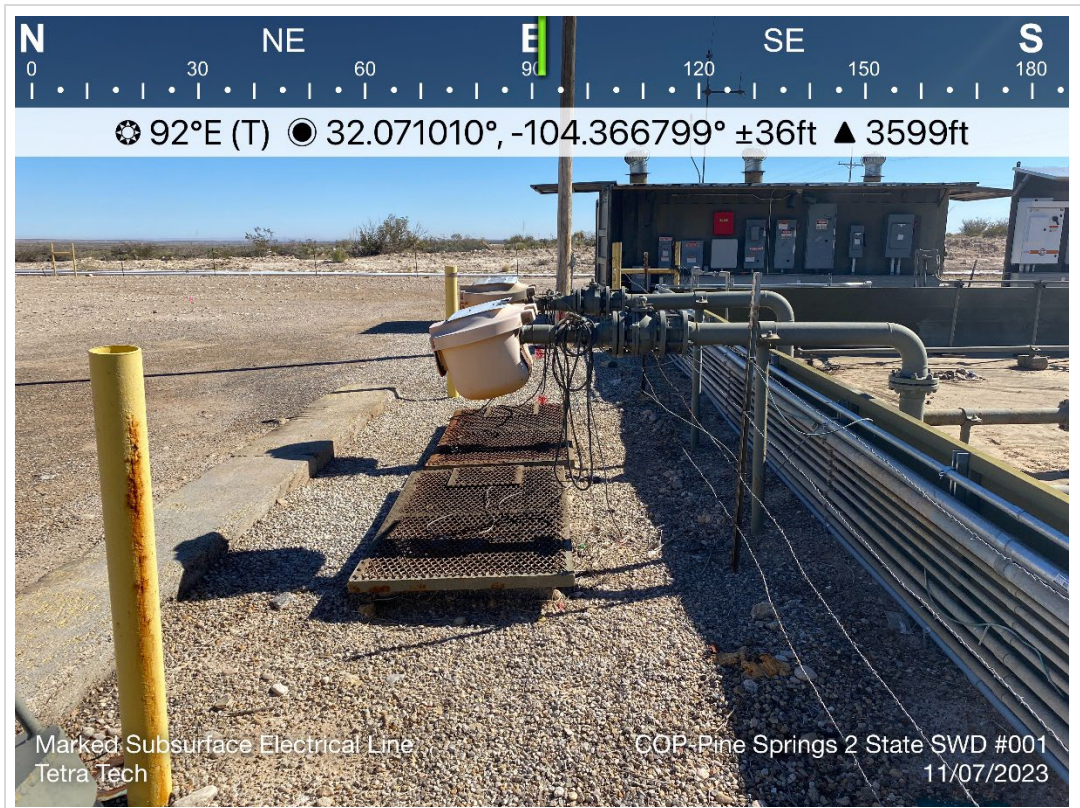
TETRA TECH, INC. PROJECT NO. 212C-MD-02878	DESCRIPTION	View east, facility equipment present along northeastern edge of tank battery.	3
	SITE NAME	Pine Springs 2 State SWD #001 Release	11/7/2023

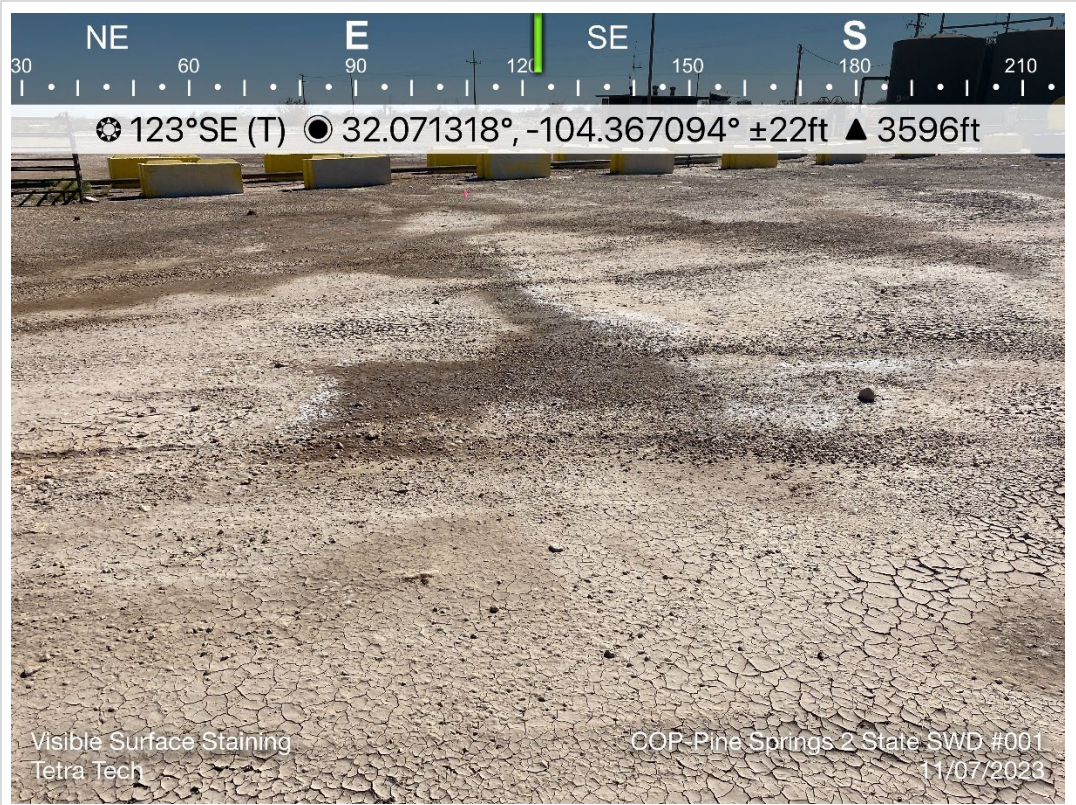
TETRA TECH, INC. PROJECT NO. 212C-MD-02878	DESCRIPTION	View southeast, pad surface with desiccation cracks and visible staining.	6
	SITE NAME	Pine Springs 2 State SWD #001 Release	11/7/2023

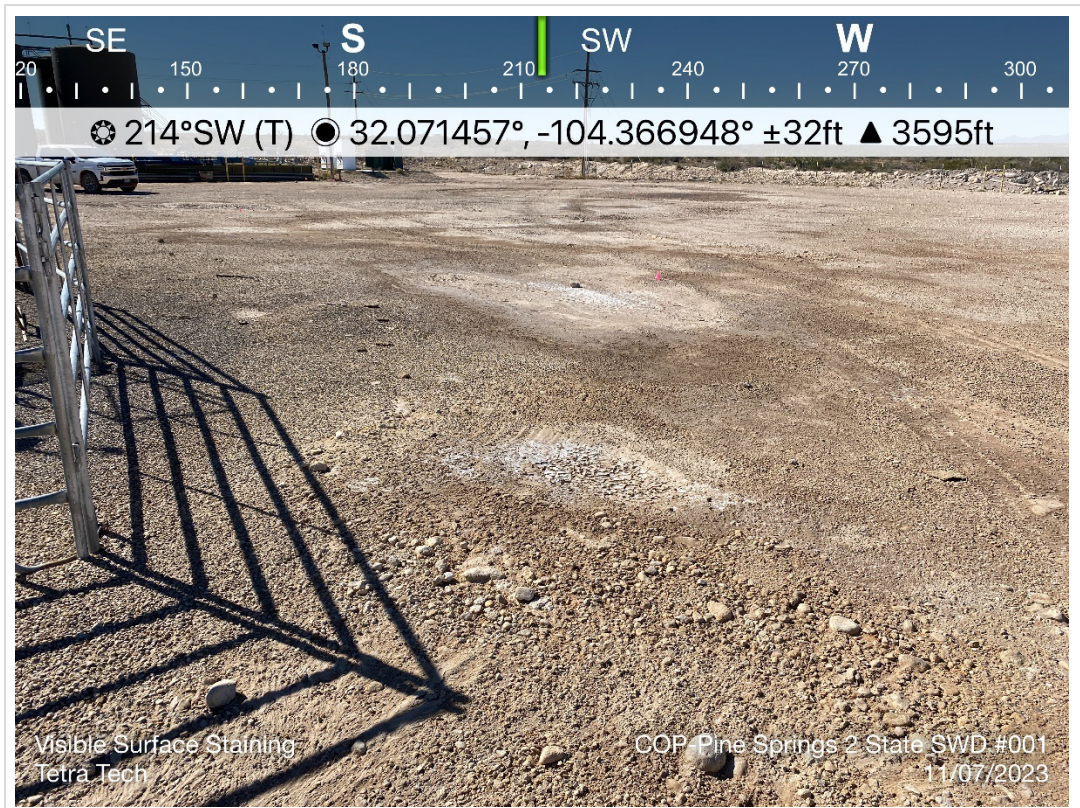
TETRA TECH, INC. PROJECT NO. 212C-MD-02878	DESCRIPTION	View southwest, pad surface with borehole location marked by pin-flag, and visible staining.	7
	SITE NAME	Pine Springs 2 State SWD #001 Release	11/7/2023

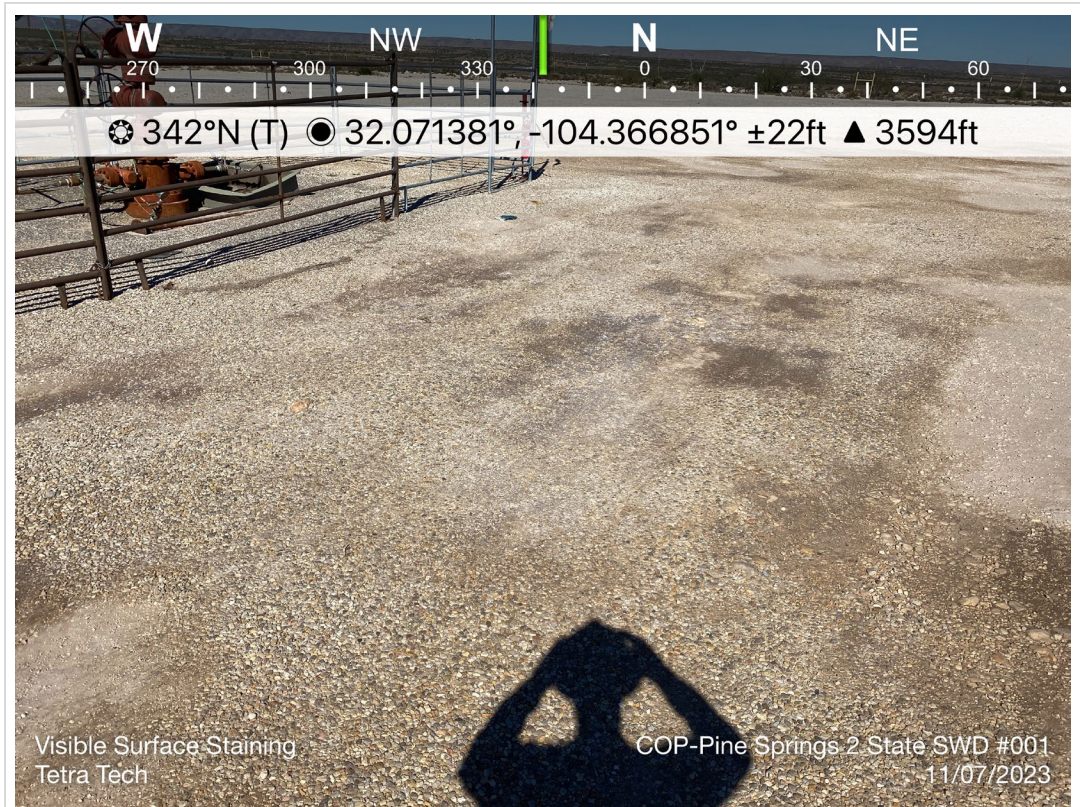
TETRA TECH, INC. PROJECT NO. 212C-MD-02878	DESCRIPTION	View north, east side of wellhead, possible minor staining.	8
	SITE NAME	Pine Springs 2 State SWD #001 Release	11/7/2023

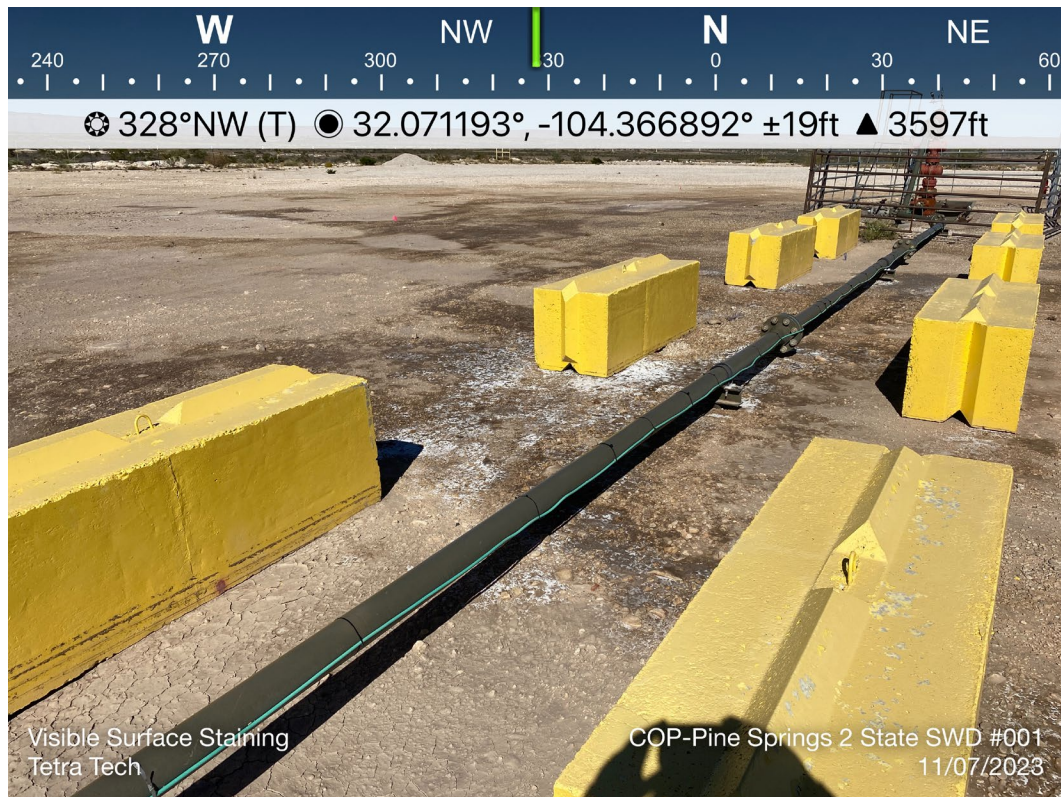
TETRA TECH, INC. PROJECT NO. 212C-MD-02878	DESCRIPTION	View northwest, surface steel line surrounded by cement blocks. Visible surface staining.	10
	SITE NAME	Pine Springs 2 State SWD #001 Release	11/7/2023

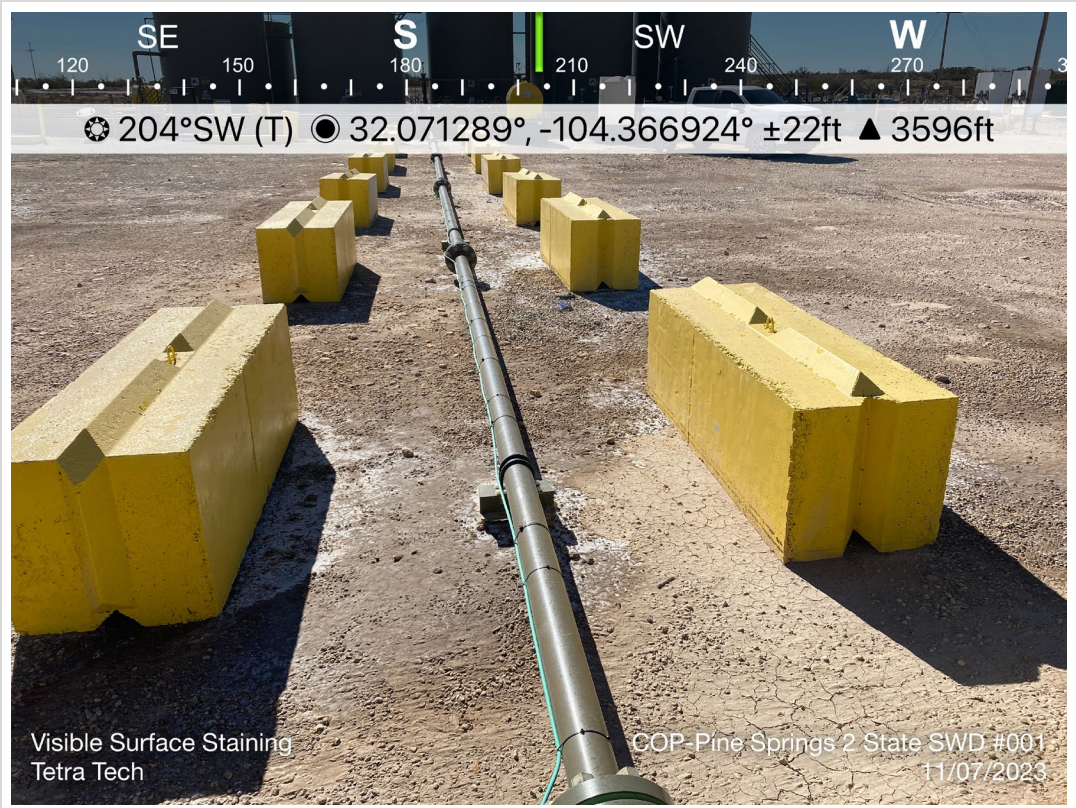
TETRA TECH, INC. PROJECT NO. 212C-MD-02878	DESCRIPTION	View south, raised steel line and surrounding cement blocks. Visible surface staining.	11
	SITE NAME	Pine Springs 2 State SWD #001 Release	11/7/2023
