**Re: REVISED Release Characterization and Remediation Work Plan
Cuatro Hijos/Airstrip Fee Com 1H PW Flowline Release
ConocoPhillips (Heritage COG Operating LLC)
Lea County, New Mexico
DOR: 4/20/2023
INCIDENT ID NAPP2311541081
Approximate Release Point 32.661348° -103.488105°**

Tetra Tech, Inc. (Tetra Tech) was contacted by ConocoPhillips Company (ConocoPhillips) to assess a release that occurred from a flowline associated with Cuatro Hijos-Airstrip Fee Com 1H. The release footprint is located on private land in Public Land Survey System (PLSS) Unit Letter E, Section 17, Township 19 South, Range 35 East, in Lea County, New Mexico (Site). The approximate release point occurred at coordinates 32.661348°, -103.488105°, as shown on Figures 1 and 2.

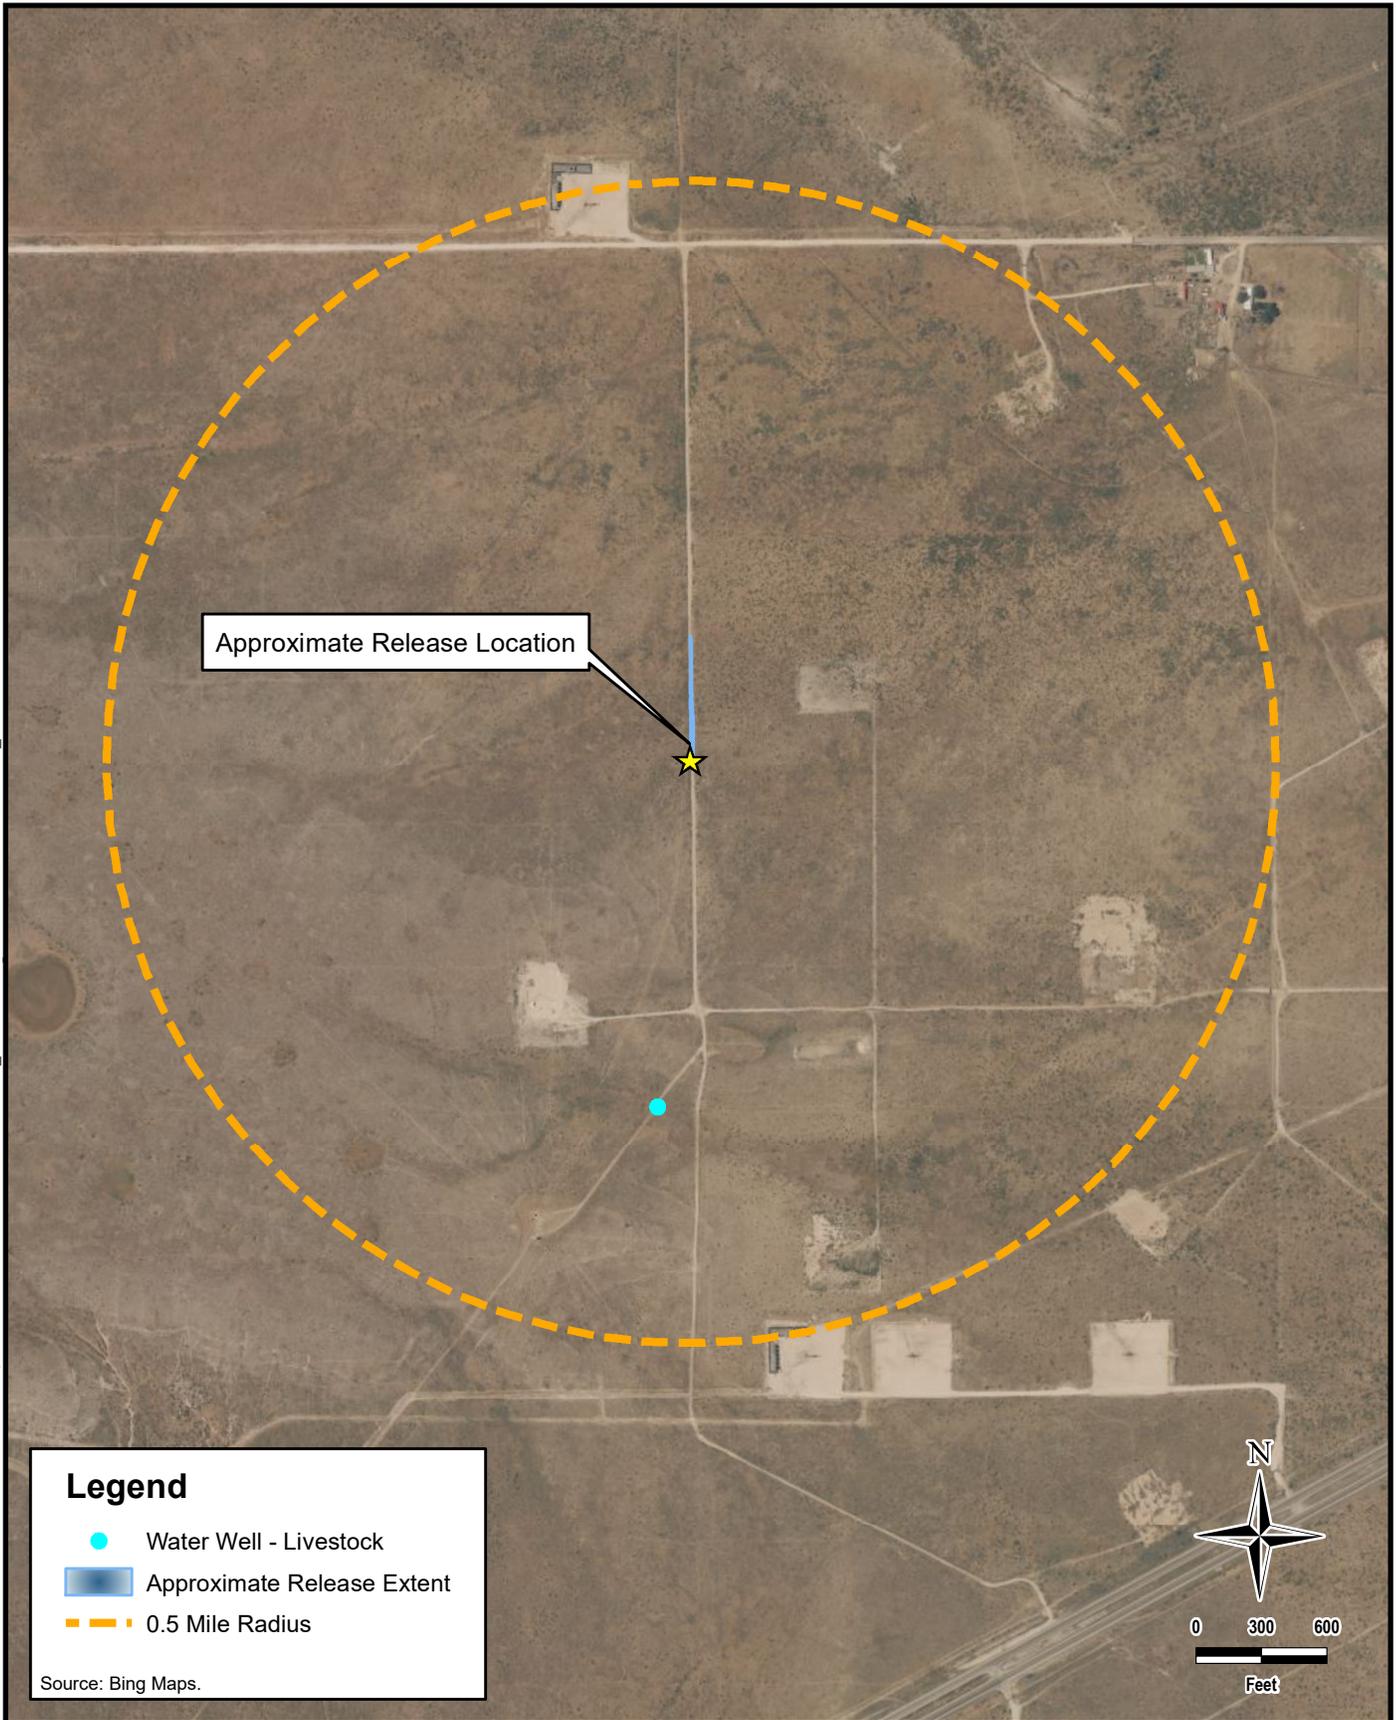
According to the New Mexico Office of the State Engineers (NMOSE) reporting system, there are two (2) water wells within ½ mile (800 meters) of the Site. The minimum depth to groundwater based on the data from these wells is 80 feet below ground surface (bgs).

DOCUMENT PATH: C:\USERS\LISSA.VILLAMONEDRIVE - TETRA TECH\INCIDENTS\ILLULLI\COPICUATRO_HIJOS\MXD\FIGURE 5 DEPTH TO WATER_CUATRO HIJOS.MXD

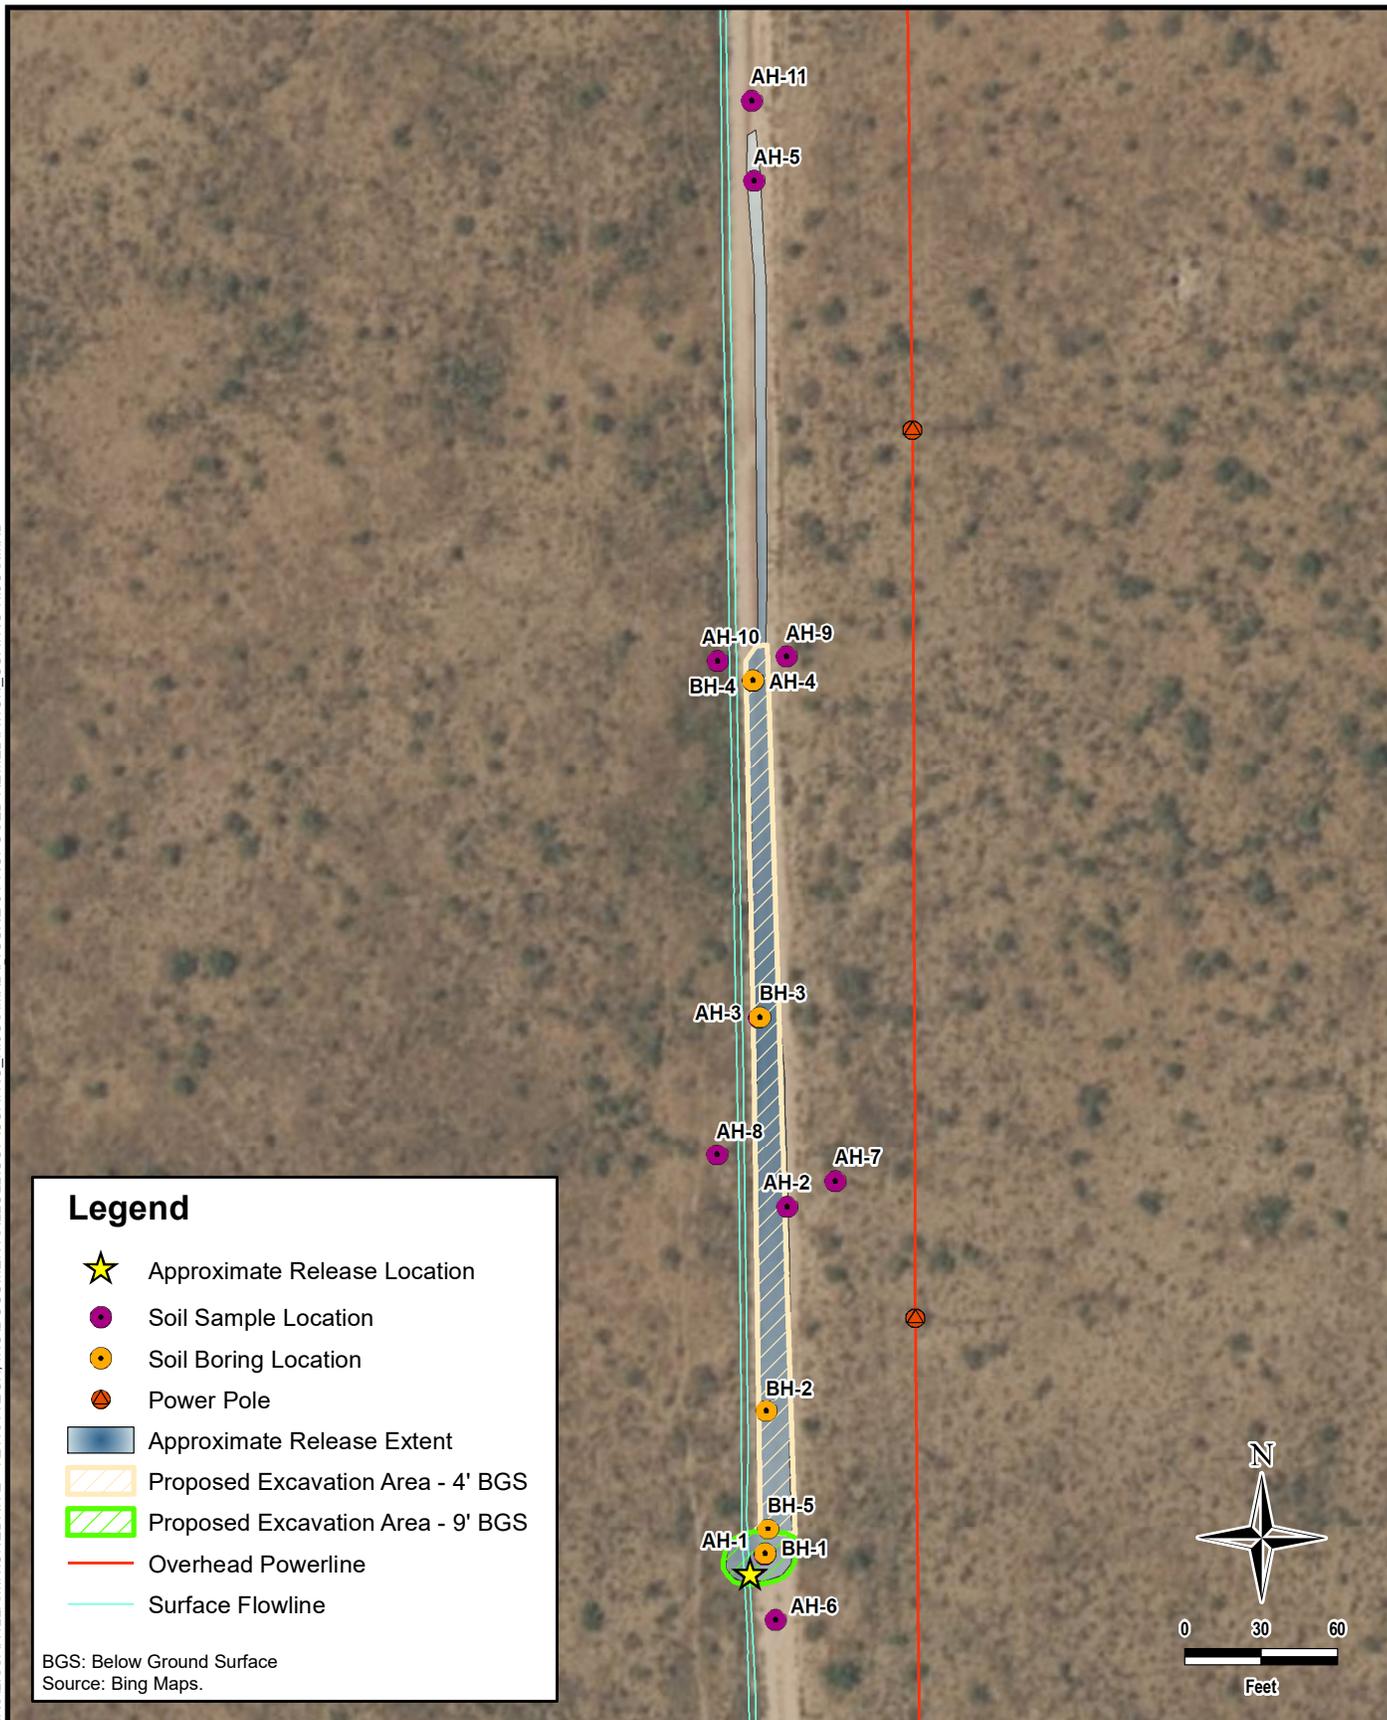
Figure No.
6

DOCUMENT PATH: C:\USERS\LISSA.VILLAMINONEDRIVE - TETRA TECH\INCIDOCUMENTS\ILLULLI\COPICUATRO_HIJOS\MXD\FIGURE 6 PROPOSED REMEDIATION_CUATRO HIJOS.MXD

- ★ Approximate Release Location
- Soil Sample Location
- Soil Boring Location
- ⚡ Power Pole
- ▭ Approximate Release Extent
- ▨ Proposed Excavation Area - 4' BGS
- ▨ Proposed Excavation Area - 9' BGS
- Overhead Powerline
- Surface Flowline

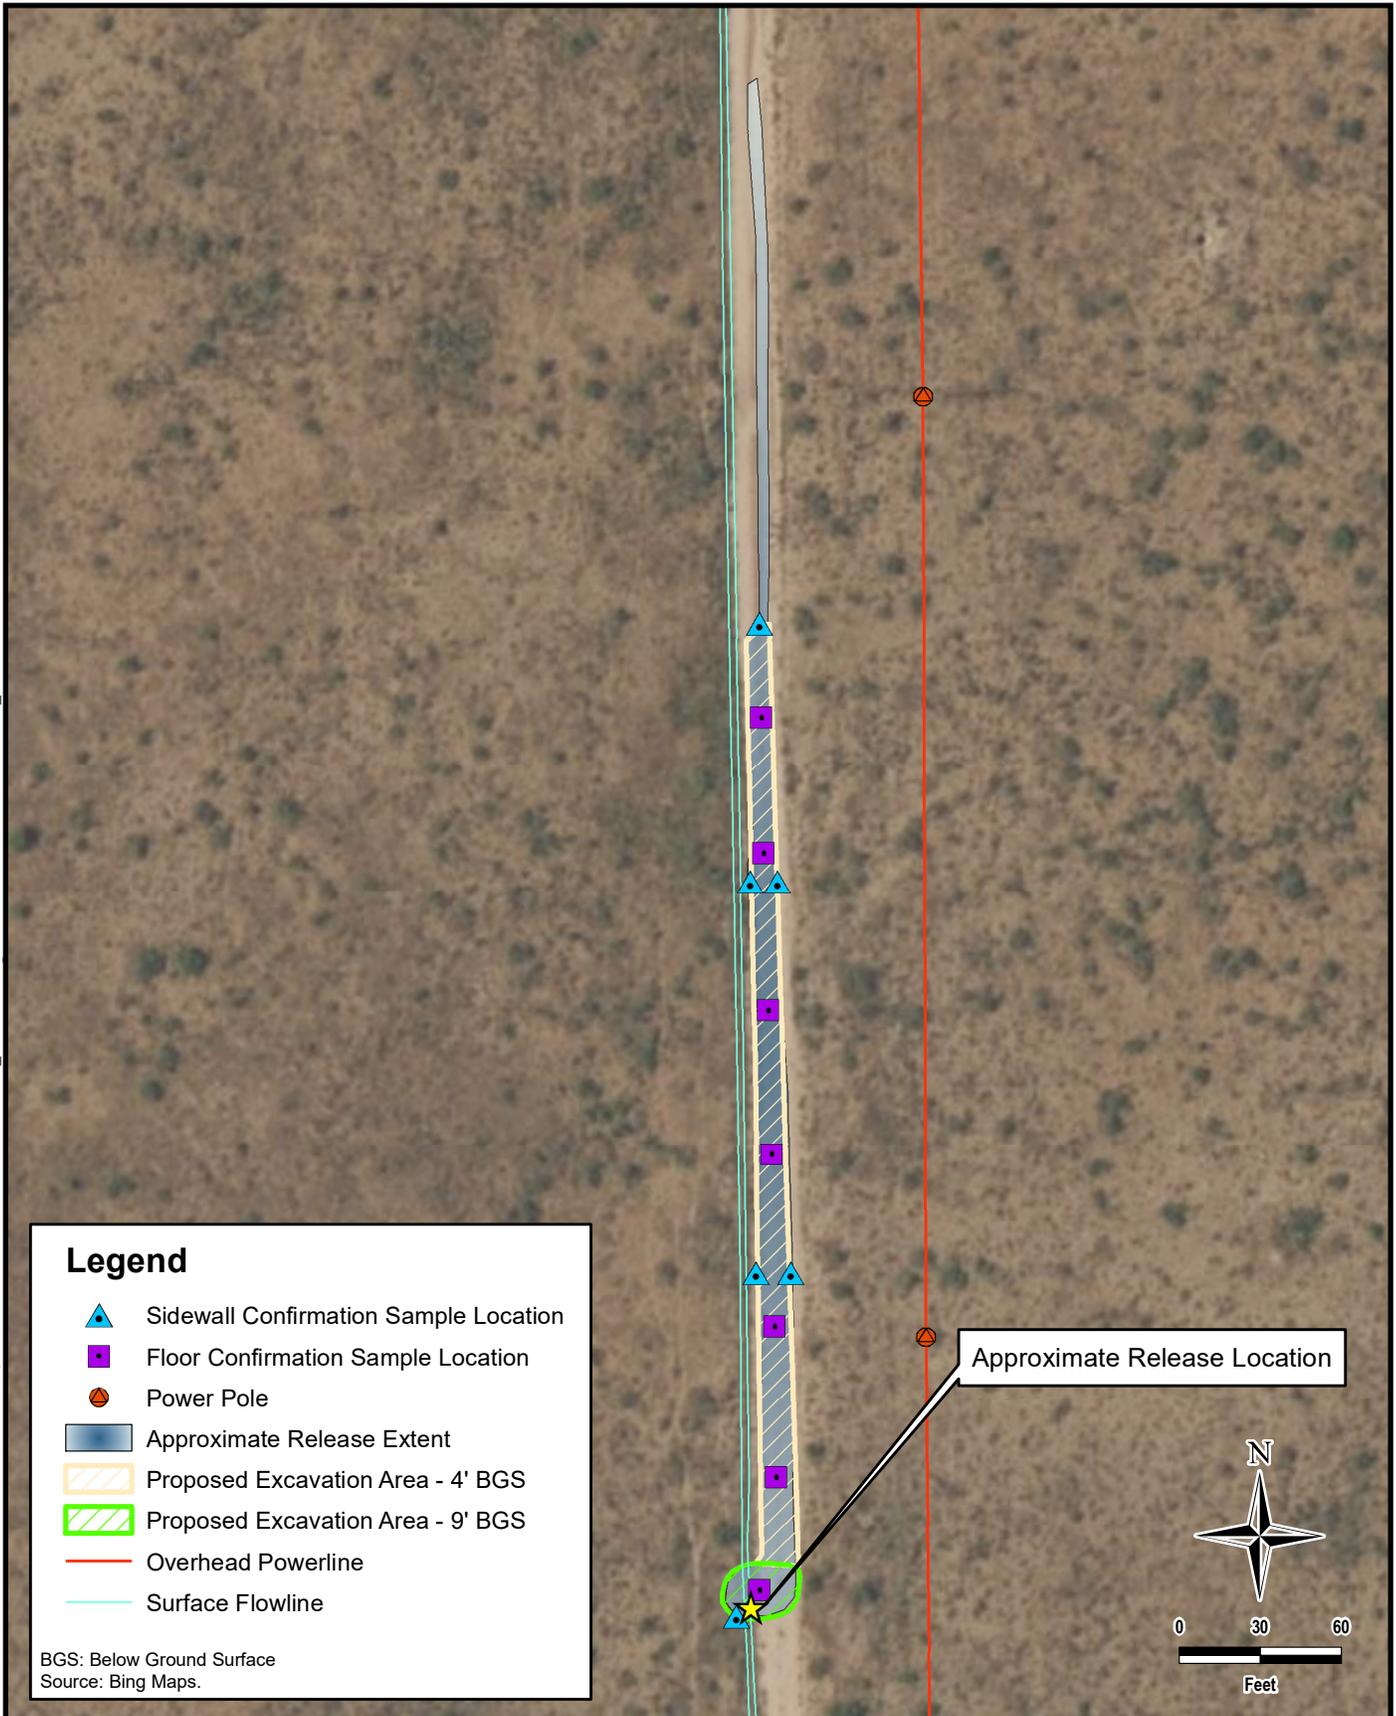
DOCUMENT PATH: C:\USERS\LISSA.VILLAMINON\DRIVE - TETRA TECH\INC\DOCUMENTS\ILLULLI\COPICUATRO_HIJOS\MXD\FIGURE 7\ALTERNATIVE_CONFIRM_CUATRO_HIJOS.MXD

- Sidewall Confirmation Sample Location
- Floor Confirmation Sample Location
- Power Pole
- Approximate Release Extent
- Proposed Excavation Area - 4' BGS
- Proposed Excavation Area - 9' BGS
- Overhead Powerline
- Surface Flowline

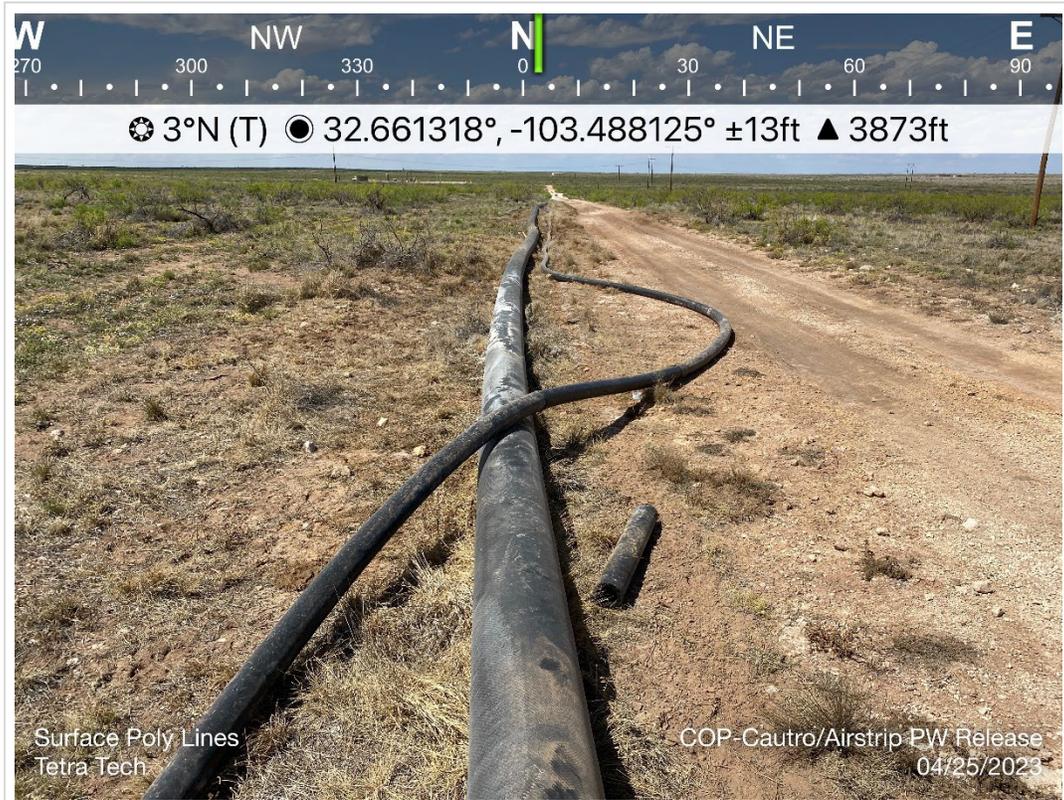
TETRA TECH, INC. PROJECT NO. 212C-MD-03105A	DESCRIPTION	View north. Release point with flowline repair.	1
	SITE NAME	Cuatro Hijos-Airstrip Flowline Release	4/25/23

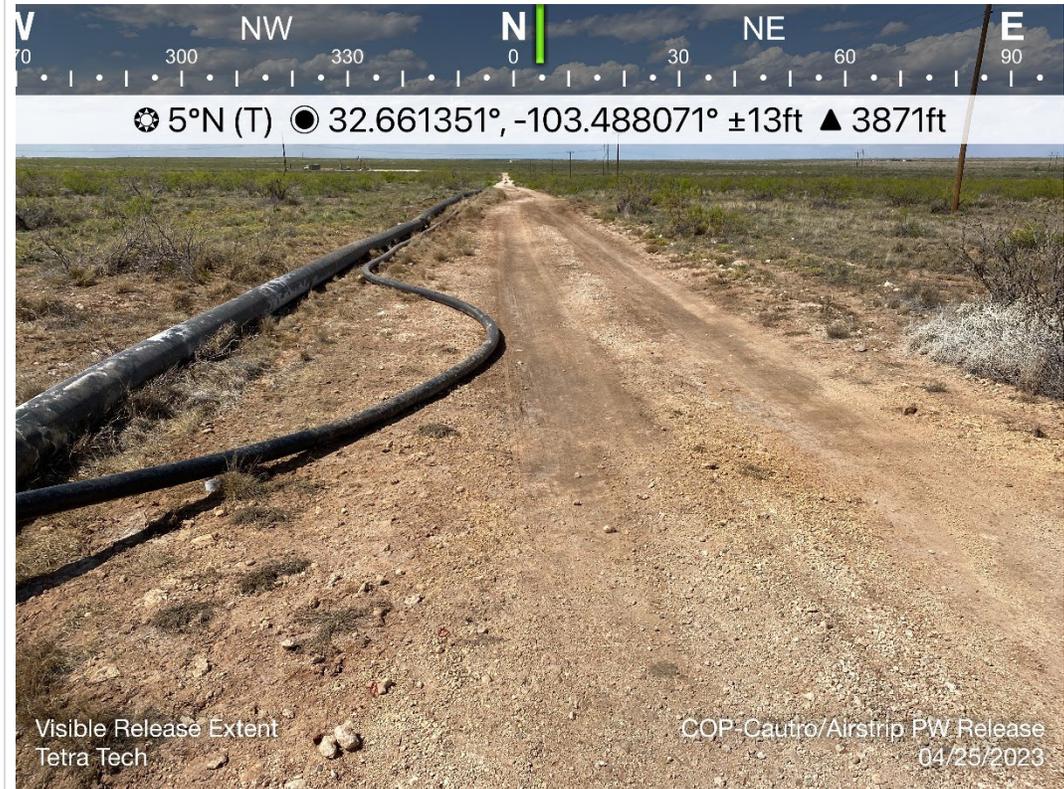
TETRA TECH, INC. PROJECT NO. 212C-MD-03105A	DESCRIPTION	View north. Release extent flow path along caliche road.	2
	SITE NAME	Cuatro Hijos-Airstrip Flowline Release	4/25/23

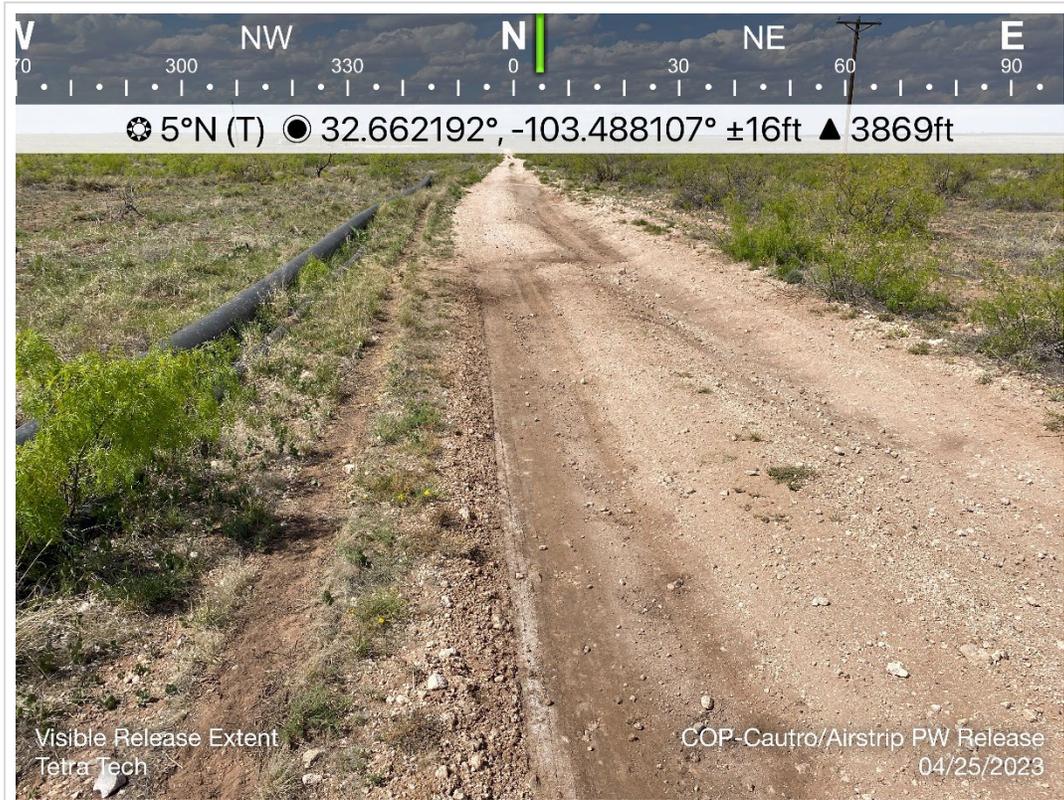
TETRA TECH, INC. PROJECT NO. 212C-MD-03105A	DESCRIPTION	View north. Release extent flow path switching along east side of caliche road.	3
	SITE NAME	Cuatro Hijos-Airstrip Flowline Release	4/25/23

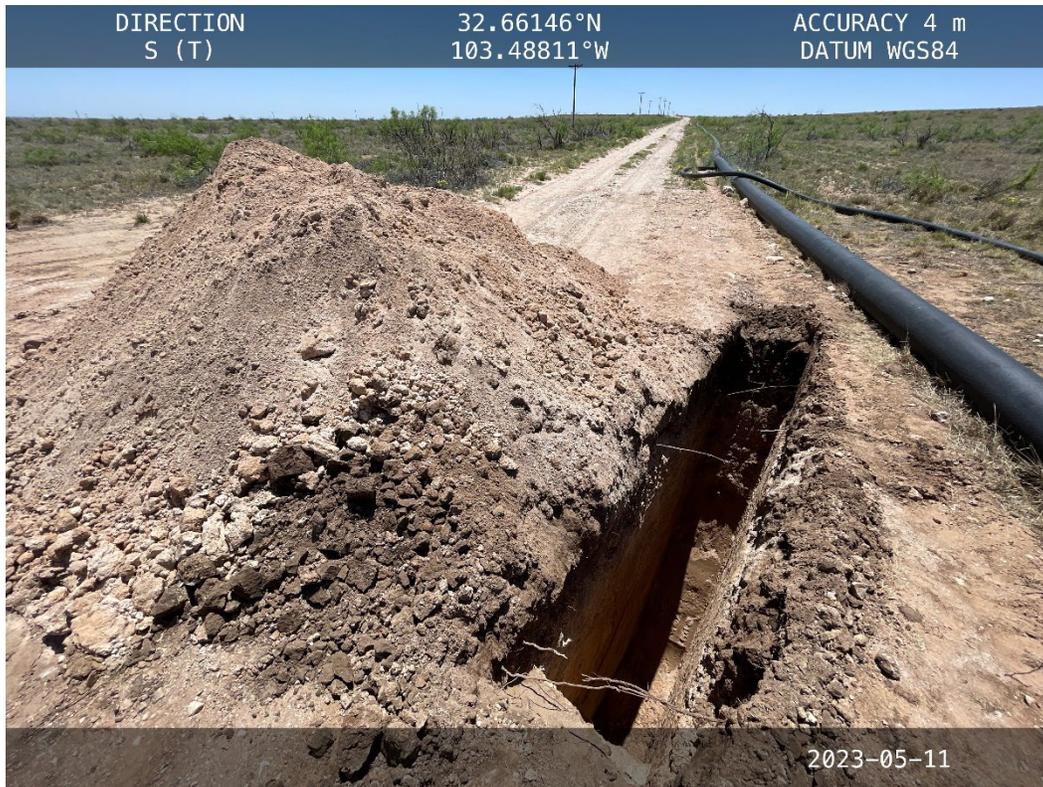
1. The area of AH-1 is underlain by loose silty material, which allowed for deeper migration of released fluids in the area. However, the area of AH-2, AH-3, AH-4 and AH-5 is underlain by shallow, lithified caprock. Even with a backhoe, refusal was encountered at shallow depth at AH-2, AH-3, AH-4 and AH-5. However, during trenching at AH-1, the backhoe was able to advance to roughly 12-13 feet bgs.

TETRA TECH, INC. PROJECT NO. 212C-MD-03105A	DESCRIPTION	View south. Vertical trench sampling location AH-1.	4
	SITE NAME	Cuatro Hijos-Airstrip Flowline Release	4/25/23

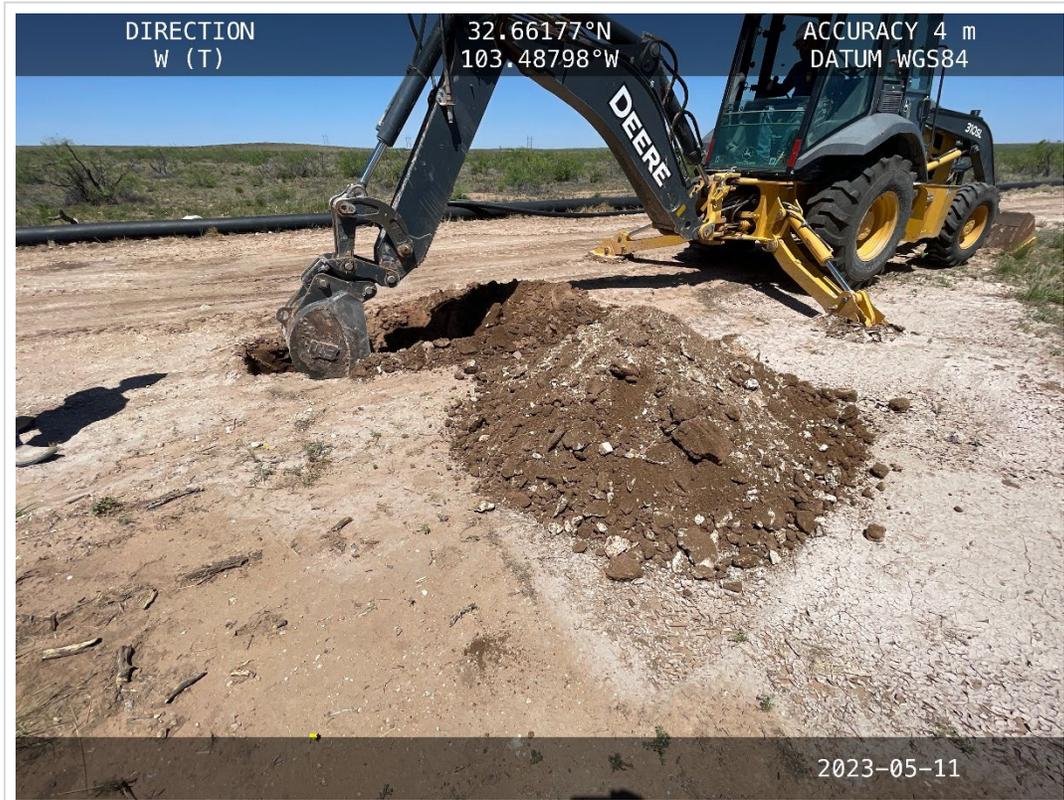
TETRA TECH, INC. PROJECT NO. 212C-MD-03105A	DESCRIPTION	View west. Vertical trench sampling location AH-2.	5
	SITE NAME	Cuatro Hijos-Airstrip Flowline Release	5/11/2023

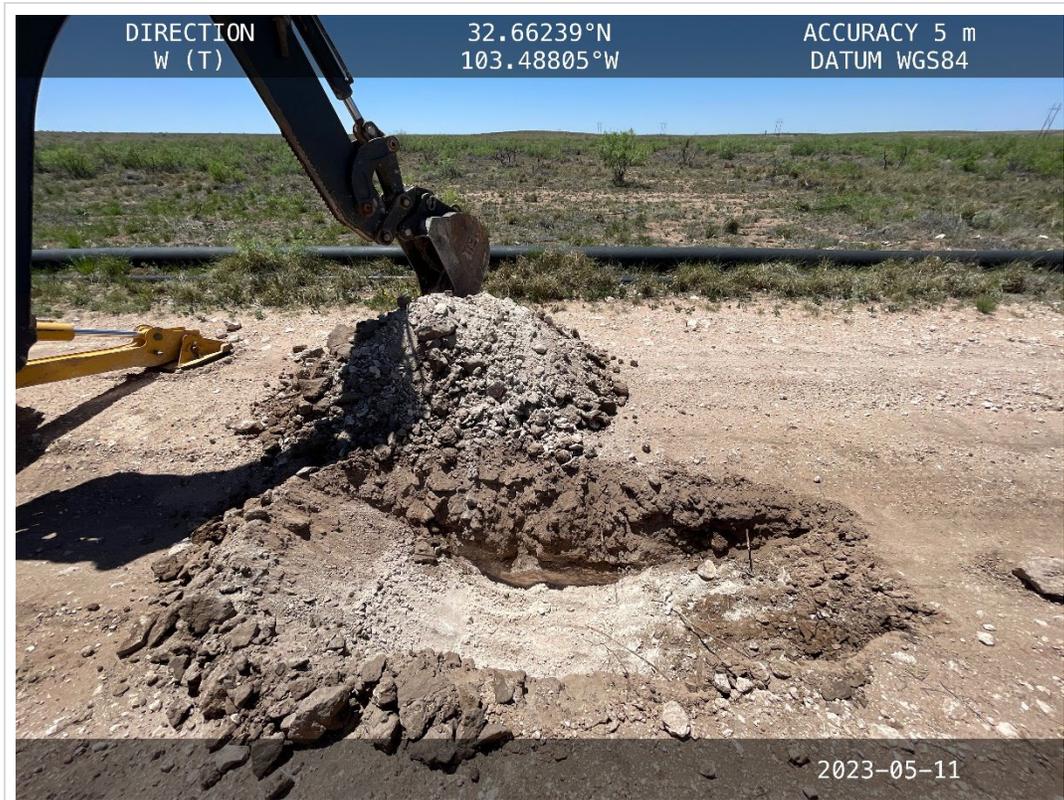
TETRA TECH, INC. PROJECT NO. 212C-MD-03105A	DESCRIPTION	View west. Vertical trench sampling location AH-4. Dense subsurface lithology visible.	6
	SITE NAME	Cuatro Hijos-Airstrip Flowline Release	5/11/2023

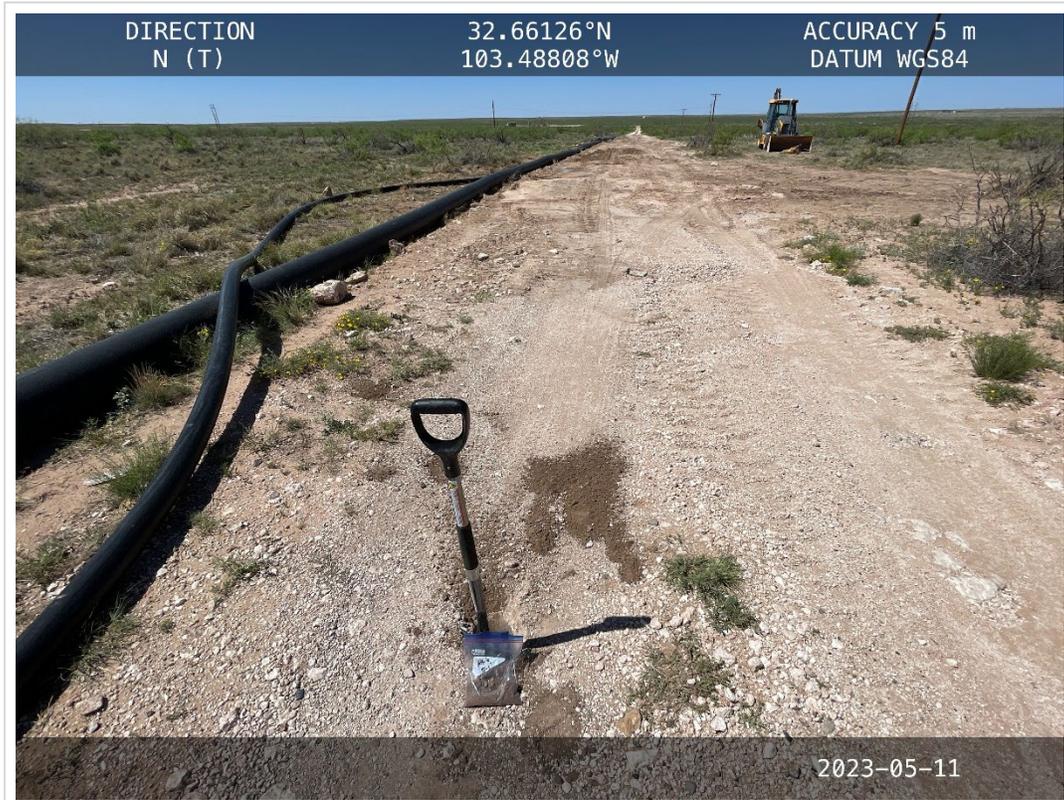
TETRA TECH, INC. PROJECT NO. 212C-MD-03105A	DESCRIPTION	View North. Horizontal soil sampling location AH-6.	7
	SITE NAME	Cuatro Hijos-Airstrip Flowline Release	5/11/2023

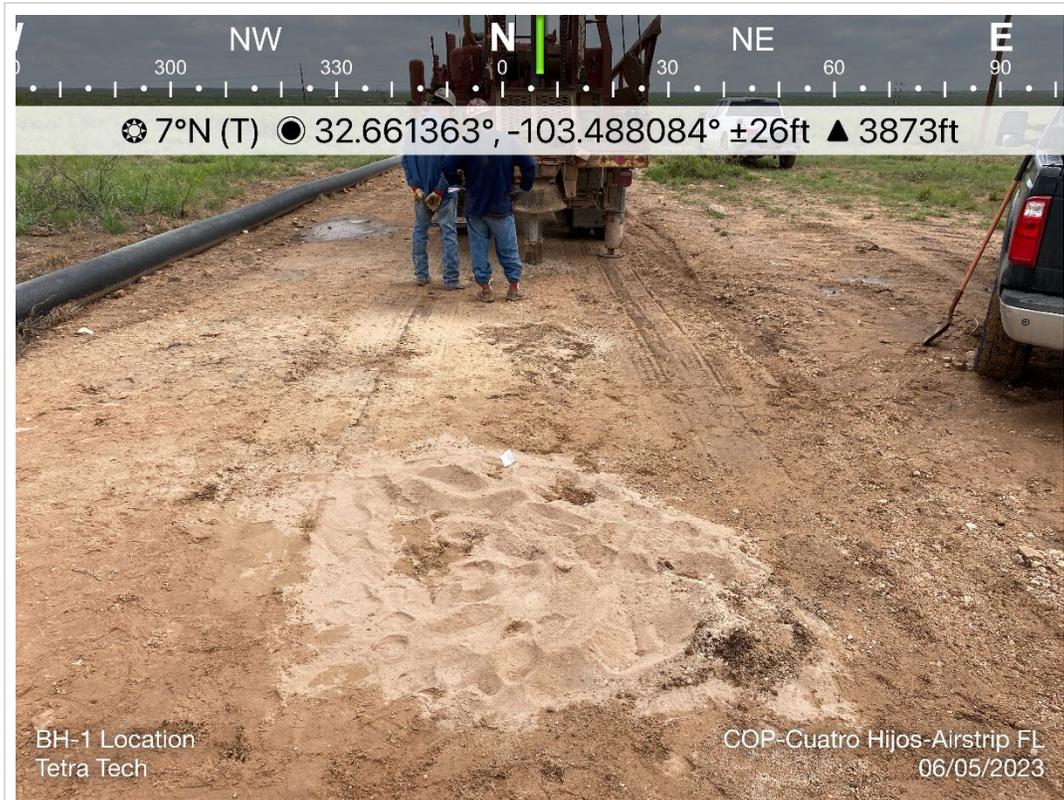
TETRA TECH, INC. PROJECT NO. 212C-MD-03105A	DESCRIPTION	View north. Air rotary boring assessment location BH-1.	8
	SITE NAME	Cuatro Hijos-Airstrip Flowline Release	6/5/2023

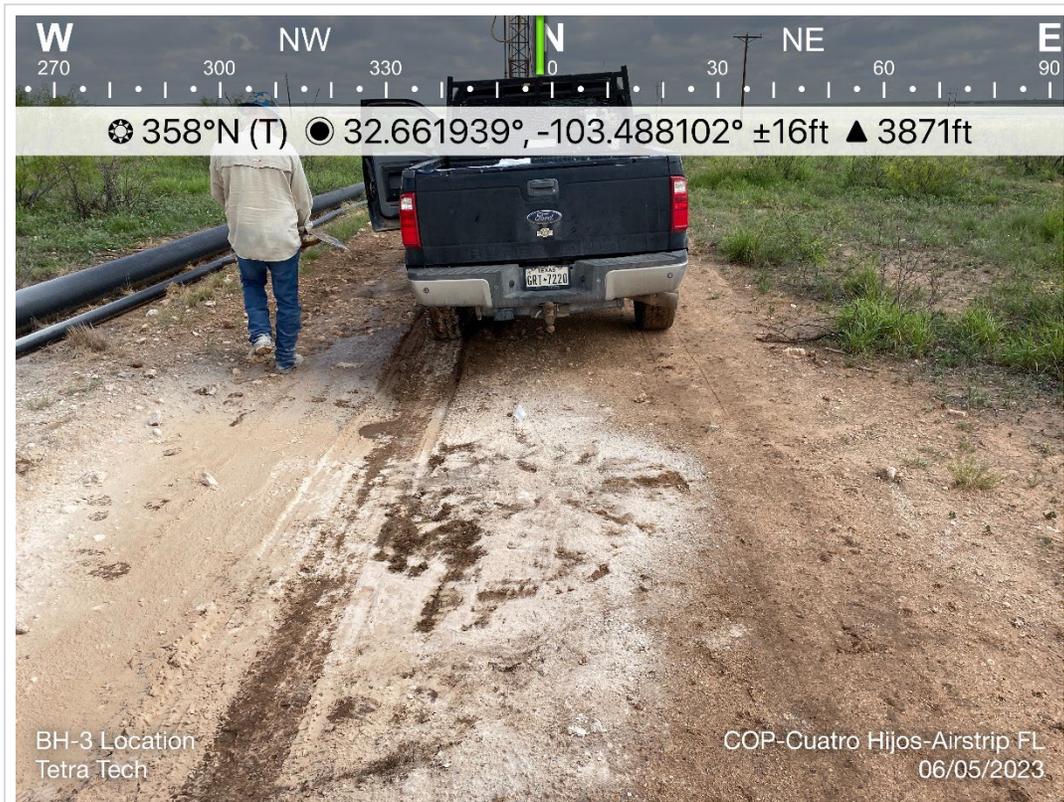
TETRA TECH, INC. PROJECT NO. 212C-MD-03105A	DESCRIPTION	View north. Air rotary boring assessment location BH-3.	9
	SITE NAME	Cuatro Hijos-Airstrip Flowline Release	6/5/2023

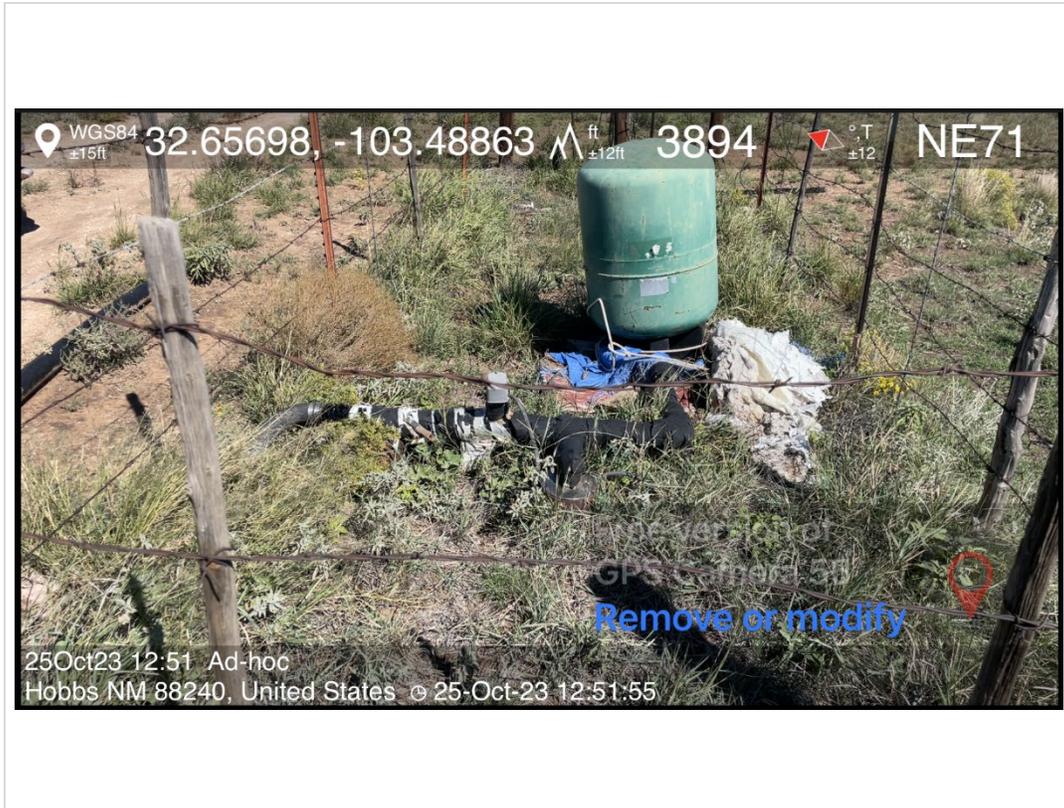
TETRA TECH, INC. PROJECT NO. 212C-MD-03105A	DESCRIPTION	Livestock Water Well (32.65698, -103.48863)	10
	SITE NAME	Cuatro Hijos-Airstrip Flowline Release	10/25/2023
