Release Notification

Site Name: Pipeline ROW 1002	Site Type Natural Gas Processing Plant
Date Release Discovered: 10/14/2016	Serial # (if applicable) N/A

Closure Report

Pipeline Right of Way, 1002

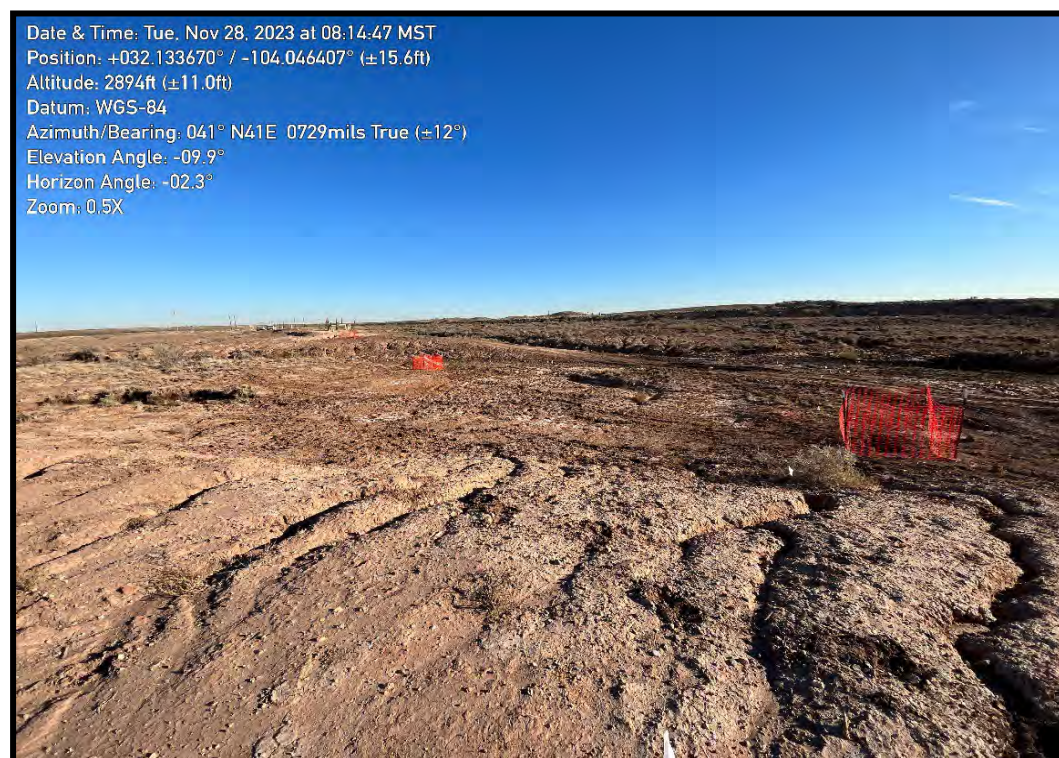
View of former release extent, facing northeast (11/28/2023).

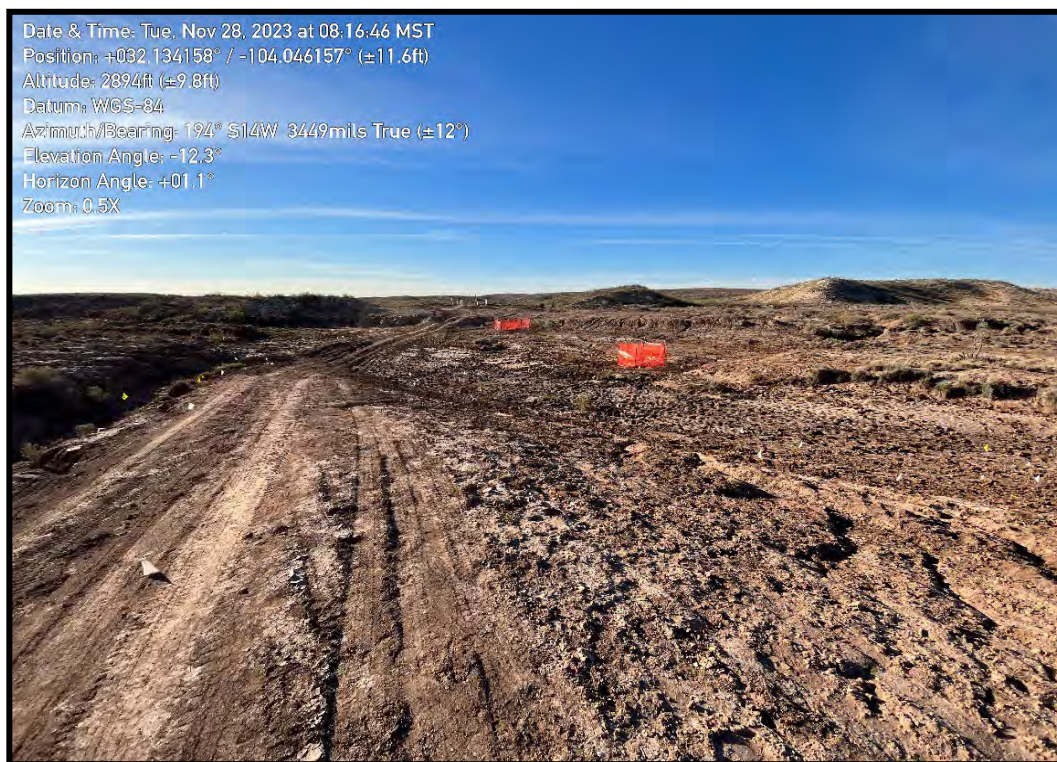
View of former release extent, facing southwest (11/28/2023).

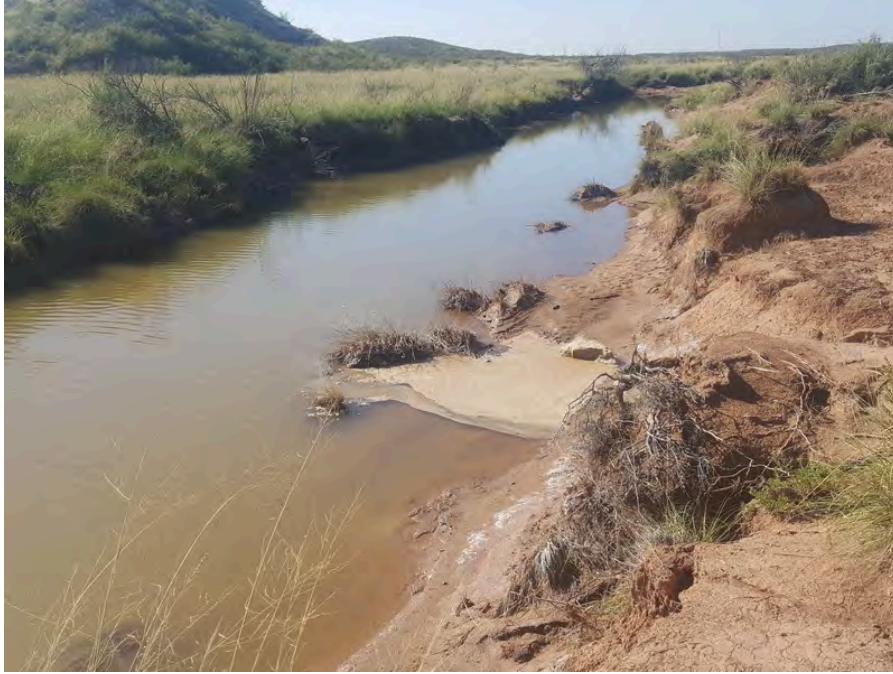
Photograph No. 1
Description:

Northwest. View of impacted surface water.

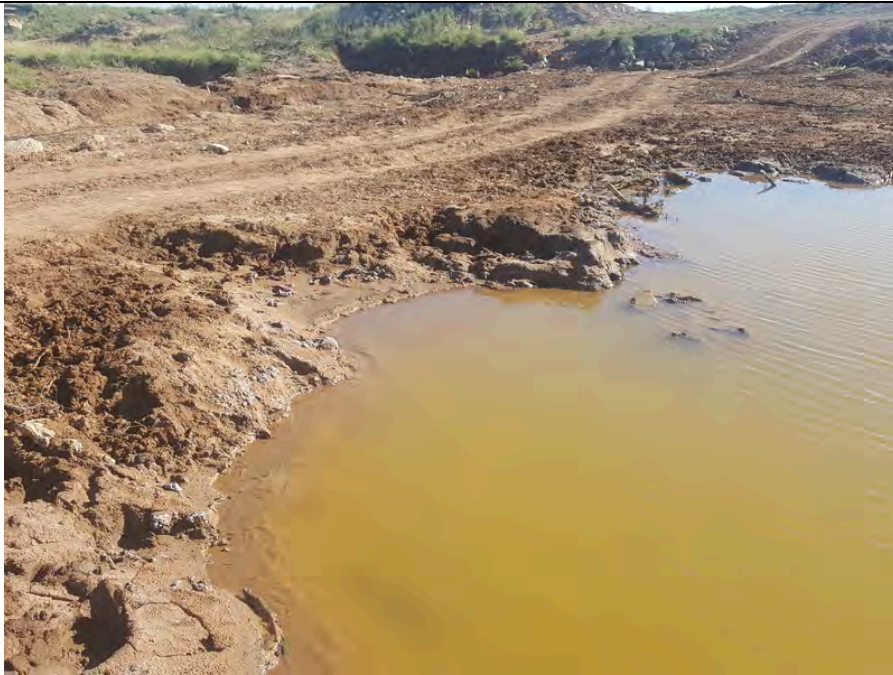
Photograph No. 2
Description:

Southeast. View of soil impacted by Natural Gas liquid release on the bank of the Salt Draw.

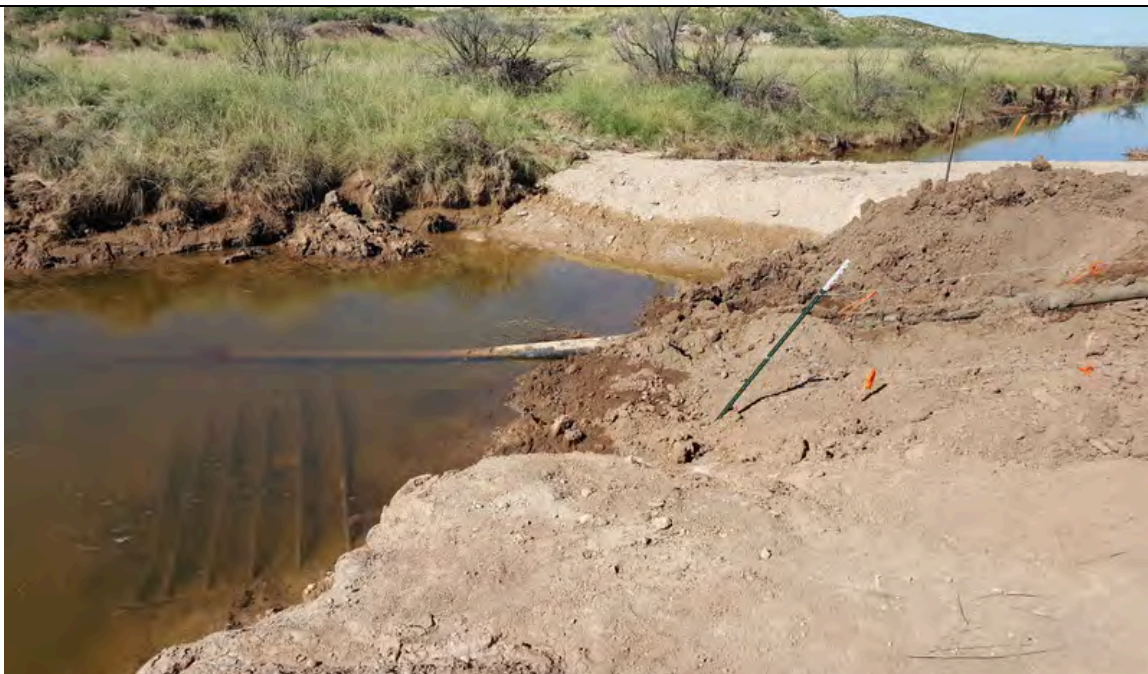
Photograph No. 3
Description:

Southwest. View of the northwest containment dam

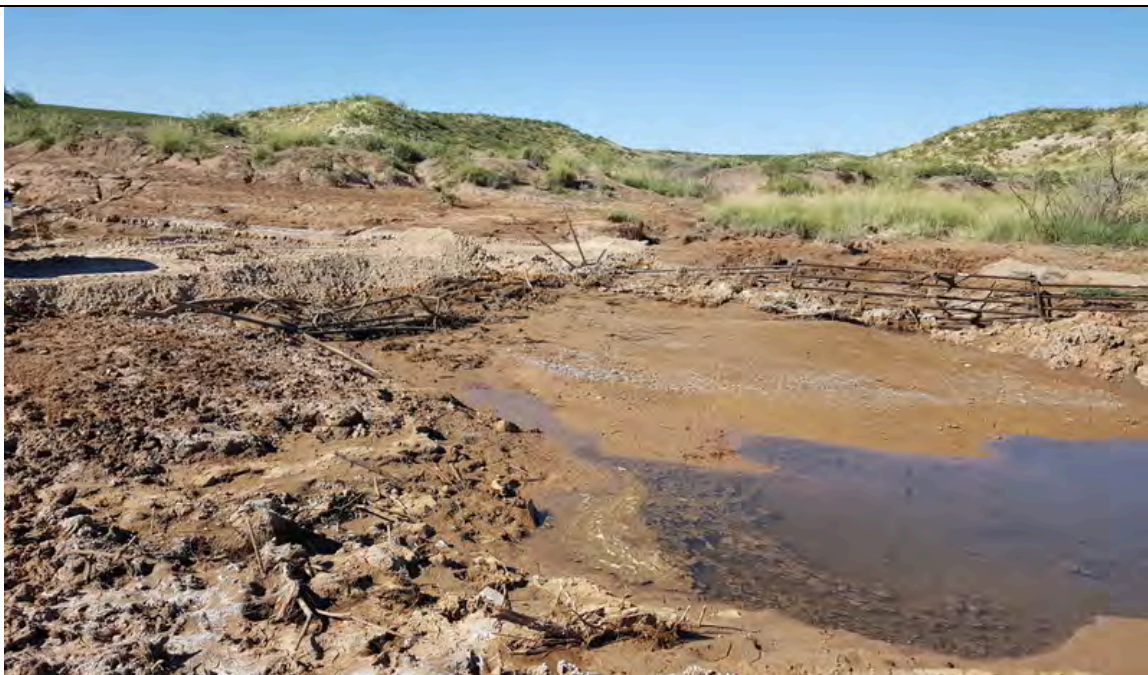
Photograph No. 4
Description:

Southwest. View of the southeast containment dam.

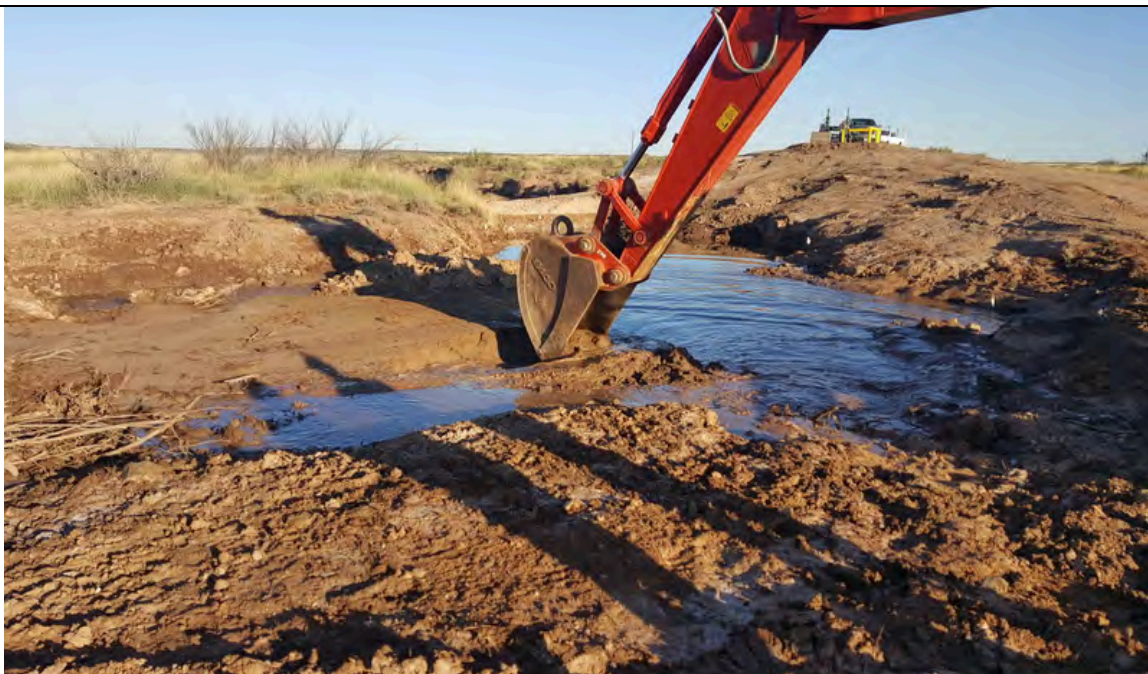
Photograph No. 5
Description:

Northwest. Mixing and blending activities.

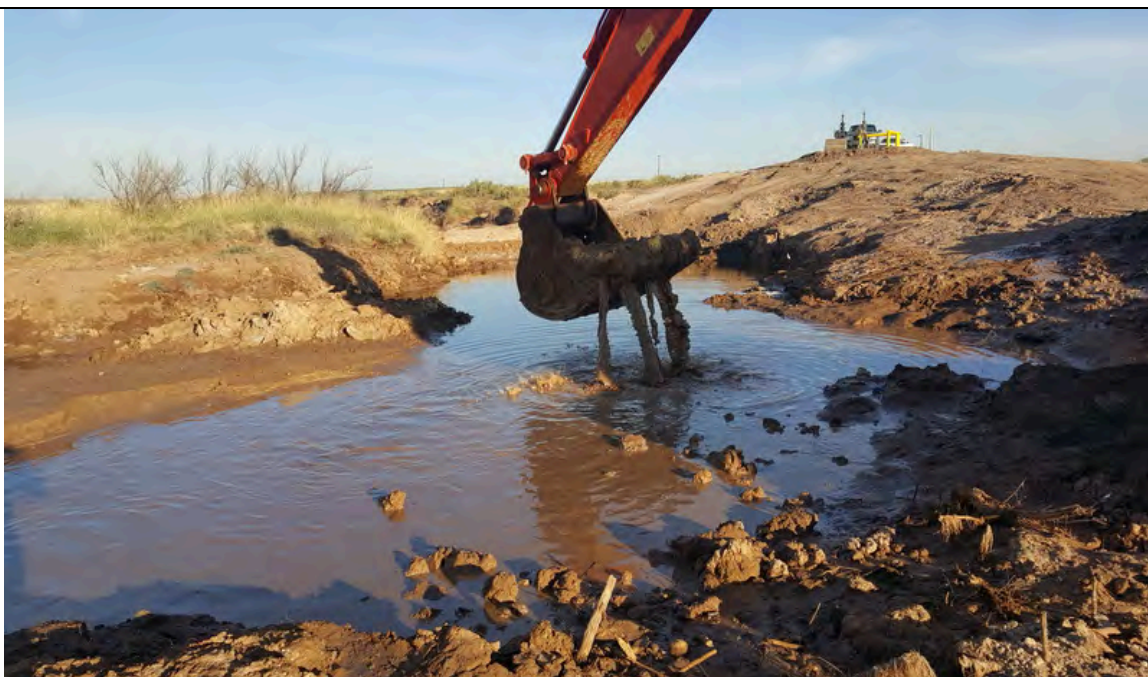
Photograph No. 6
Description:

North. View of excavation activities.

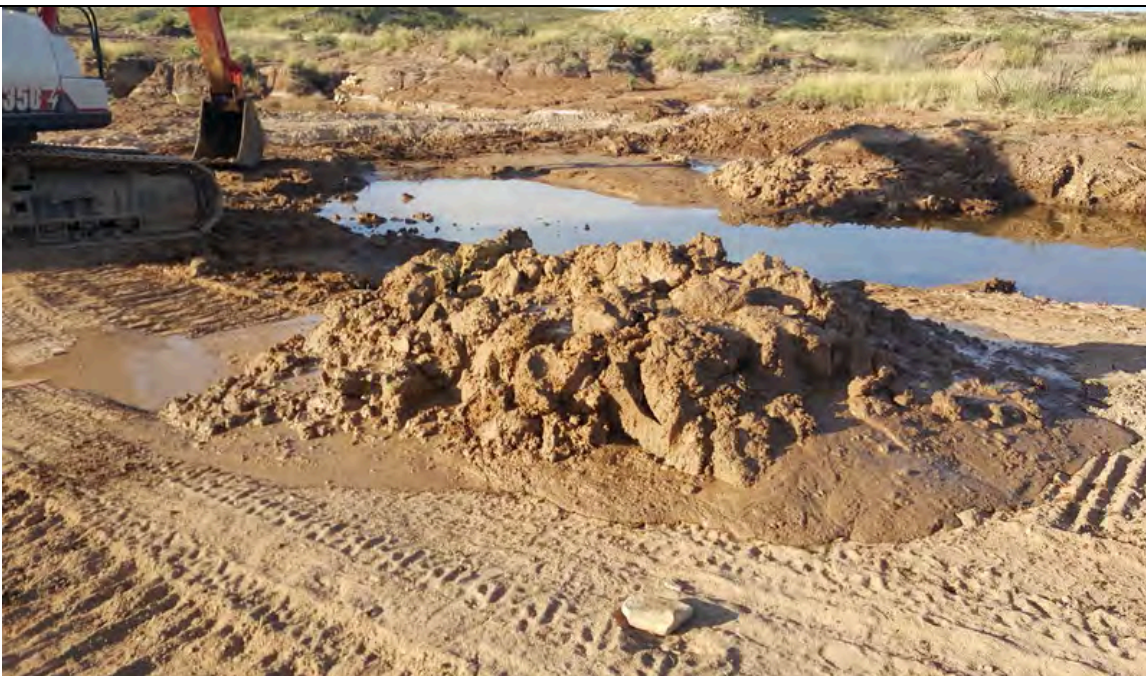
Photograph No. 7
Description:

Southwest. Stockpile of excavated soil prior to disposal.

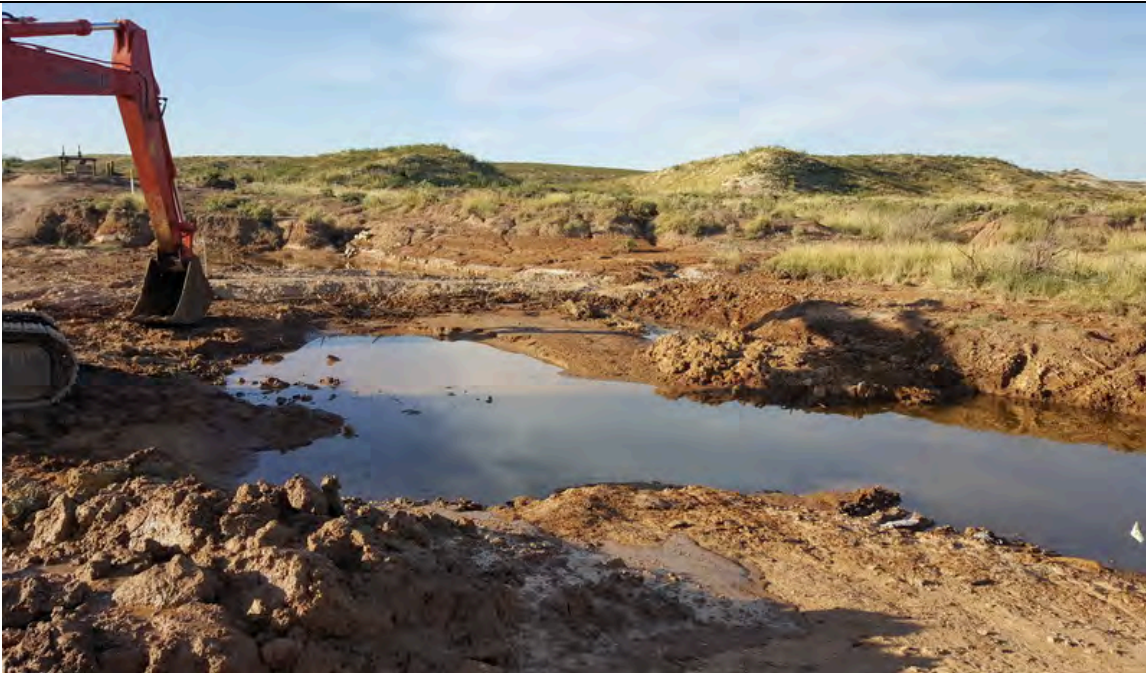
Photograph No. 8
Description:

Southwest. Site following all remediation and excavation activities.
