Closure Report
Screech Owl Federal 002H (06.13.23)
Incident #NAPP2319139283
Eddy County, New Mexico
Unit N Sec 18 T26S R27E
32.0359°, -104.2324°

Produced Water Release
Point of Release: Leaking Flowline
Release Date: 06.13.2023
Volume Released: 1.4859 Barrels of Produced Water
Volume Recovered: 0 Barrels of Produced Water

**Re: Closure Report
Screech Owl Federal 002H (06.13.23)
Concho Operating, LLC
Site Location: Unit N, S18, T26S, R27E
(Lat 32.0359°, Long -104.2324°)
Eddy County, New Mexico**

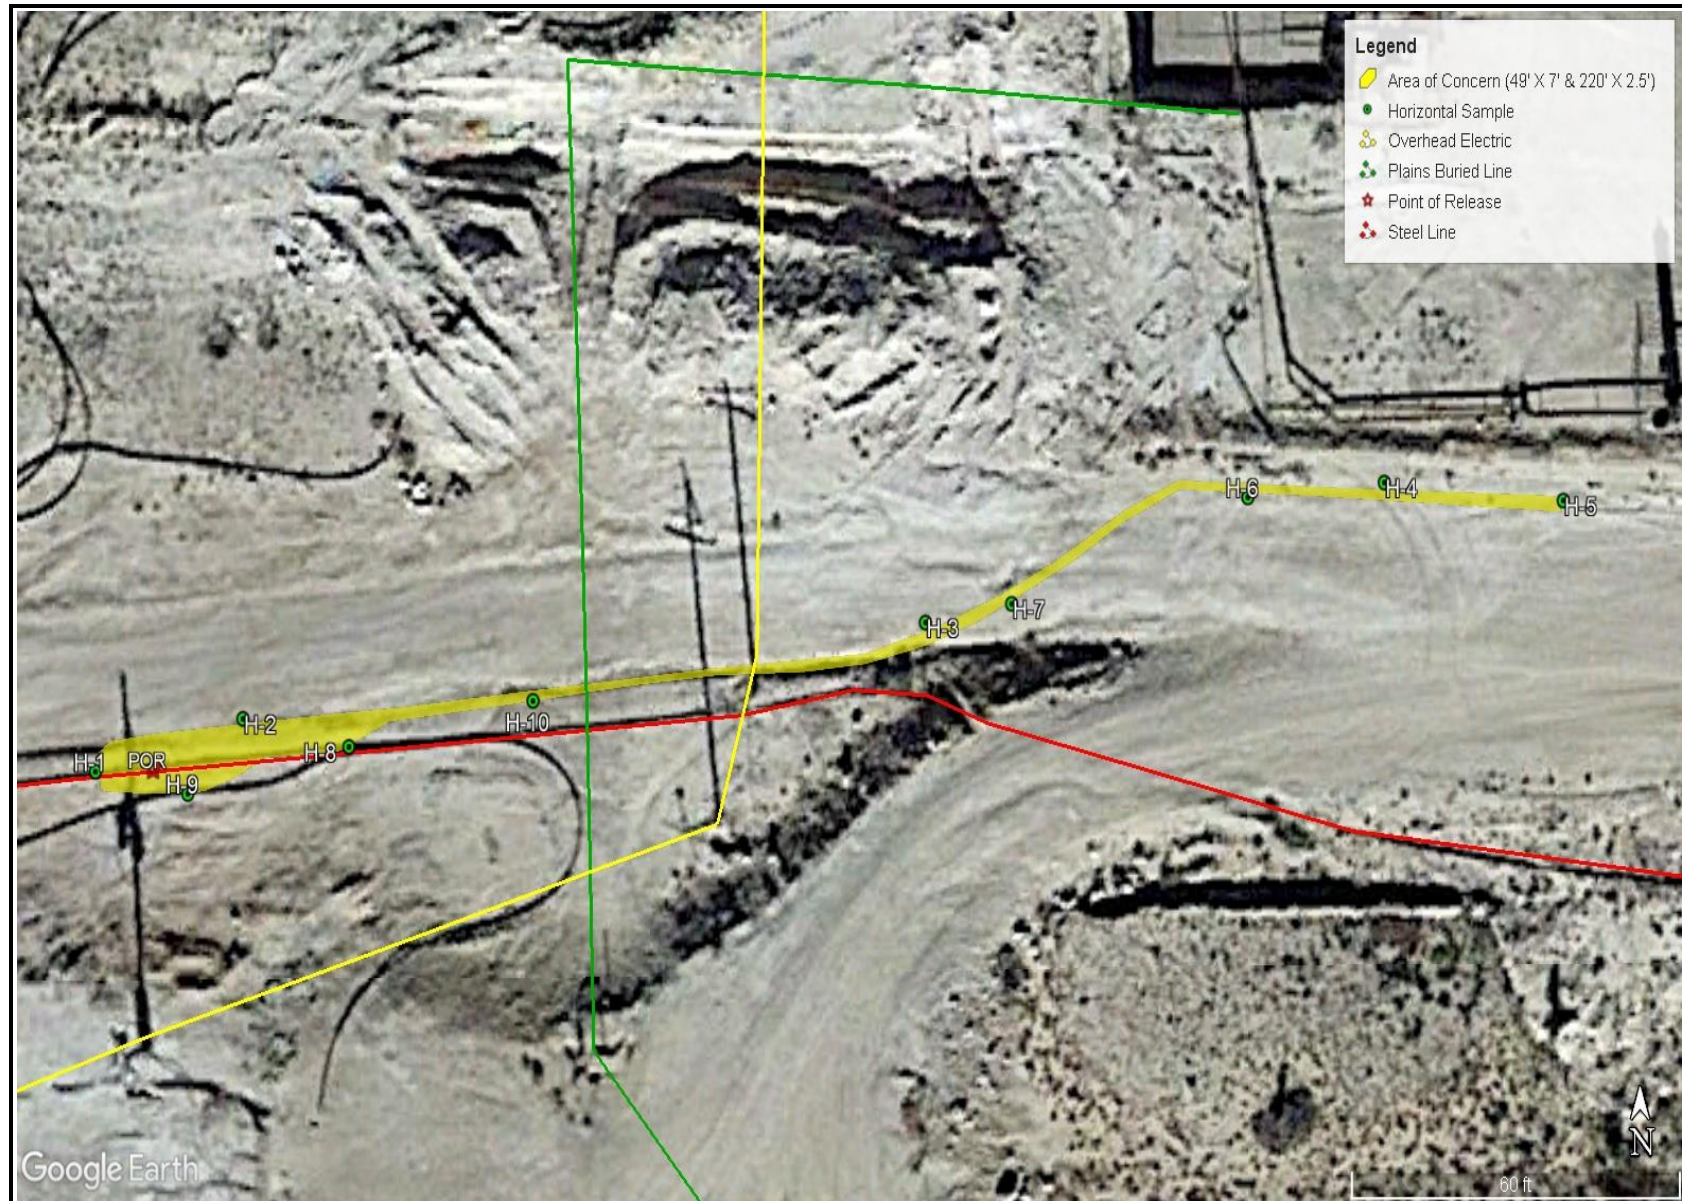
FIGURE 3

SAMPLE LOCATION MAP (06.16.23)
 COG OPERATING, LLC
 SCREECH OWL FEDERAL 002H (06.13.23)
 EDDY COUNTY, NEW MEXICO
 32.0359°, -104.2324°

Based on the initial C-141 obtained from the New Mexico Oil Conservation Division (NMOCD), the release was discovered on June 13, 2023, caused by a leaking flowline due to corrosion. It released approximately one point four eight five nine (1.4859) barrels of produced water, and zero (0) barrels of produced water were recovered. The impacted area occurred off the pad, as shown in Figure 3. The initial C-141 form is attached in Appendix C.

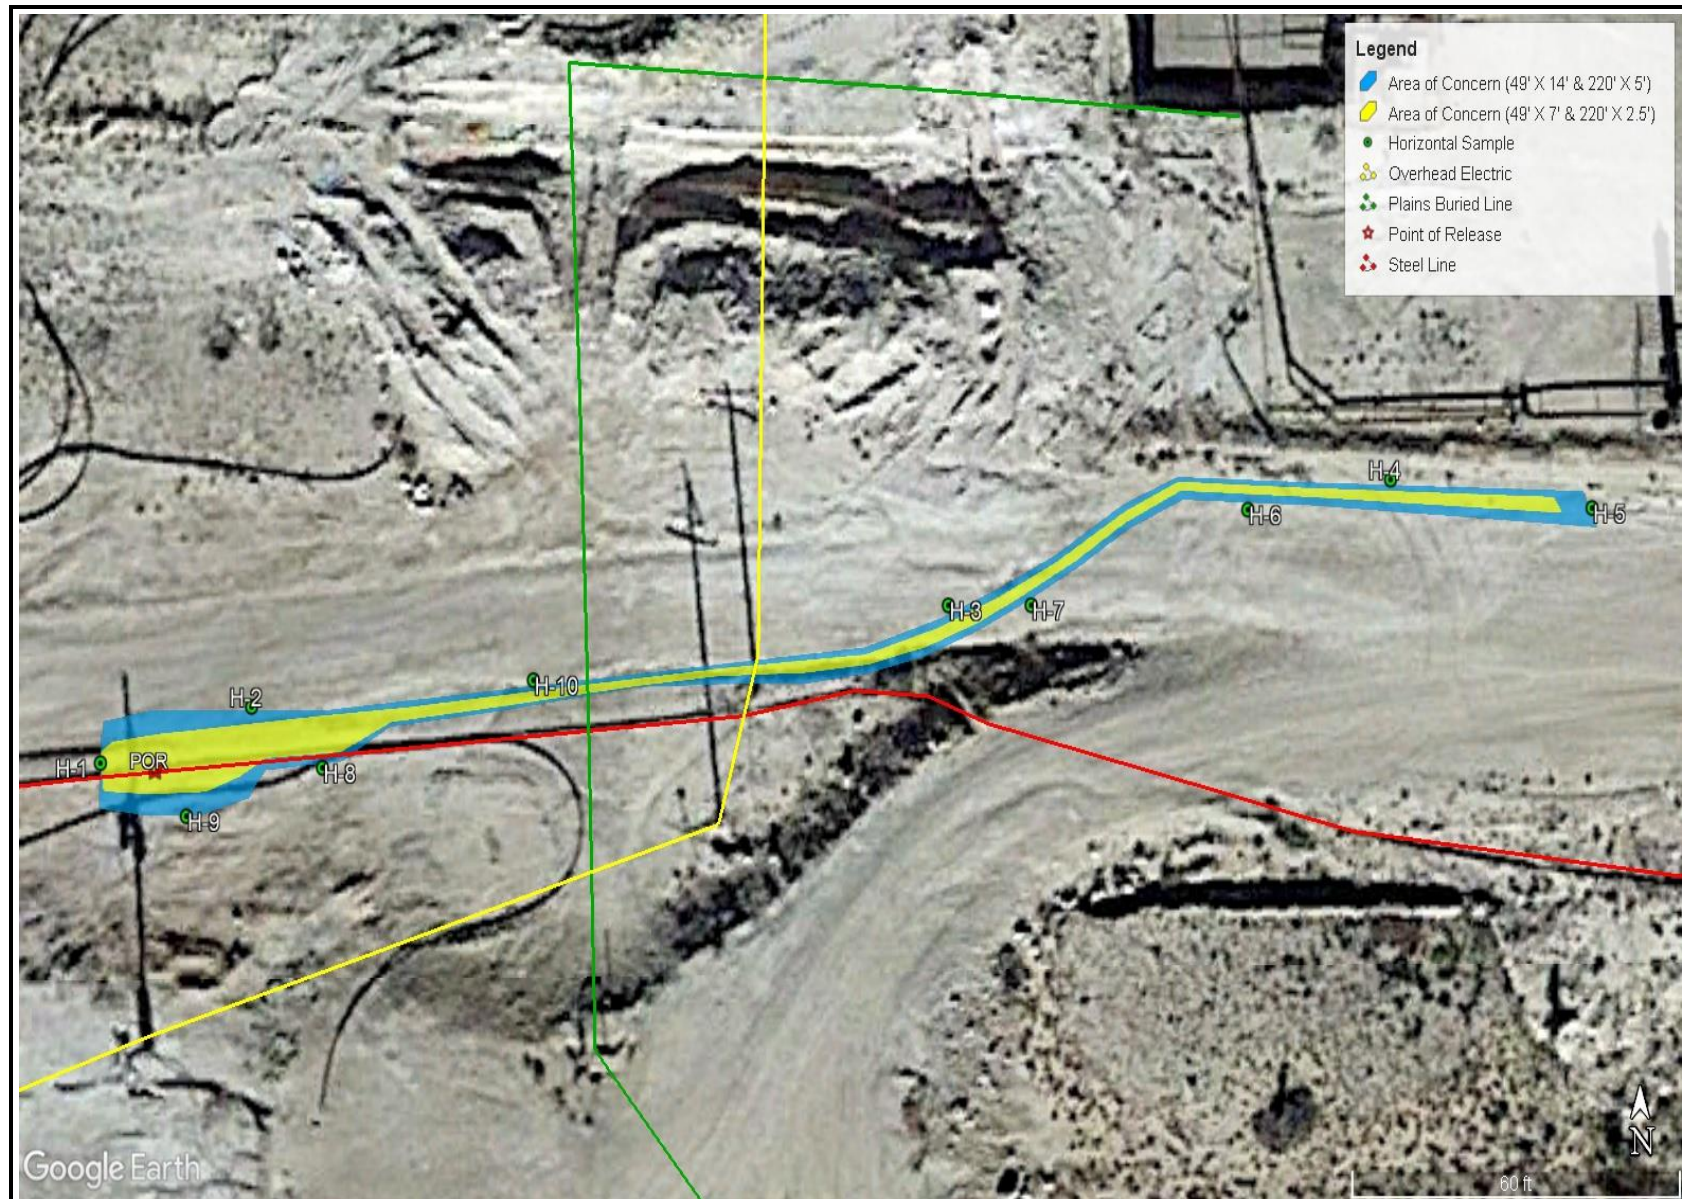
FIGURE 3A

SAMPLE LOCATION MAP (09.08.23)
 COG OPERATING, LLC
 SCREECH OWL FEDERAL 002H (06.13.23)
 EDDY COUNTY, NEW MEXICO
 32.0359°, -104.2324°

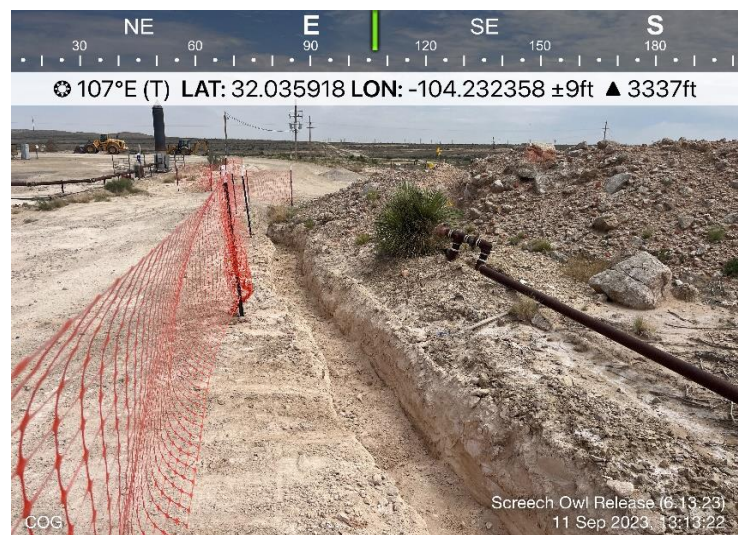
View East, area of CS-5.

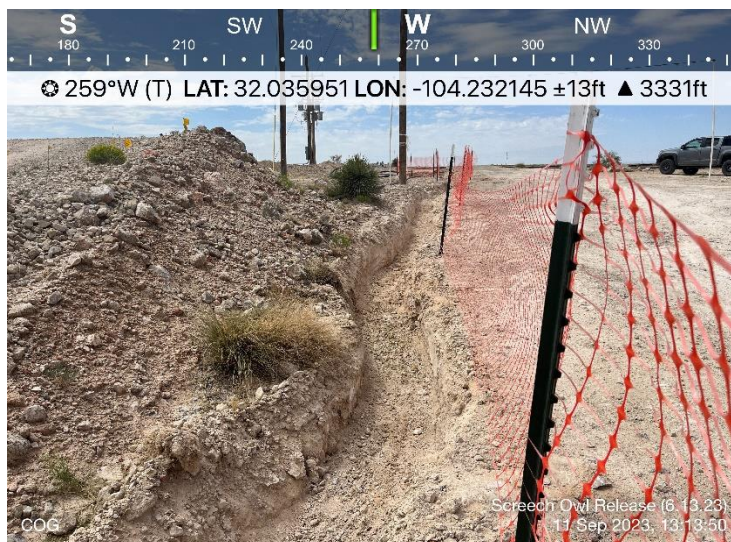
View West, area of CS-5.

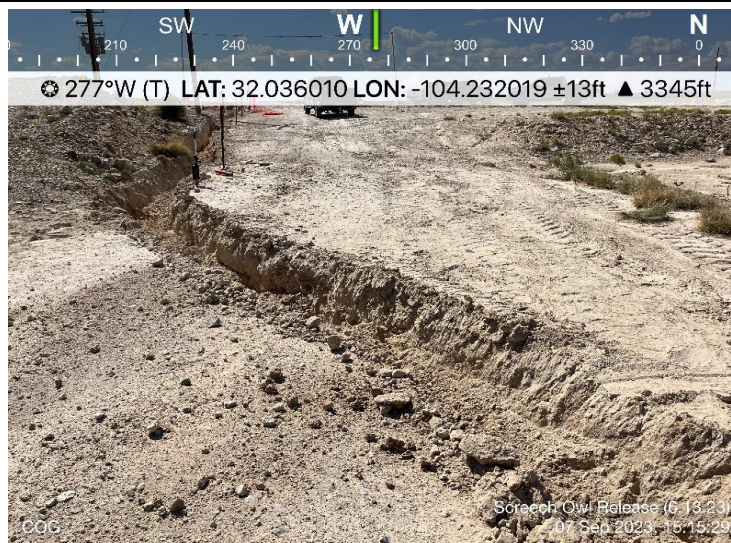
Photograph No. 5

View West, area of CS-6.

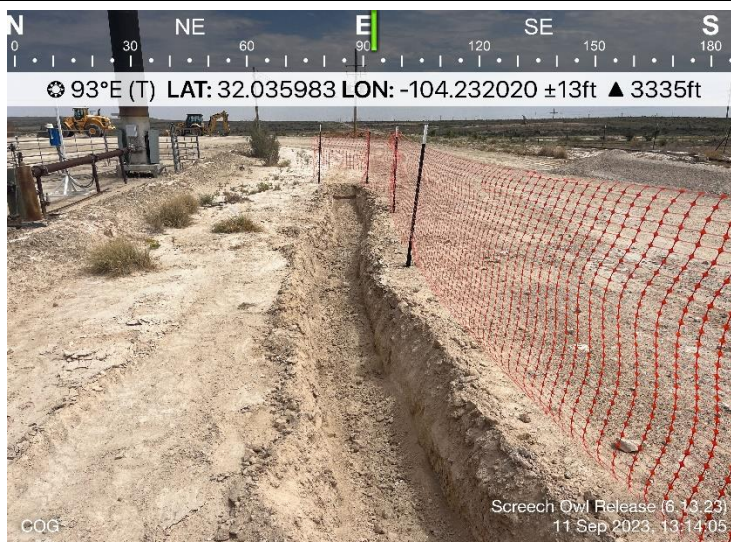
Photograph No. 6

View East, area of CS-7.
