November 16, 2023

**Re: Release Characterization and Remediation Work Plan  
Oriole State Com #001 Flowline Release  
ConocoPhillips  
Lea County, New Mexico  
DOR: 9/06/23  
INCIDENT ID: NAPP2326829702  
Approximate Release Point 32.713645° -103.538223°  
Landowner: Private Agricultural Lease (Pearce Trust) / State Trust Land**

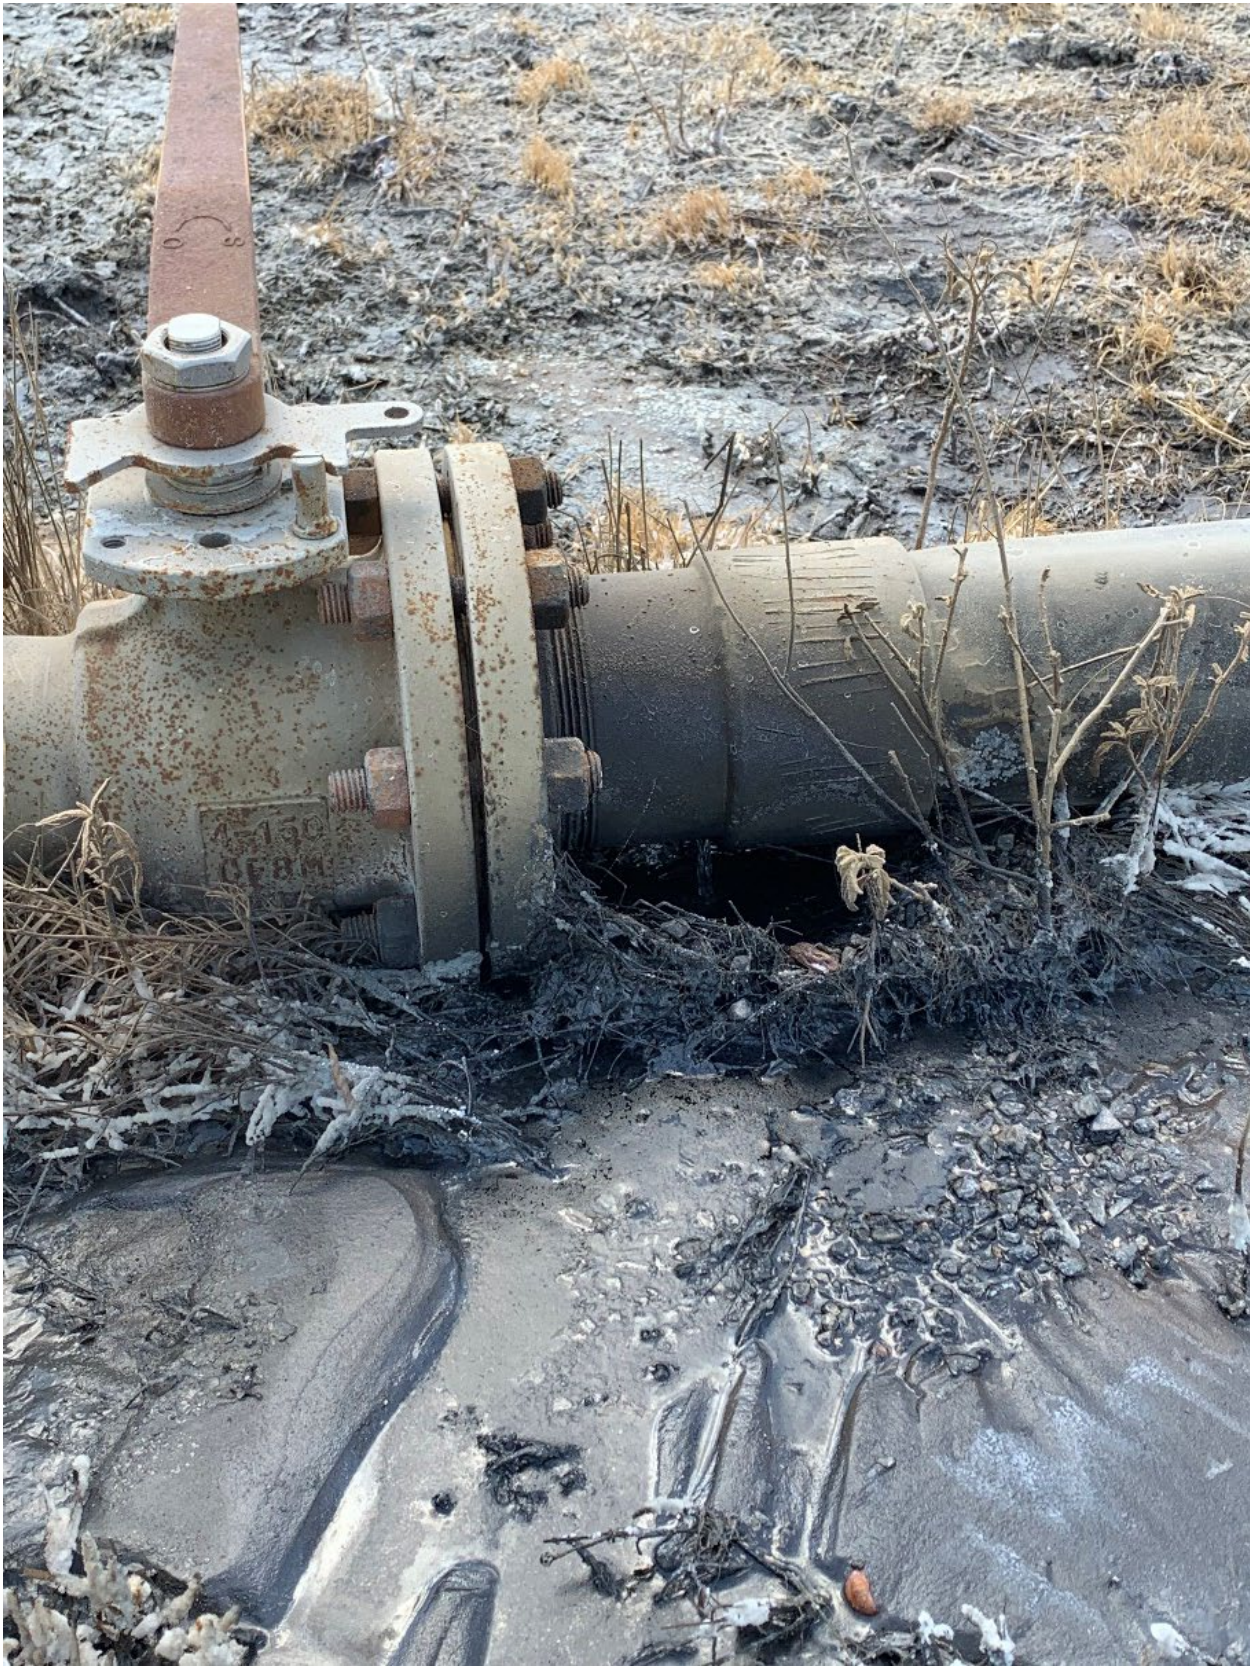
TETRA TECH, INC. PROJECT NO. 212C-MD-03236	DESCRIPTION	View of approximate release point.	1
	SITE NAME	ORIOLE STATE COM 1 Release	UNK

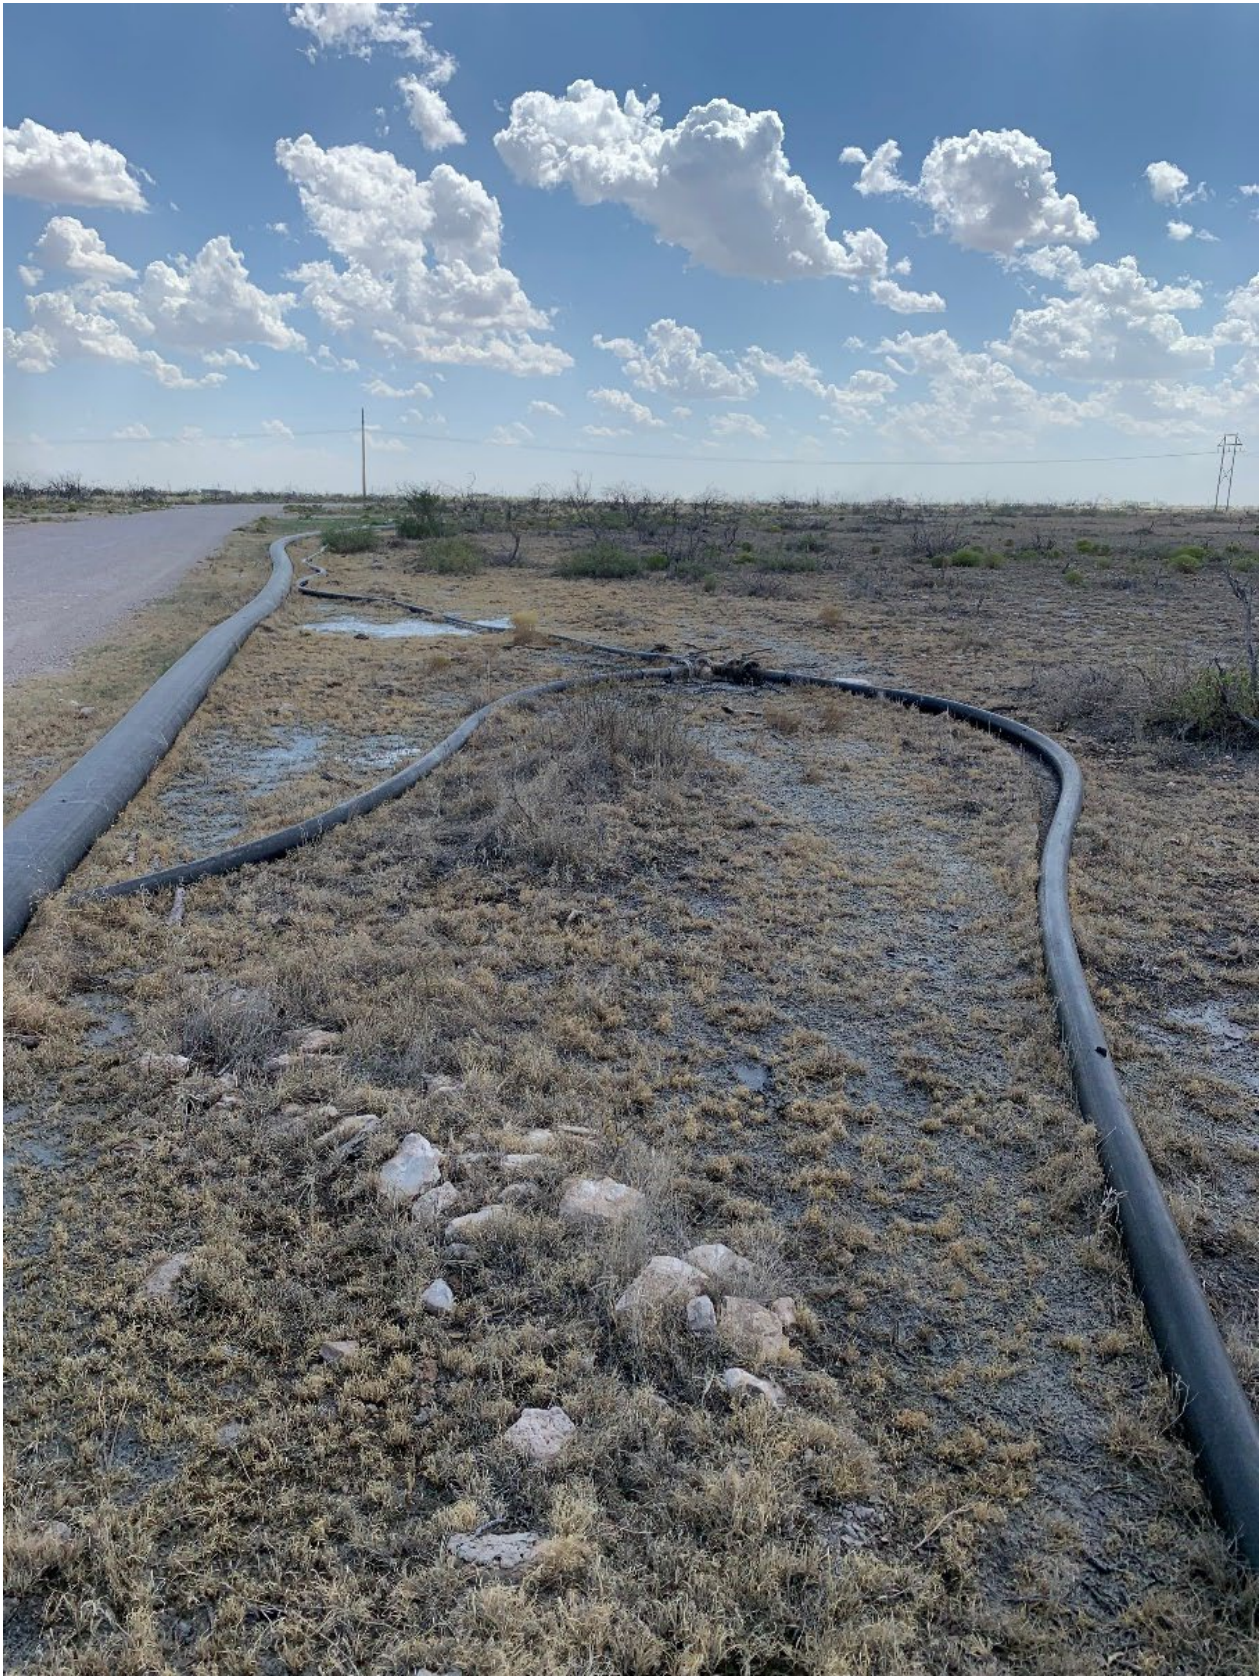
TETRA TECH, INC. PROJECT NO. 212C-MD-03236	DESCRIPTION	View of approximate release Extent.	2
	SITE NAME	ORIOLE STATE COM 1 Release	UNK

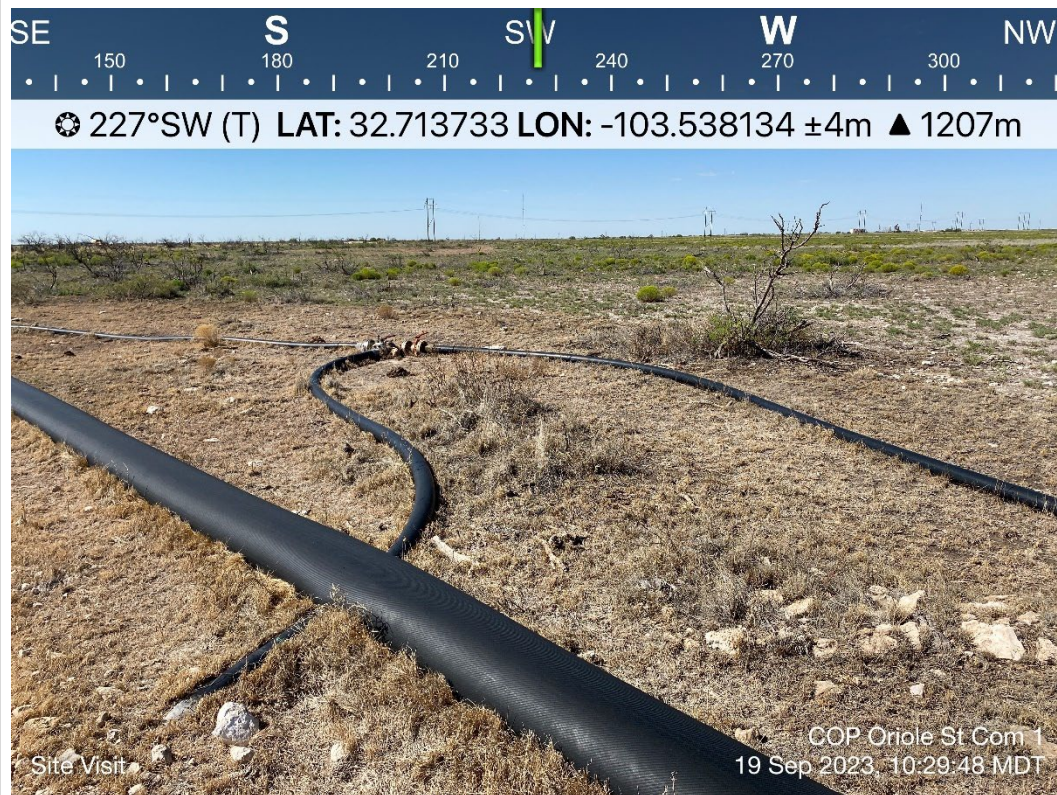
TETRA TECH, INC. PROJECT NO. 212C-MD-03236	DESCRIPTION	View southwest of release. Surface polylines and lay flat.	4
	SITE NAME	ORIOLE STATE COM 1 Release	9/19/2023

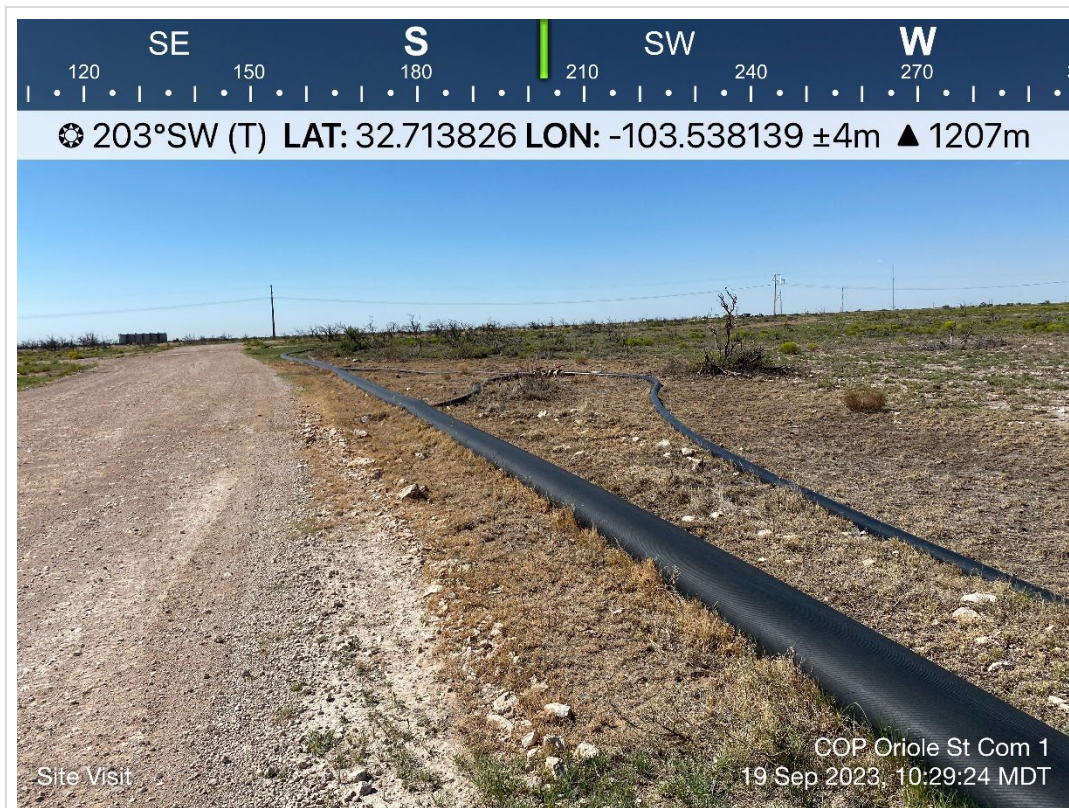
TETRA TECH, INC. PROJECT NO. 212C-MD-03236	DESCRIPTION	View south-southwest of approximate release extent. Surface polylines and lay flat.	5
	SITE NAME	ORIOLE STATE COM 1 Release	9/19/2023

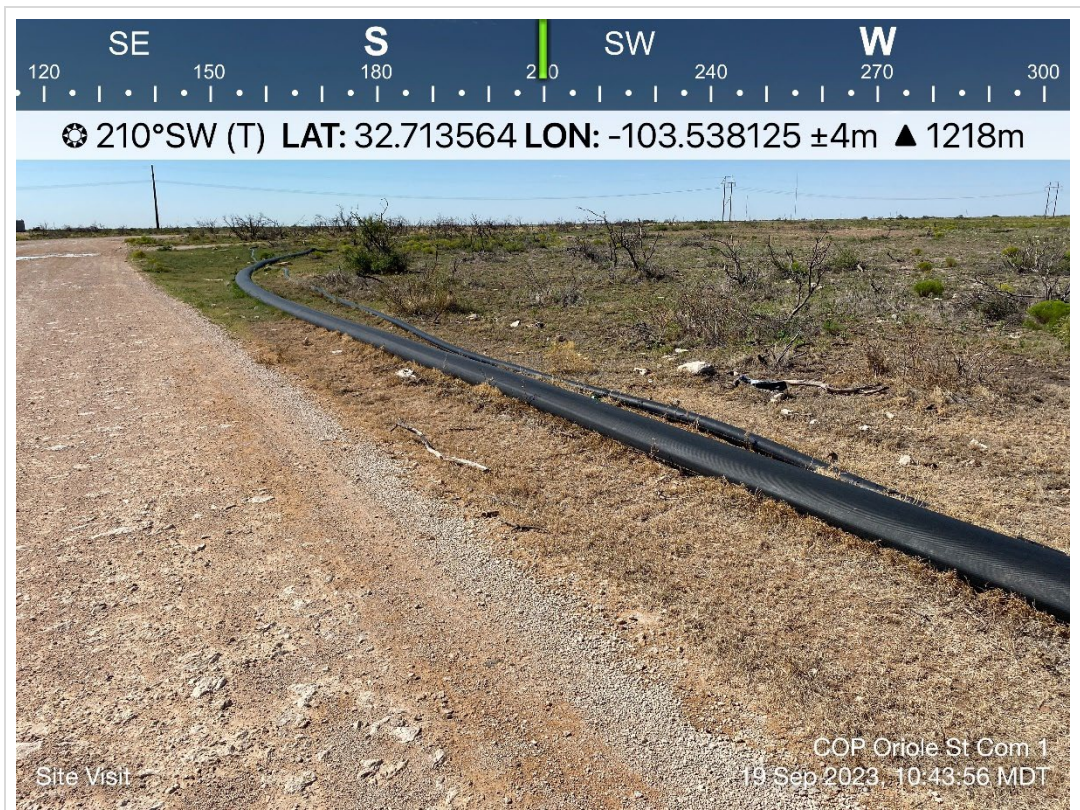
TETRA TECH, INC. PROJECT NO. 212C-MD-03236	DESCRIPTION	View south-southwest of approximate release extent. Surface polylines and lay flat. Staining observed.	7
	SITE NAME	ORIOLE STATE COM 1 Release	9/19/2023

Based on the analytical results, ConocoPhillips proposes to remove the impacted material within the release footprint as indicated on Figure 4. Impacted soils in the vicinity of AH-1 through AH-3 and trench locations T-1 through T-3 will be excavated using heavy equipment (backhoes, hoe rams, and track hoes) to a maximum depth of 4 feet below pre-release grade or until a representative sample from the walls and bottom of the excavation is below the applicable reclamation requirements (or RRALs, if applicable). Any area containing pressurized lines will be hand-dug to the proposed depth shown on Figure 4 or to the maximum extent practicable; heavy equipment will come no more than 4 feet from any pressurized lines. The estimated volume of material to be remediated is approximately 385 cubic yards. Excavated soils will be transported offsite and disposed of at an NMOCD-approved or permitted facility.

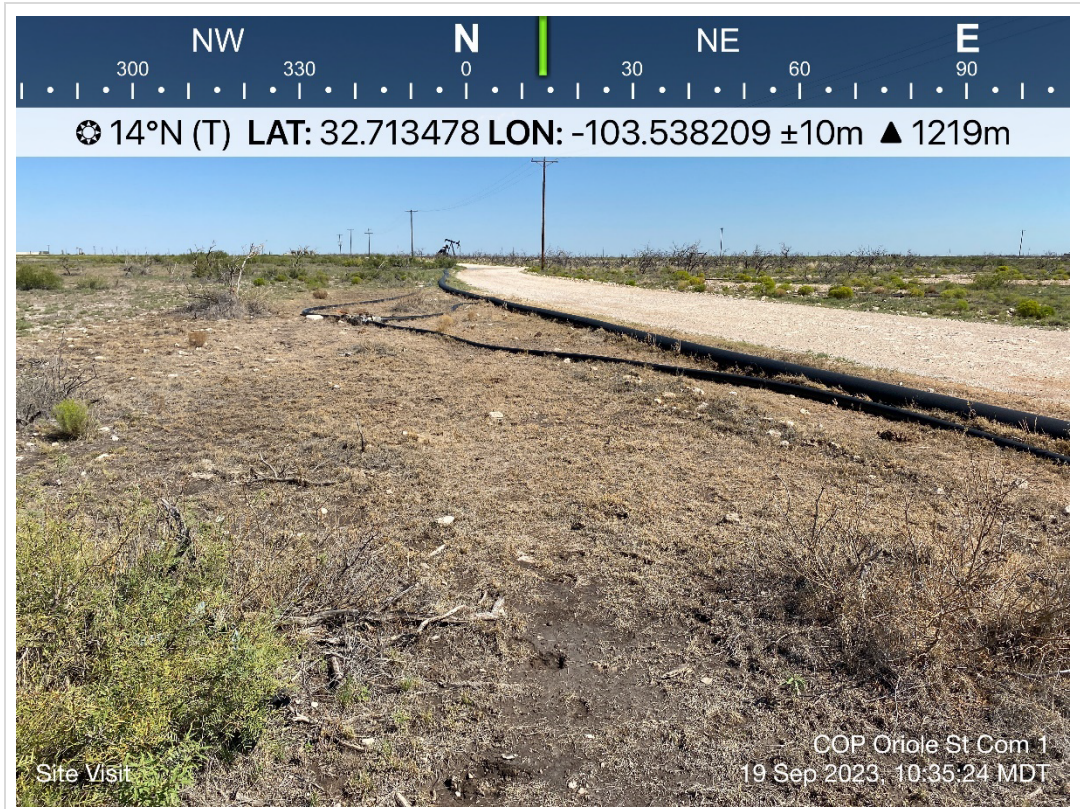
TETRA TECH, INC. PROJECT NO. 212C-MD-03236	DESCRIPTION	View north-northeast of approximate release extent. Surface polylines and lay flat.	8
	SITE NAME	ORIOLE STATE COM 1 Release	9/19/2023
