According to information provided, the release was caused by internal corrosion in a fitting resulting in the release of 1.88 barrels (bbls) of produced water in an off-pad pasture area. The spill calculator provided with the C-141 indicates a release extent of approximately 1,692 square feet in area. The release extent was identified based on information provided by ConocoPhillips representatives, a review of photographs from the release area, and a Site visit conducted by Tetra Tech personnel as indicated on Figure 3. This release footprint is located on State Trust Land. The New Mexico Oil Conservation Division (NMOCD) received the C-141 report form for the release on September 25, 2023, and subsequently assigned the release Incident ID NAPP2326829702. A copy of the C-141 is included in Appendix A.

TABLE 1
SUMMARY OF ANALYTICAL RESULTS
SOIL ASSESSMENT- nMLB1011352696
CONOCOPHILLIPS
ORIOLE STATE COM #001 FLOWLINE RELEASE
LEA COUNTY, NM

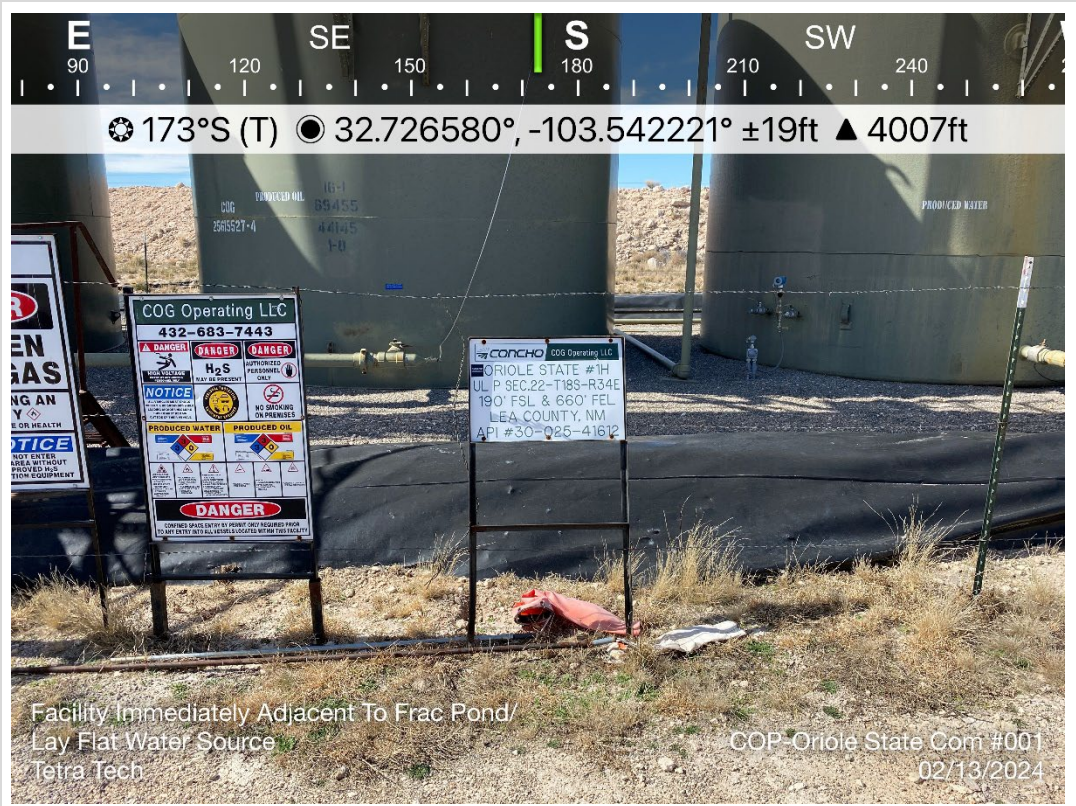
TETRA TECH, INC. PROJECT NO. 212C-MD-03236	DESCRIPTION	View of site signage. Oriole State #1H.	1
	SITE NAME	ORIOLE STATE COM 1 Release	2/13/2024

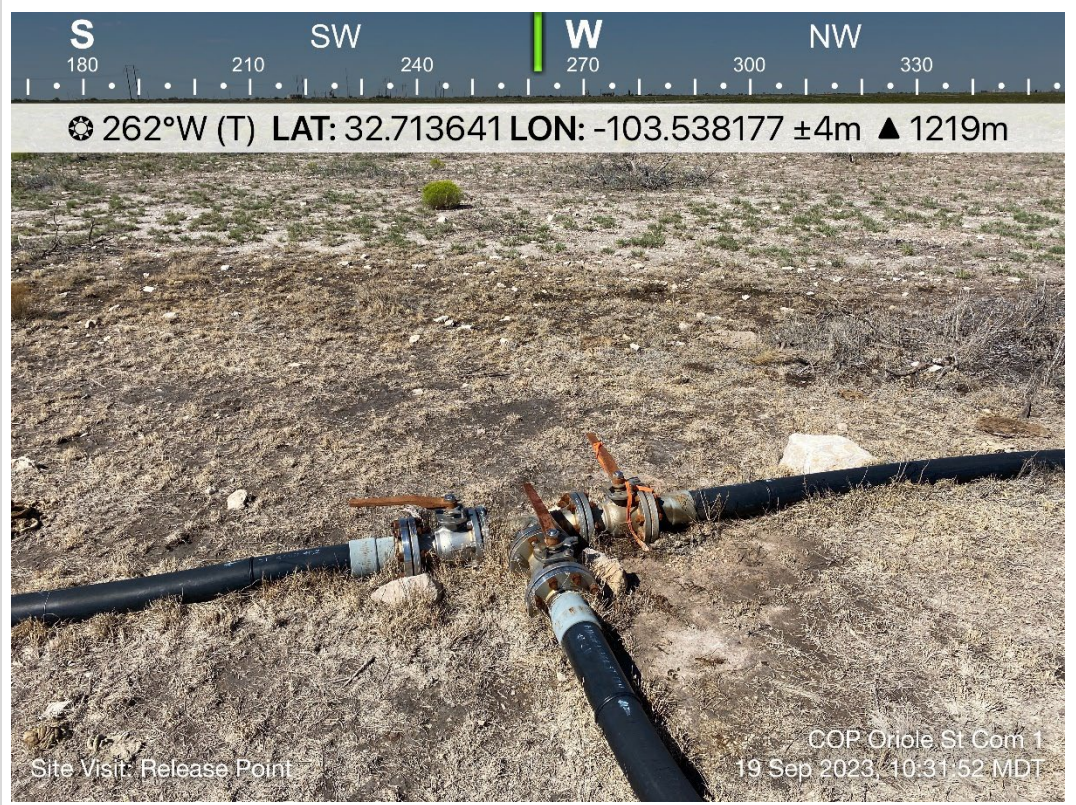
TETRA TECH, INC. PROJECT NO. 212C-MD-03236	DESCRIPTION	View west of approximate release point. Surface polylines present.	2
	SITE NAME	ORIOLE STATE COM 1 Release	9/19/2023

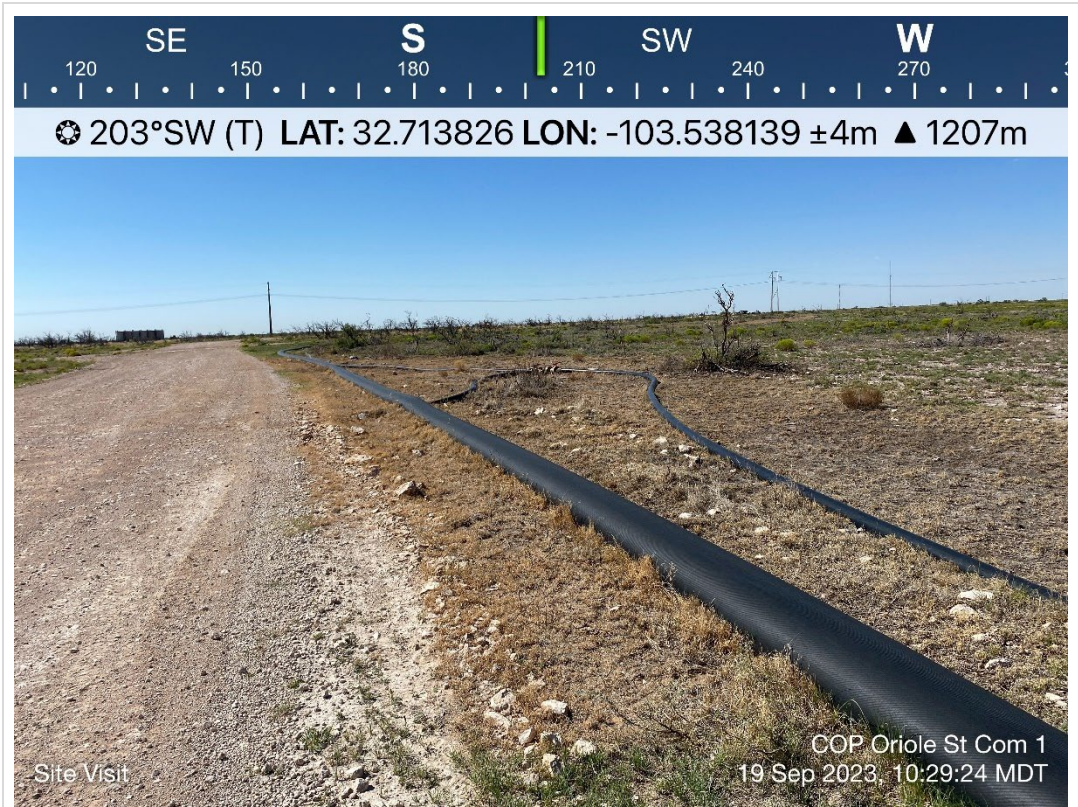
TETRA TECH, INC. PROJECT NO. 212C-MD-03236	DESCRIPTION	View south-southwest of approximate release extent. Surface polylines and lay flat.	4
	SITE NAME	ORIOLE STATE COM 1 Release	9/19/2023

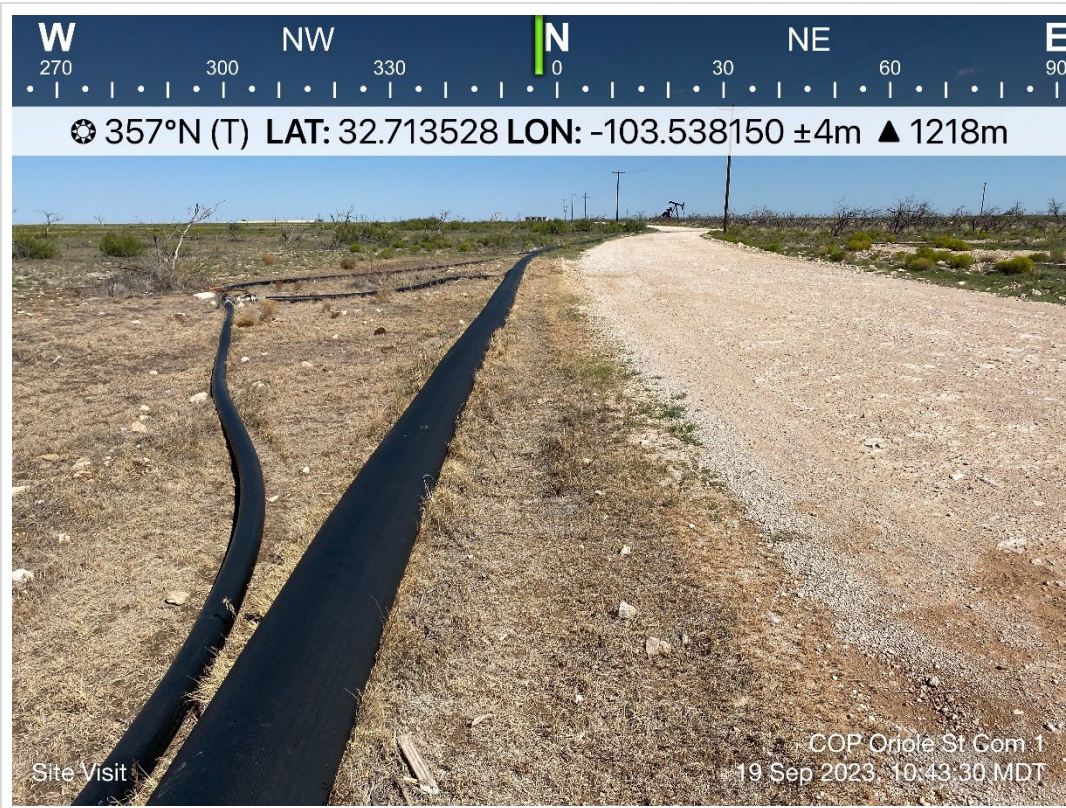
TETRA TECH, INC. PROJECT NO. 212C-MD-03236	DESCRIPTION	View north of approximate release extent. Surface polylines and lay flat. Staining observed.	5
	SITE NAME	ORIOLE STATE COM 1 Release	9/19/2023

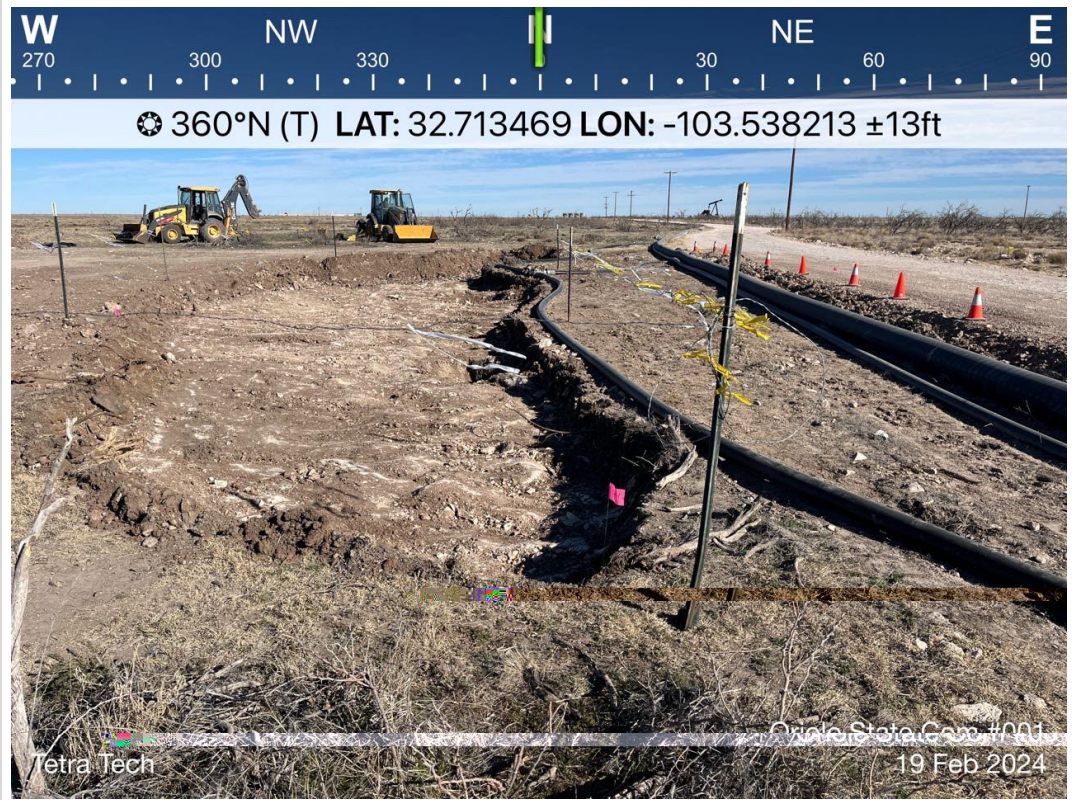
TETRA TECH, INC. PROJECT NO. 212C-MD-03236	DESCRIPTION	View north of open excavation progress and removed lay flats.	8
	SITE NAME	ORIOLE STATE COM 1 Release	2/19/2024

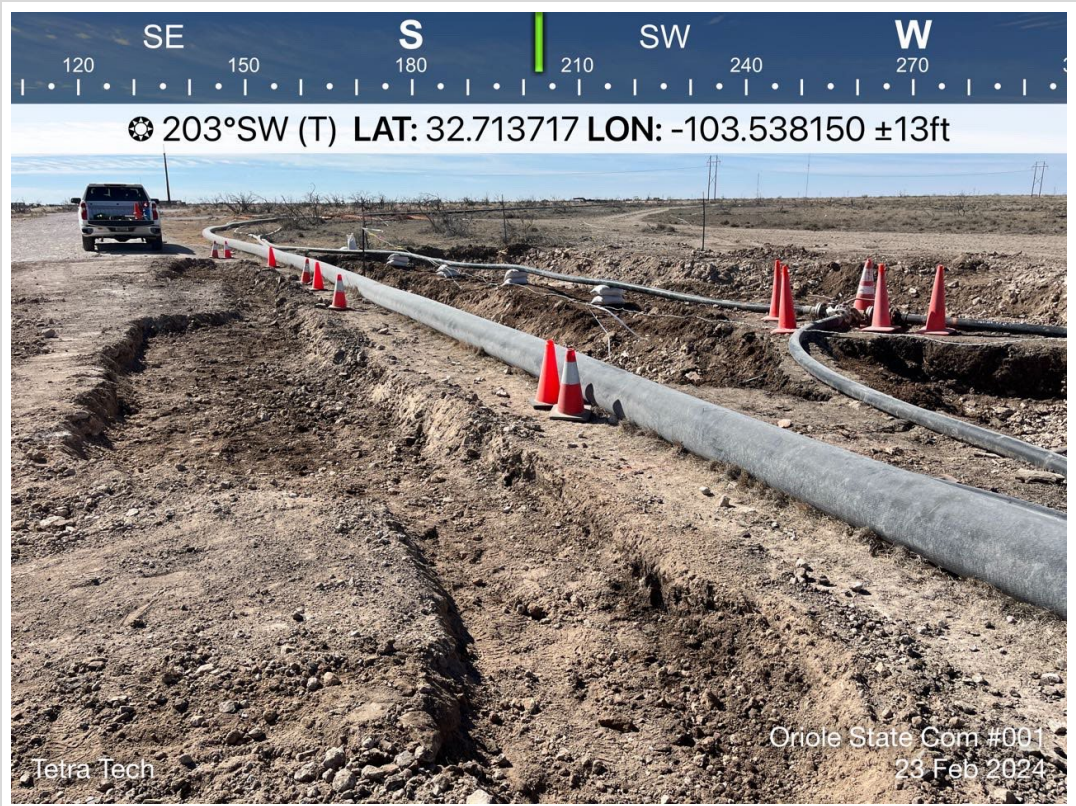
TETRA TECH, INC. PROJECT NO. 212C-MD-03236	DESCRIPTION	View southwest of open excavation progress east side of the road. Non-aggressive excavation area around lay flat.	9
	SITE NAME	ORIOLE STATE COM 1 Release	2/23/2024

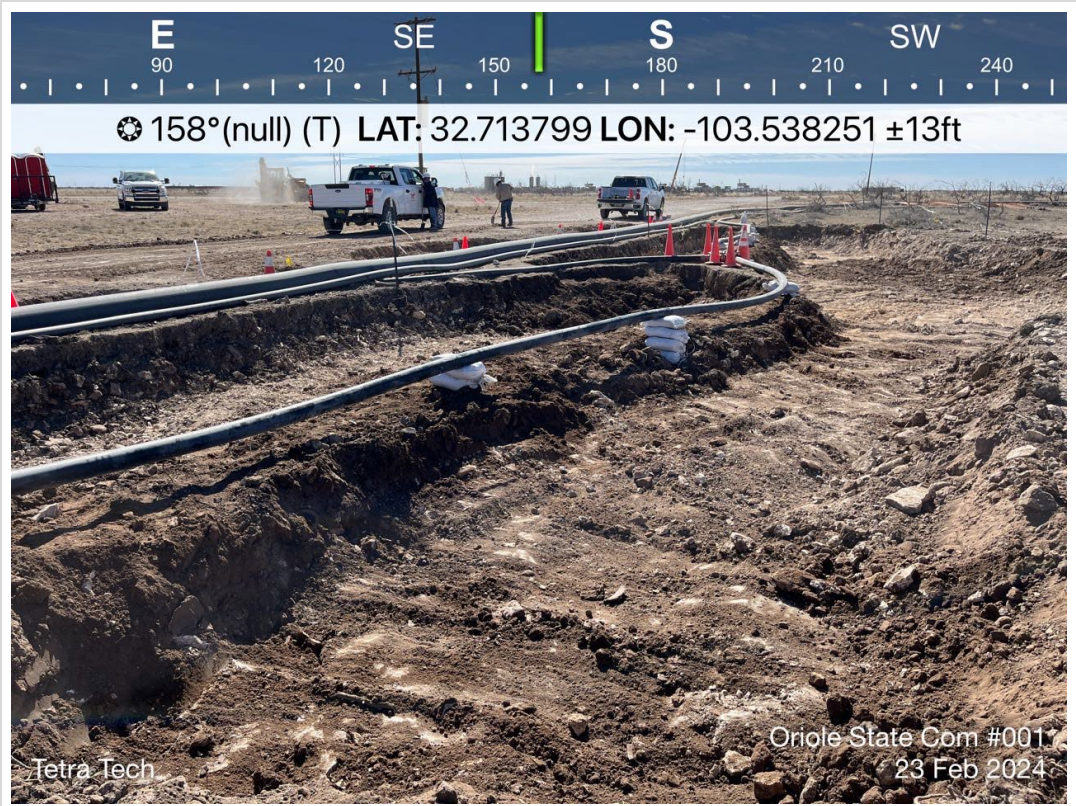
TETRA TECH, INC. PROJECT NO. 212C-MD-03236	DESCRIPTION	View south-southwest of open excavation. Non-aggressive excavation area around padded polylines.	11
	SITE NAME	ORIOLE STATE COM 1 Release	2/23/2024

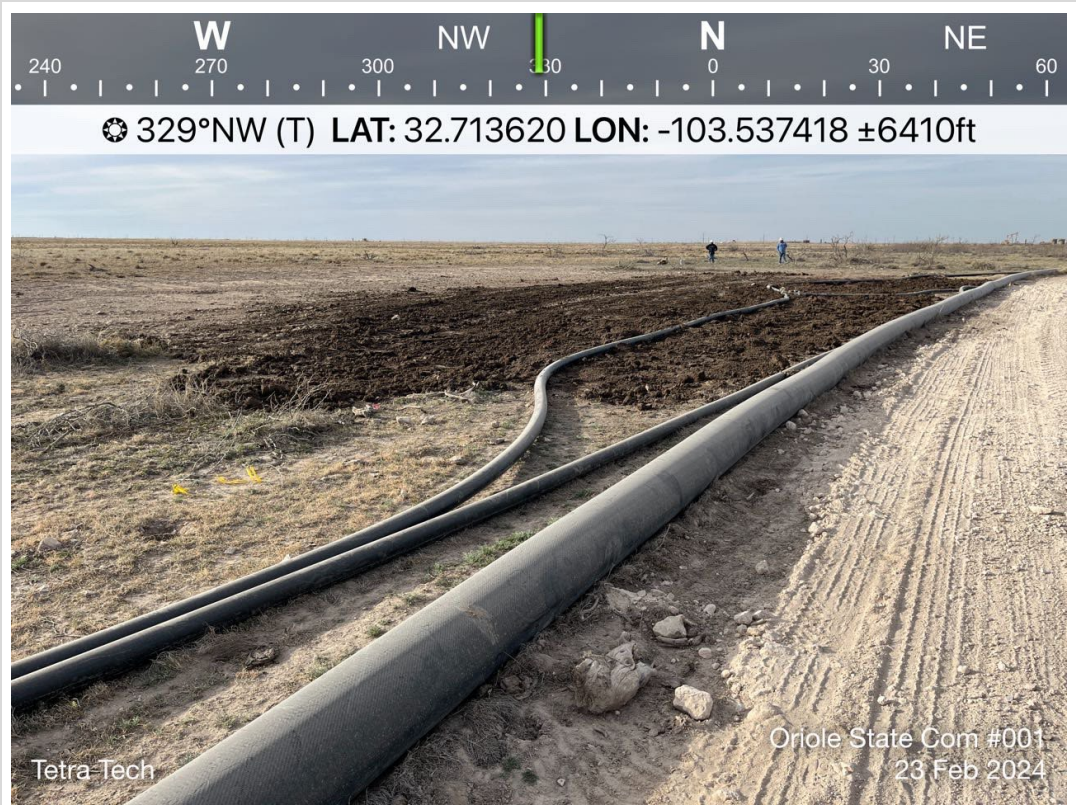
TETRA TECH, INC. PROJECT NO. 212C-MD-03236	DESCRIPTION	View north-northwest of backfilled and seeded excavation.	12
	SITE NAME	ORIOLE STATE COM 1 Release	2/23/2024

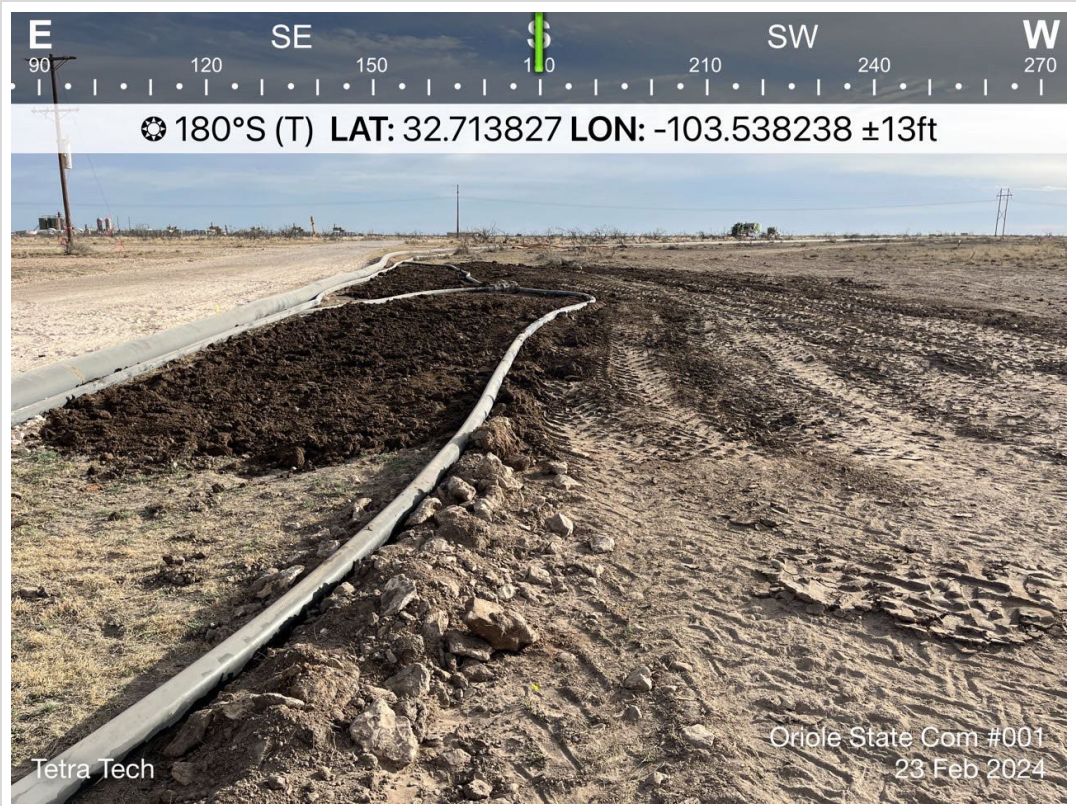
TETRA TECH, INC. PROJECT NO. 212C-MD-03236	DESCRIPTION	View south of backfilled and seeded excavation.	13
	SITE NAME	ORIOLET STATE COM 1 Release	2/23/2024
