Incident ID	nAPP2309726350
District RP	
Facility ID	
Application ID

State of New Mexico
Oil Conservation Division

**SITE LOCATION MAP
CLOSURE REPORT
DEVON ENERGY PRODUCTION COMPANY
COTTON DRAW UNIT 118 BATTERY
EDDY COUNTY, NEW MEXICO**

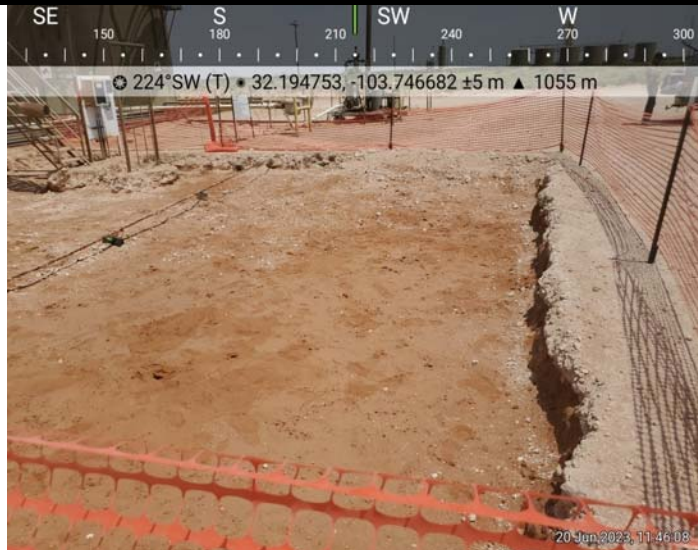
**Photograph No. 2**

Description:
View of Final Excavation.

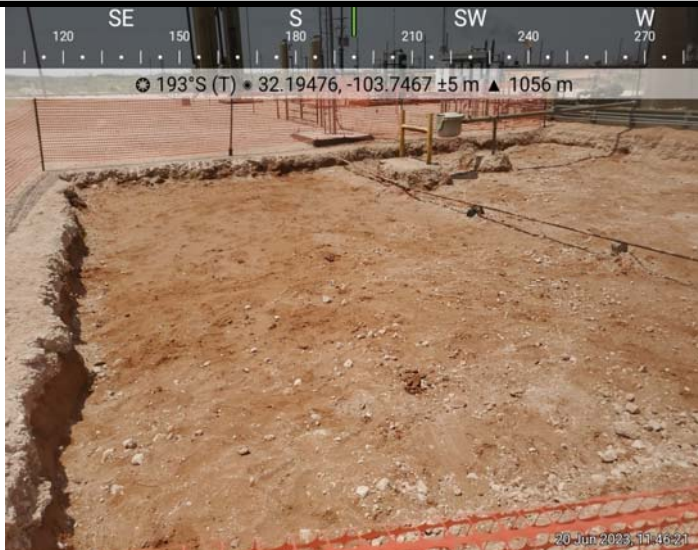
**Photograph No. 3**

Description:
View of Final Excavation.

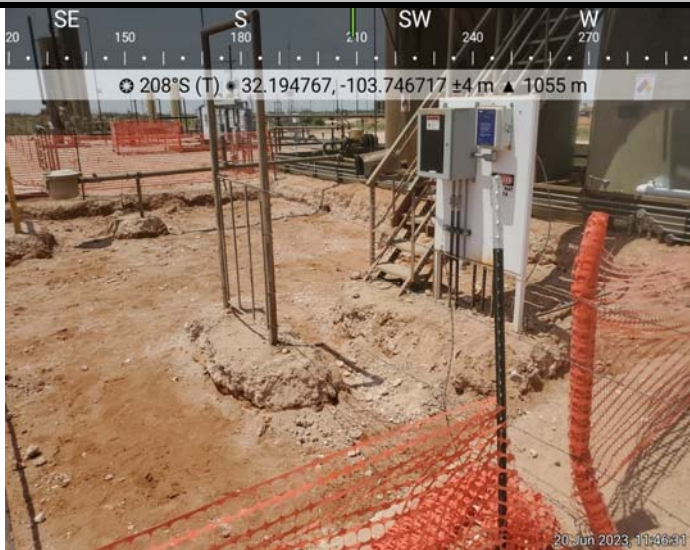
Description:
View of Final Excavation.

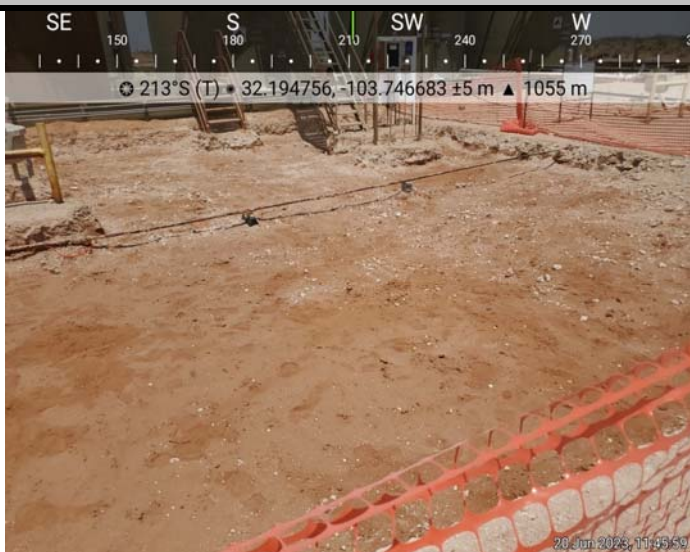
**Photograph No. 6**

Description:
View of Final Excavation.

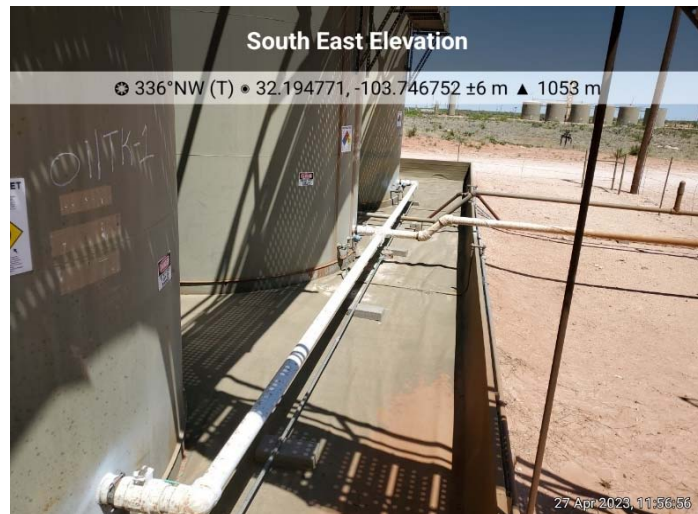
Description:
View of Liner.

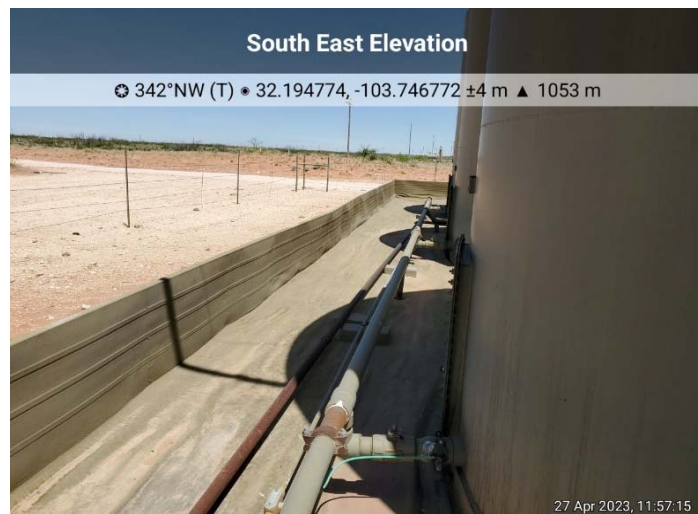
Photograph No. 8

Description:
View of Liner.

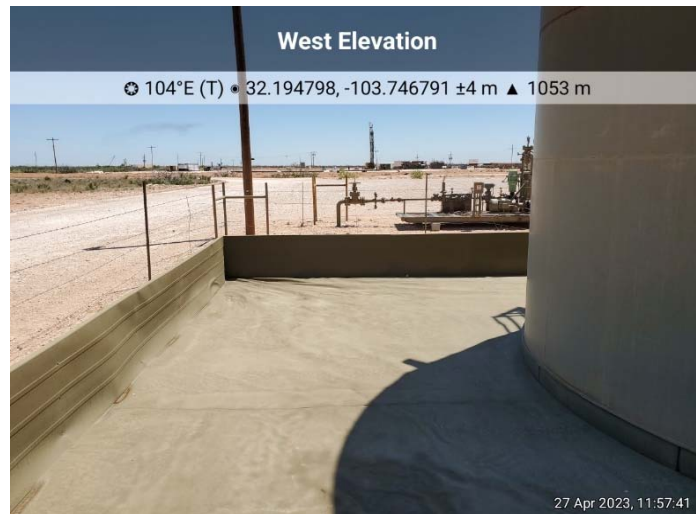
Description:
View of Liner.

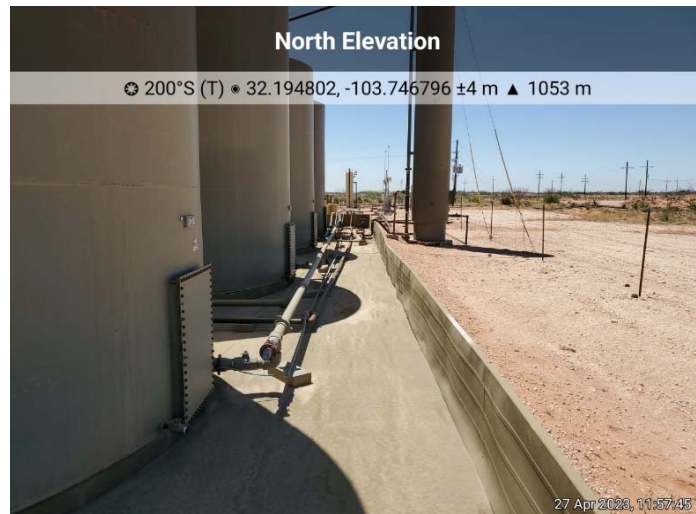
**Photograph No. 11**

Description:
View of Liner.

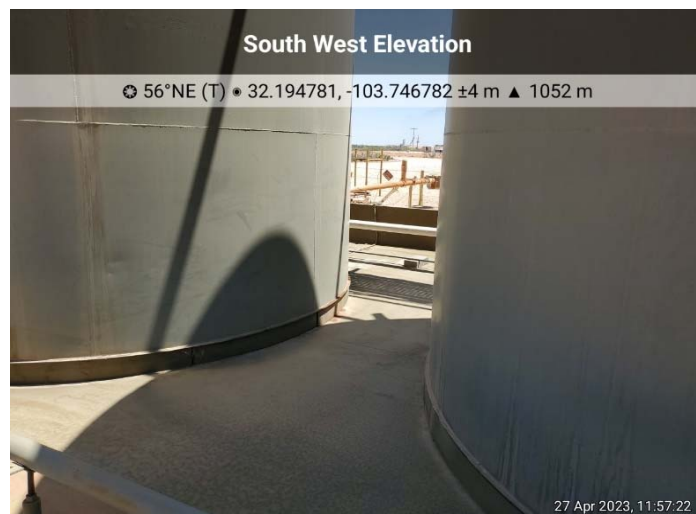
**Photograph No. 12**

Description:
View of Liner.
