**Re: Remediation Work Plan  
Twin Lakes SA Unit #046  
Incident Number nAPP2405244889  
Chaves County, New Mexico**

Oxy USA Inc.  
Remediation Work Plan  
Twin Lakes SA Unit #046

Oxy USA Inc.  
 Twin Lakes SA Unit #046  
 Incident Number: nAPP2405244889  
 Unit O, Sec 36, T08S, R28E  
 Chaves County, New Mexico

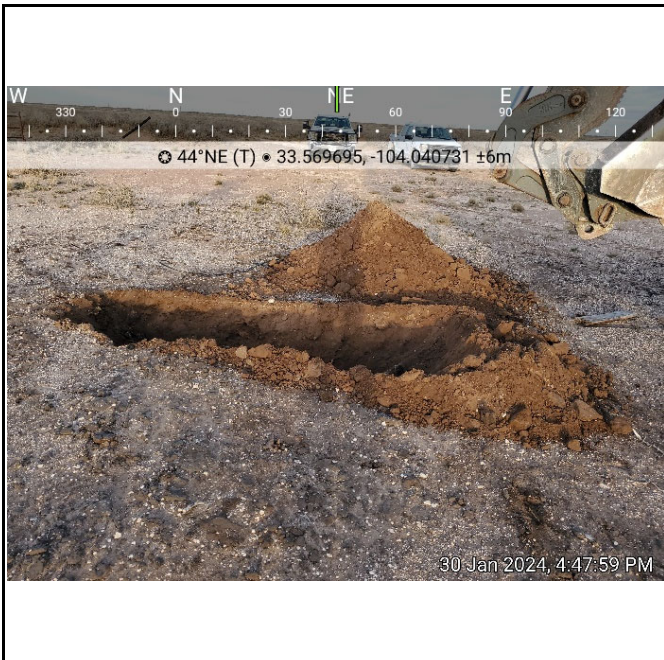
Photograph 1 Date: 01/30/2024  
Description: Delineation activities  
View: Northeast
