Cause of Release:

Failed nipple on Filter Pot 301 caused the release.

Based on laboratory analytical results and field activities conducted to date, Etech recommends Goodnight Midstream Permian, LLC, provide copies of this *Remediation Summary and Deferral Request* to the appropriate agencies and request that a deferral be granted to the Jalapeno SWD Filter Pot 301 site.

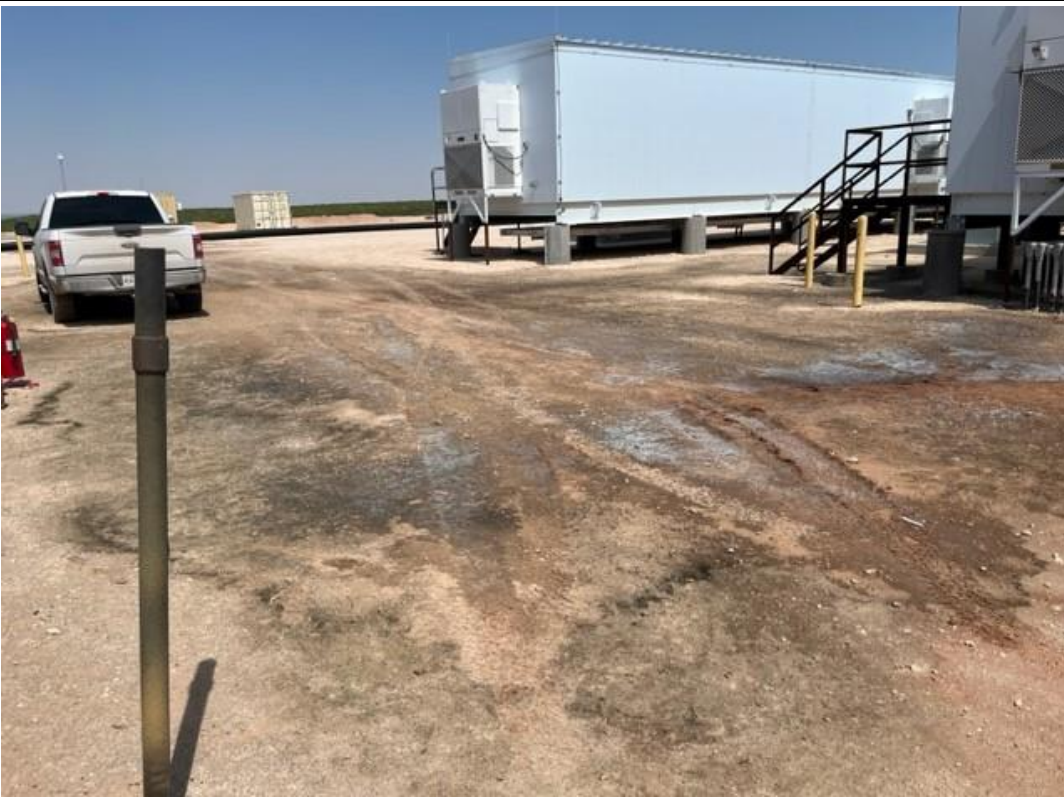
Photo Number: 1

Photo Direction: West	
GPS: 32.371289, -103.410157	
Photo Description: View of initial release.

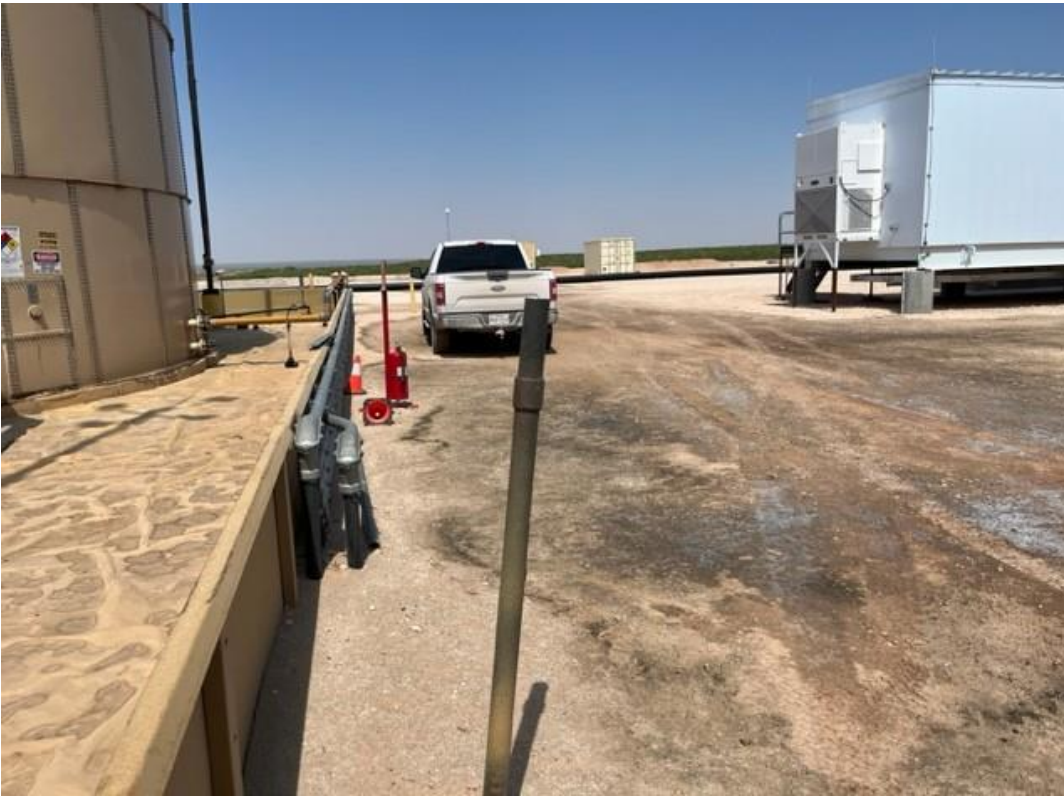
Photo Number: 4

Photo Direction: West	
GPS: 32.371260, -103.410157	
Photo Description: View of initial release.

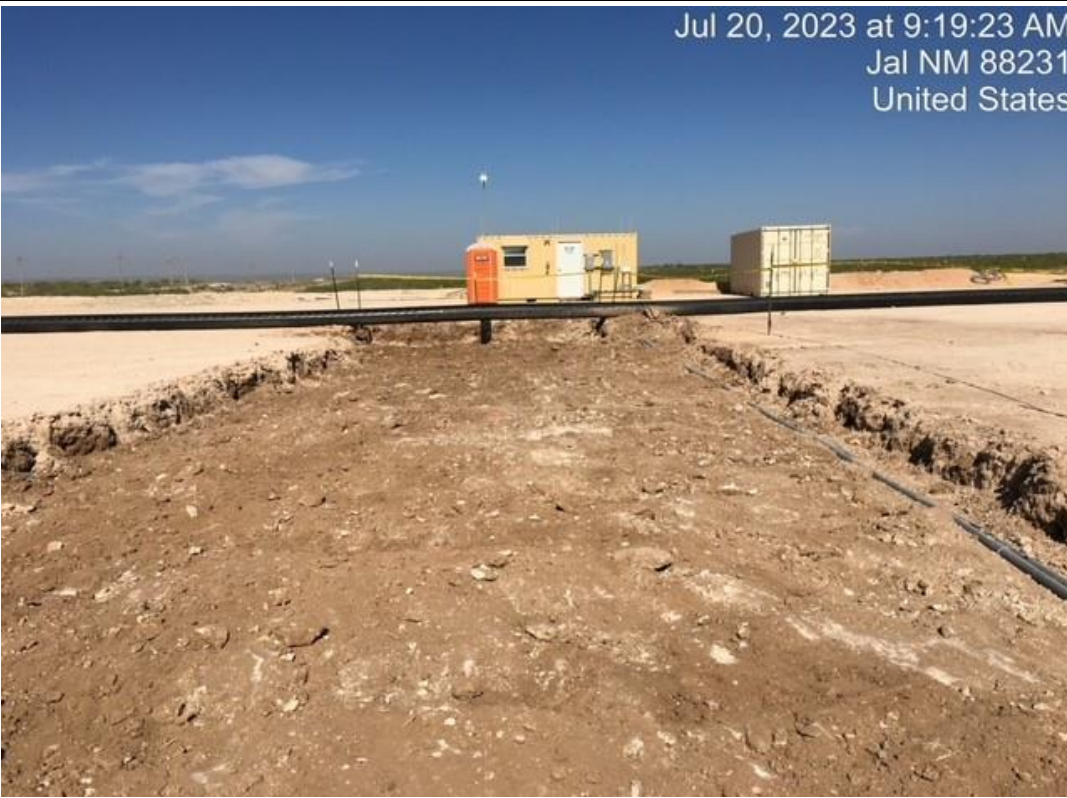
Photo Number: 5	<div>Jul 20, 2023 at 9:19:23 AM Jal NM 88231 United States</div>

Photo Direction: East	
GPS: 32.371338, -103.410373	
Photo Description: View of excavated area.

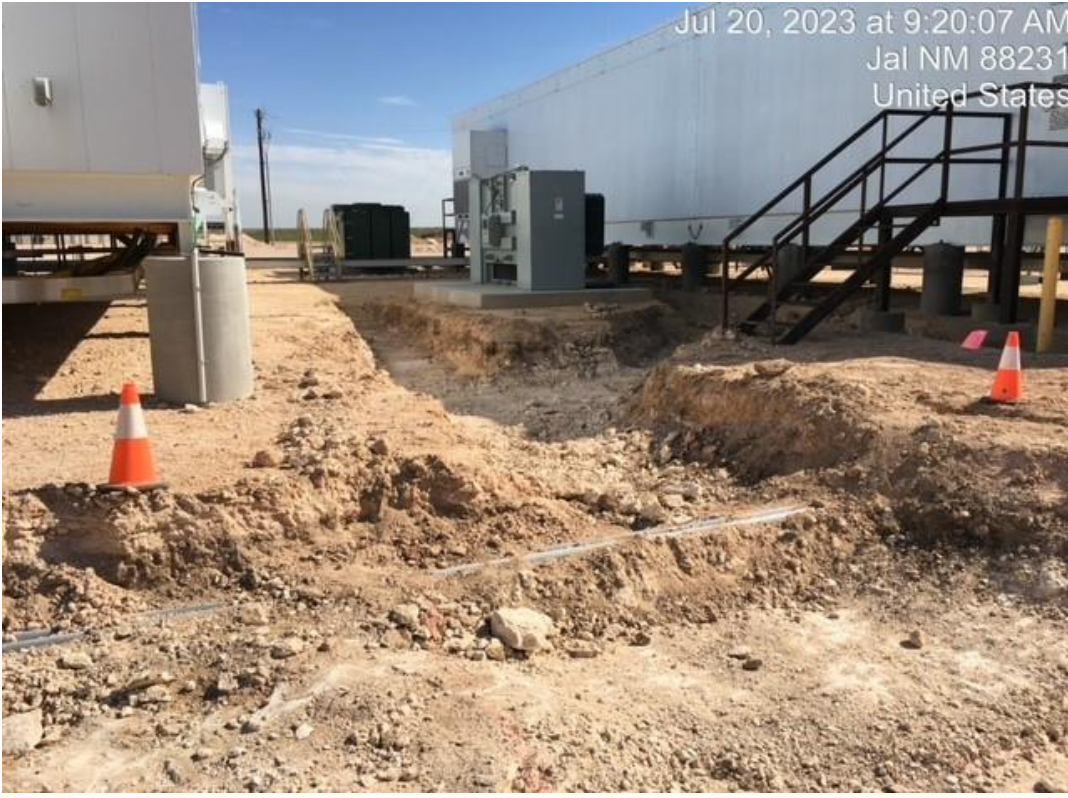
Photo Number: 8

<p>Jul 20, 2023 at 9:20:07 AM Jal NM 88231 United States</p>
Photo Direction: North	
GPS: 32.371318, -103.410359	
Photo Description: View of excavated area.
