CLOSURE REQUEST REPORT

RDX 15 #012

Incident Number nAPP2327248298

SYNOPSIS

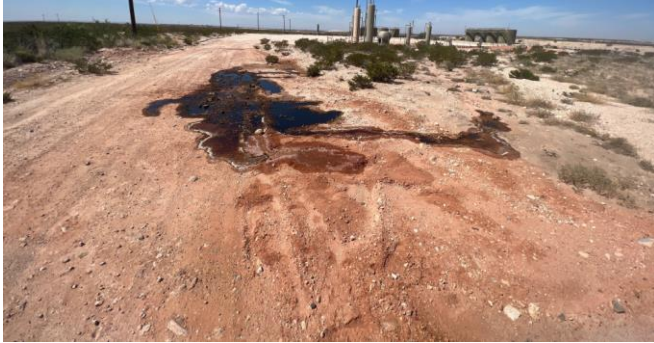
Photograph 1

Description: Northwestern view of the area of concern.

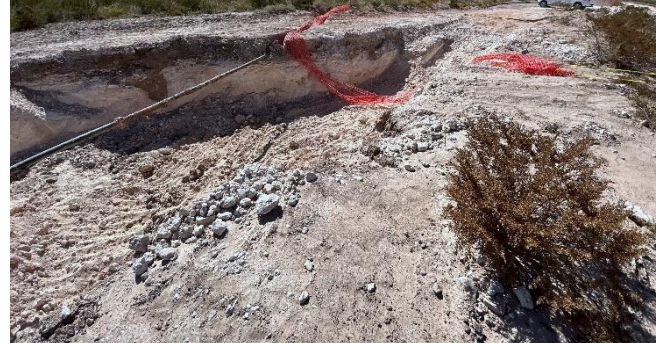
Photograph 2

Description: Western view of the excavation extent.

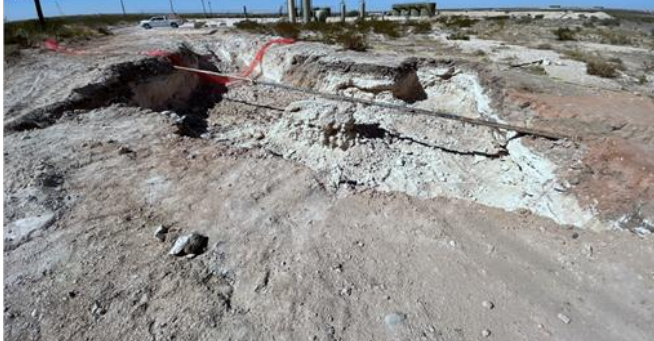
Photograph 3

Description: Northwestern view of the excavation extent.

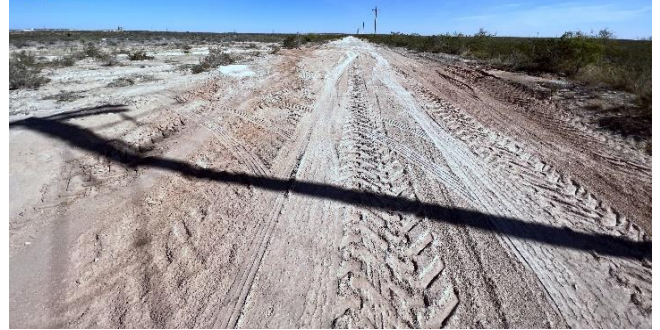
Photograph 4

Date & Time: Wed, Nov 08, 2023 at 11:52:57 MST
 Position: +032.043597° / -103.872325° (±15.9ft)
 Altitude: 3125ft (±13.1ft)
 Datum: WGS-84
 Azimuth/Bearing: 083° N83E 1476mils True (±10°)
 Elevation Angle: -13.0°
 Horizon Angle: +01.1°
 Zoom: 0.5X
 RDX 15-12 backfill
