**Re: Revised Closure Request
Grayburg Eumont Strawn Battery
Incident Number NAPP2302036818
Lea County, New Mexico**

Maverick Permian, LLC
Revised Closure Request
Grayburg Eumont Strawn Battery

Maverick Permian, LLC
Grayburg Eumont Strawn Battery
NAPP2302036818

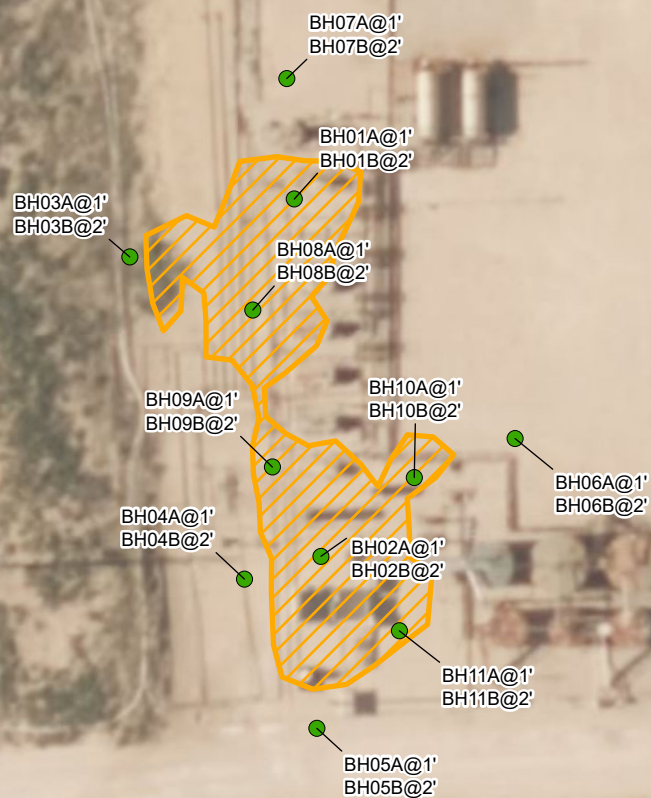
- Delineation Soil Sample
in Compliance with
NMOCD Closure Criteria
- Release Extent

Notes:
Sample ID @ Depth Below Ground Surface.

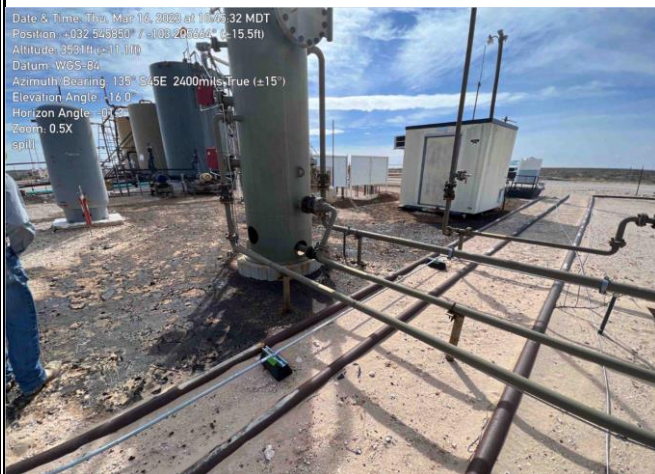
Photograph 1 Date: 03/16/23
Description: Soil staining in release footprint
View: Southeast

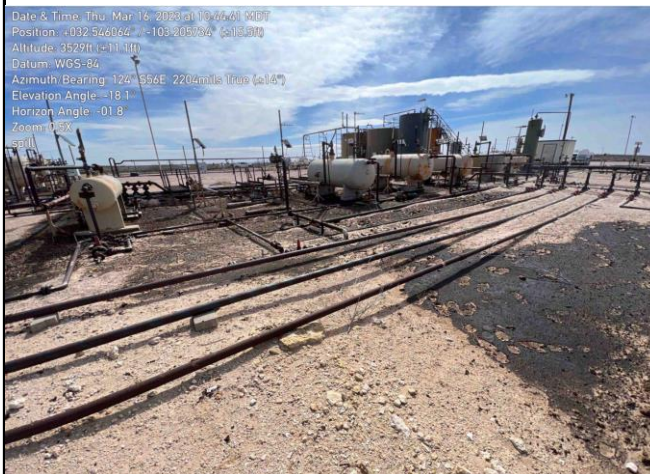
Photograph 2 Date: 03/16/23
Description: Soil staining in release footprint
View: Southeast

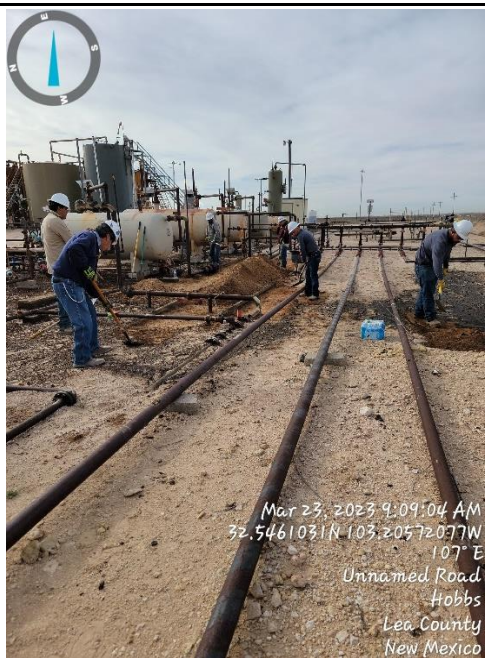
Photograph 3 Date: 03/23/23
Description: Remediation activities
View: East

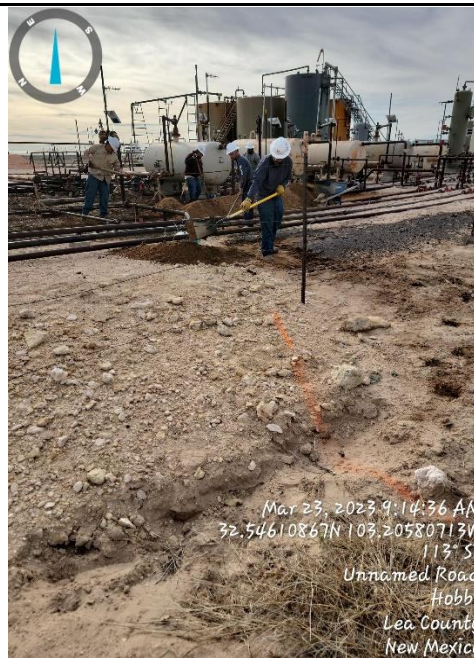
Photograph 4 Date: 03/23/23
Description: Remediation activities
View: Southeast

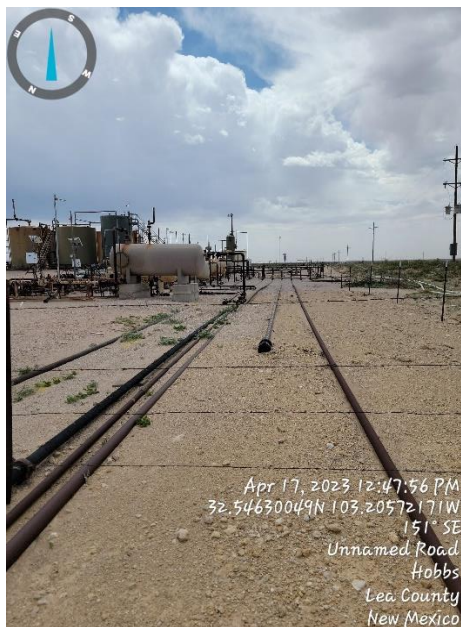
Photograph 5

Description: Remediated and backfilled

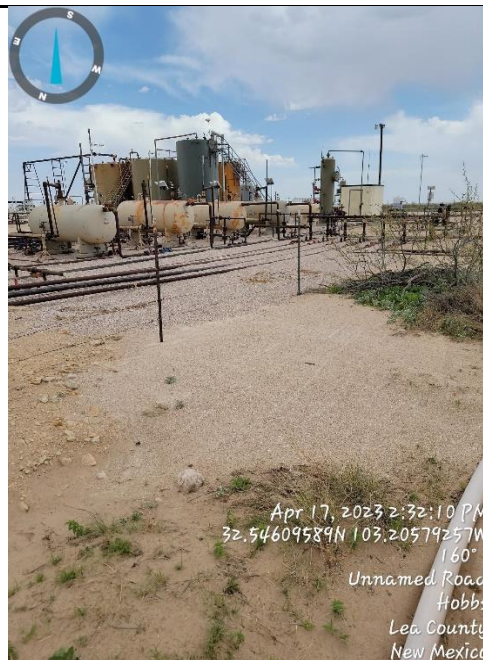
Photograph 6

Description: Remediated and backfilled

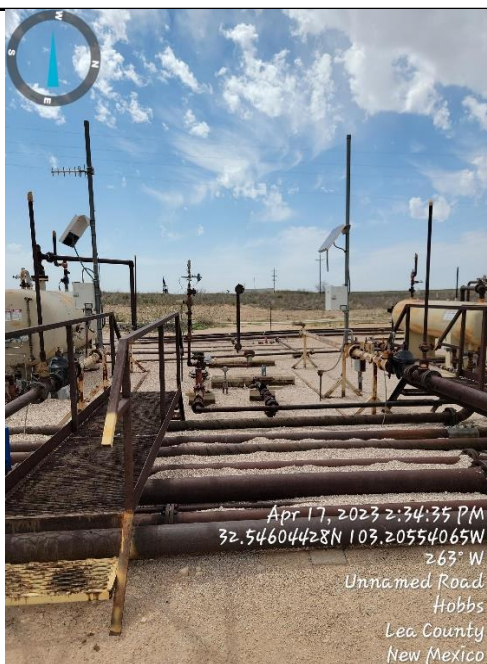
Photograph 7

Description: Remediated and backfilled
