Re: Closure Request Addendum Ross Draw Unit #075H Incident Number nAPP2231850149

Eddy County, New Mexico

Ensolum, LLC (Ensolum), on behalf of WPX Energy Permian, LLC (WPX), has prepared this *Closure Request Addendum* (CRRA) regarding a produced water release at the Ross Draw Unit #075H (Site), located in Unit C, Section 22, Township 26 South, Range 30 East, in Eddy County, New Mexico (Figure 1). The Site (32.0343971°, -103.8702927°) is associated with oil and gas exploration and production operations on Federal Land managed by the Bureau of Land Management (BLM).

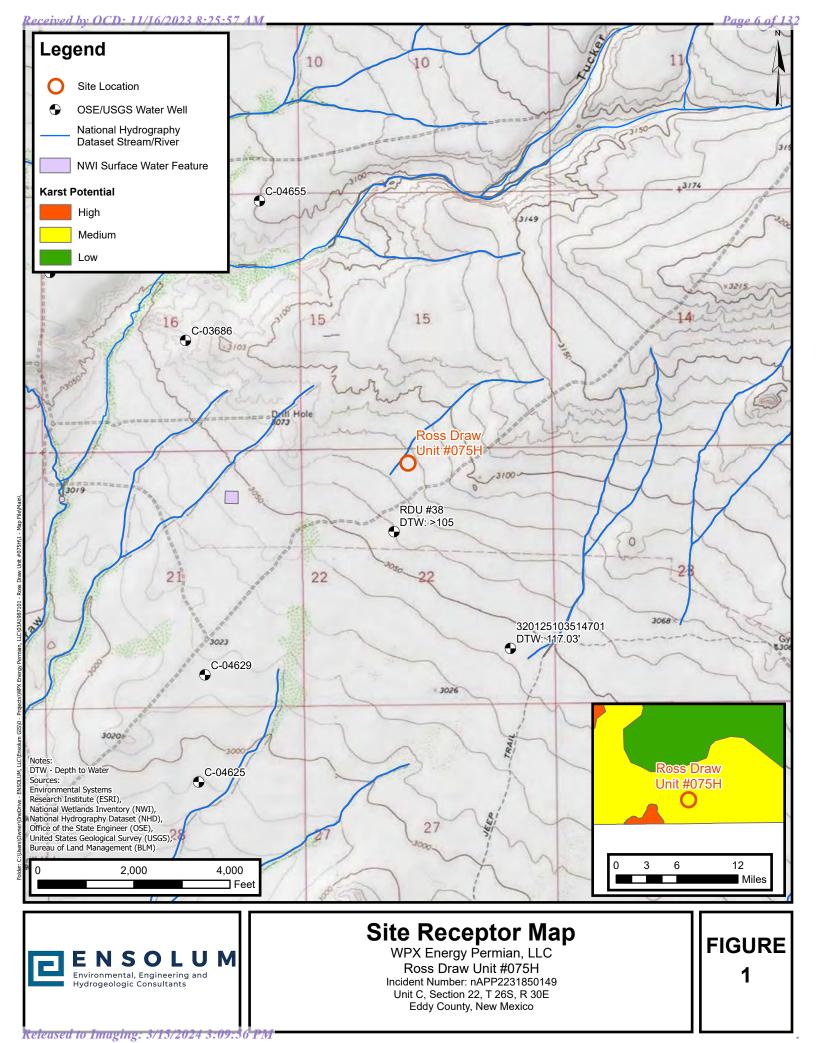
Figure 1 Site Receptor Map

The Site was characterized to assess the applicability of Table I, Closure Criteria for Soils Impacted by a Release, of Title 19, Chapter 15, Part 29 (19.15.29) of the New Mexico Administrative Code (NMAC). Results from the characterization desktop review are presented on page 3 of Form C-141, Site Assessment/Characterization. Potential Site receptors are identified in Figure 1.

The closest continuously flowing or significant watercourse to the Site is an intermittent dry wash, located approximately 301 feet northwest of the Site. The Site is greater than 200 feet from a lakebed, sinkhole, or playa lake and greater than 300 feet from an occupied residence, school, hospital, institution, church, or wetland. The Site is greater than 1,000 feet to a freshwater well or spring and is not within a 100-year floodplain or overlying a subsurface mine. The Site is not underlain by unstable geology (medium potential karst designation area). Site receptors are identified in Figure 1.

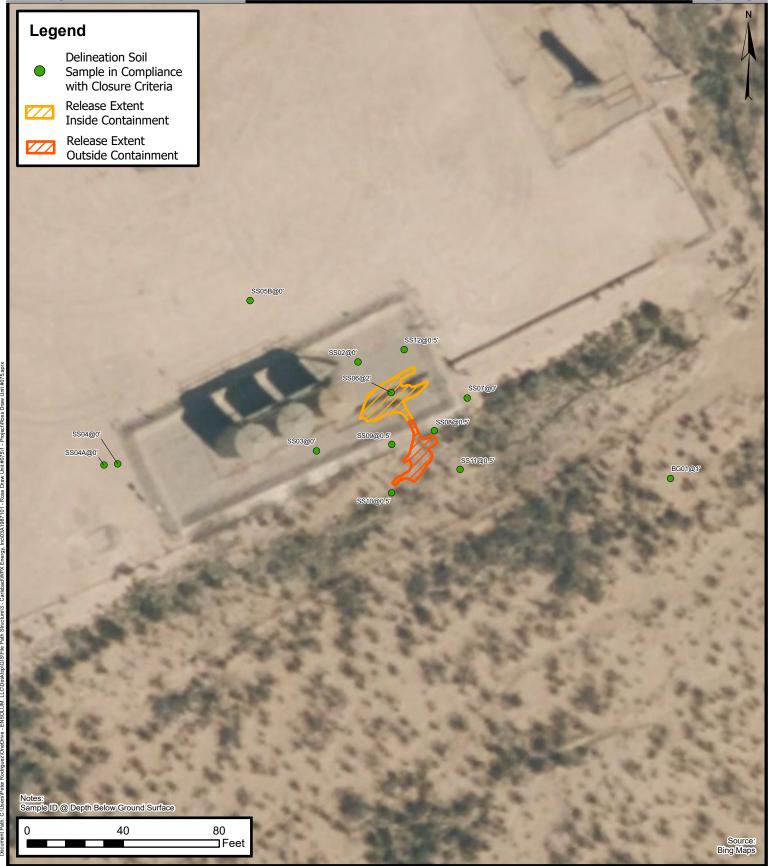
Unit C, Section 22, T 26S, R 30E Eddy County, New Mexico FIGURE 2

Laboratory analytical results for delineation soil samples SS08 through SS11, collected at 0.5 feet bgs, indicated all COC concentrations were in compliance with the Site Closure Criteria and with the reclamation requirement in the area surrounding the off-pad release. Delineation soil sample SS12, collected at 0.5 feet bgs, was in compliance with the Site Closure Criteria and with the reclamation requirement inside the earthen containment.

Delineation Soil Sample Locations

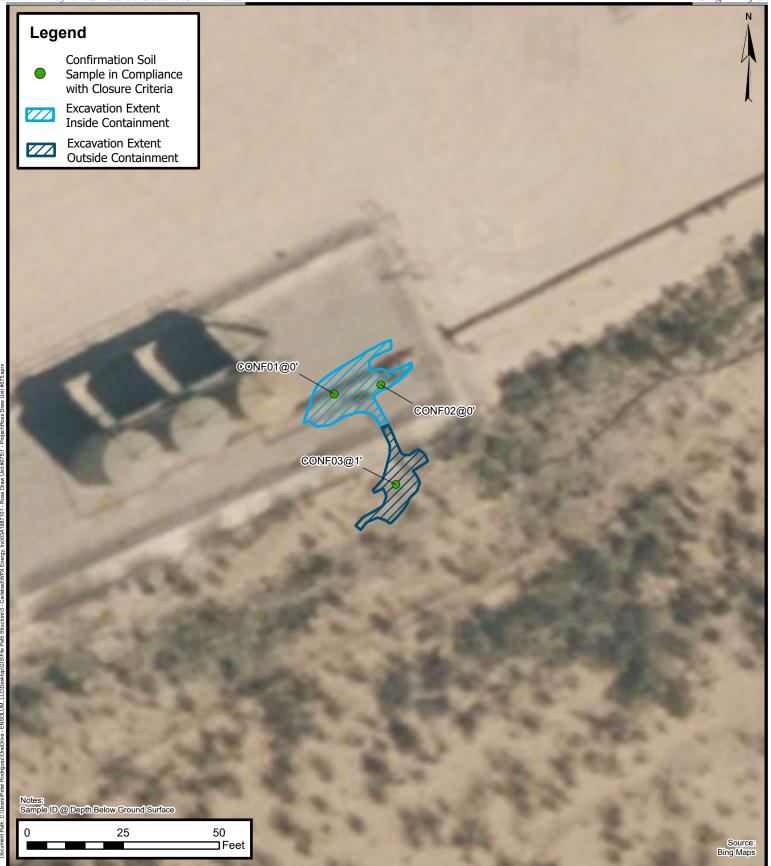
Unit C, Section 22, T 26S, R 30E Eddy County, New Mexico FIGURE 3

Following remediation efforts, three composite confirmation soil samples were collected. Two confirmation samples (CONF01-0' and CONF02-0') were collected from the on-pad spill area and one confirmation sample (CONF03-1') was collected from the off-pad spill area. Confirmation soil samples (CONF01-0' and CONF02-0') collected from inside the earthen containment were in compliance with the Site Closure Criteria and confirmation soil sample (CONF03-1') collected from the off-pad spill area was in compliance with Site Closure Criteria and with the reclamation requirement. The off-pad excavation has been backfilled, recontoured, and seeded with an approved BLM seed mixture.

Confirmation Soil Sample Locations

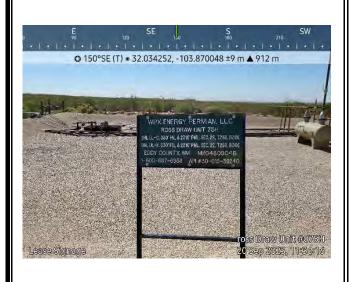
Photograph 1 Date: 9/20/2023 Photograph 2 Date: 9/20/2023

Description: Lease Sign Description: Vertical Delineation

View: Southeast View: Southeast
