CLOSURE REPORT

Lateral 10D-2 (07/12/23)
Unit Letter P, S8 T26N R11W
San Juan County, New Mexico

New Mexico EMNRD OCD Incident ID No. NAPP2319529764

Ensolum Project No. 05A1226257

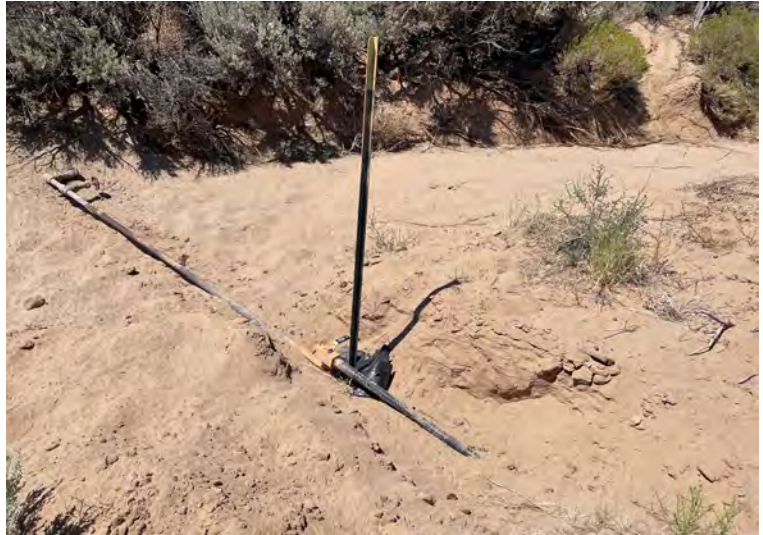
Photograph 1

Photograph Description: View of the excavation.

The excavation measured approximately 7.5 feet long and 2 feet wide at the maximum extents. The maximum depth of the excavation measured approximately one foot bgs. The lithology encountered during the completion of remediation activities consisted primarily of silty sand.

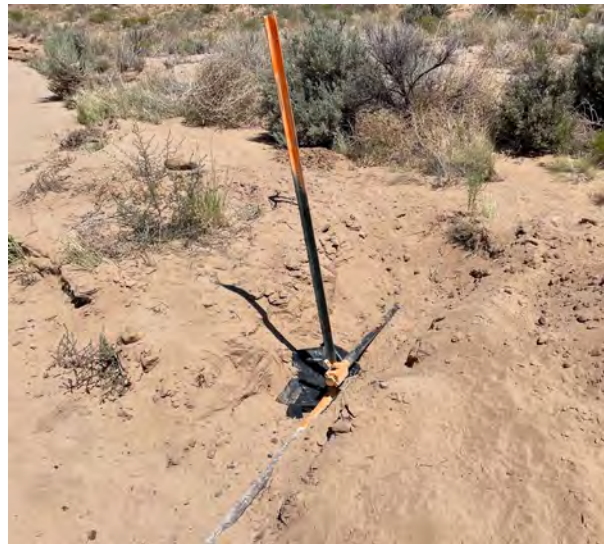
Photograph 2

Photograph Description: View of the excavation.
