Closure Report

M-Chavez-8-S-07262023
Incident ID: nAPP2321447226
Chavez County, New Mexico
Unit M Sec 18 T15S R30E
33.011688°, -103.965595°

Condensate Release

Point of Release: Corroded Pipe

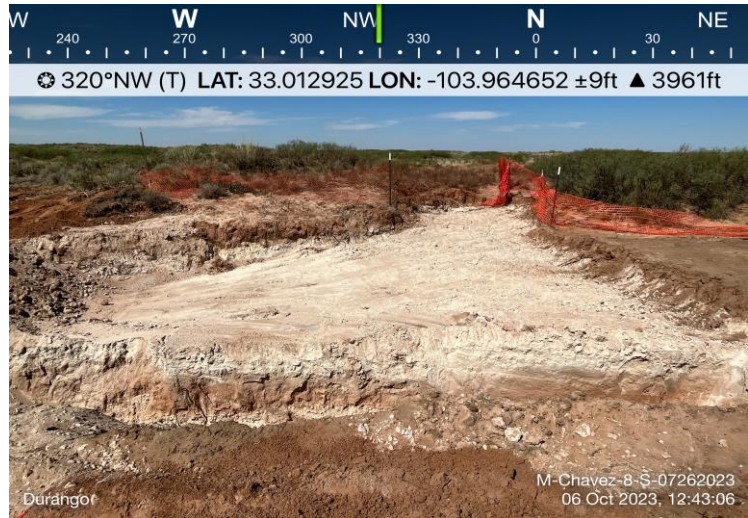
View Northwest, area of CS-1 through CS-4.

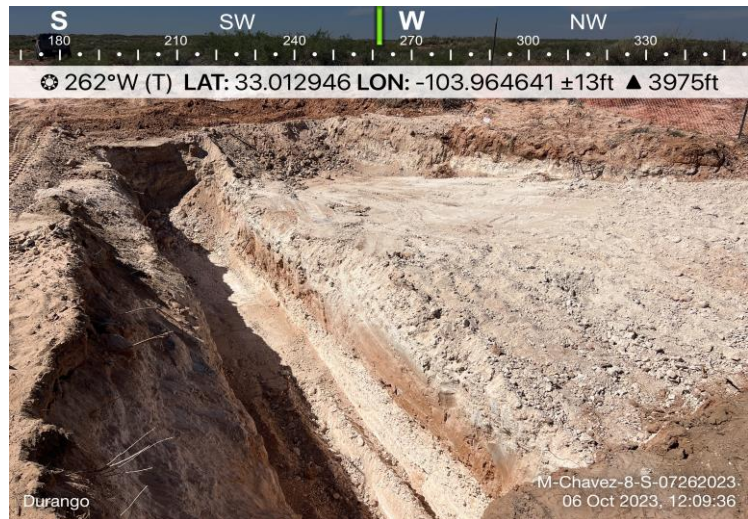
Photograph No. 2

View West, area of CS-5.

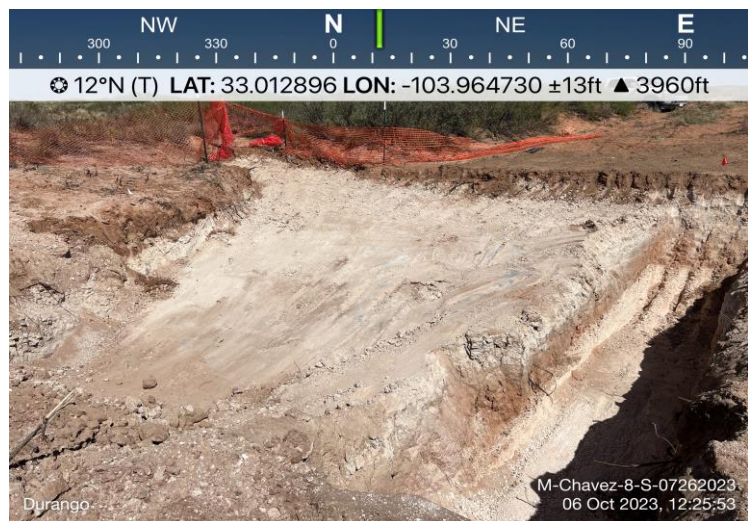
Photograph No. 3

View North, area of CS-1 through CS-5.

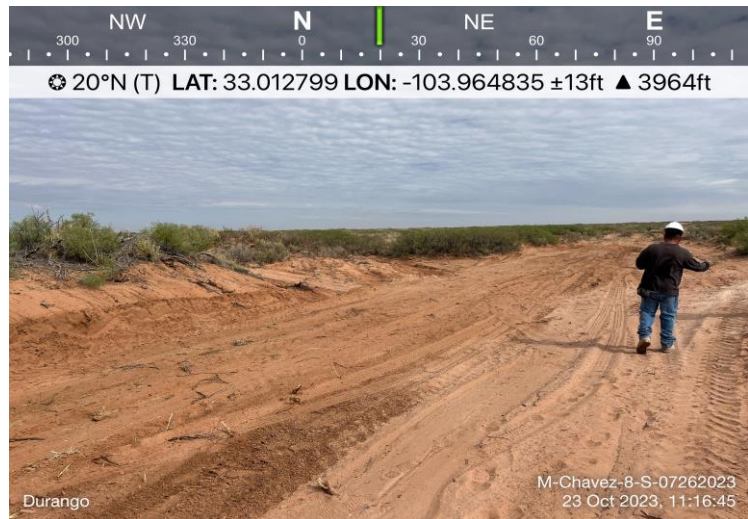
Photograph No. 5

Description:
View North, hand broadcasting of seed mixture.

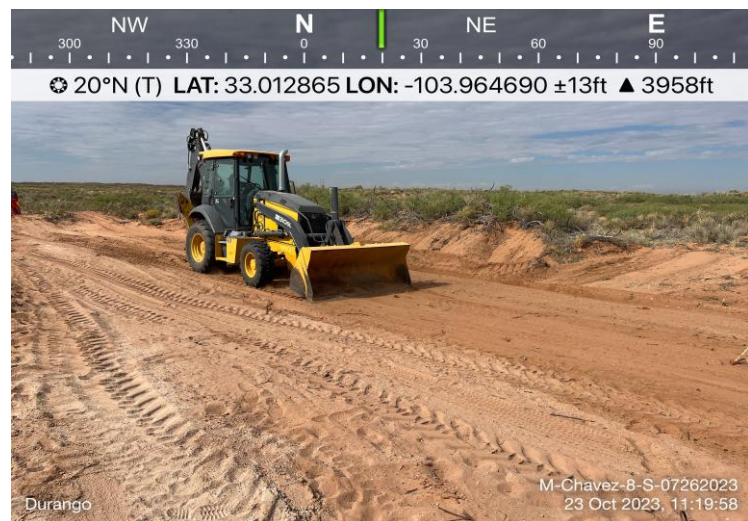
Photograph No. 6

Description:
View North, backdrag of reclaimed area.
