Closure Report

New Mexico DE State Com #1
Eddy County, New Mexico
API # 30-015-24122
Incident # nAPP2209133003

Subject: **Closure Report**
New Mexico DE State Com #1
Eddy County, New Mexico
API # 30-015-24122
Incident # nAPP2209133003

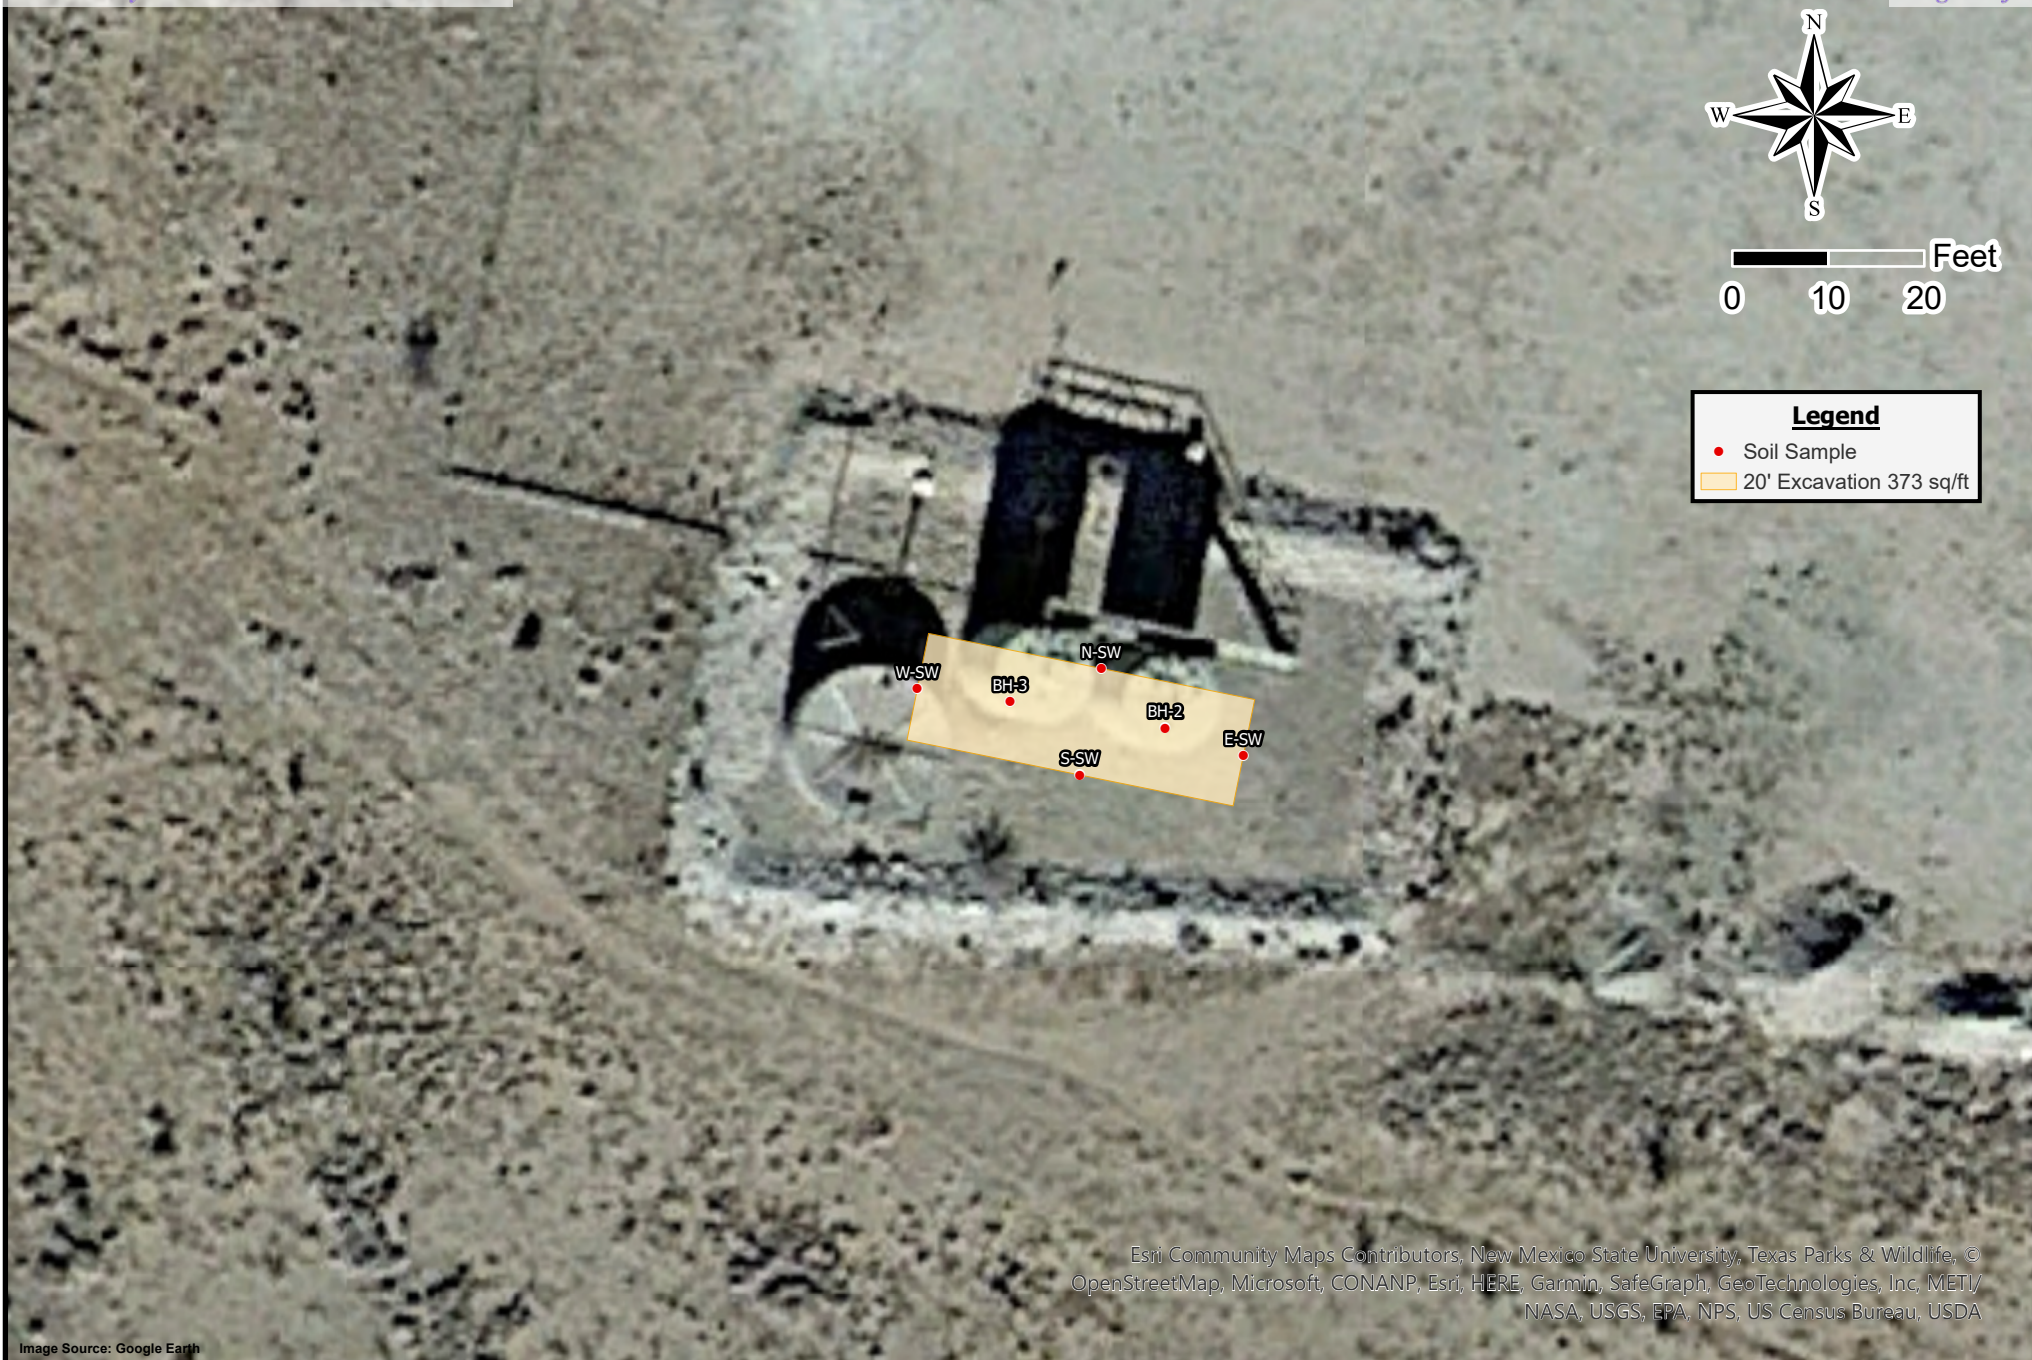
New Mexico DE State Com #1
EOG Resources, Inc.
32.65164°N, -104.63005°W
Eddy County, NM
Sample Map

On August 2, 2023, Talon personnel and equipment returned to location to excavate the impacted area to depths of 20 feet bgs to provide a floor sample as requested by NMOCD. Using field titration data, the sidewalls were advanced to the extent that NMOCD soil remediation guidelines were met or exceeded. All soil samples were retrieved on a composite basis, properly contained, preserved on ice and transported to Cardinal Laboratories for confirmation. The results are recapped below. The sample positions are illustrated on Figure 4 ([Appendix I](#)).

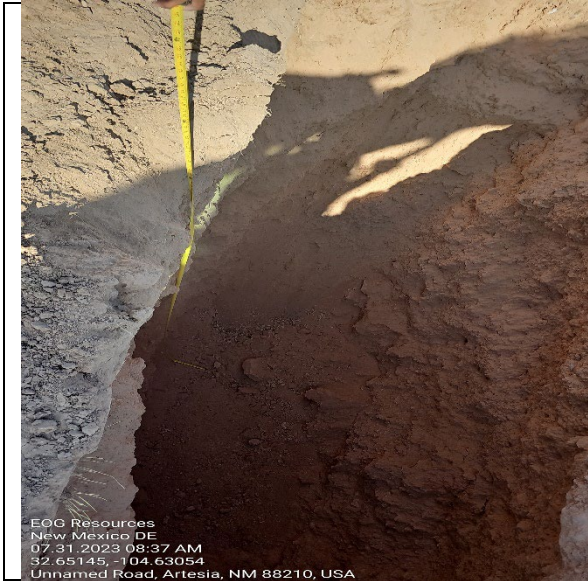
Photograph No.1 Description:

New Mexico DE State Com #1
Remediation

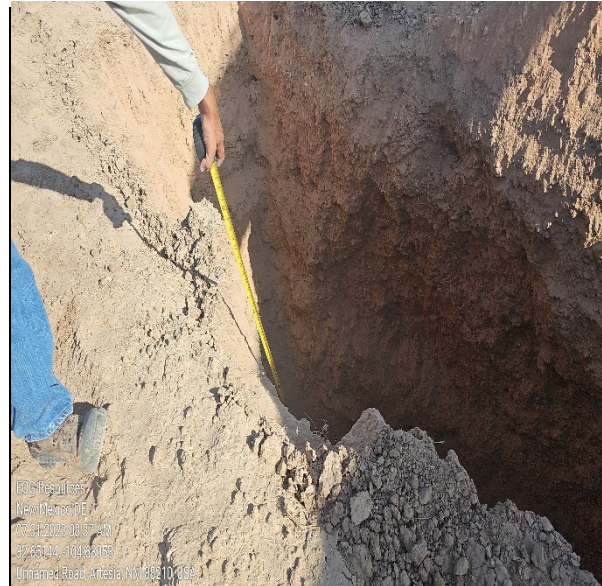
Photograph No.2 Description:

New Mexico DE State Com #1
Remediation

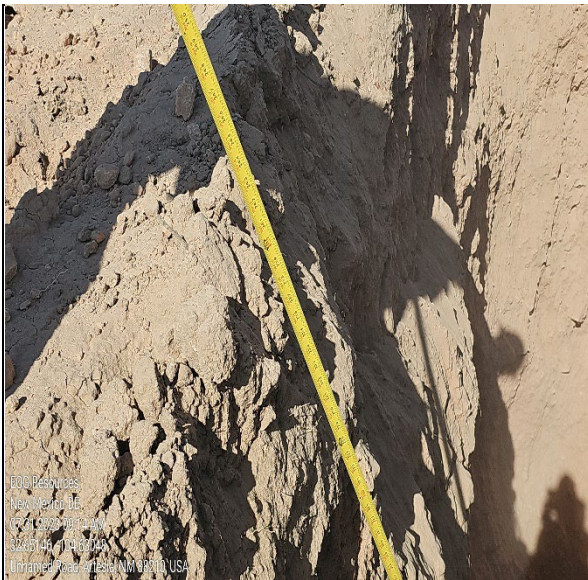
Photograph No.3 Description:

New Mexico DE State Com #1
Remediation 20 feet excavation.

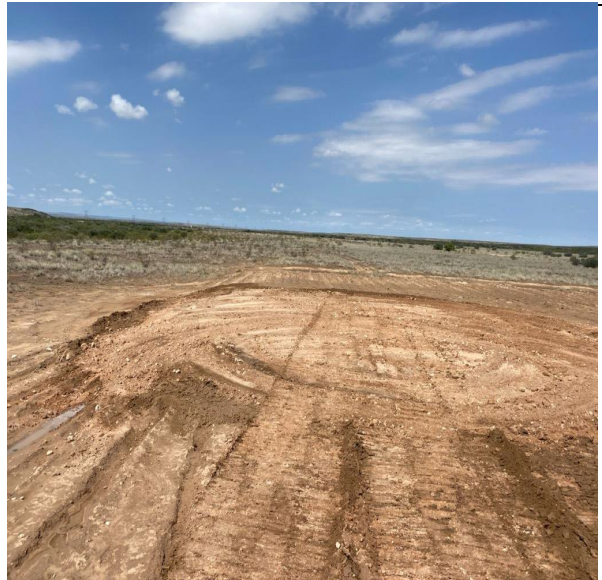
Photograph No.4 Description:

New Mexico DE State Com #1 Backfill
