Remediation Summary and Closure Request

**Frontier Field Services, LLC
Abo-7 Plant W. Inlet 12" Poly
Eddy County, New Mexico
Unit Letter "M", Section 3, Township 18 South, Range 27 East
Latitude 32.775524 North, Longitude 104.263014 West
NMOCD Incident # nAPP2233226355**

March 2023

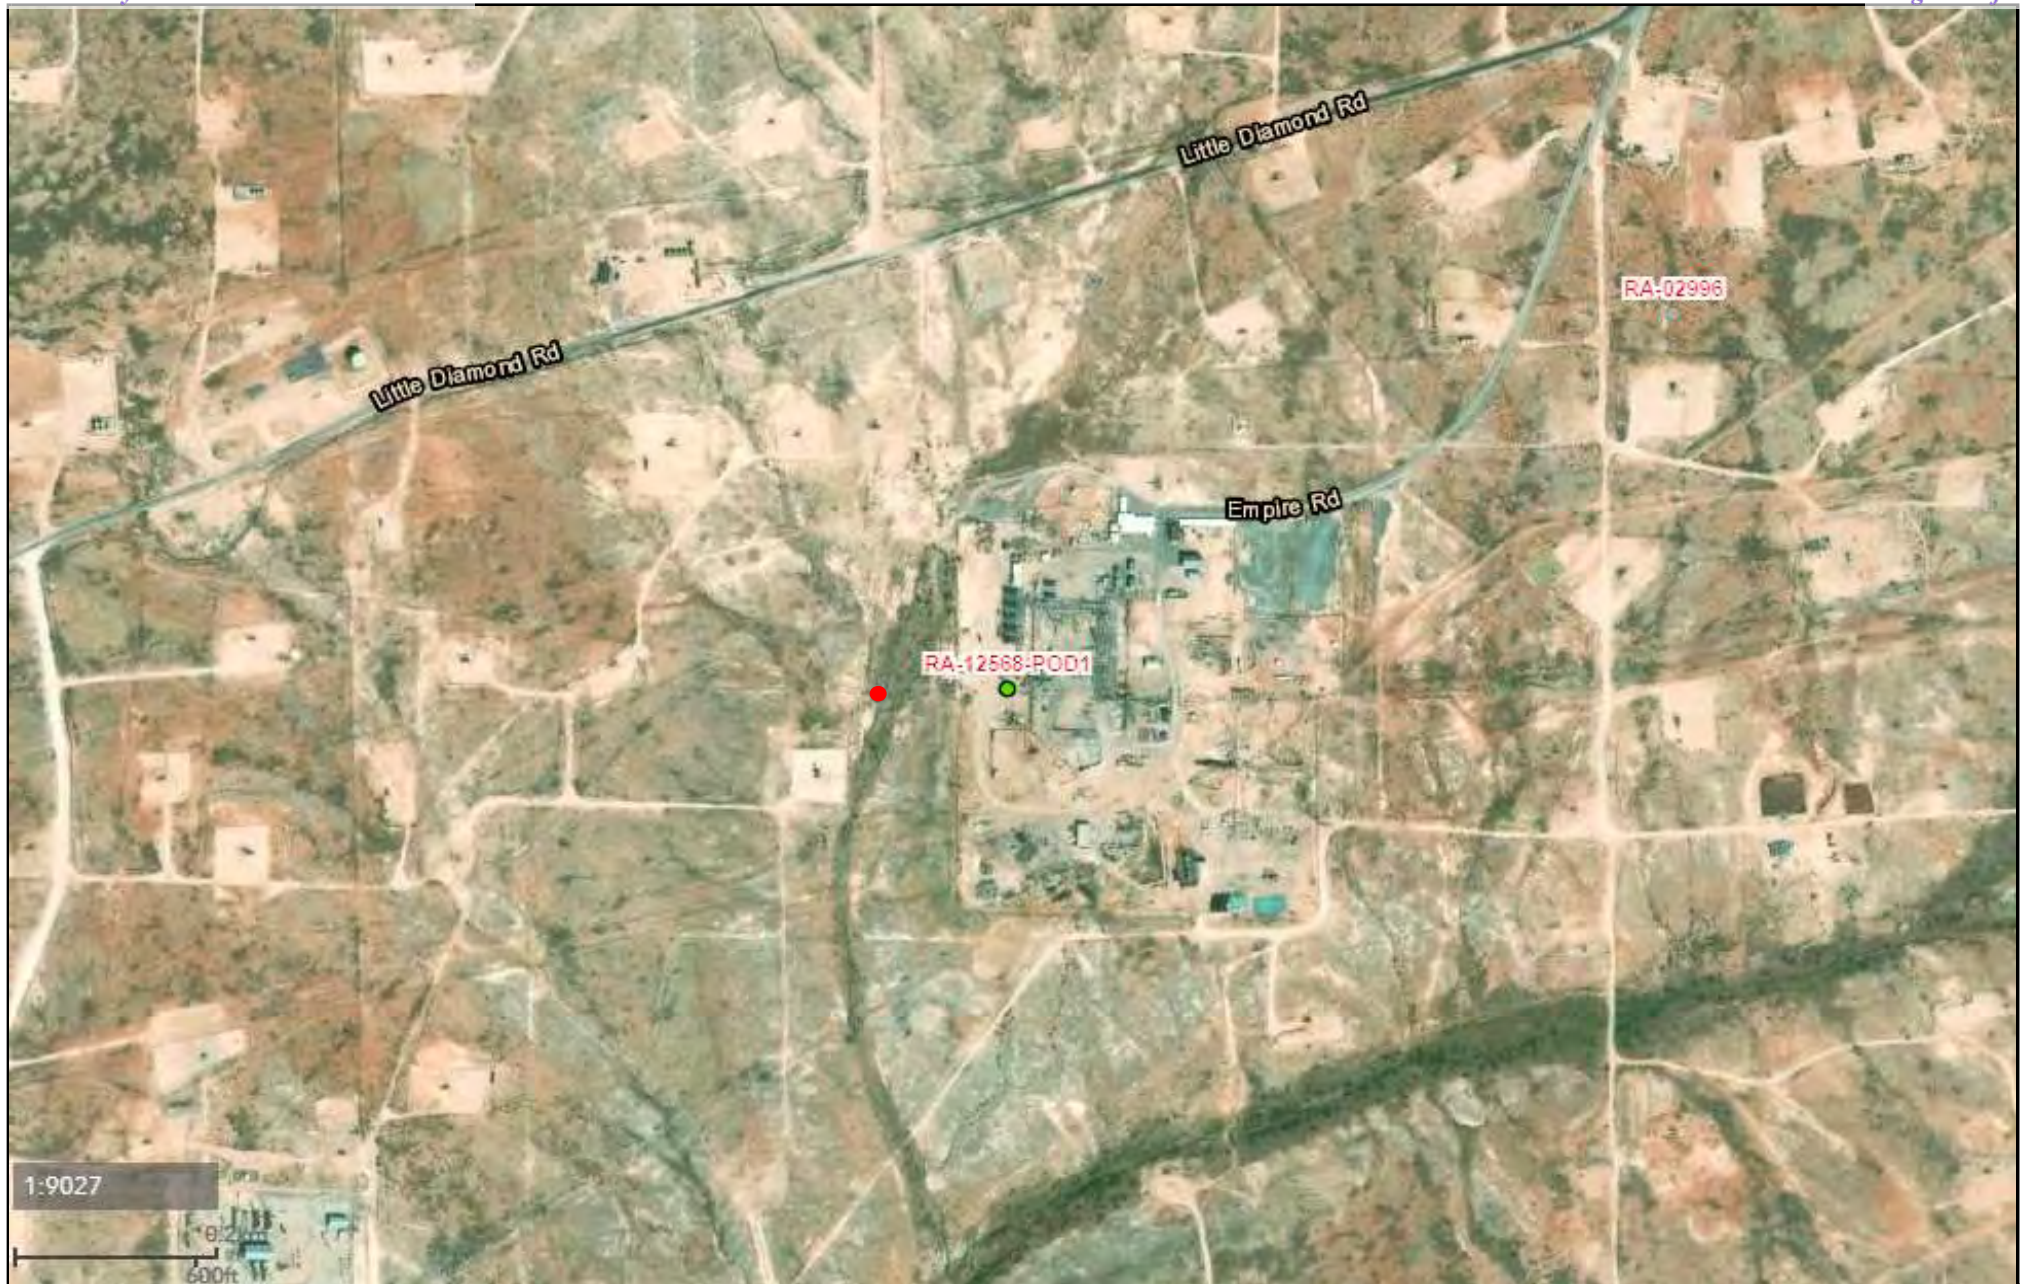
**Figure 2**

OSE POD Locations Map
Frontier Field Services, LLC
Abo-7 Plant W. Inlet 12" Poly
GPS: 32.775524, -104.263014
Eddy County

A search of the New Mexico Office of the State Engineer (NMOSE) and United States Geological Survey (USGS) groundwater databases was completed in an effort to determine the horizontal distance to known water sources within a half mile radius of the Release Site. Approximate depth to groundwater was determined using maintained and published water well data. Karst mapping indicates the site is located in a Karst designated area. Karst and Wetland Maps are provided as Attachment I. Depth to groundwater information is provided as Attachment IV and the results are depicted on Figures 2 & 3.

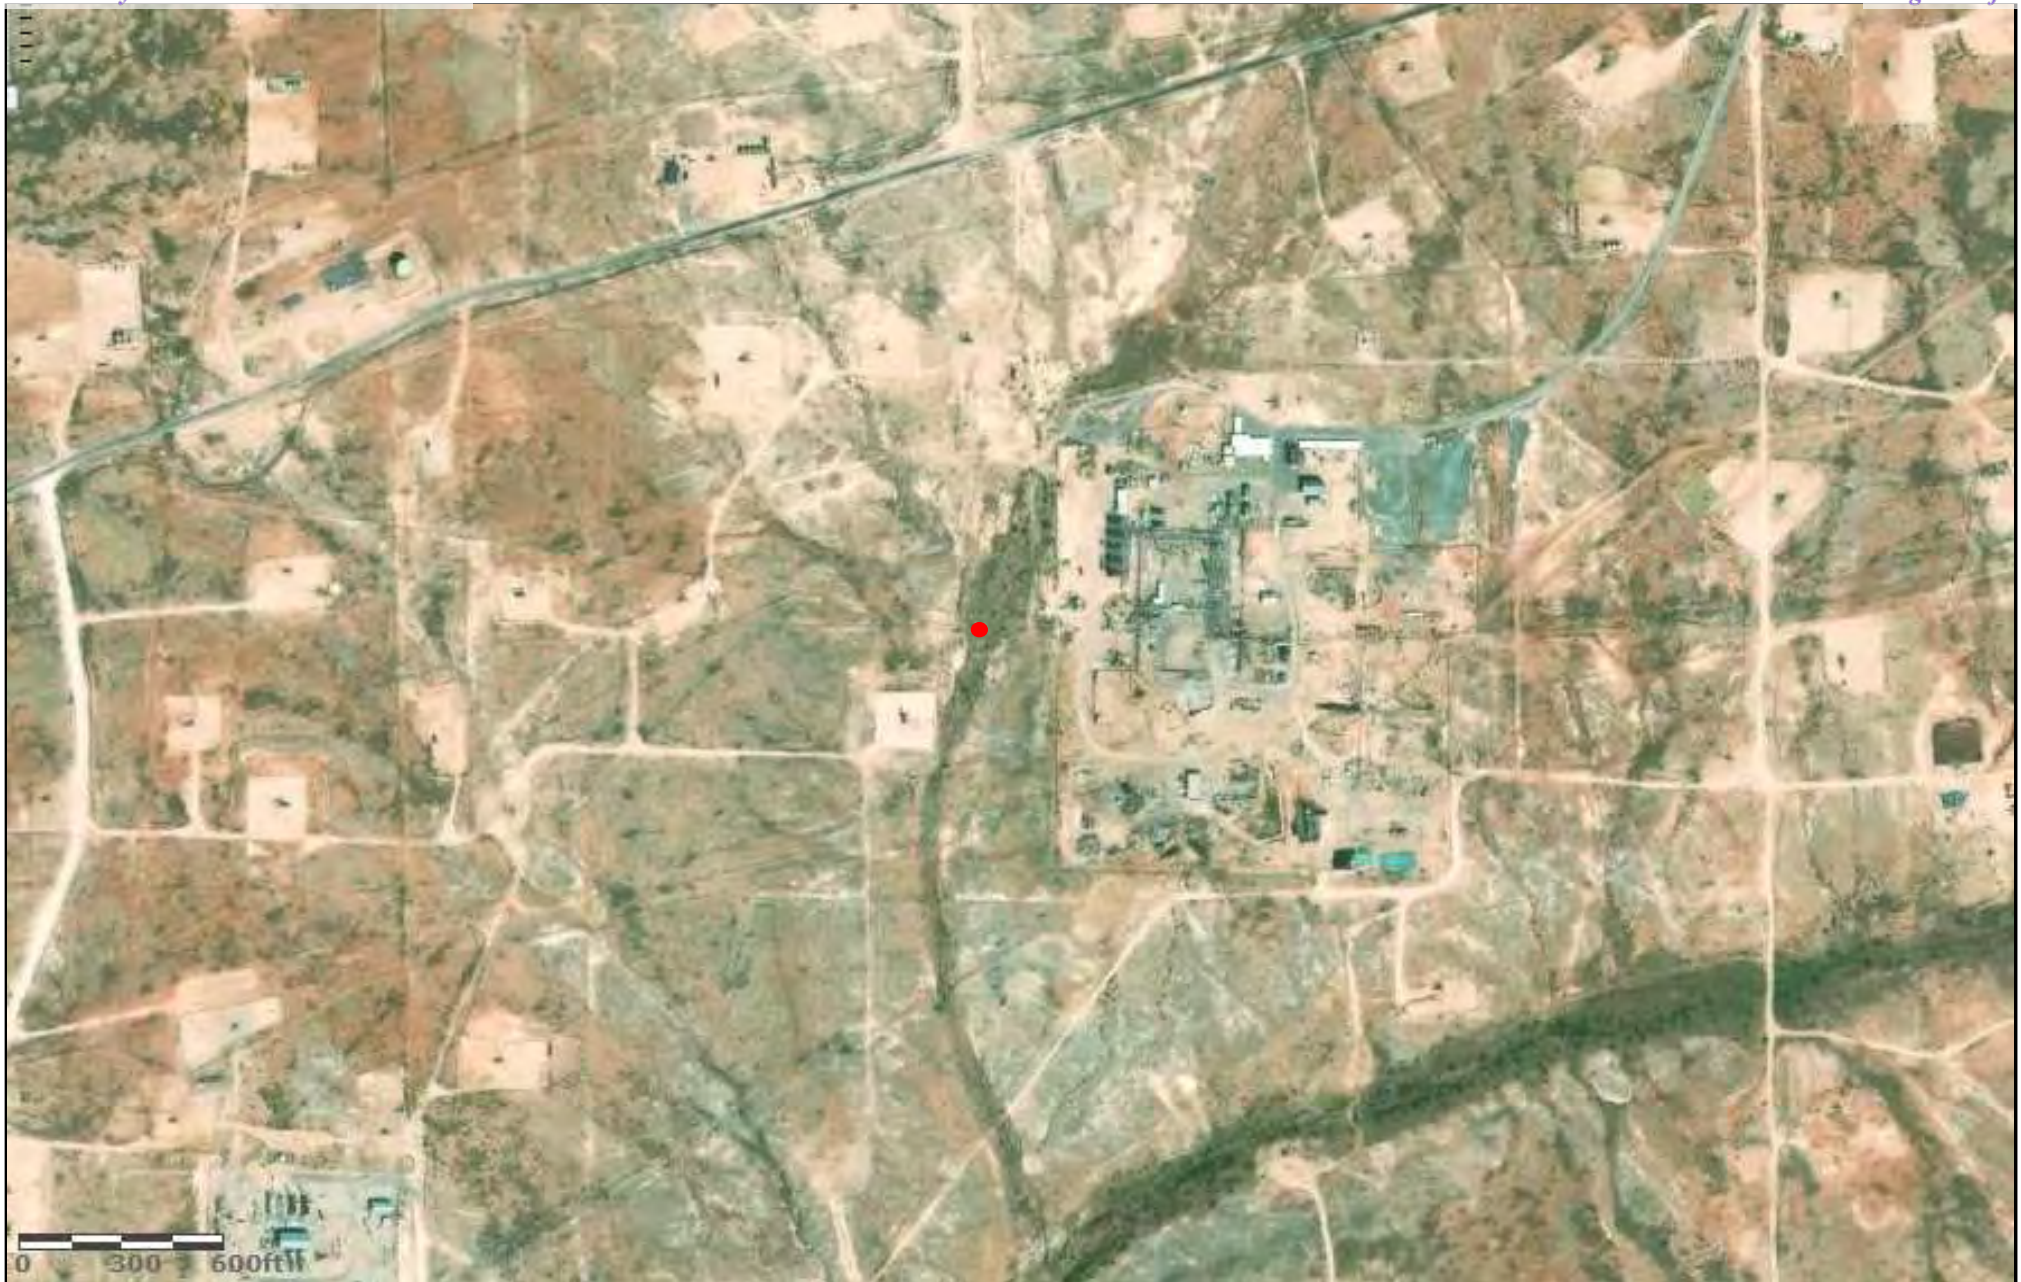
**Figure 3**

USGS Well Locations Map
Frontier Field Services, LLC
Abo-7 Plant W. Inlet 12" Poly
GPS: 32.775524, -104.263014
Eddy County

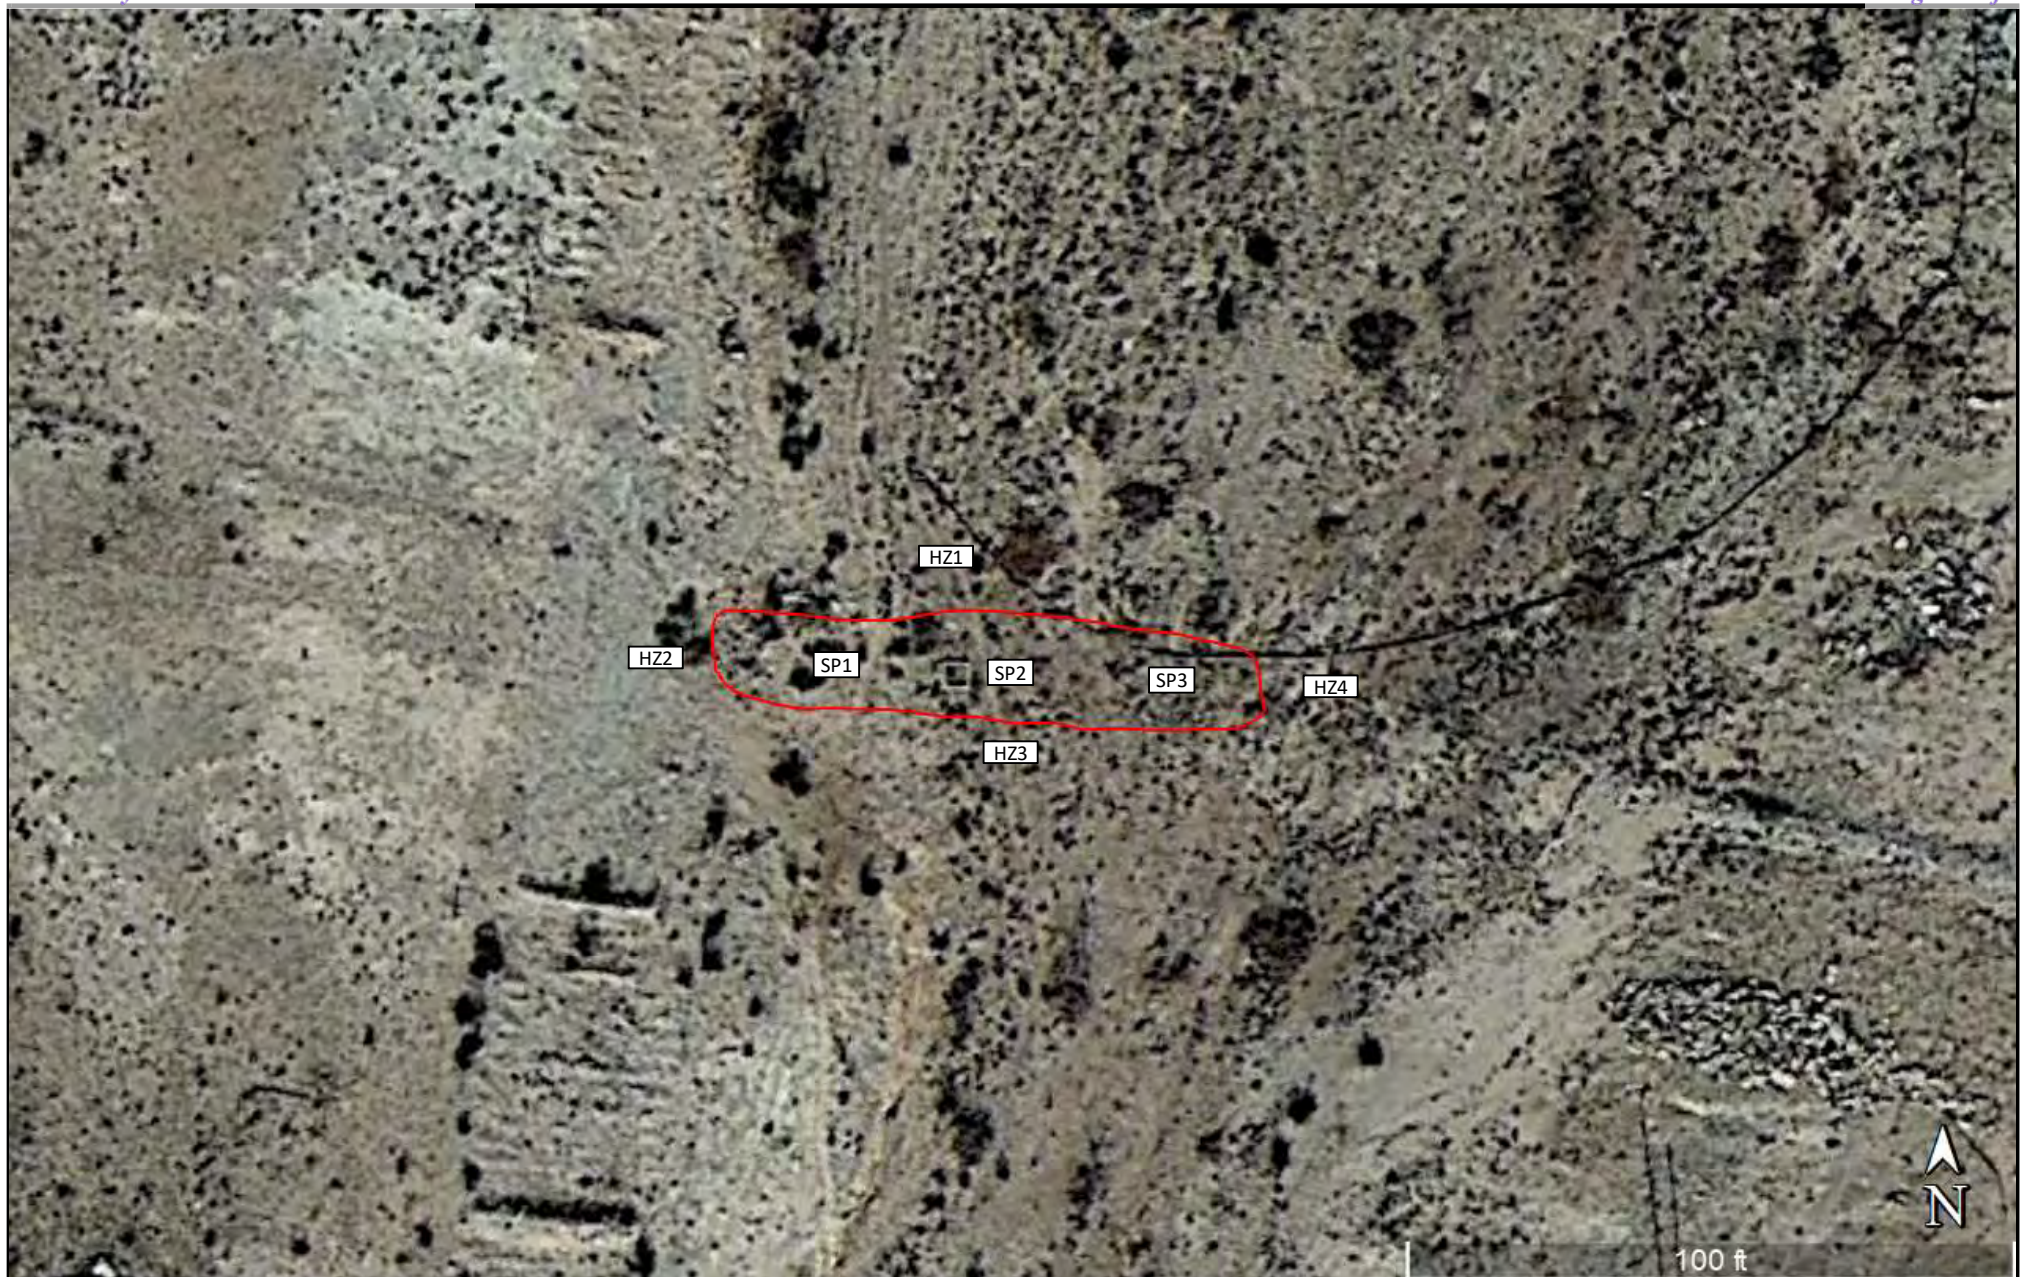
**Figure 4**

Delineation Sample Map
Frontier Field Services, LLC
Abo-7 Plant W. Inlet 12" Poly
GPS: 32.775524, -104.263014
Eddy County

Based on field observations and field test data noted above and provided in Attachment V, fourteen representative soil samples, two from each sample location, were selected for laboratory analysis. Delineation soil samples SP1 through SP3, and HZ1 through HZ4, were submitted to the laboratory for analysis of BTEX, TPH, and chloride. Laboratory analytical results indicated contaminant concentrations were below the NMOCD Closure Criteria in each of the submitted samples, with the exception of SP1, SP2, and SP3, at Surface, which exhibited TPH and/or chloride concentrations in excess of NMOCD Closure Criteria.

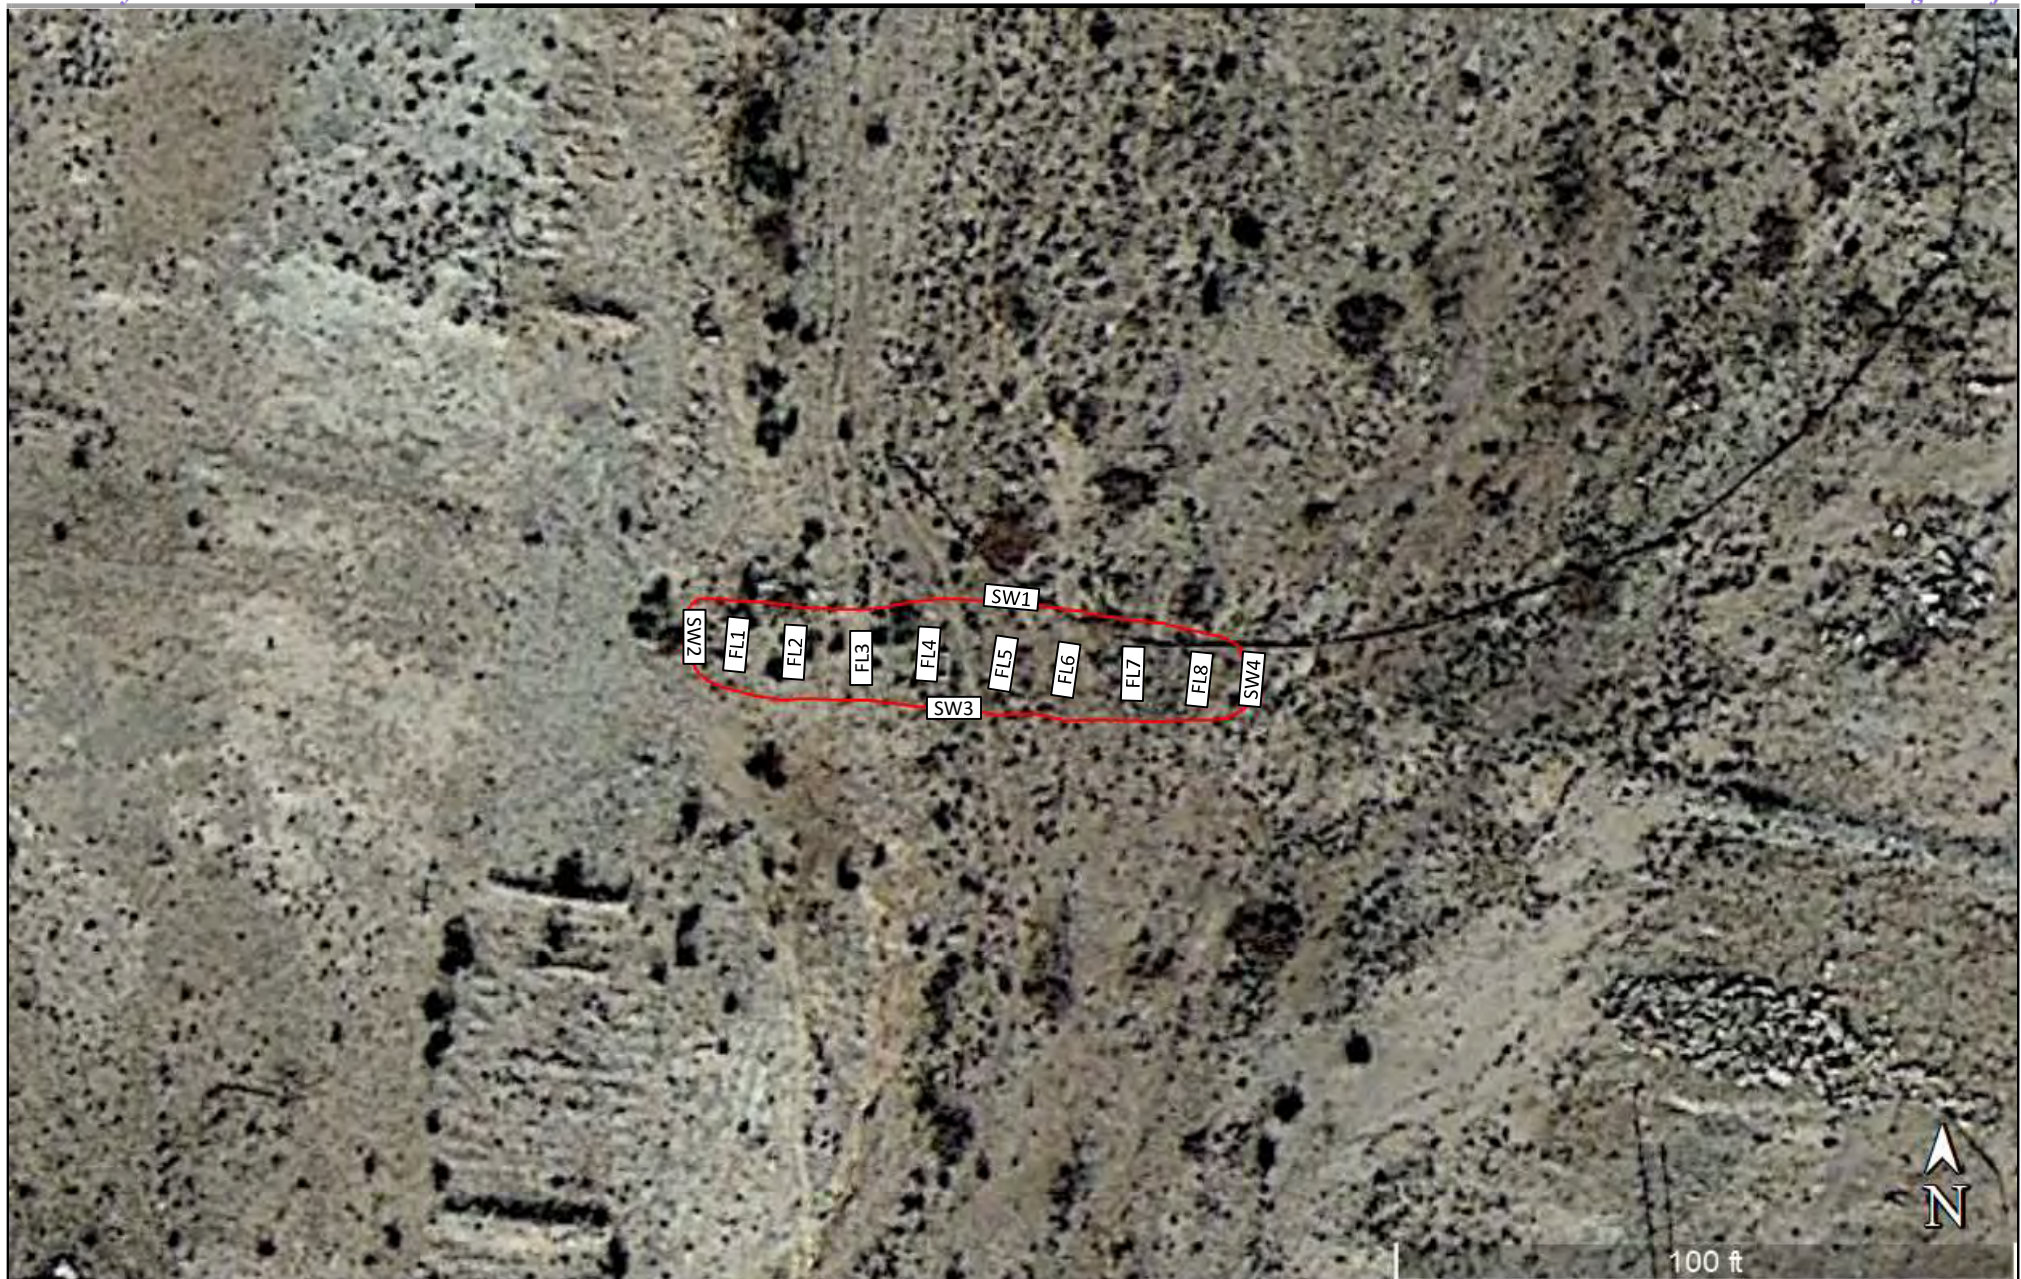
**Figure 5**

Excavation Sample Map
Frontier Field Services, LLC
Abo-7 Plant W. Inlet 12" Poly
GPS: 32.775524, -104.263014
Eddy County
