Release Notification

Site Name Dayton Water Recycle	Site Type Produced Water Recycle Facility
Date Release Discovered 2/21/2023	API# (if applicable)

Environmental Site Remediation Work Plan

NMOCD District:	2 – Artesia	Incident ID:	nAPP2307356662
Landowner:	Silverback Operating	RP Reference:	N/A
Client:	Silverback Exploration	Site Location:	Dayton Recycle Release
Date:	July 15, 2023	Project #:	23E-02248
Client Contact:	Mark Ritchie	Phone #:	713.553.8320
Vertex PM:	Michael Moffitt	Phone #:	575.988.2681

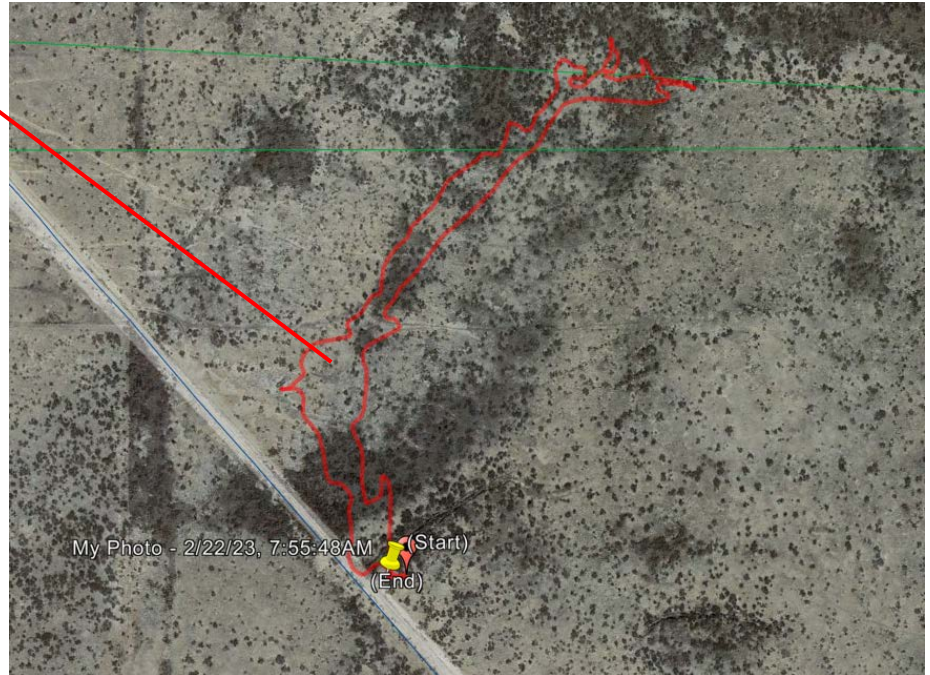
Surface Area, sqft	77077
Estimated Depth, in	2
Estimated Depth, ft	0.166667
Calculated Volume, cu. ft	12846.17
cu. ft to bbl	0.18
Calculated Volume, bbl	2312.31

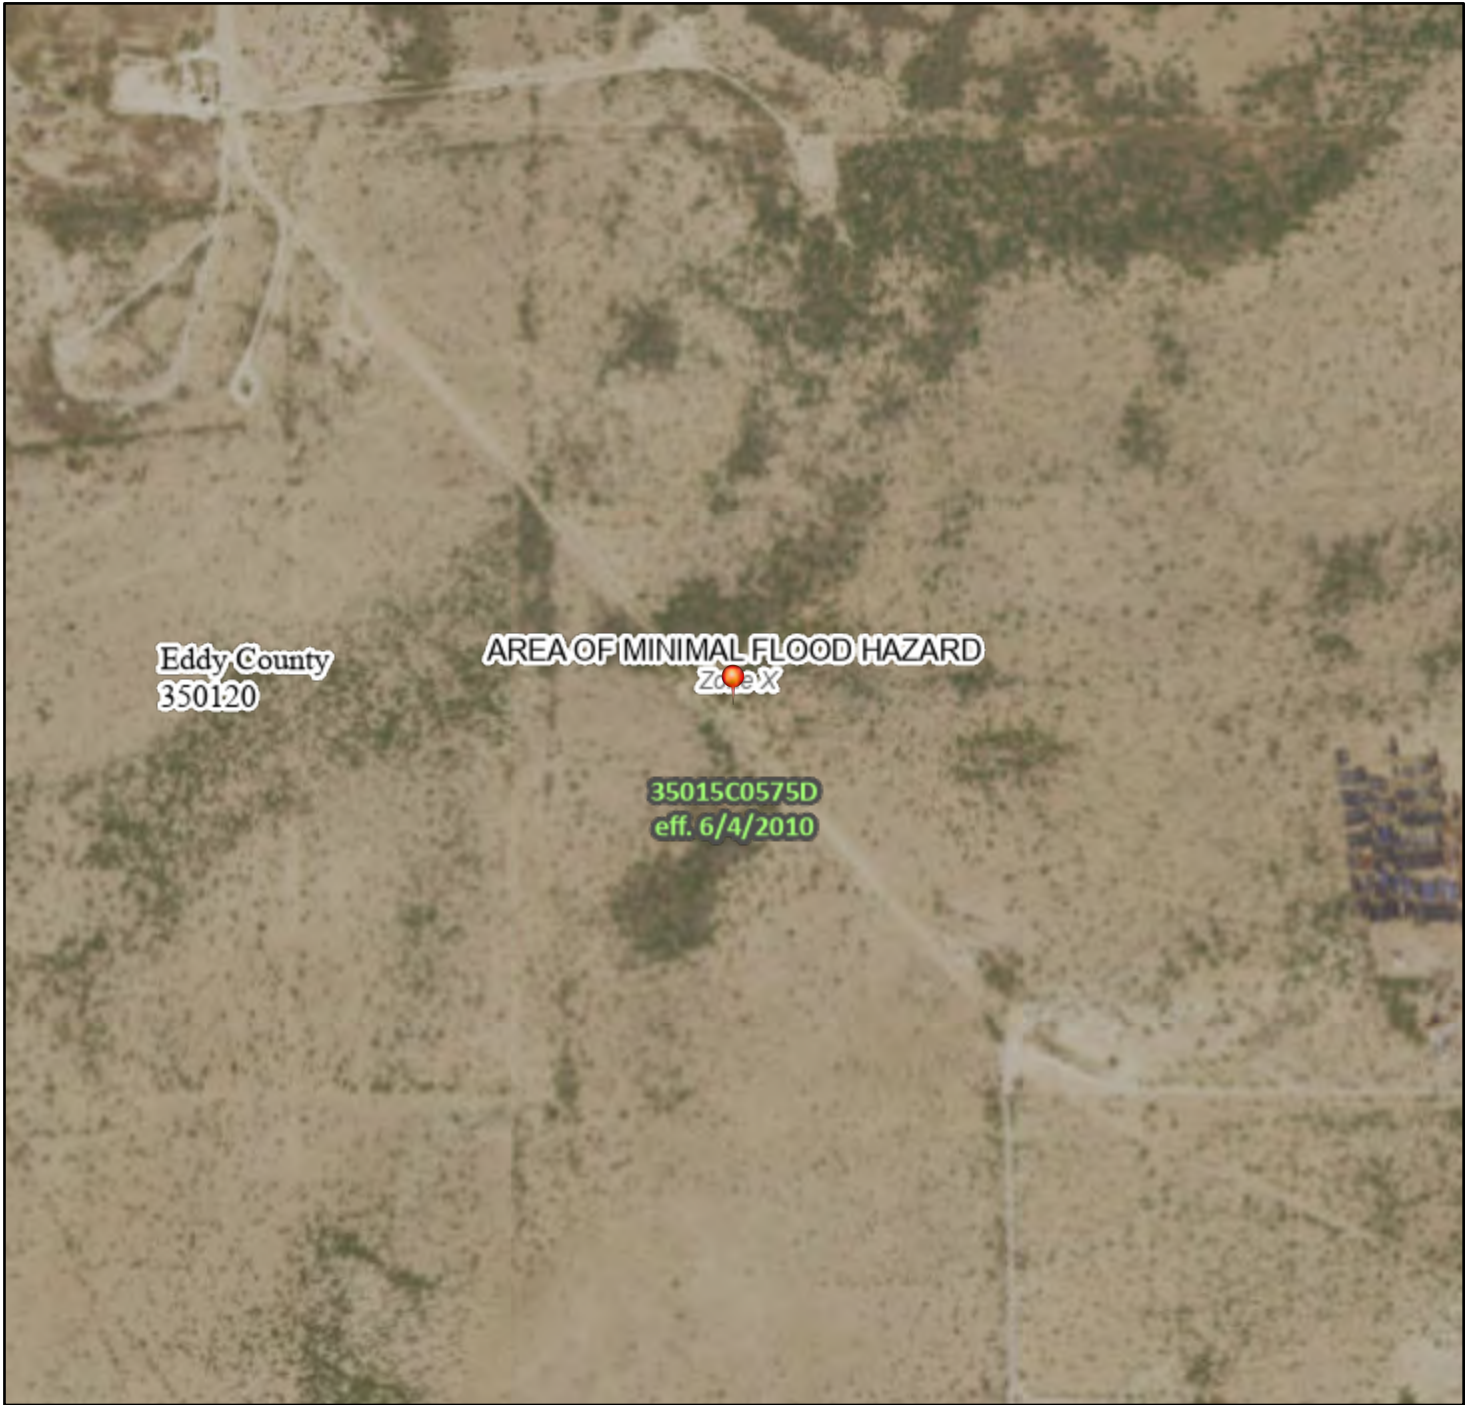
National Flood Hazard Layer FIRMette

The flood hazard information is derived directly from the authoritative NFHL web services provided by FEMA. This map was exported on 5/10/2023 at 9:38 AM and does not reflect changes or amendments subsequent to this date and time. The NFHL and effective information may change or become superseded by new data over time.

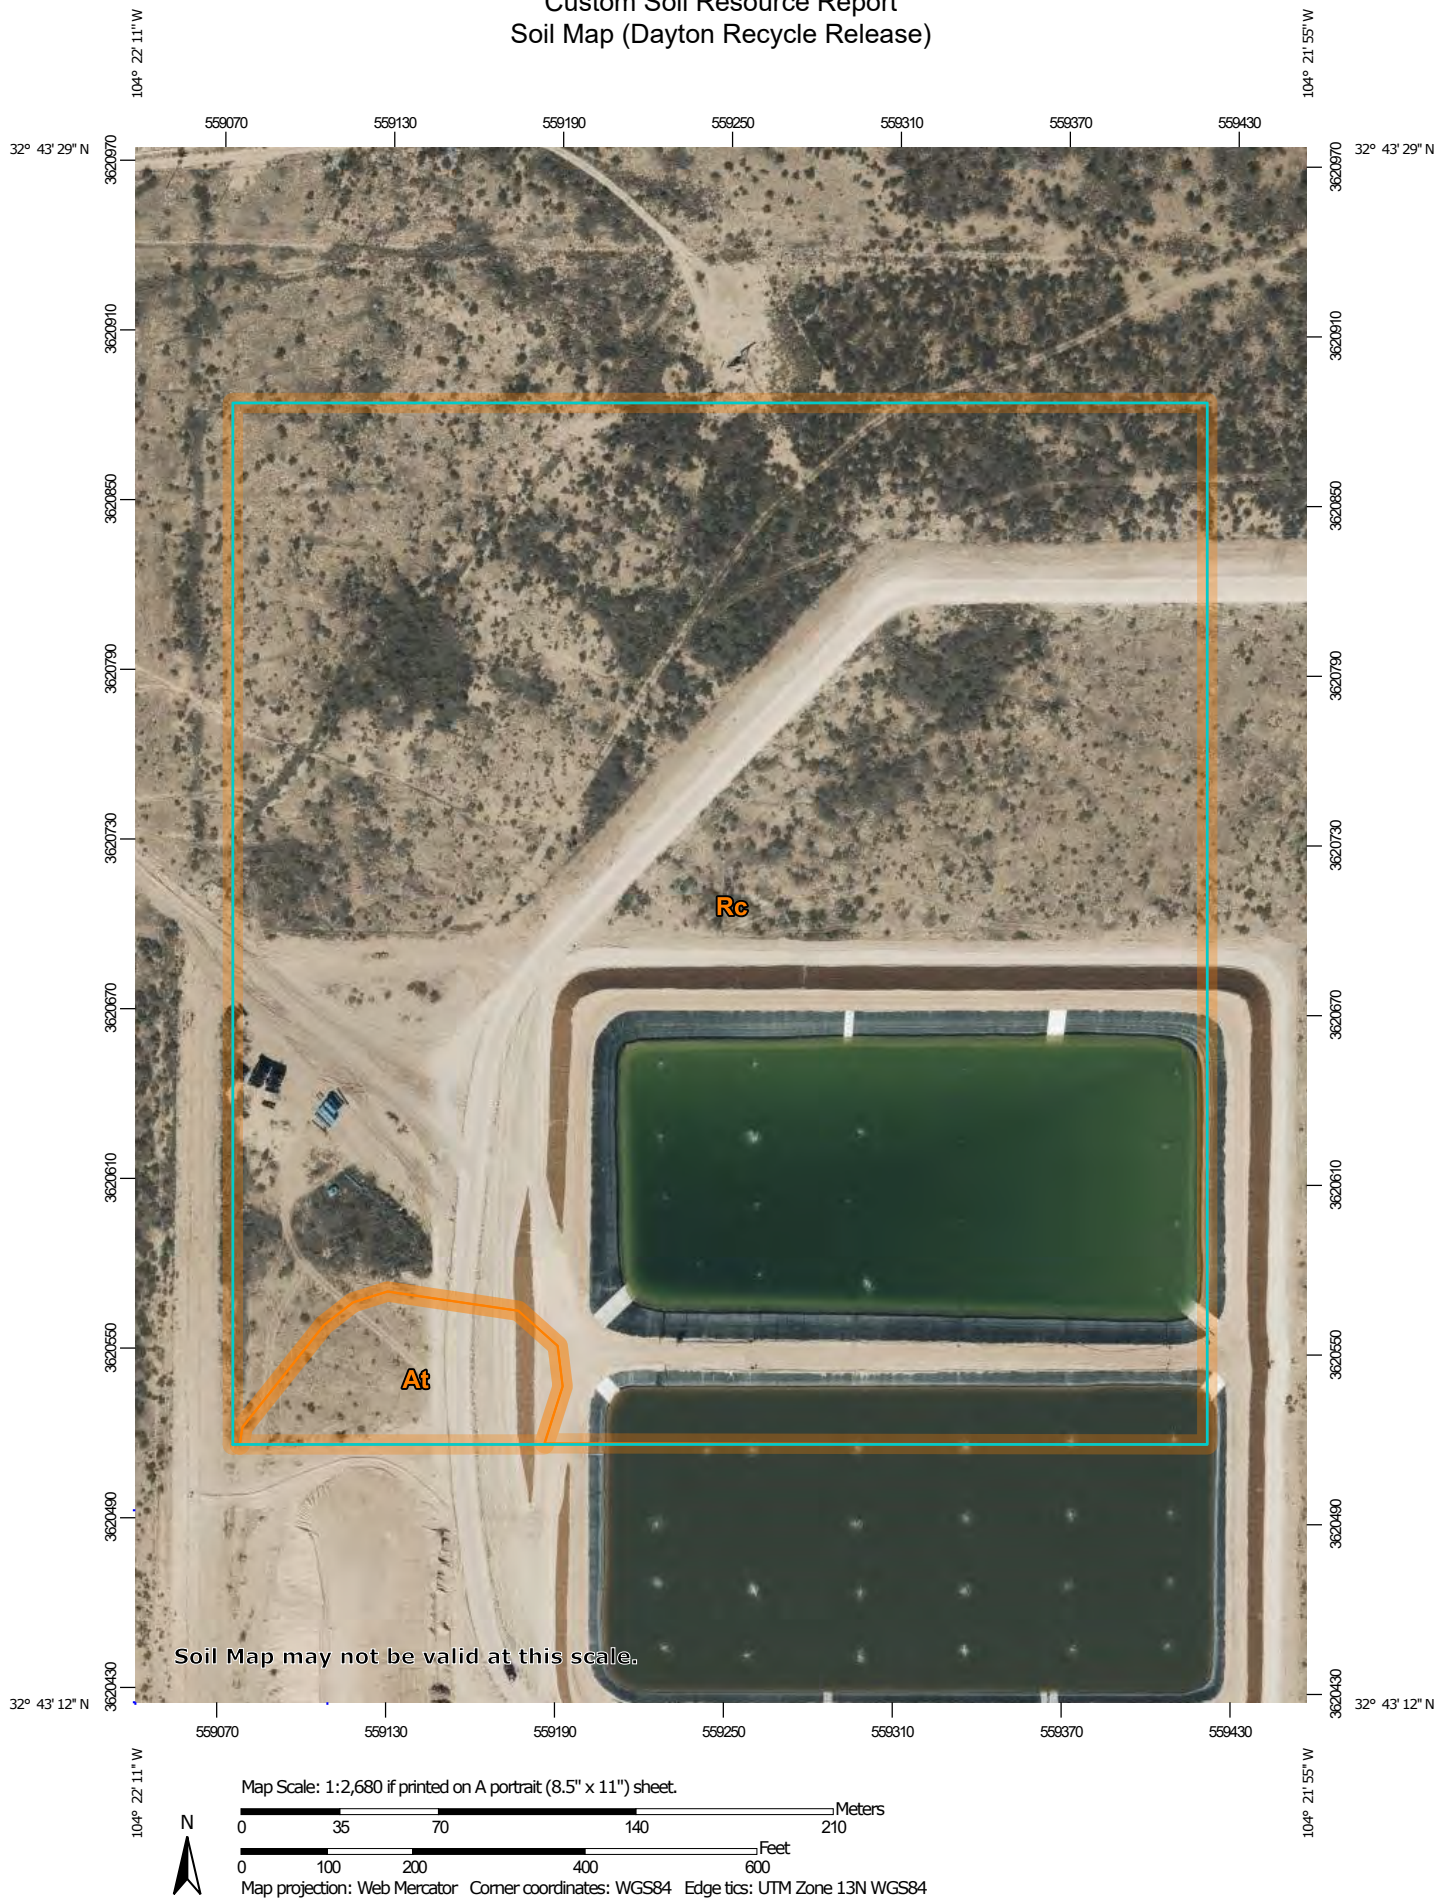
Custom Soil Resource Report
Soil Map (Dayton Recycle Release)

The soil map section includes the soil map for the defined area of interest, a list of soil map units on the map and extent of each map unit, and cartographic symbols displayed on the map. Also presented are various metadata about data used to produce the map, and a description of each soil map unit.
