Re: Site Assessment, Remediation, and Closure Report
Ragnar Fed Com 25H Battery
API No. N/A
GPS: Latitude 32.82710 Longitude -103.75330
UL "B", Sec. 22, T17S, R32E
Lea County, NM
NMOCD Ref. No. NAPP2325539044

Paragon Environmental, LLC (Paragon) has been contracted by Spur Energy Partners (Spur) to perform a spill assessment and write the closure report for the release site known as the Ragnar Fed Com 25H Battery (Ragnar). Contractor BB&I performed the remediation since they were the responsible party that caused the release. Details of the release are summarized below:

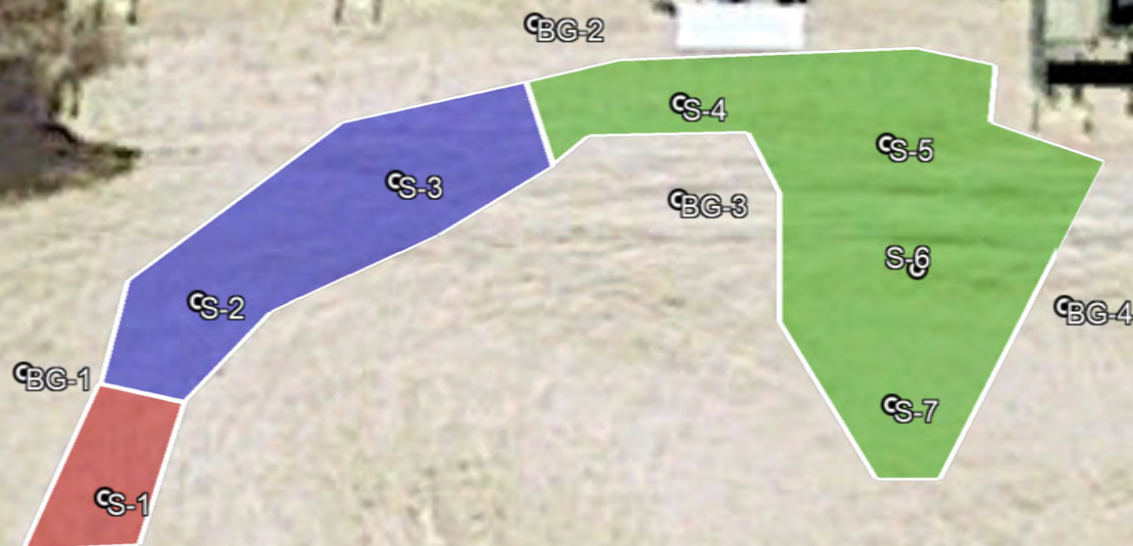
- 1' Spill Area
- 2' Spill Area
- 4' Spill Area
- Feature 1
- Ragnar Fed Com 25H Battery 32.8271,-103.7533

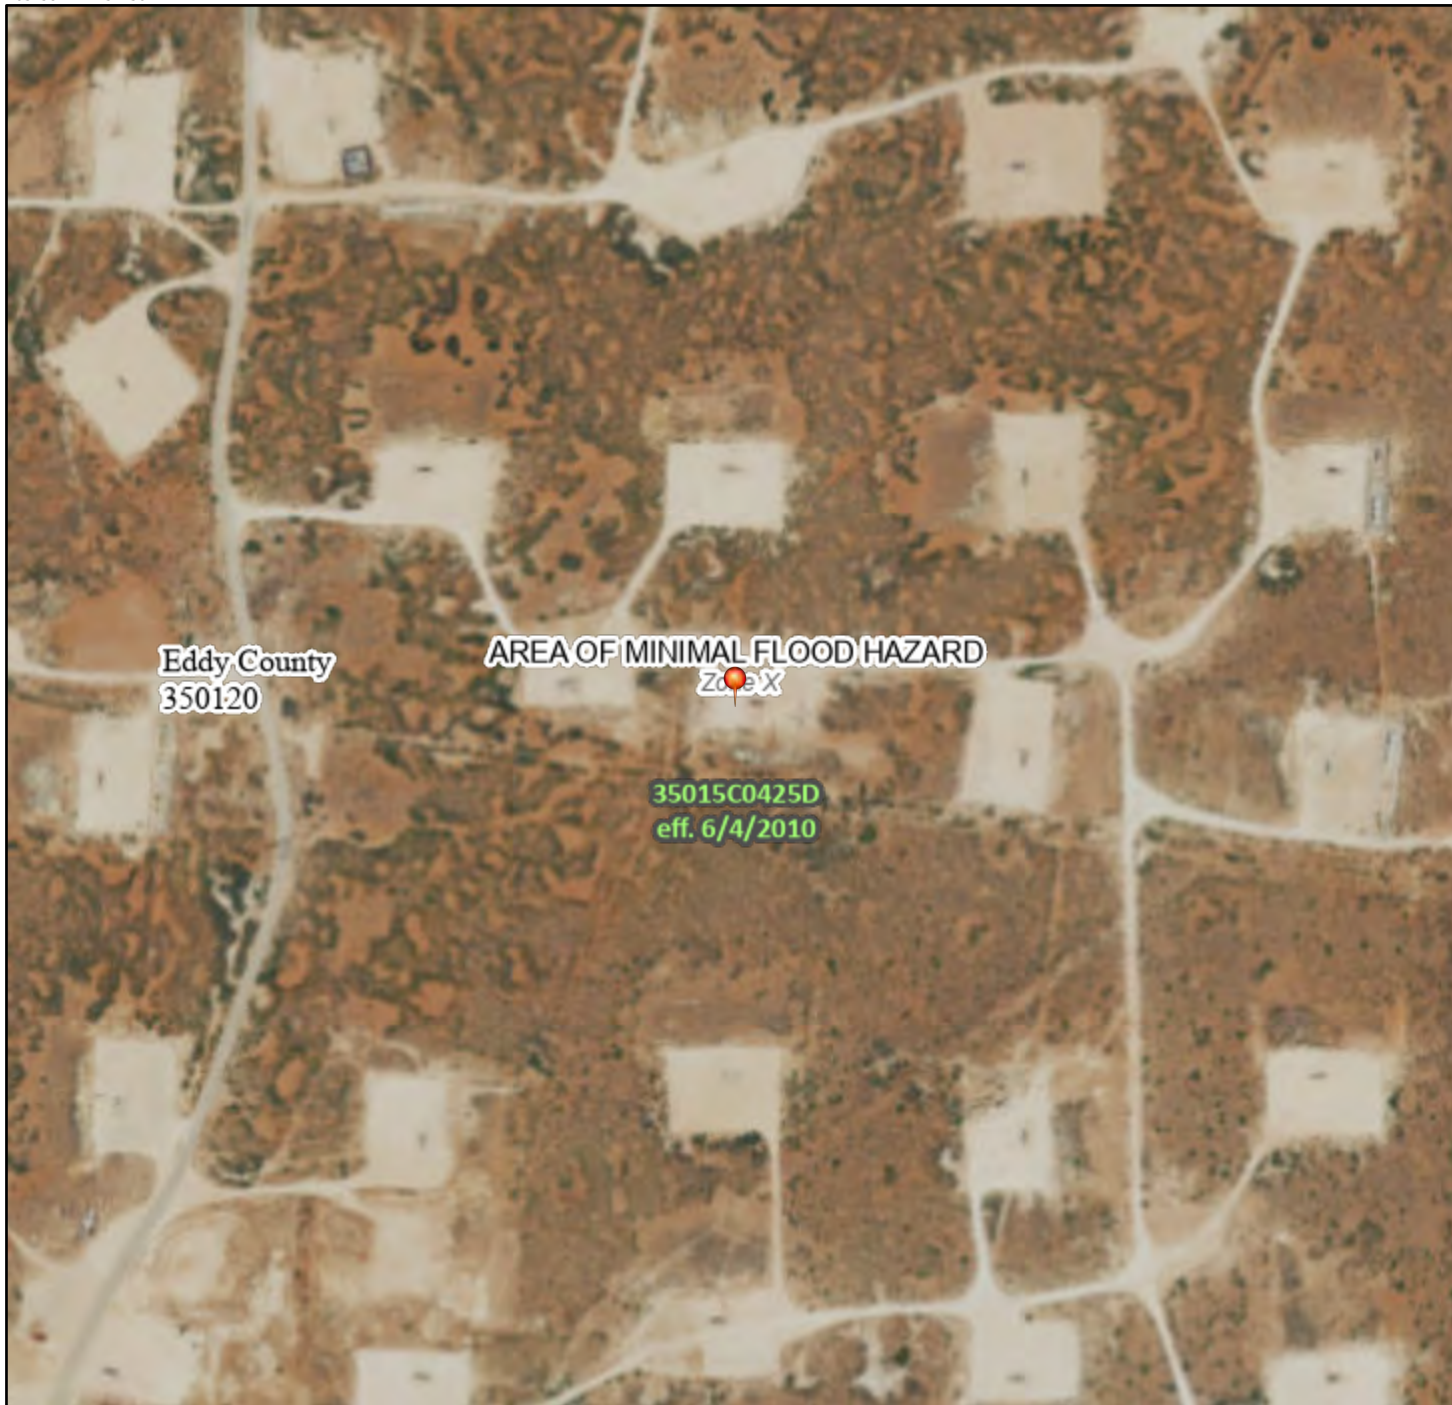
National Flood Hazard Layer FIRMette

SPECIAL FLOOD HAZARD AREAS		Without Base Flood Elevation (BFE) Zone A, V, A99
		With BFE or Depth Zone AE, AO, AH, VE, AR
		Regulatory Floodway
OTHER AREAS OF FLOOD HAZARD		0.2% Annual Chance Flood Hazard, Areas of 1% annual chance flood with average depth less than one foot or with drainage areas of less than one square mile Zone X
		Future Conditions 1% Annual Chance Flood Hazard Zone X
		Area with Reduced Flood Risk due to Levee. See Notes. Zone X
		Area with Flood Risk due to Levee Zone D
OTHER AREAS		NO SCREEN Area of Minimal Flood Hazard Zone X
		Effective LOMRs
		Area of Undetermined Flood Hazard Zone D
GENERAL STRUCTURES		Channel, Culvert, or Storm Sewer
		Levee, Dike, or Floodwall
OTHER FEATURES		20.2 Cross Sections with 1% Annual Chance Water Surface Elevation
