Incident ID	nAPP2315150992
District RP	
Facility ID	
Application ID

Based on laboratory analytical results and field activities conducted to date, Etech recommends Spur Energy Partners, LLC, provide copies of this *Remediation Summary and Soil Closure Request* to the appropriate agencies and request closure be granted to the Tin Horn 73 Main Line site.

**Figure 2**  
Aerial Proximity Map  
Spur Energy Partners, LLC  
Tin Horn 73 Main Line  
GPS: 32.82605, -103.87067  
Eddy County

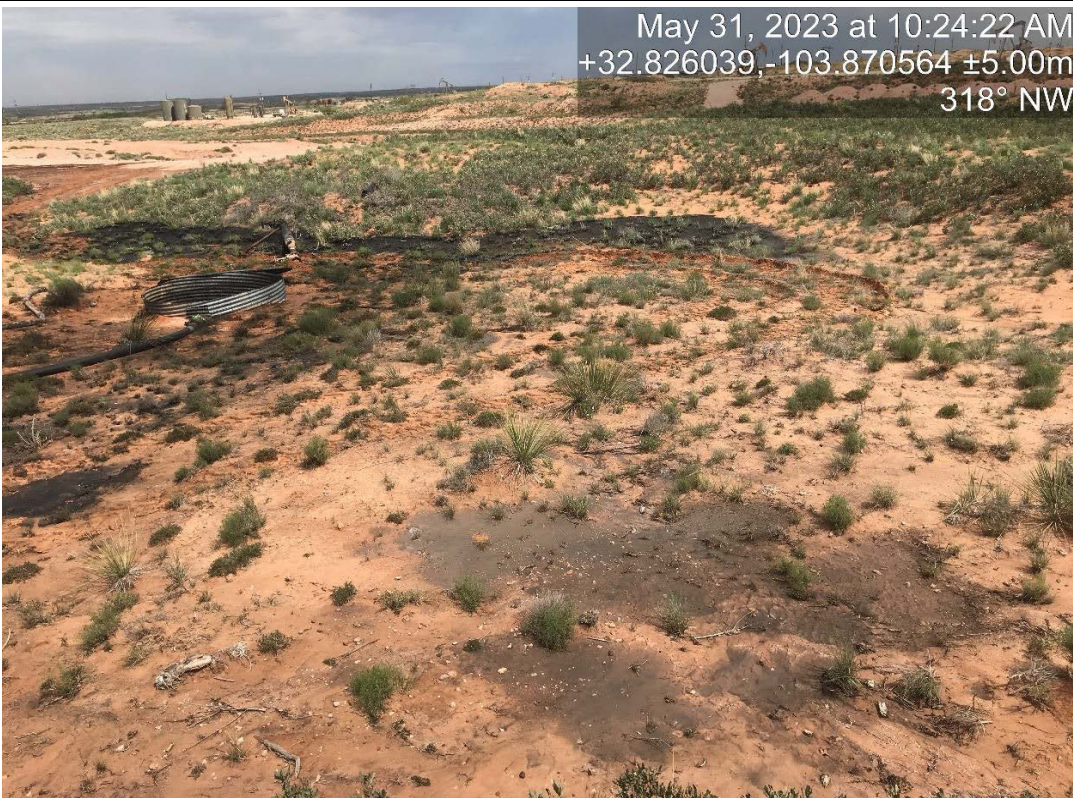
<b>Photo Number:</b> 1

<p>May 31, 2023 at 10:24:22 AM +32.826039,-103.870564 ±5.00m 318° NW</p>
<b>Photo Direction:</b> Northwest	
<b>Photo Description:</b>  View of release area.

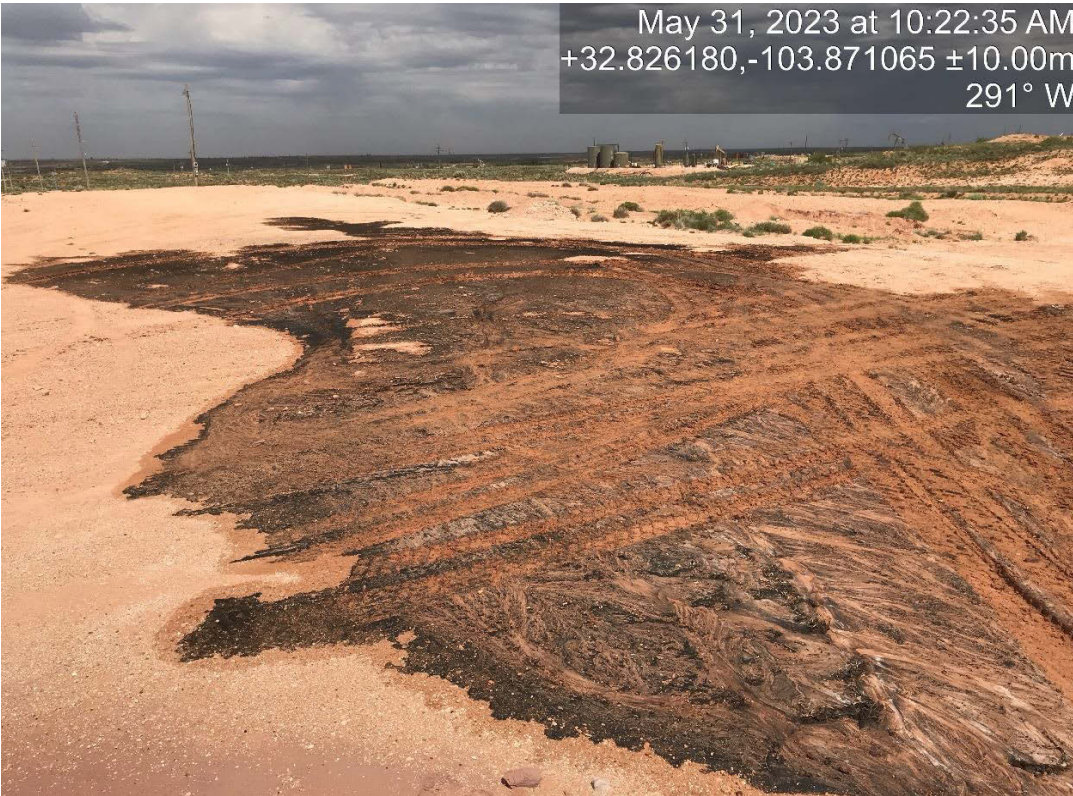
<b>Photo Number:</b> 2

<p>May 31, 2023 at 10:22:35 AM +32.826180,-103.871065 ±10.00m 291° W</p>
<b>Photo Direction:</b> West	
<b>Photo Description:</b>  View of release area.

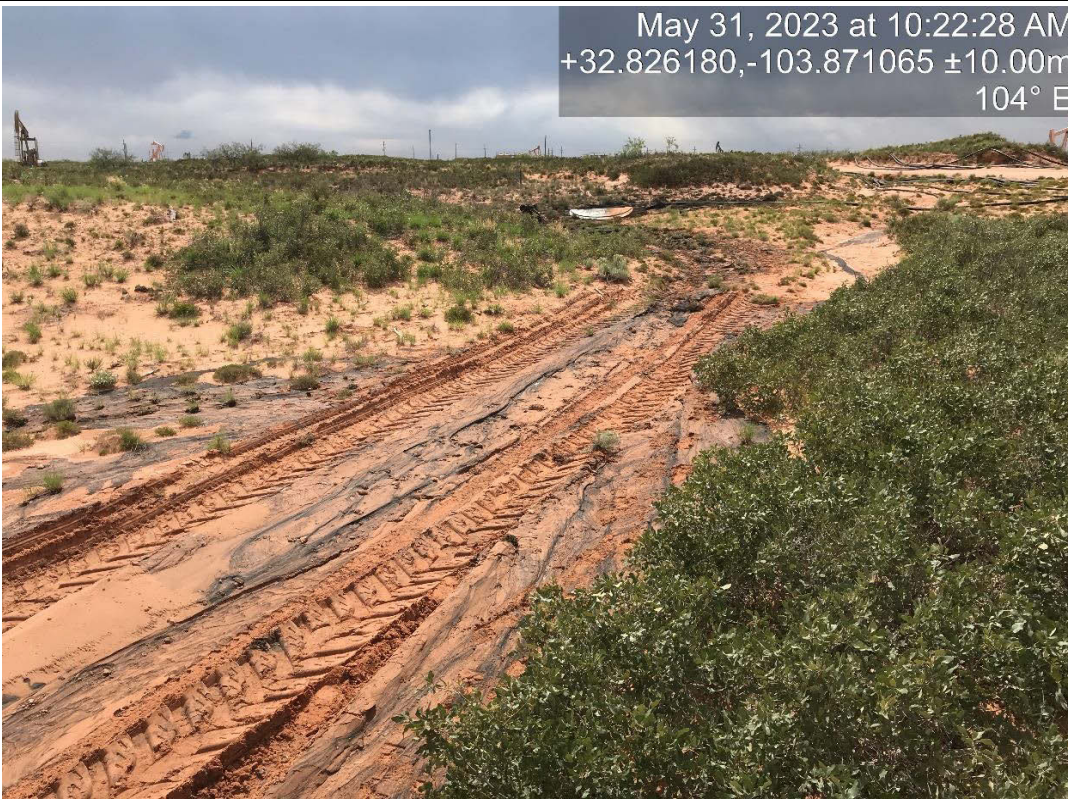
<b>Photo Number:</b> 3

<p>May 31, 2023 at 10:22:28 AM +32.826180,-103.871065 ±10.00m 104° E</p>
<b>Photo Direction:</b> East	
<b>Photo Description:</b>  View of release area.

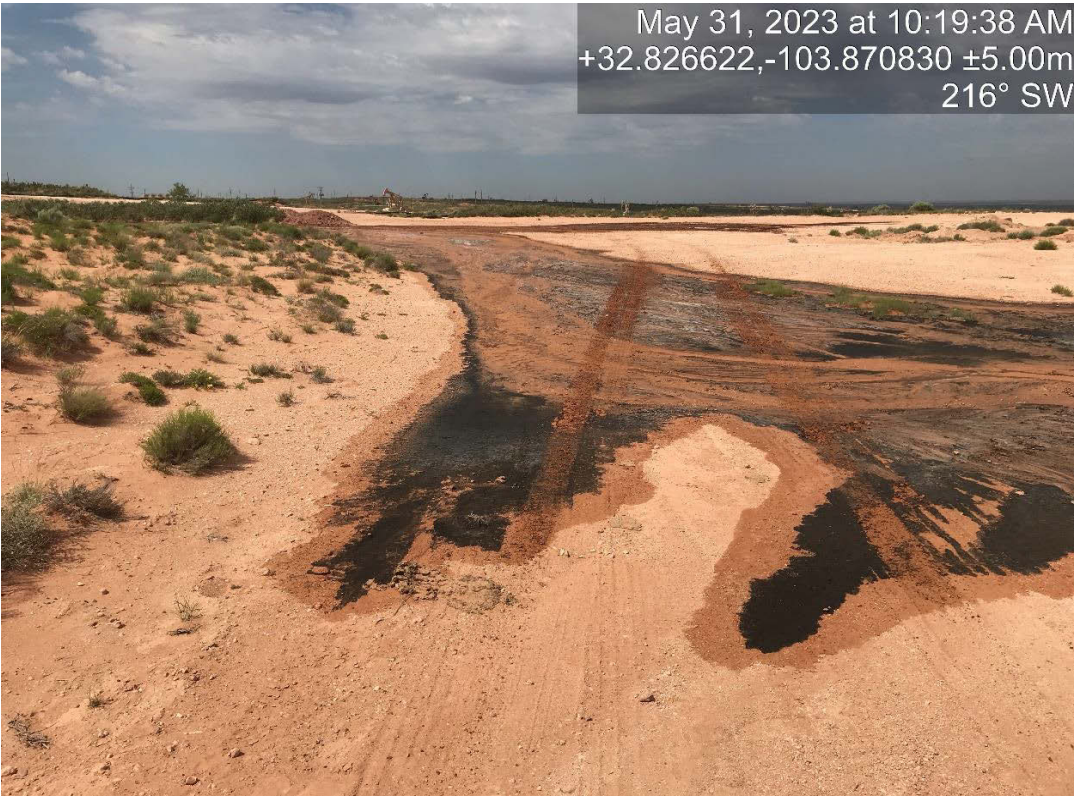
<b>Photo Number:</b> 4

<p>May 31, 2023 at 10:19:38 AM +32.826622,-103.870830 ±5.00m 216° SW</p>
<b>Photo Direction:</b> Southwest	
<b>Photo Description:</b>  View of release area.

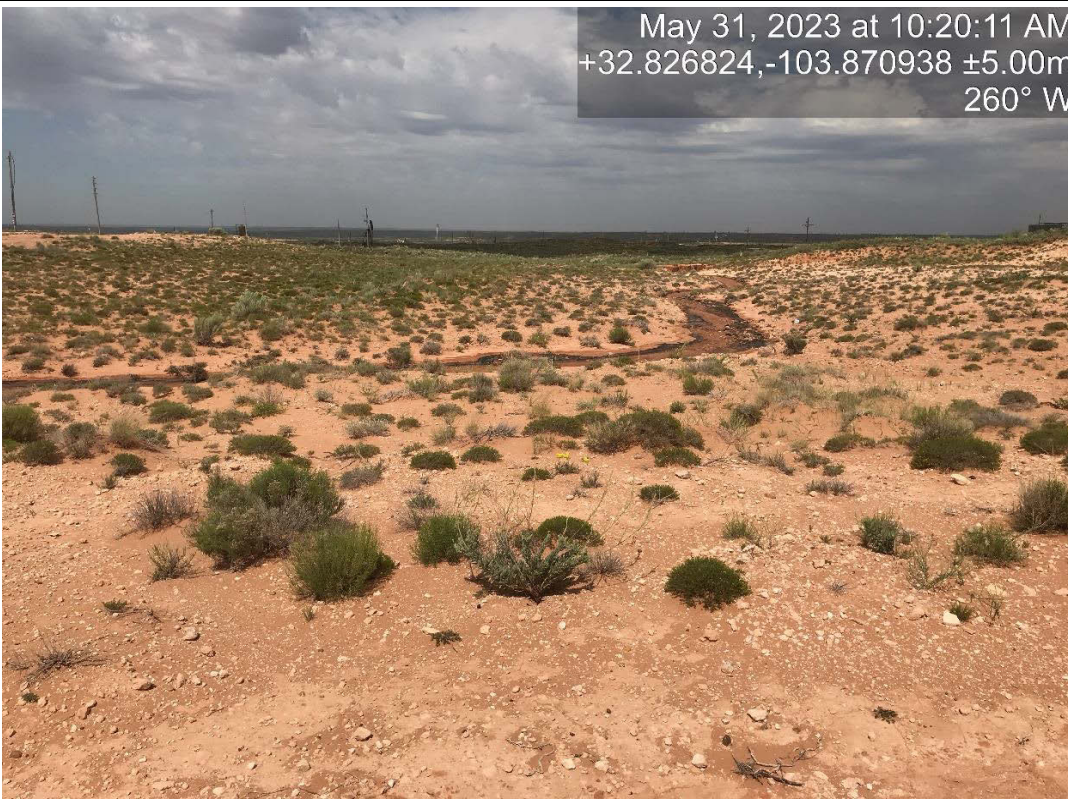
<b>Photo Number:</b> 5

<b>Photo Direction:</b> West	
<b>Photo Description:</b>  View of release area.

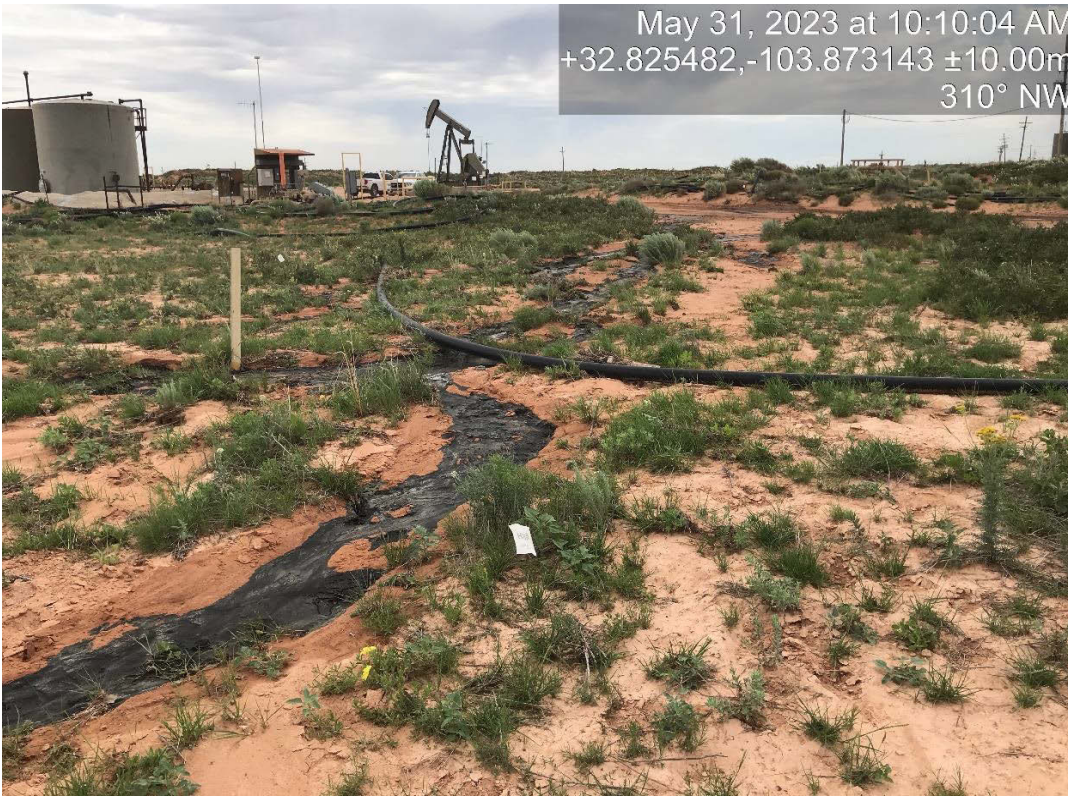
<b>Photo Number:</b> 6

<b>Photo Direction:</b> Northwest	
<b>Photo Description:</b>  View of release area.

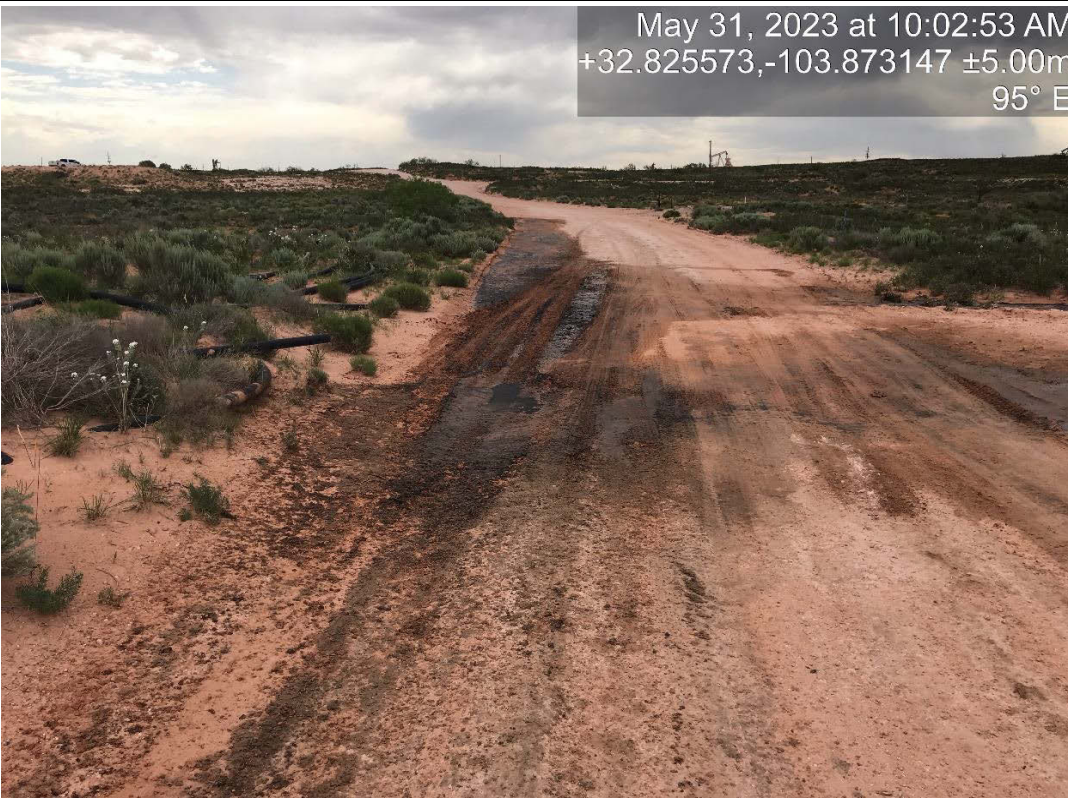
<b>Photo Number:</b> 7	<div>May 31, 2023 at 10:02:53 AM +32.825573,-103.873147 ±5.00m 95° E</div>

<b>Photo Direction:</b> East	
<b>Photo Description:</b>  View of release area.

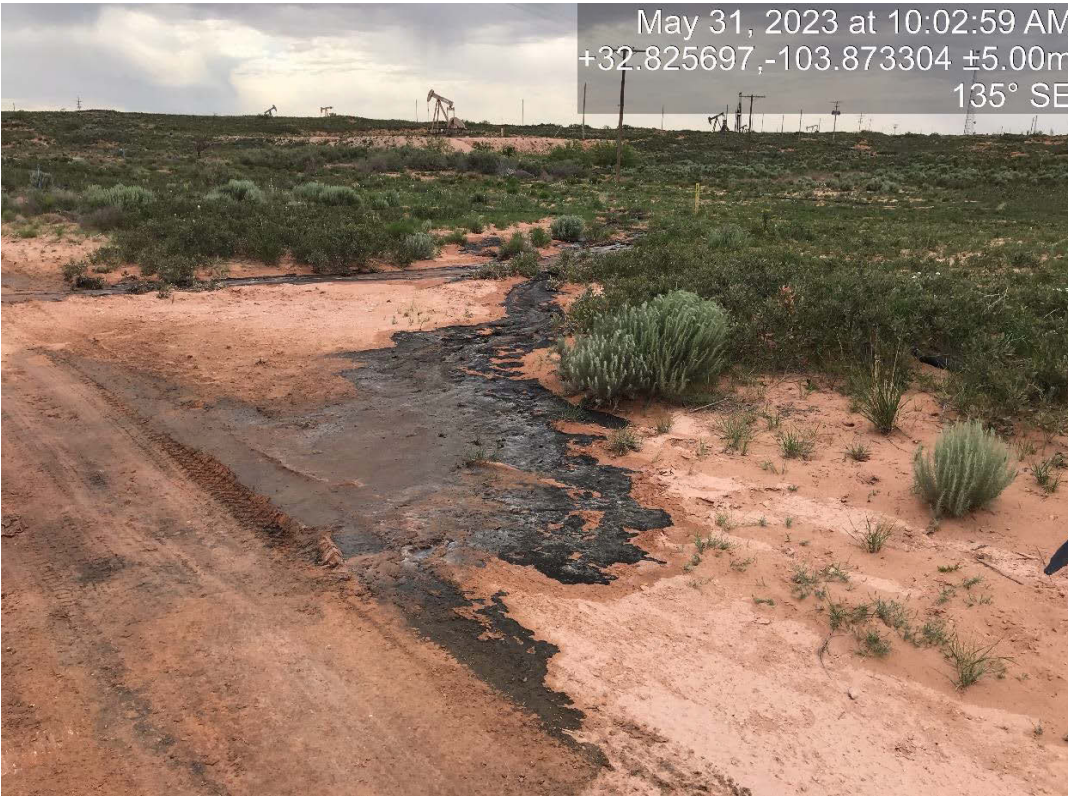
<b>Photo Number:</b> 8	<div>May 31, 2023 at 10:02:59 AM +32.825697,-103.873304 ±5.00m 135° SE</div>

<b>Photo Direction:</b> Southeast	
<b>Photo Description:</b>  View of release area.

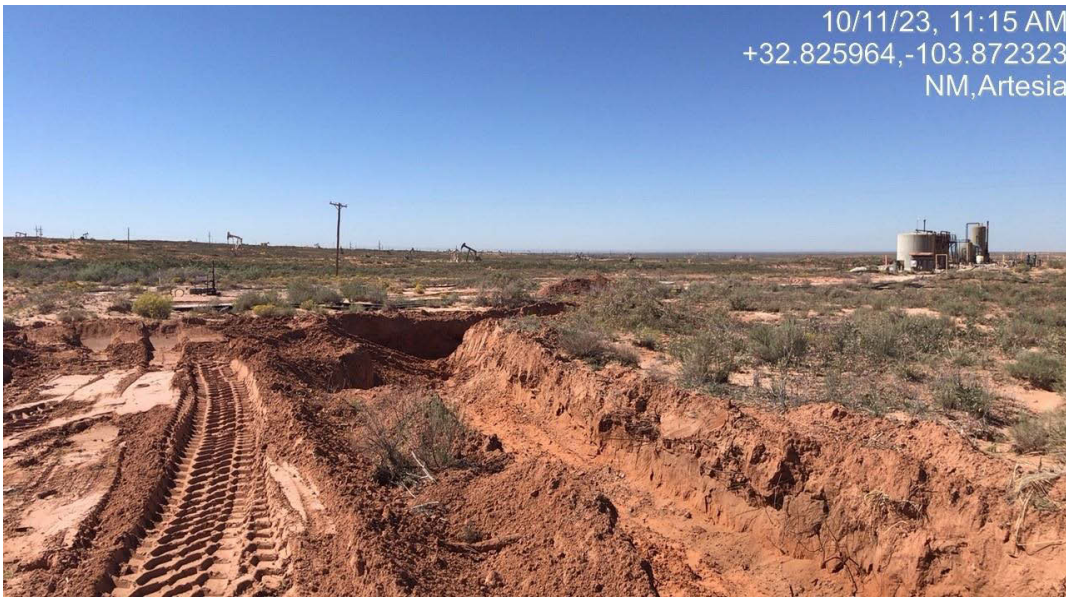
<b>Photo Number:</b> 10	<div>10/11/23, 11:15 AM +32.825964,-103.872323 NM,Artesia</div>

<b>Photo Direction:</b> West	
<b>Photo Description:</b>  View of open excavation.

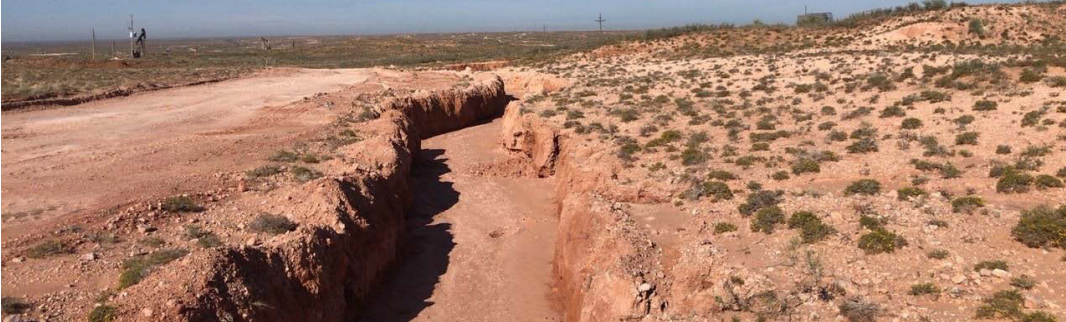
<b>Photo Number:</b> 11	<div>10/10/23, 9:32 AM +32.826848,-103.871062 NM,Artesia</div>

<b>Photo Direction:</b> West	
<b>Photo Description:</b>  View of open excavation.

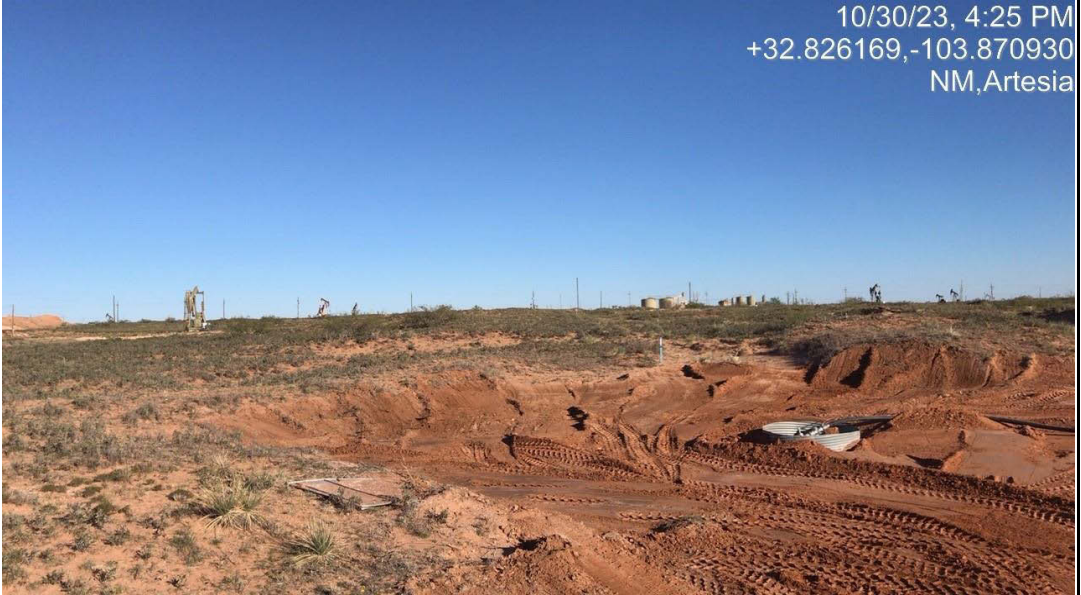
<b>Photo Number:</b> 18	<div>10/30/23, 4:25 PM +32.826169,-103.870930 NM,Artesia</div>

<b>Photo Direction:</b> East	
<b>Photo Description:</b>  View of remediated area after backfill and grading.

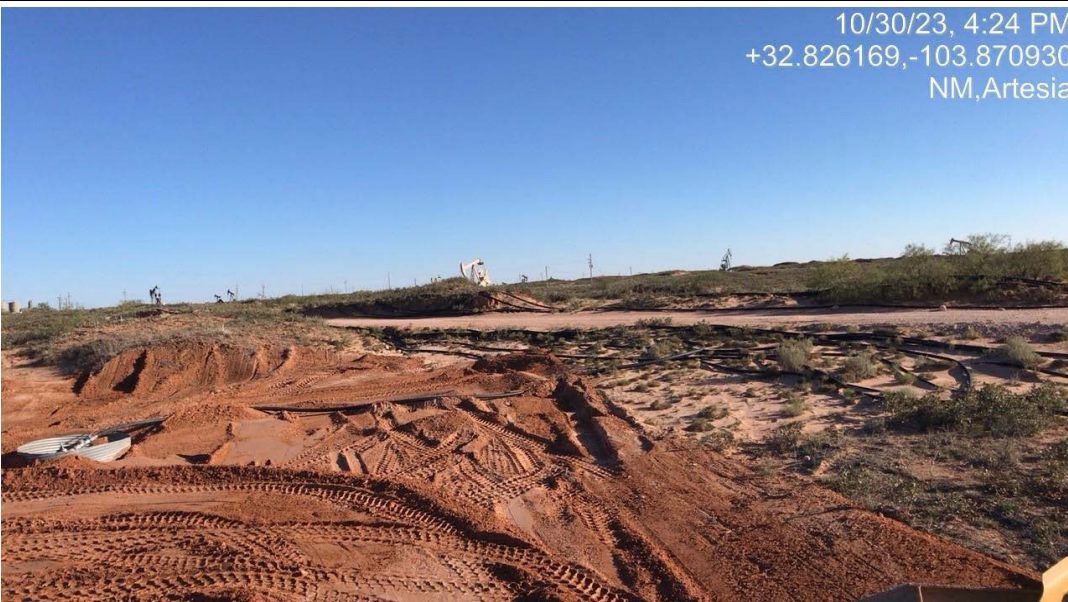
<b>Photo Number:</b> 19	<div>10/30/23, 4:24 PM +32.826169,-103.870930 NM,Artesia</div>

<b>Photo Direction:</b> East	
<b>Photo Description:</b>  View of remediated area after backfill and grading.

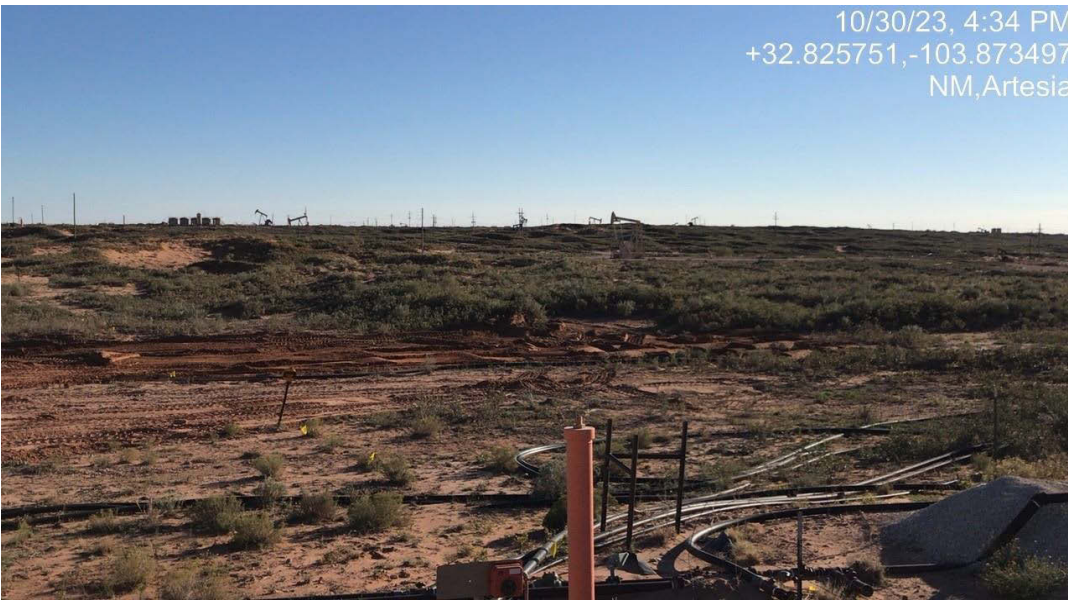
<b>Photo Number:</b> 20	<div>10/30/23, 4:34 PM +32.825751,-103.873497 NM,Artesia</div>

<b>Photo Direction:</b> East	
<b>Photo Description:</b>  View of remediated area after backfill and grading.

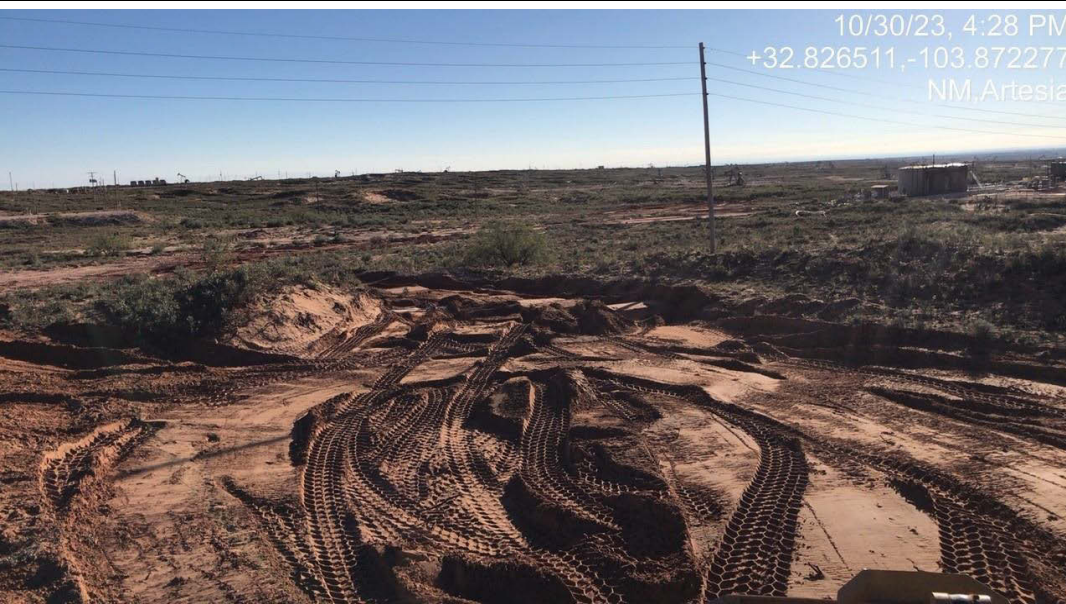
<b>Photo Number:</b> 21	<div>10/30/23, 4:28 PM +32.826511,-103.872277 NM,Artesia</div>

<b>Photo Direction:</b> North	
<b>Photo Description:</b>  View of remediated area after backfill and grading.

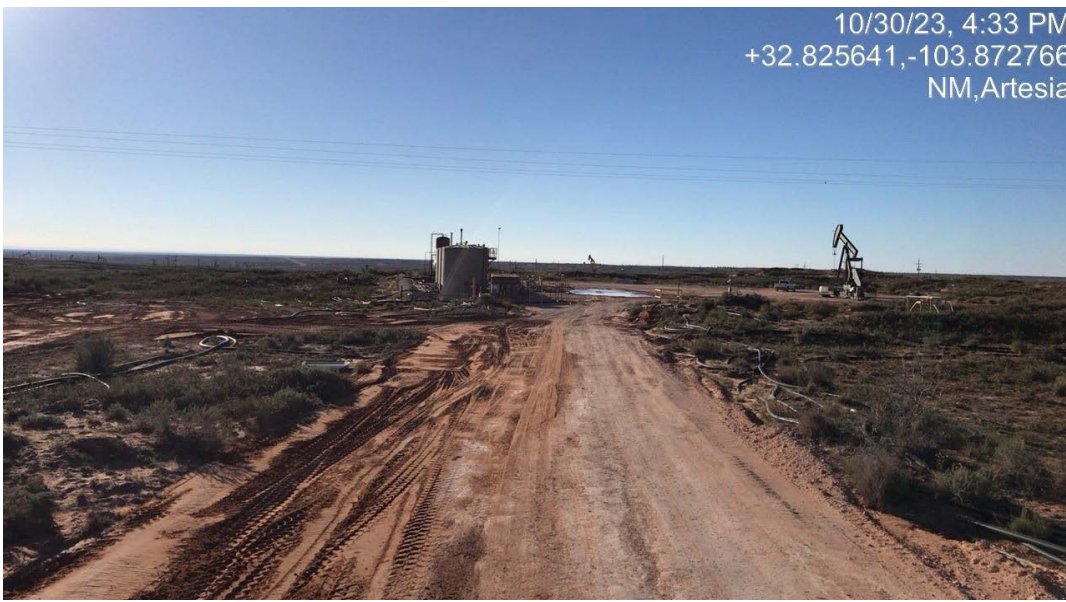
<b>Photo Number:</b> 22	<div>10/30/23, 4:33 PM +32.825641,-103.872766 NM,Artesia</div>

<b>Photo Direction:</b> West	
<b>Photo Description:</b>  View of remediated area after backfill and grading.

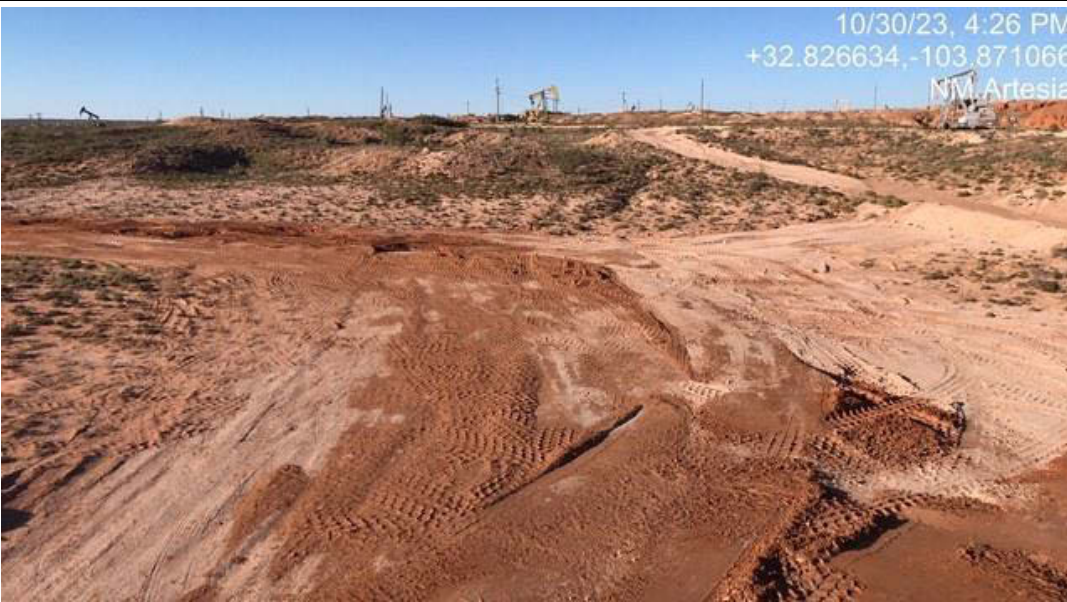
<b>Photo Number:</b> 23

<p>10/30/23, 4:26 PM +32.826634,-103.871066 NM, Artesia</p>
<b>Photo Direction:</b> North	
<b>Photo Description:</b>  View of remediated area after backfill and grading.

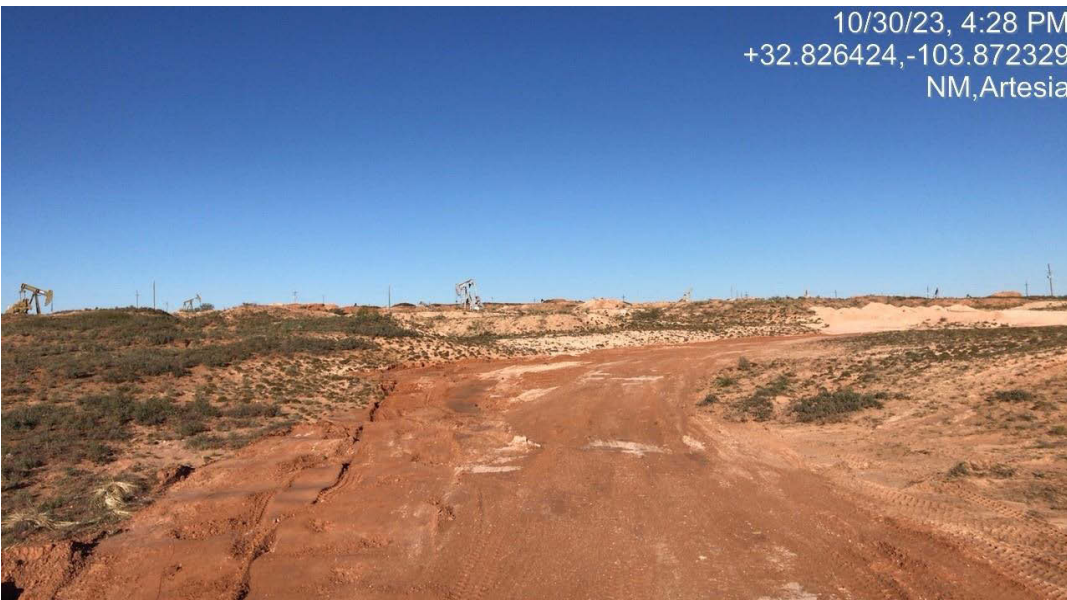
<b>Photo Number:</b> 24

<p>10/30/23, 4:28 PM +32.826424,-103.872329 NM, Artesia</p>
<b>Photo Direction:</b> East	
<b>Photo Description:</b>  View of remediated area after backfill and grading.
