**Re: Site Assessment, Remediation, and Closure Report
Dexter/Sinclair Parke Tank Battery
API No. 30-015-30325
GPS: Latitude 32.81915 Longitude -103.95877
UL "J", Sec. 22, T17S, R30E
Eddy County, NM
NMOCD Ref. No. NAPP2322846505**

Dexter/Sinclair Parke Tank Battery

Spur Energy
30-015-30325
nAPP2322846505
Eddy County, NM
Site Map

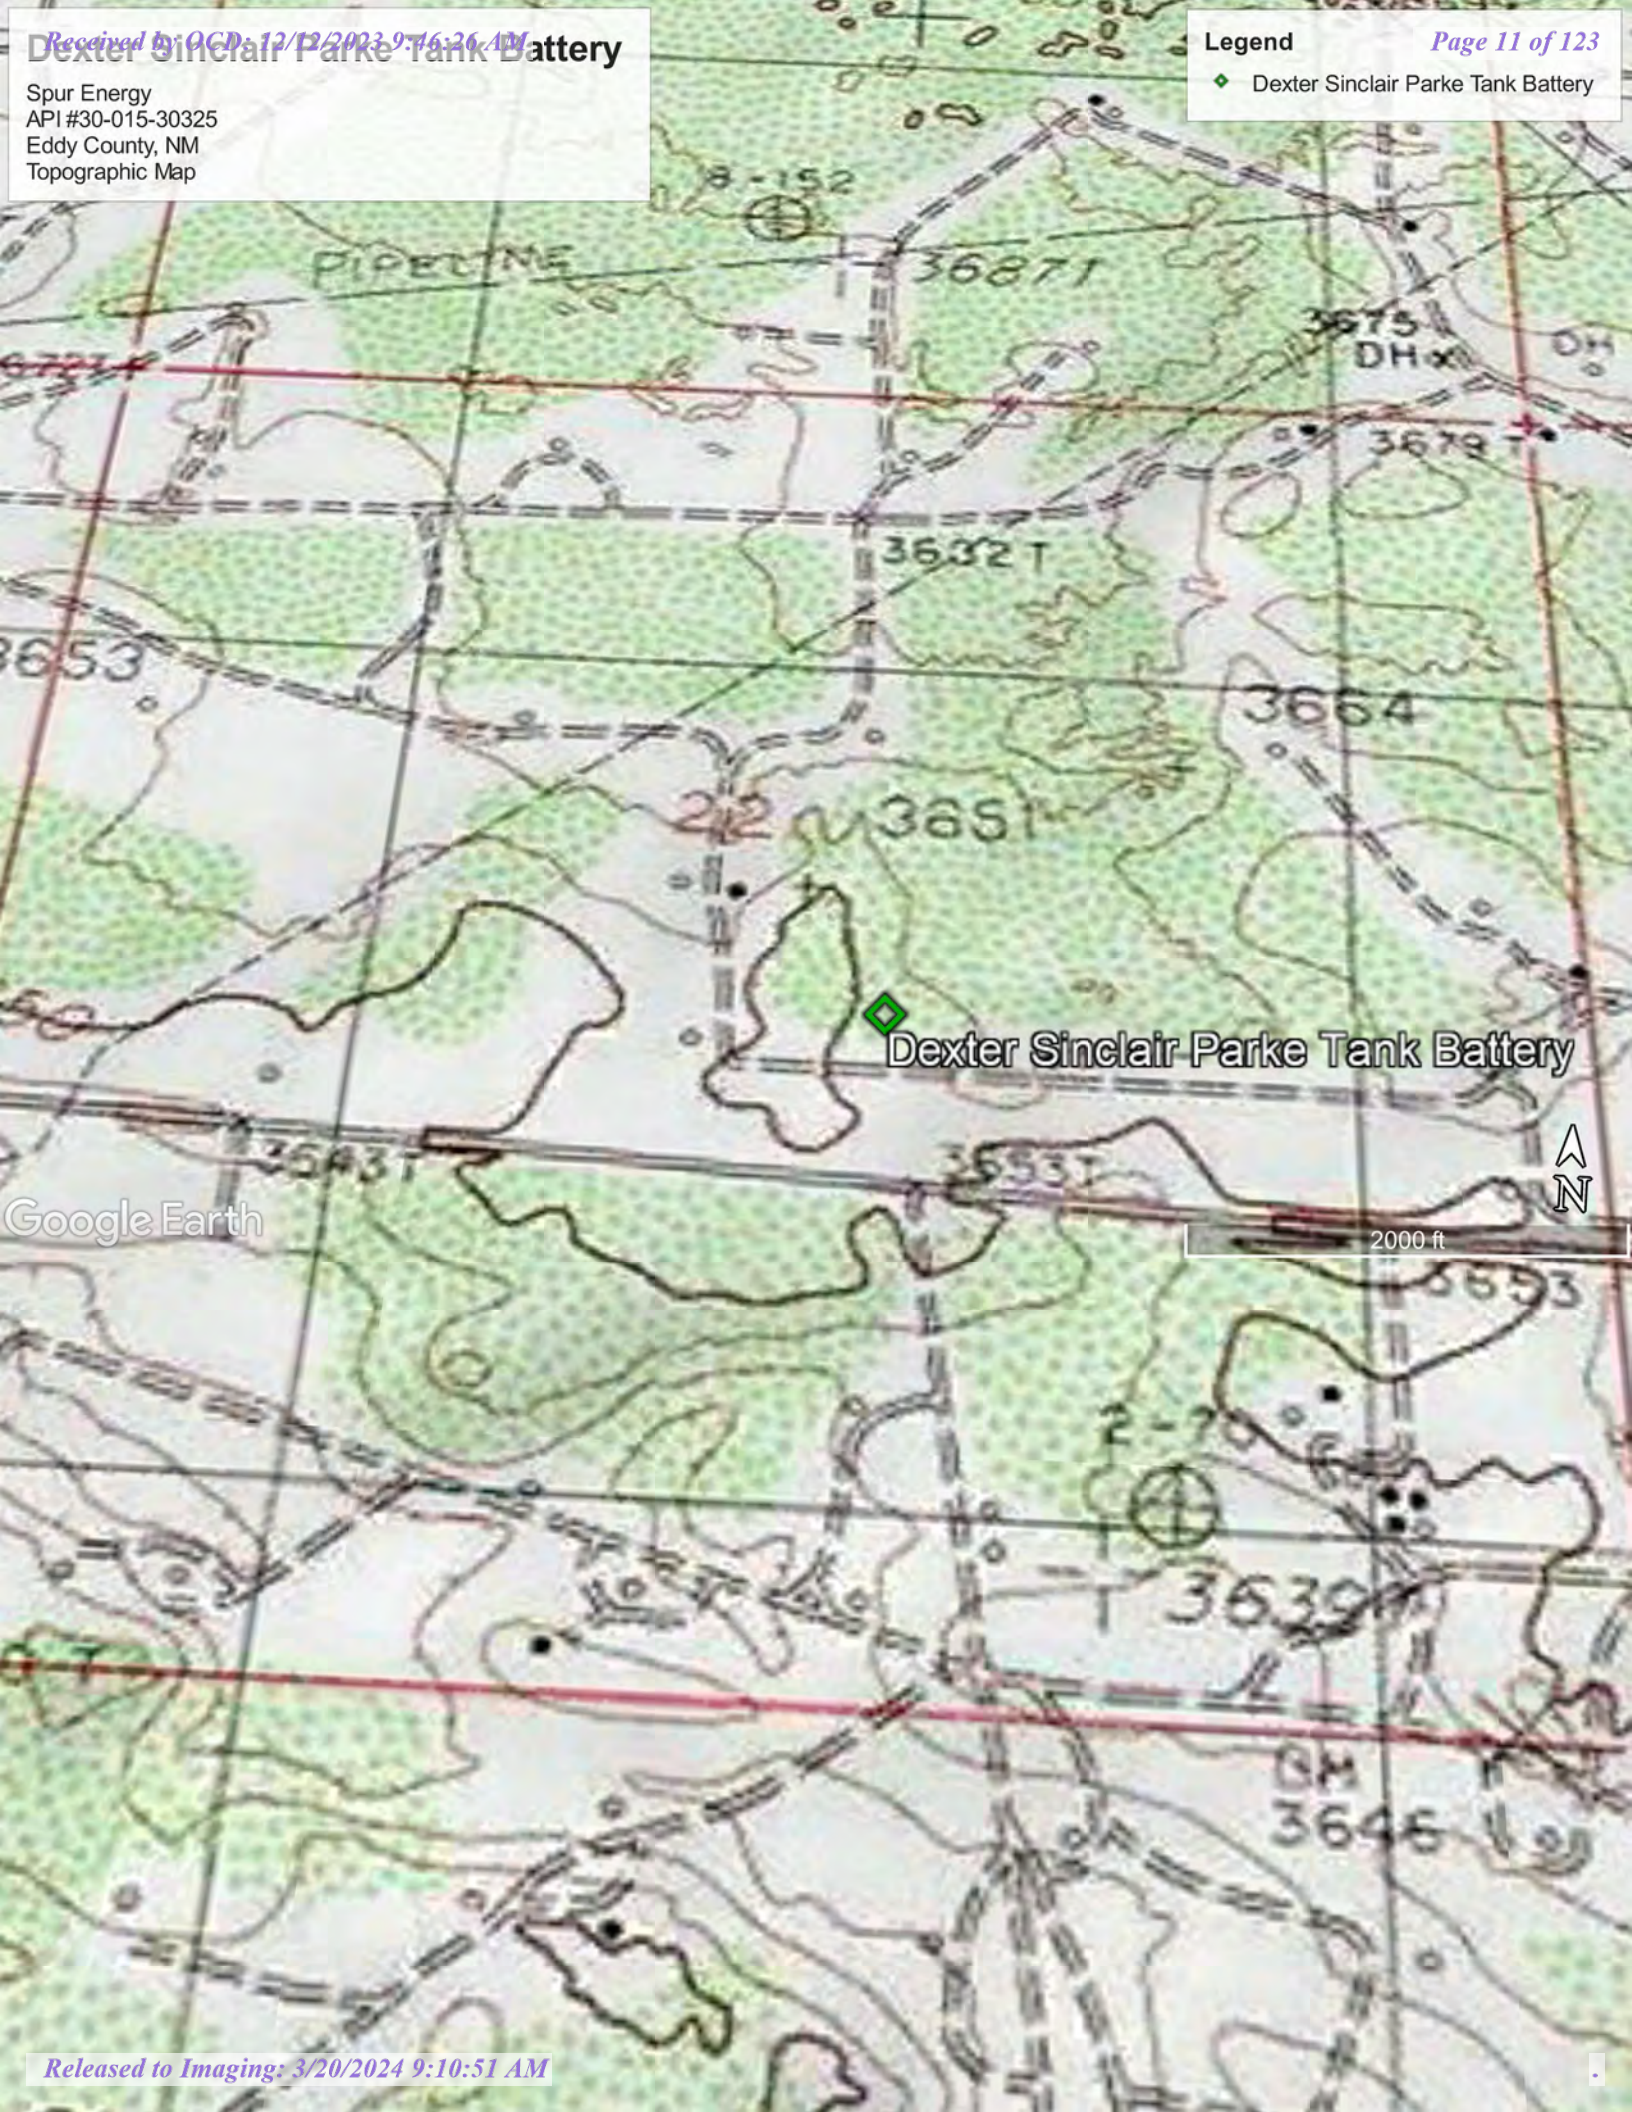
Spur Energy
API #30-015-30325
Eddy County, NM
Topographic Map

Reference Figure 2 for a Topographic map.

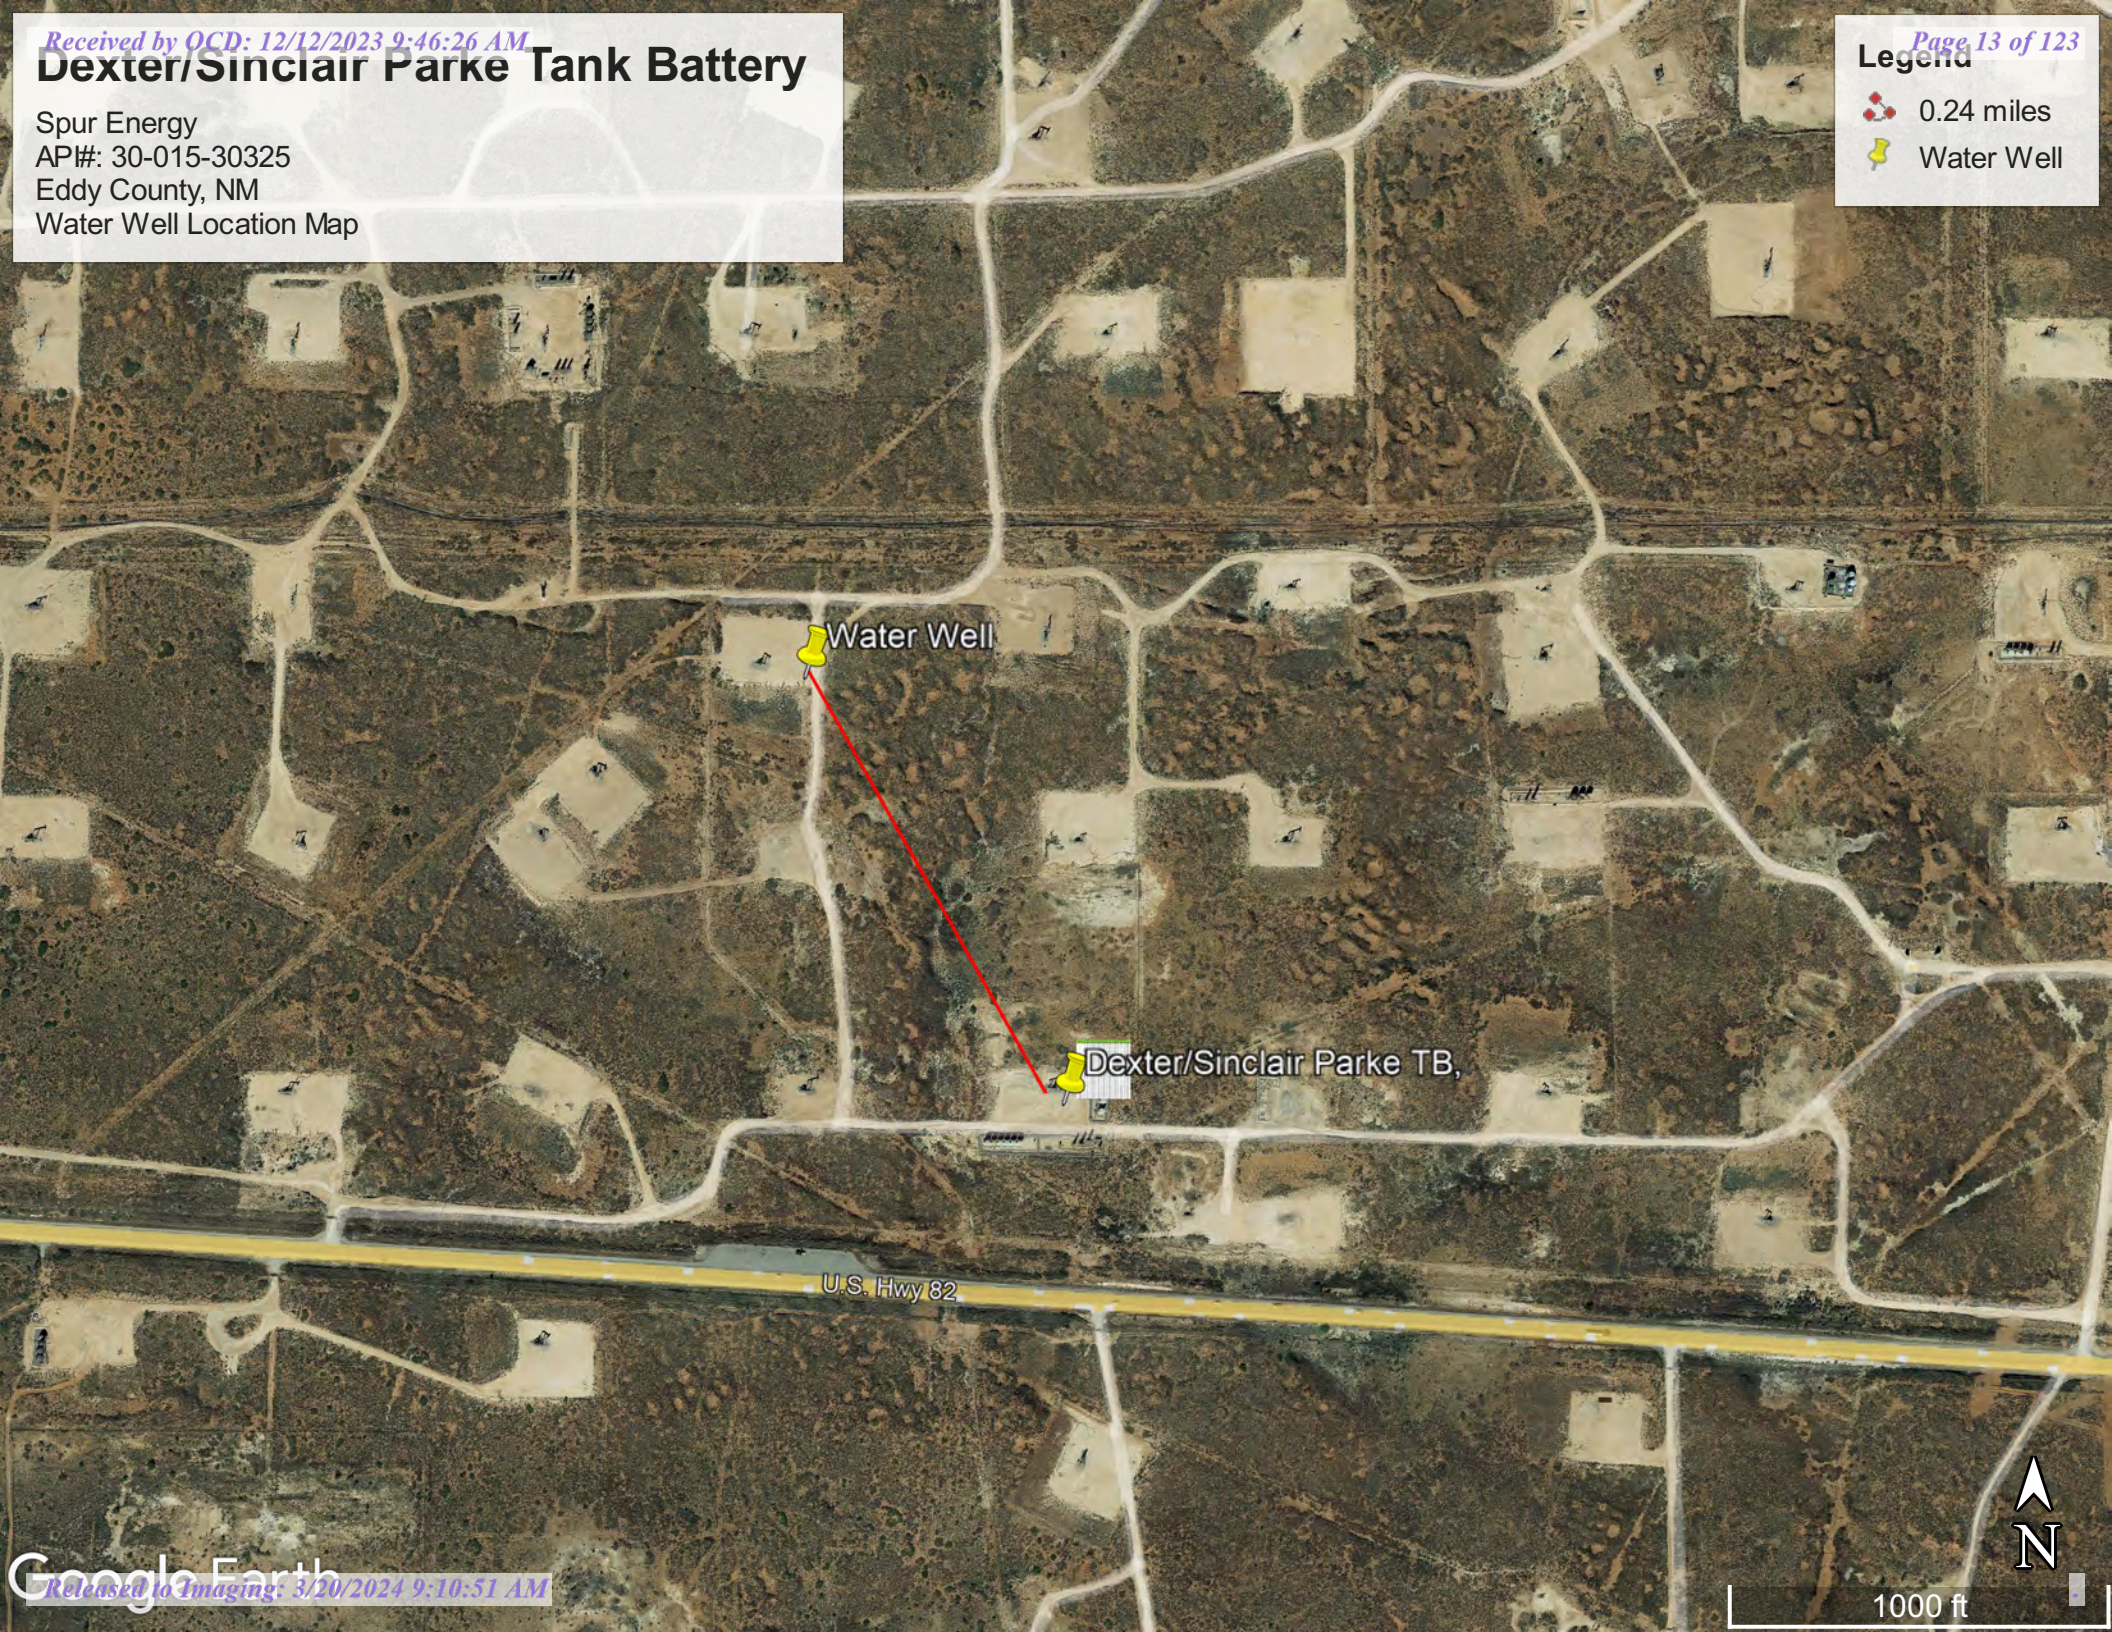
Spur Energy
API#: 30-015-30325
Eddy County, NM
Water Well Location Map

As there was insufficient groundwater data available, Spur Energy engaged a third-party vendor to drill a 101-foot water well positioned roughly 0.24 miles away from the Dexter. For a visual representation of the newly drilled water well's location along with a well log, please refer to Figure 4, included in the site map.

- 0.24 miles
- Water Well

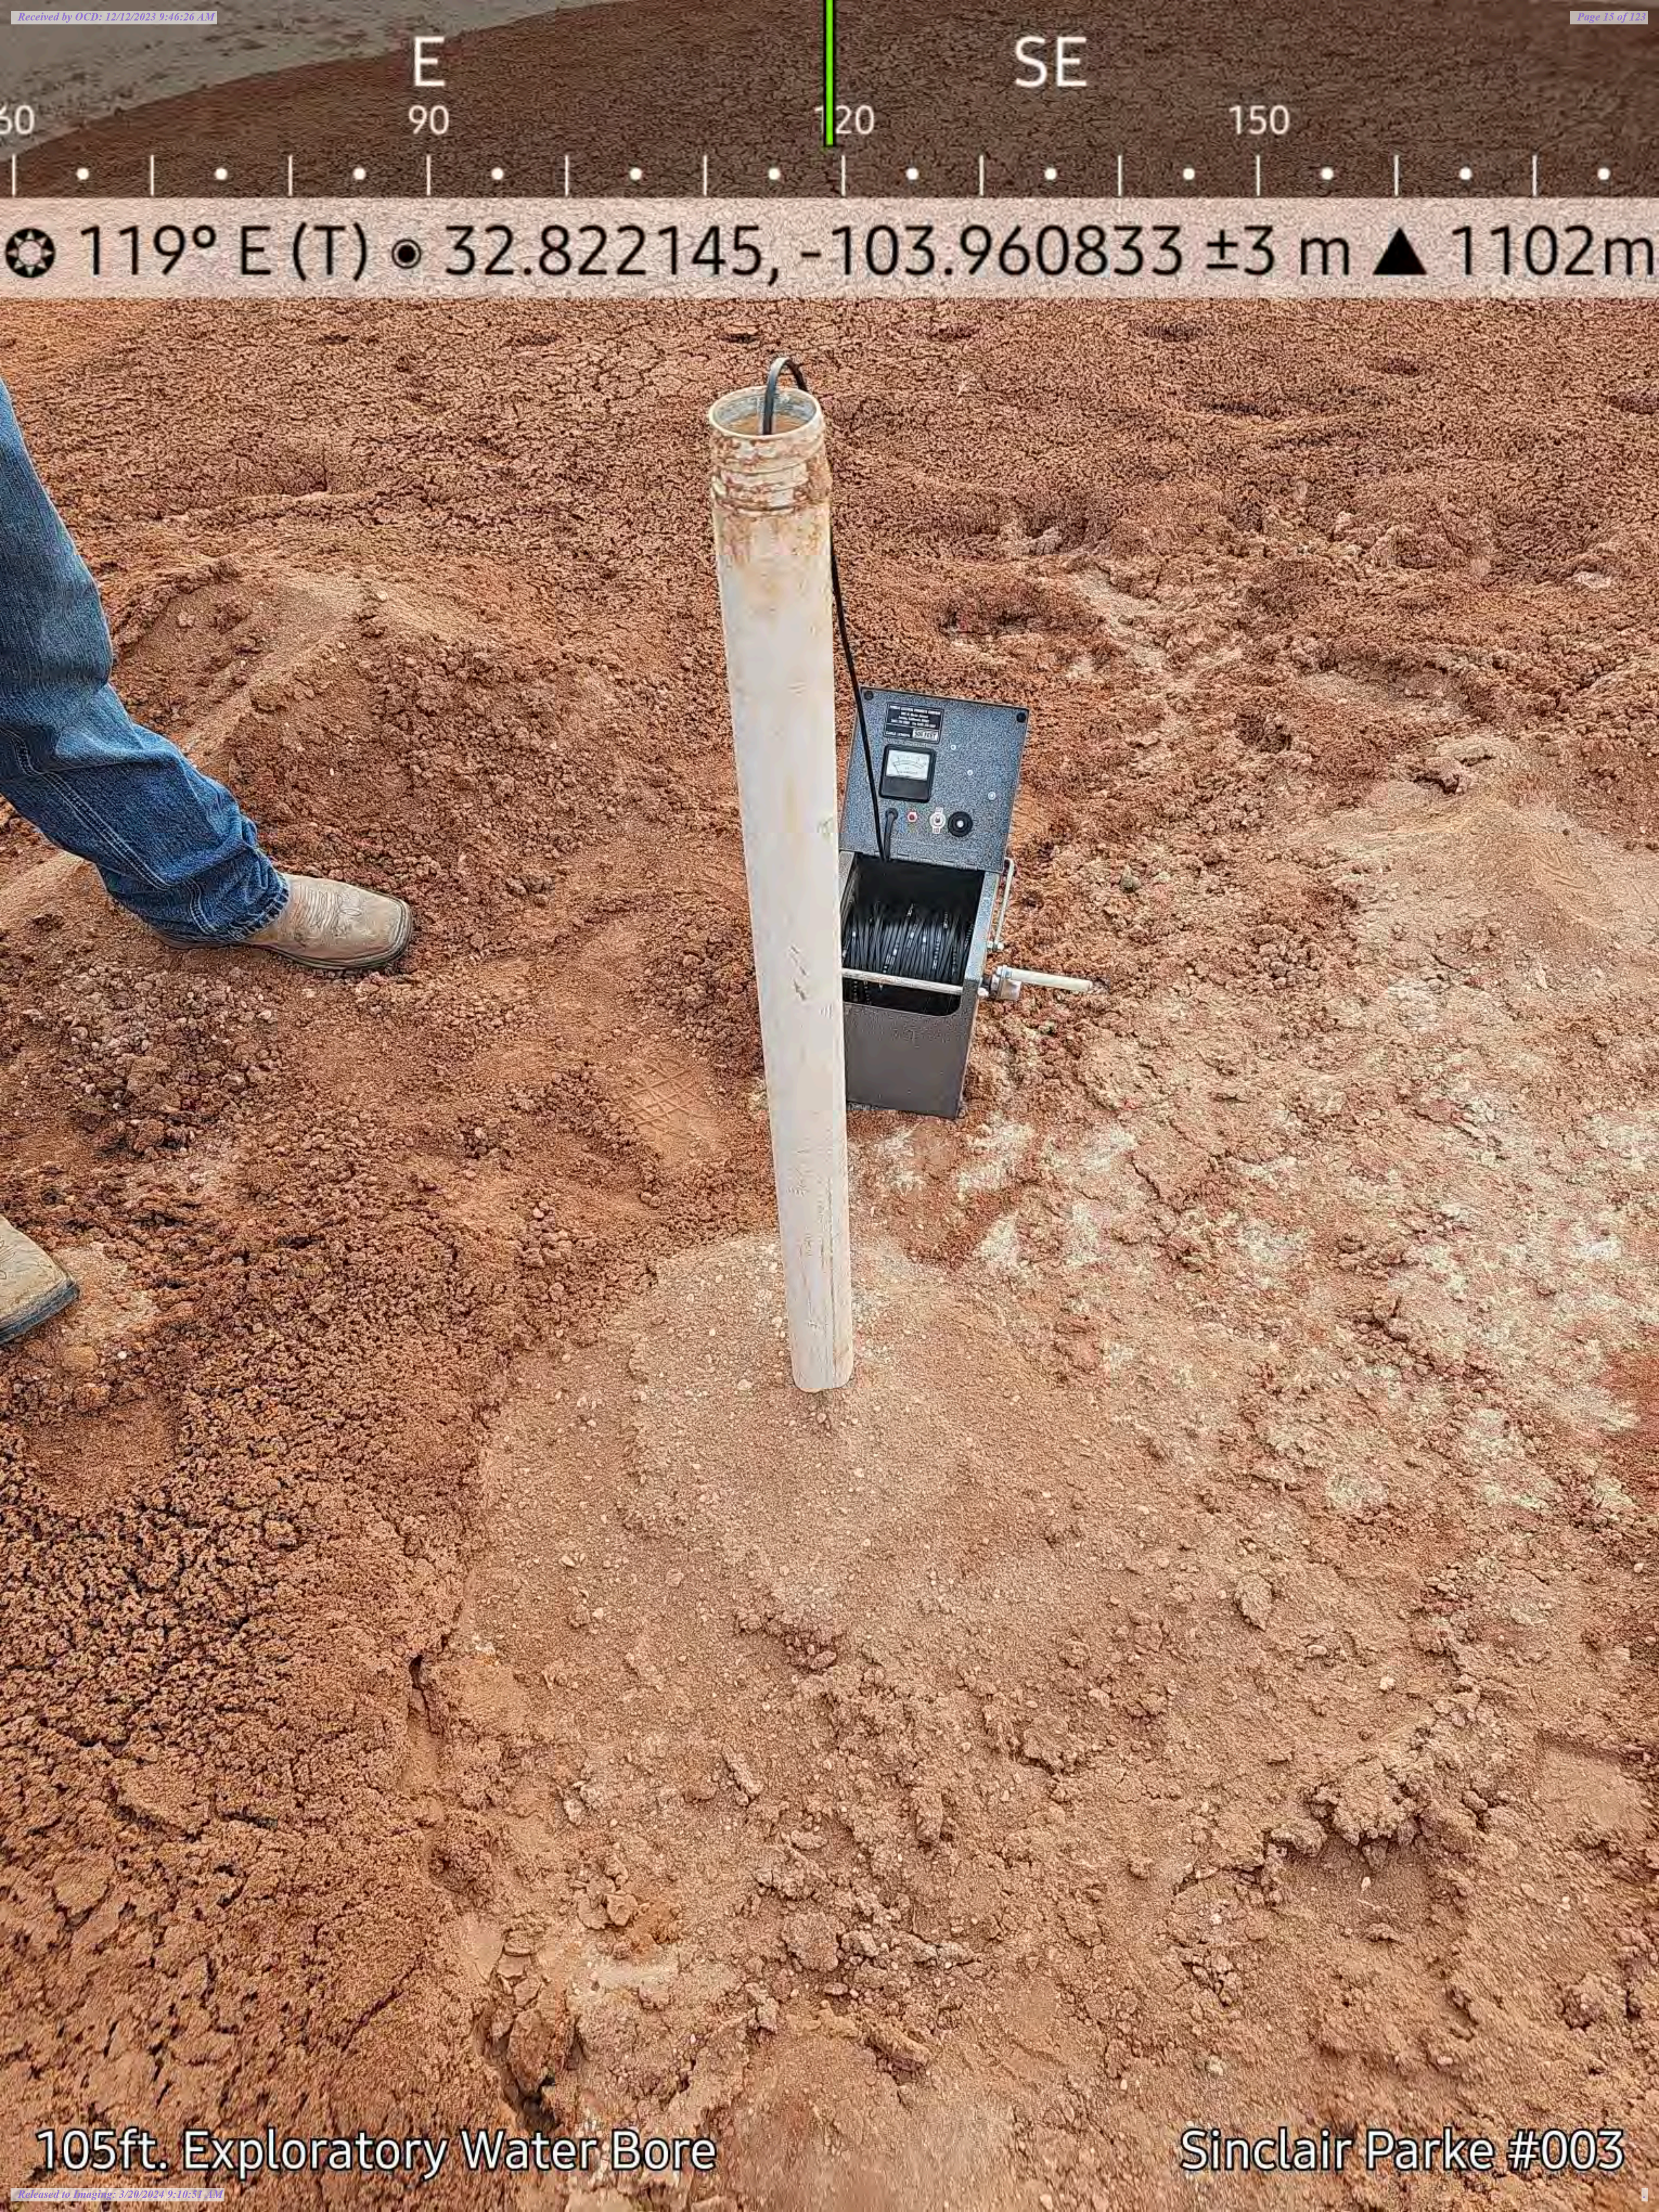
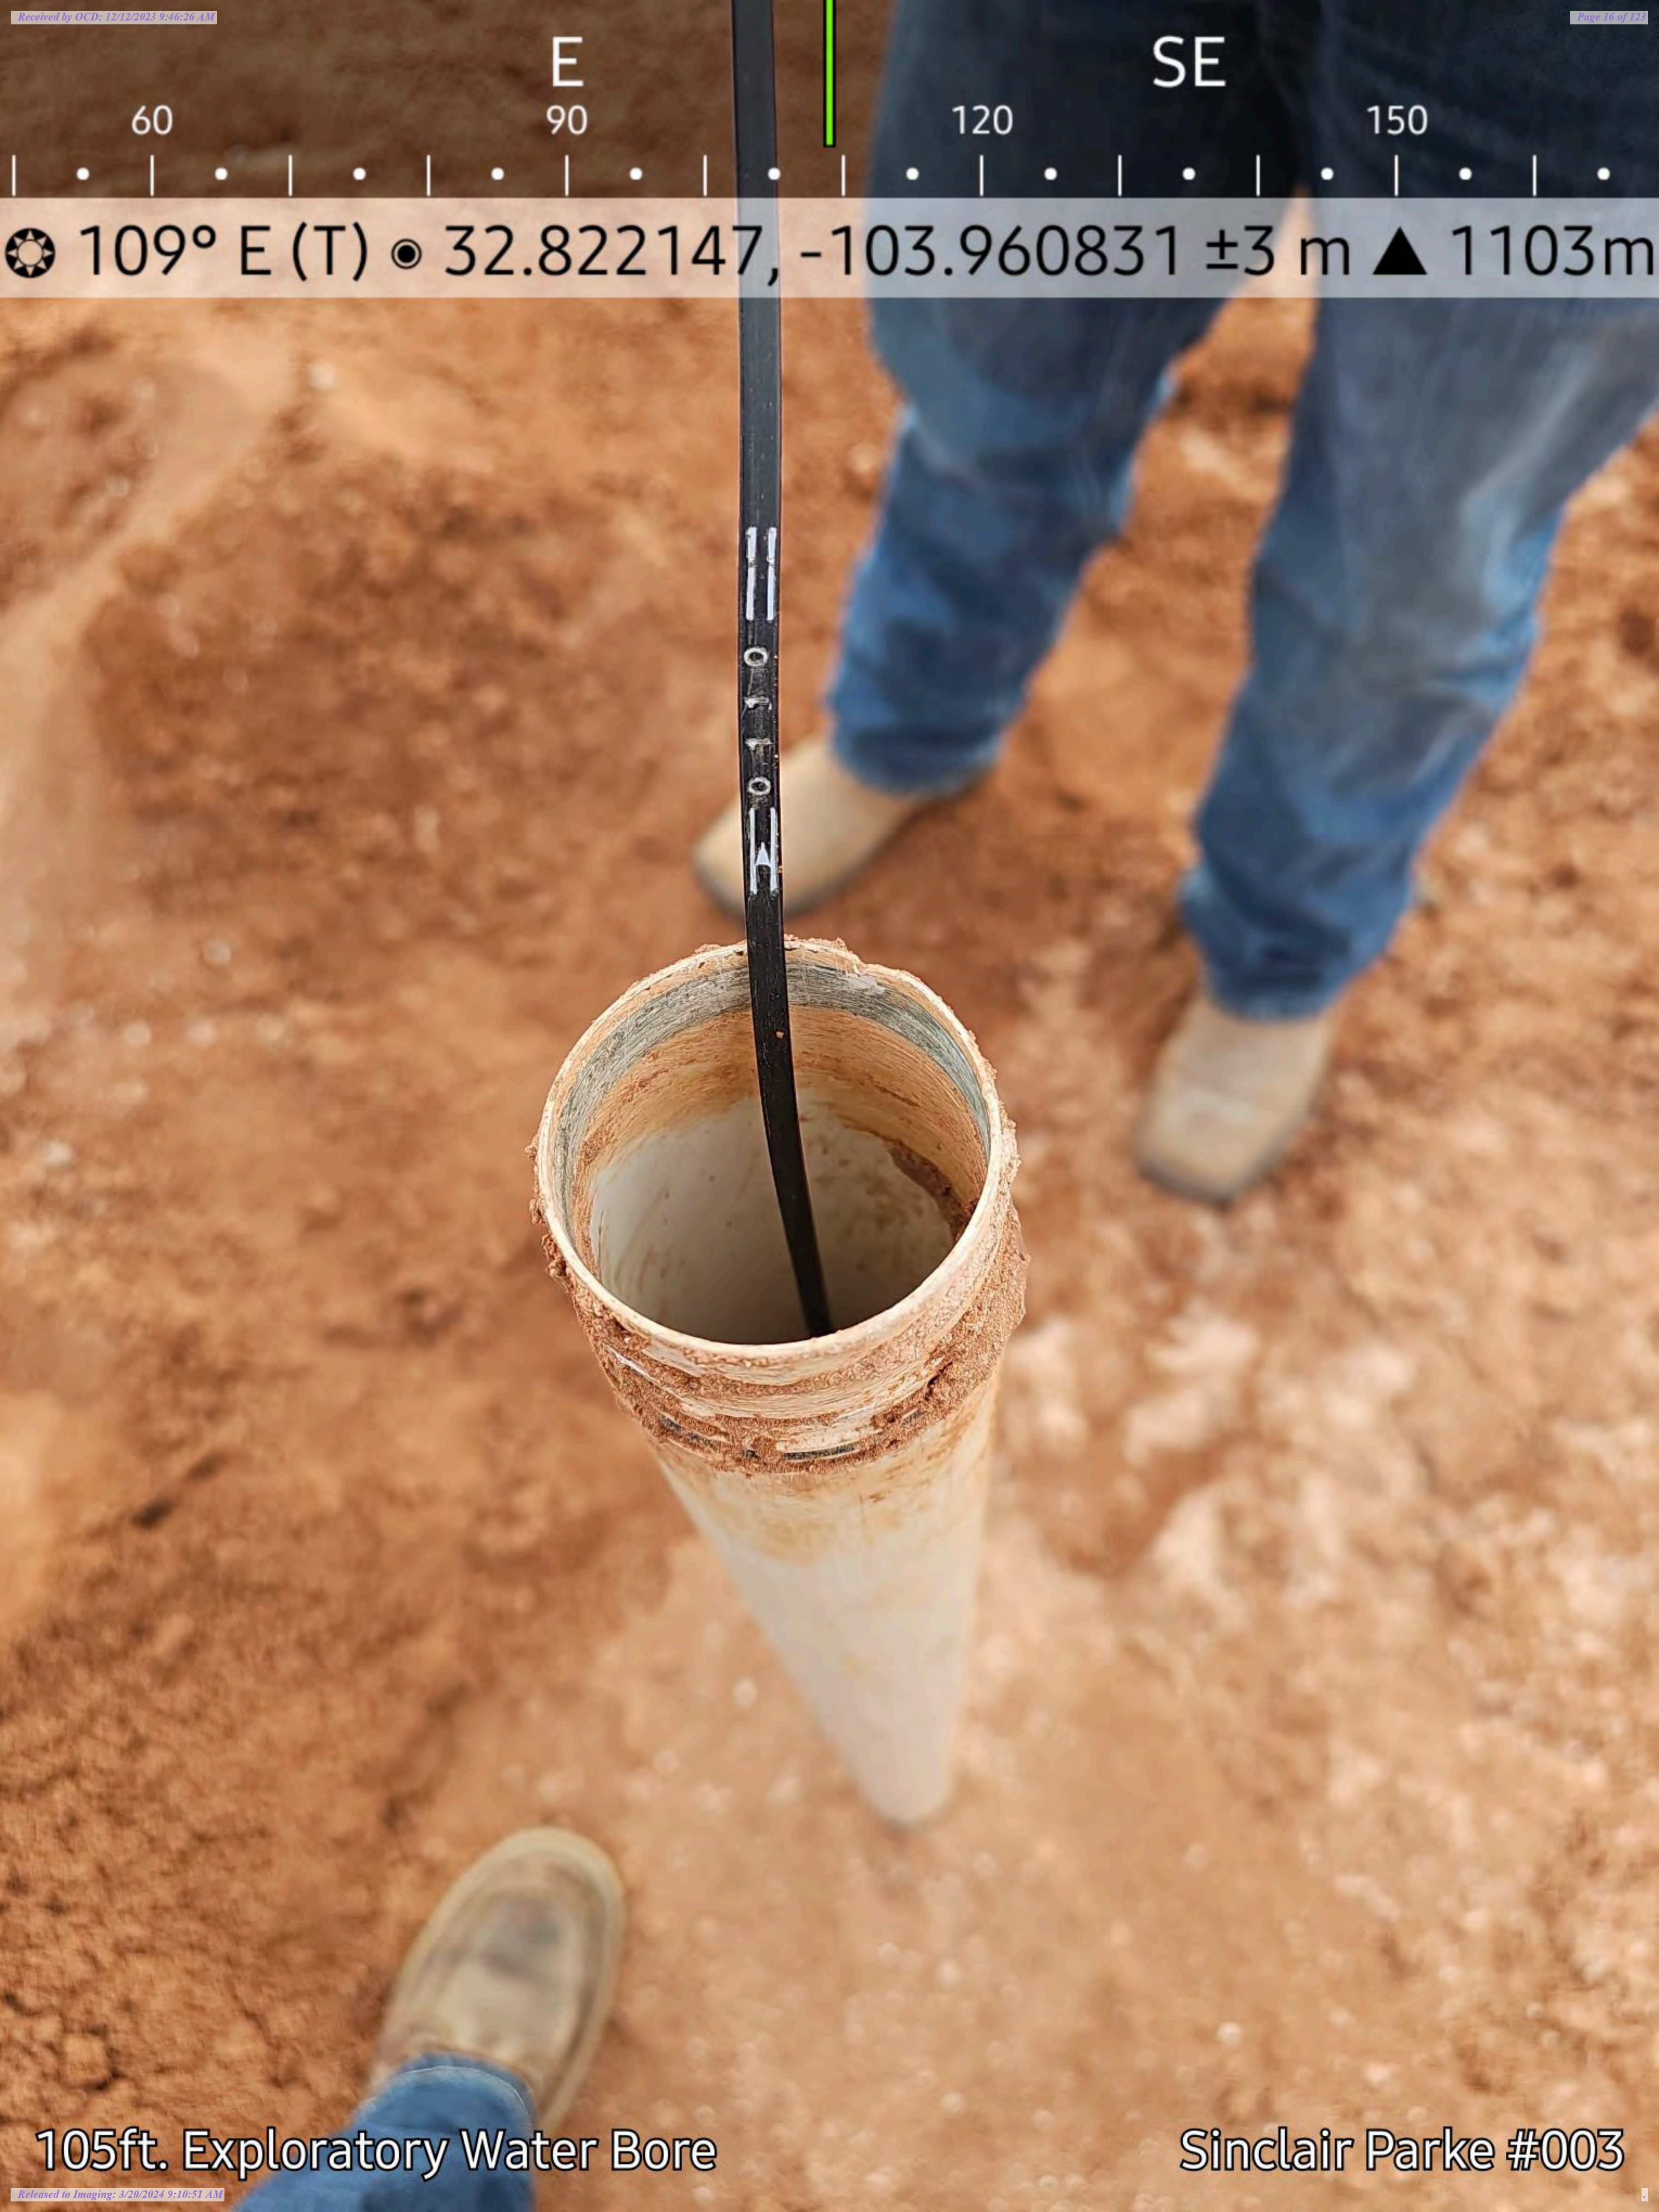
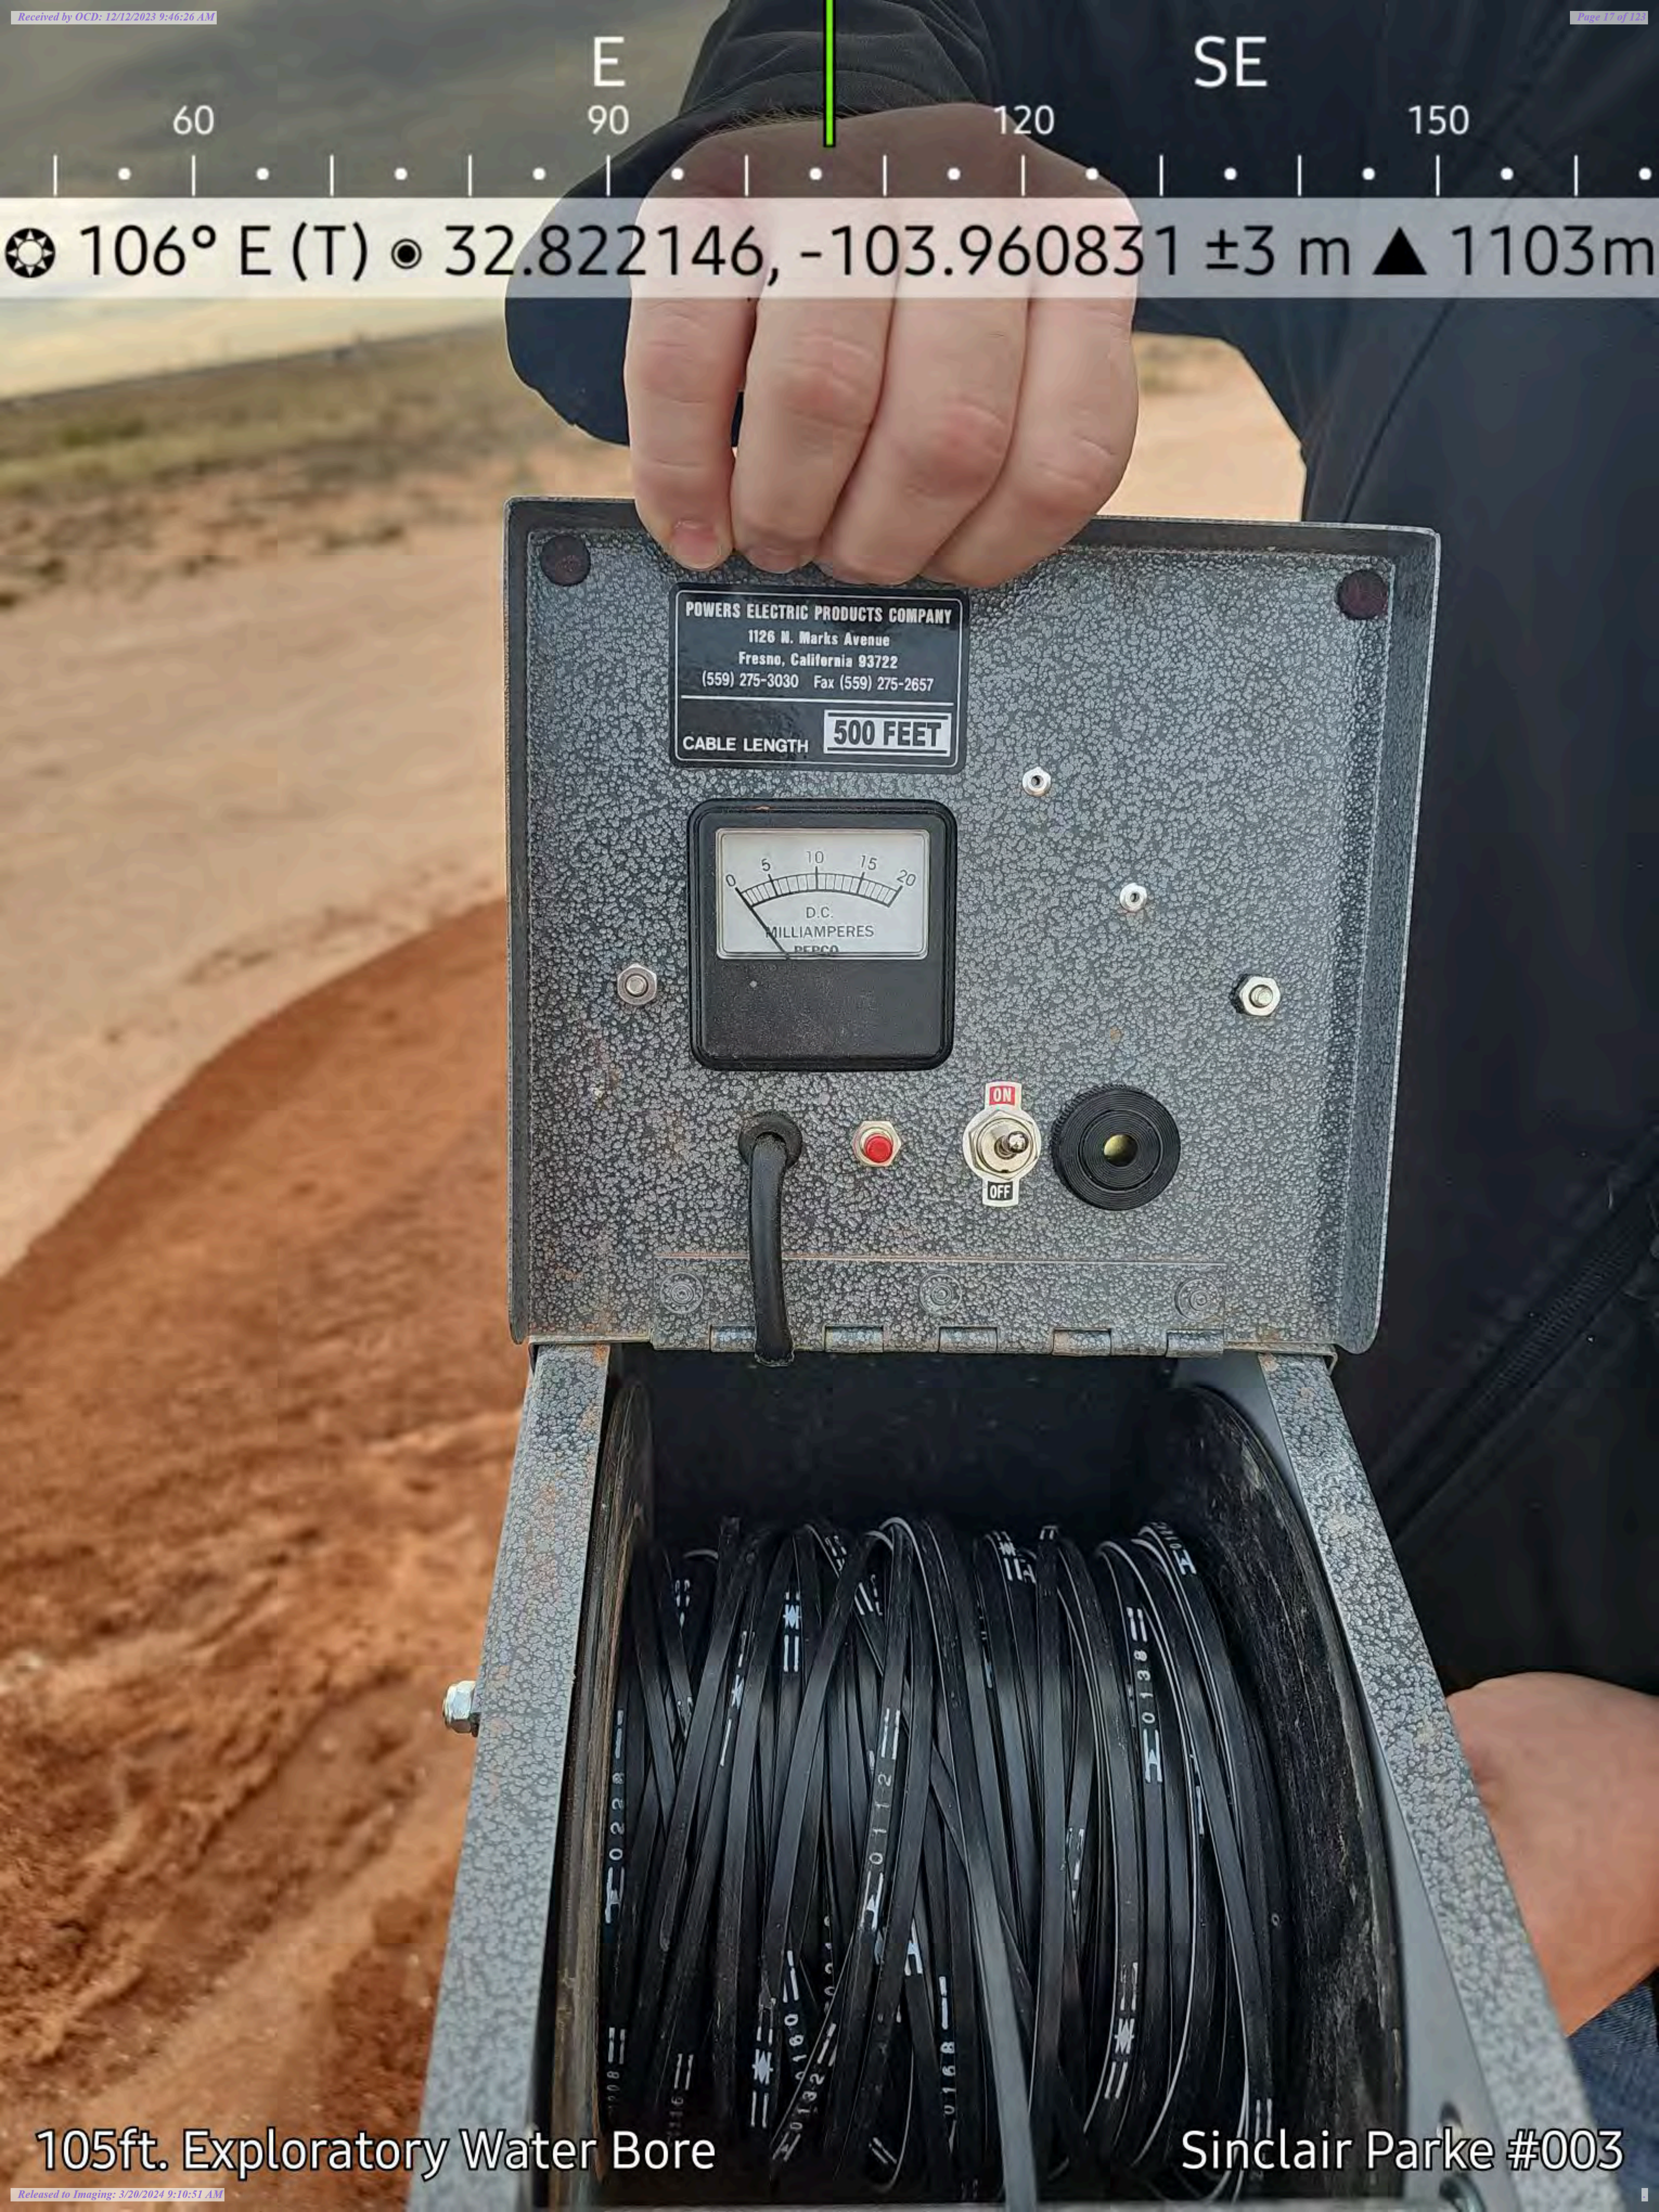
105ft. Exploratory Water Bore

Project:	Sinclair Parke #003	Date:	November 14, 2023
Type:	Exploratory Water Bore	Location:	32.822145, -103.960833

Depth	Soil Type	Classification	Comments
0-5'	Caliche 100%		
10'	Sand/Caliche		Sand-75% Caliche-25%
15'	Sand		
20'	Sand/Caliche		Sand-75% Caliche-25%
25'	Sand/Caliche		Sand-10% Caliche-90%
30'-40'	Sand/Red Clay		Sand-80% Red Clay-20%
45'-65'	Sand/Red Clay		Sand-60% Red Clay-40%
70'	Sand/Caliche		Sand-25% Caliche-75%
75-105'	Sand/ Red Clay		Sand-60% Red Clay-40%
Total Depth - 105'			Dry Hole- 11/14/2023 Dry Hole- 11/27/2023

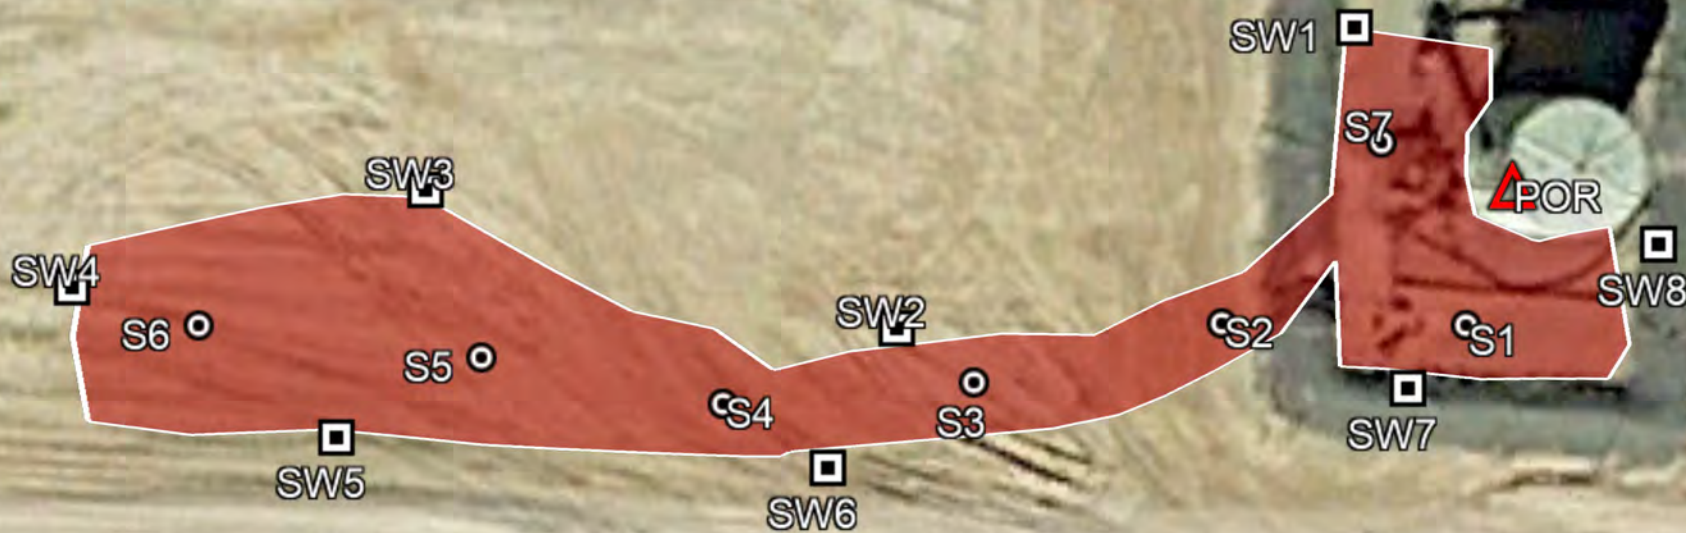
On August 16th, 2023, Spur deployed personnel to the site to carry out spill prevention measures. The origin of the release was successfully halted. Spur secured the affected area and ensured the removal and proper disposal of all standing liquids at an NMOC approved landfill. The release area highlighted in Figure 5 covers an approximate area of 3200 square feet.

Sample ID	Depth (BGS)	BTEX mg/kg	Benzene mg/kg	GRO mg/kg	DRO mg/kg	MRO mg/kg	Total TPH mg/kg	CI mg/kg
S-1	1'	ND	ND	ND	736	ND	736	2840
	3'	ND	ND	ND	27.1	ND	27.1	3280
	5'	ND	ND	ND	ND	ND	0	407
	7'	ND	ND	ND	ND	ND	0	65.3
S-2	1'	ND	ND	ND	ND	ND	0	452
	3'	ND	ND	ND	ND	ND	0	20.7
	4'	ND	ND	ND	ND	ND	0	56.1
S-3	1'	ND	ND	ND	ND	ND	0	375
	3'	ND	ND	ND	ND	ND	0	52.9
	4'	ND	ND	ND	ND	ND	0	36.2
S-4	1'	ND	ND	ND	ND	ND	0	4950
	3'	ND	ND	ND	ND	ND	0	86.6
	4'	ND	ND	ND	ND	ND	0	ND
S-5	1'	ND	ND	ND	ND	ND	0	471
	3'	ND	ND	ND	ND	ND	0	24.7
	4'	ND	ND	ND	ND	ND	0	ND
S-6	1'	ND	ND	ND	ND	ND	0	125
	3'	ND	ND	ND	ND	ND	0	289
	4'	ND	ND	ND	ND	ND	0	64
S-7	1'	ND	ND	ND	ND	ND	0	16800
	3'	ND	ND	ND	ND	ND	0	733
	5'	ND	ND	ND	ND	ND	0	413
	7'	ND	ND	ND	ND	ND	0	35
SW1	0-7'	ND	ND	ND	ND	ND	ND	ND
SW2	0-4'	ND	ND	ND	ND	ND	ND	ND
SW3	0-4'	ND	ND	ND	ND	ND	ND	ND
SW4	0-4'	ND	ND	ND	ND	ND	ND	ND
SW5	0-4'	ND	ND	ND	ND	ND	ND	ND
SW6	0-4'	ND	ND	ND	ND	ND	ND	ND
SW7	0-7'	ND	ND	ND	ND	ND	ND	ND
SW8	0-7'	ND	ND	ND	ND	ND	ND	ND

- Bottom Sample
- ▲ Point of Release
- Release Area ~3,200ft²
- Side Wall Sample

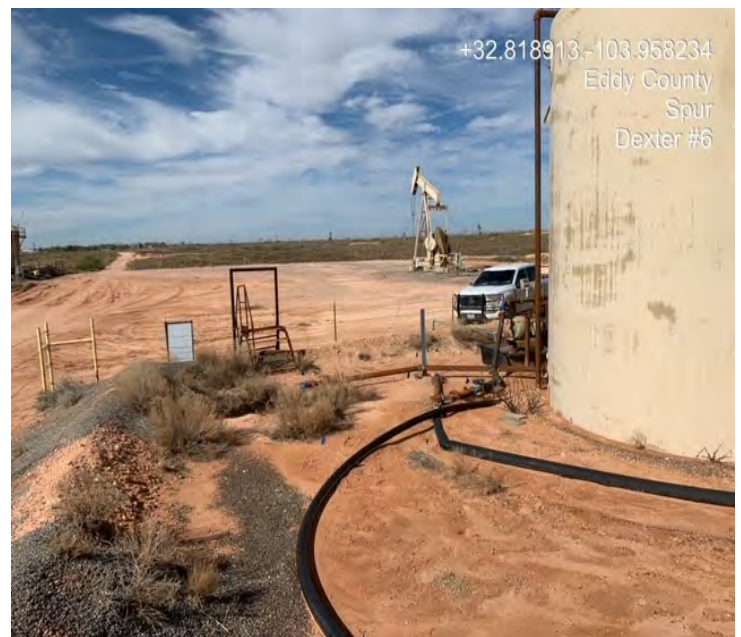
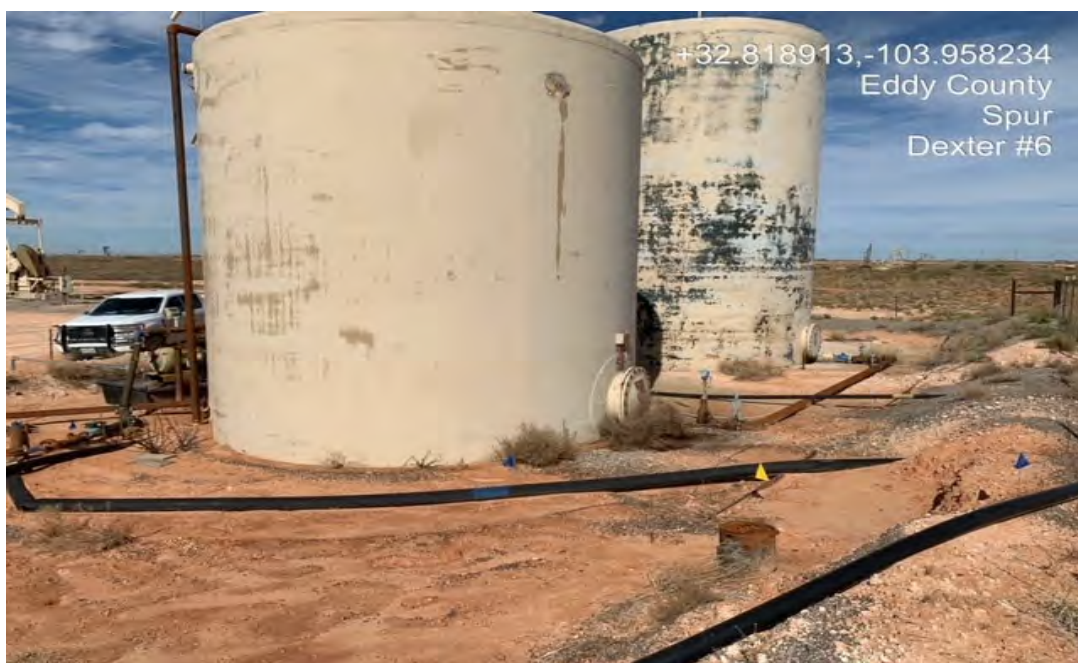
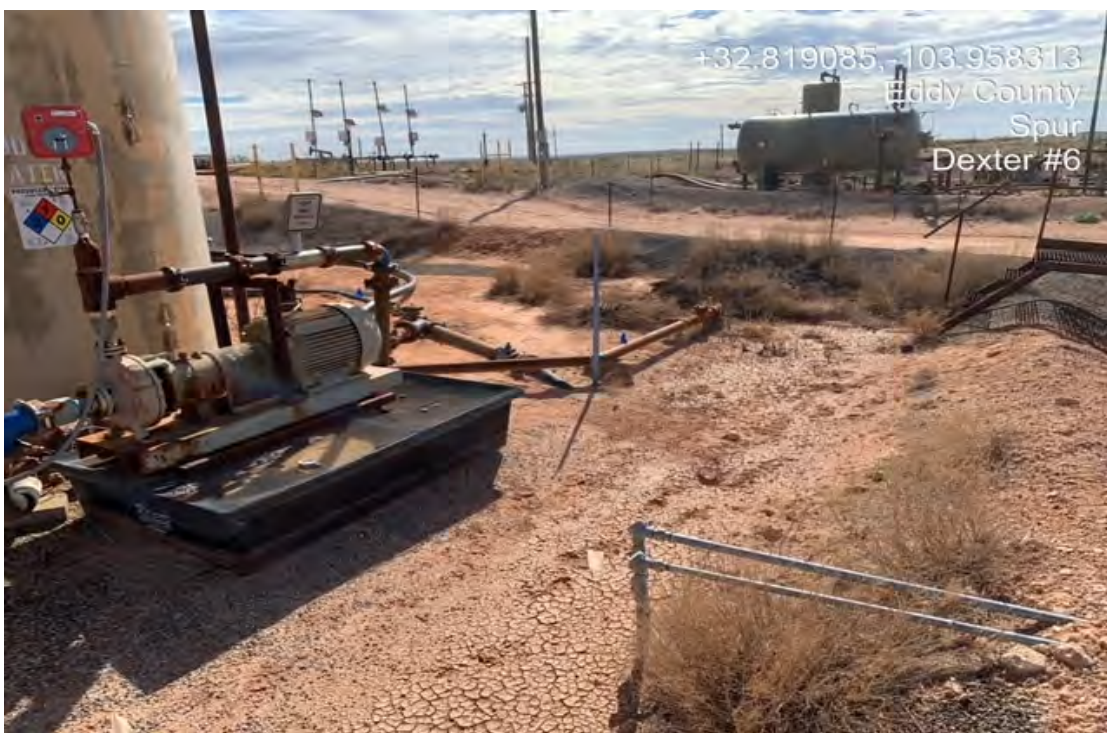
**SITE PHOTOGRAPHS
SPUR ENERGY PARTNERS
Dexter- Sinclair Parke Battery**

Napp2322846505: On August 15th, 2023, high pressure and heat caused a 4-inch poly line to split, releasing produced water onto the engineered pad. Approximately 11 barrels of produced water were released, and 10 barrels were recovered. All contamination remained on the engineered pad.
