CLOSURE REQUEST REPORT

Ross Draw Unit #011

Eddy County, New Mexico

NHMP1412241998

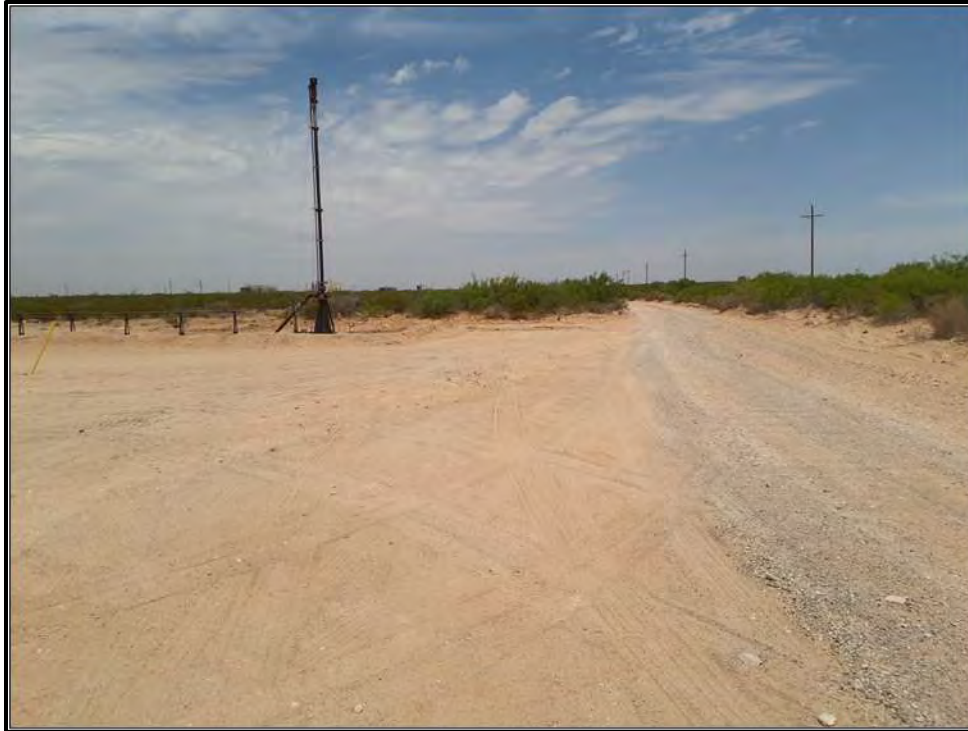
Figure 1-7. Survey area overview showing road and RDU 11 well pad near inadvertent release, facing north (Roll 80772, Frame T18-2955).

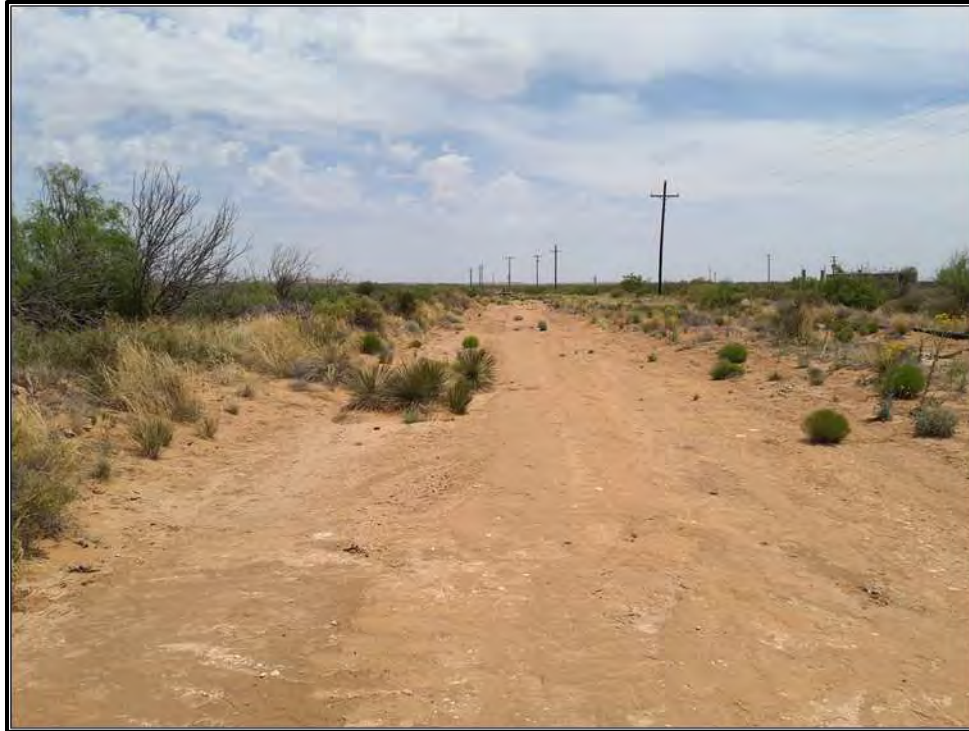
Figure 1-9. Utility line bisecting project area in vicinity of IM 4, facing east (Roll 80772, Frame T18-5707).

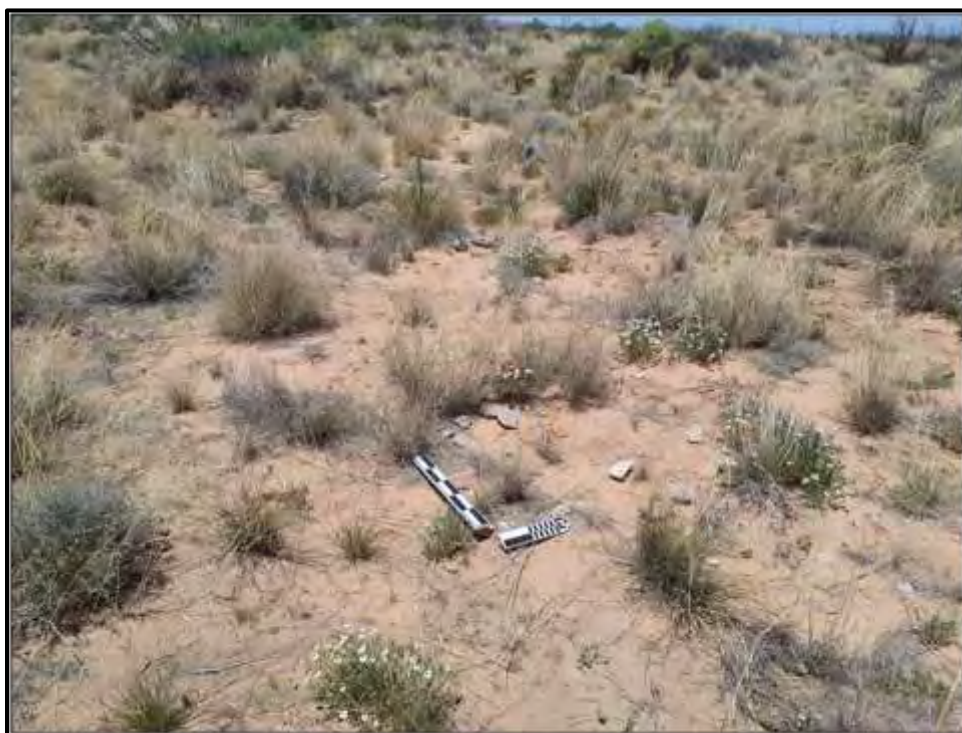
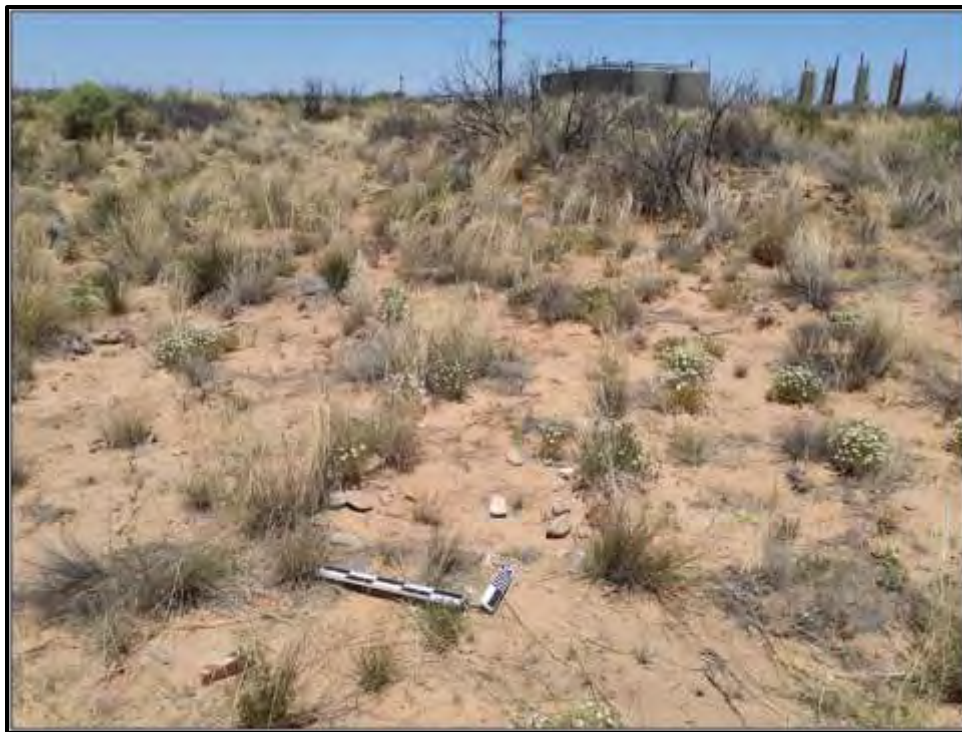
F1 measures 3.0×2.1 m and contains approximately 35 pieces of burned rock ranging from 10 to 20 cm in diameter (Figure 4-18 and Figure 4-19). A pin flag was used to see the depth of the features and penetrated down to 7 cmbs. A trowel test (TT 1) was placed in the feature and exposed buried FCR at 6 cmbs.

Figure 4-18. LA 86207, F1, overview of FCR concentration, facing west (Roll 80772, Frame T18-2964).

Figure 4-19. LA 86207, F1, overview of FCR concentration with pad in background, facing northeast (Roll 80772, Frame T18-6388).

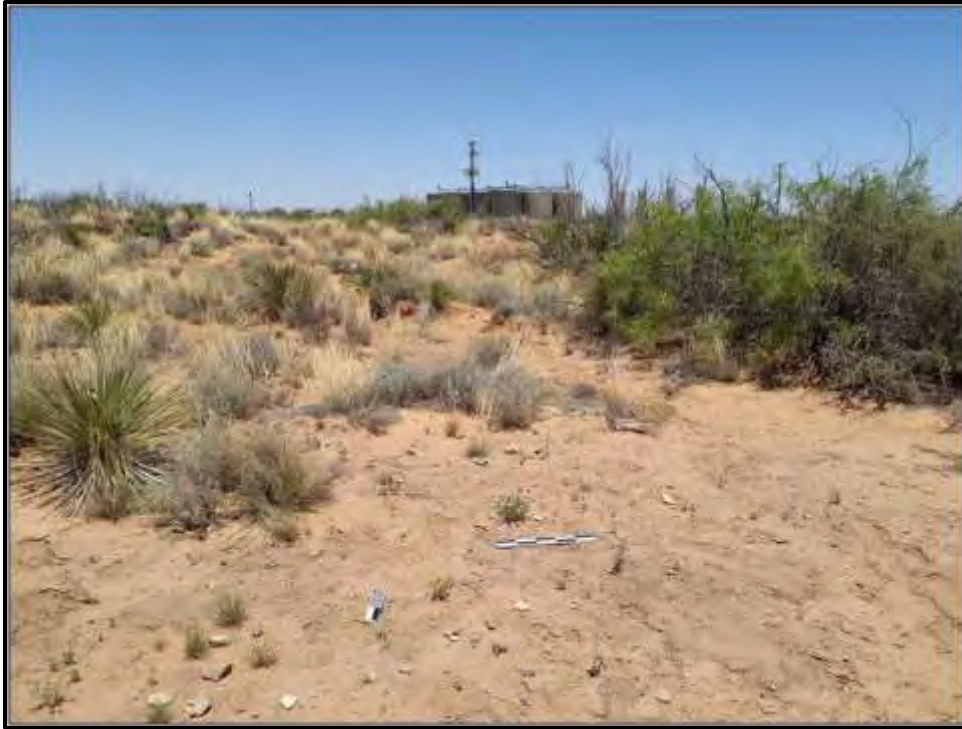
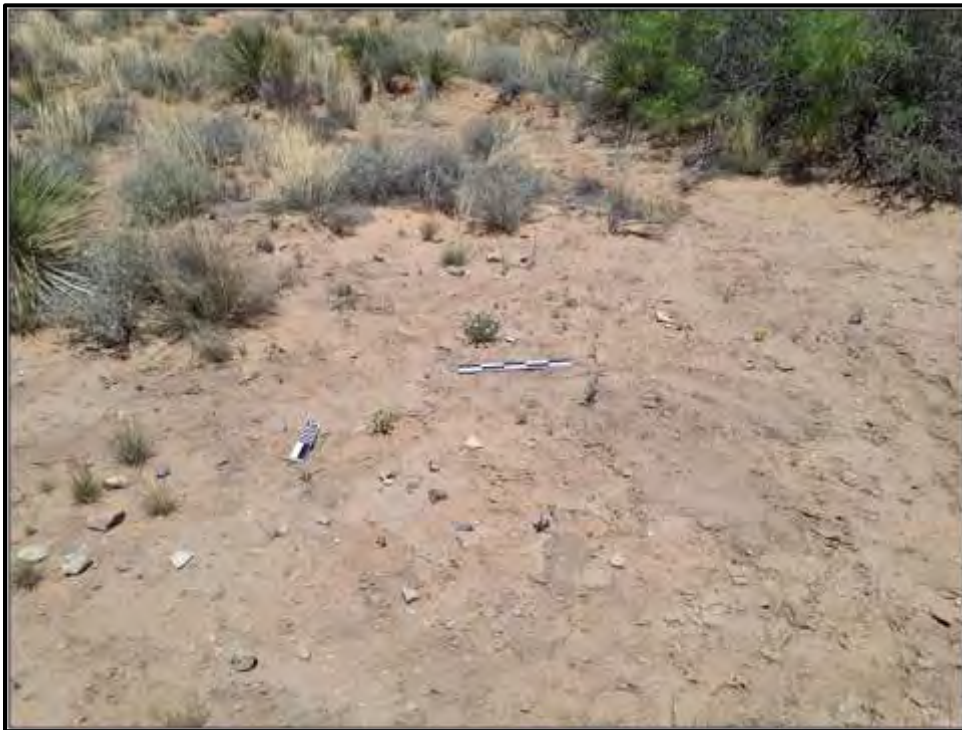
F2, the burned rock midden, measures approximately 8.4×4.3 m and includes over 200 pieces of FCR (Figure 4-20 and Figure 4-21). Each piece ranges between 5 to 20 cm in diameter. Artifacts that were observed associated with the features include five chert flakes with cortex, measuring 2 to 3 cm, and two limestone ground stone fragments. Both showed evidence of grinding on one side. Artifacts were noted but not recorded during this visit. The soil is a 7.5YR 6/3 loamy sand that was recently exposed. Based on BLM CFO consultation for testing features, no trowel test was placed in or around F2, since testing was already conducted in F1, and intact subsurface deposits were observed.

Figure 4-20. LA 86207, F2, burned rock midden with oil infrastructure visible in the background, facing north (Roll 80772, Frame T18-7924).

Figure 4-21. LA 86207, F2, burned rock midden, facing north (Roll 80772, Frame T18-2661).

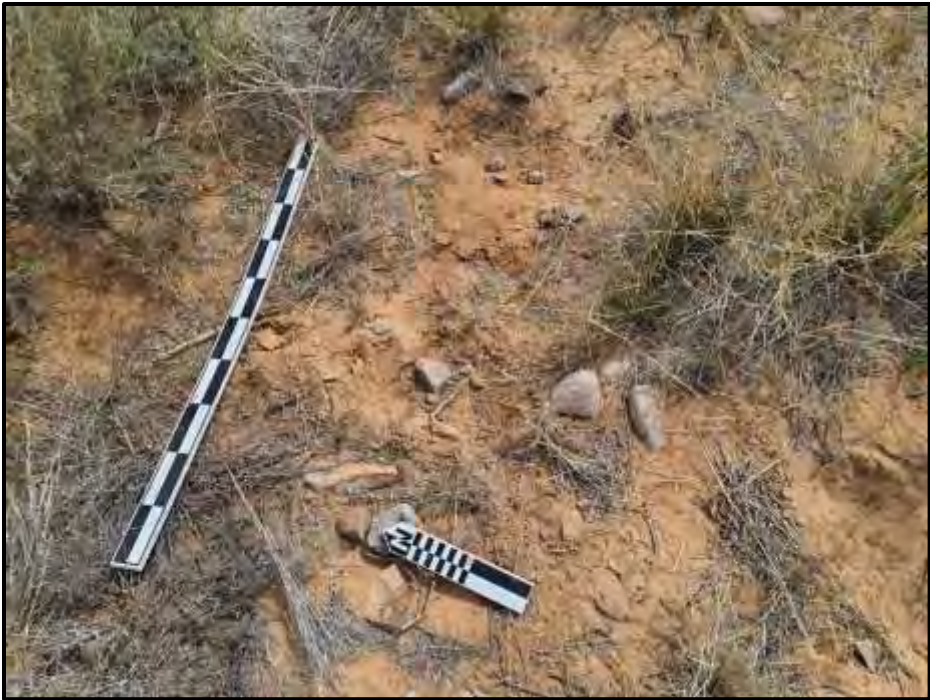
A single FCR concentration (F1) was observed and recorded at LA 203097 (Figure 4-45). The feature measured approximately 2 m (east-west) × 1.5 m (north-south). There was no visible carbon staining on the surface nor any associated artifacts. There was a total of 30 pieces of burned rock, ranging in size from 10 to 15 cm in diameter. Subsurface FCR was detected at about 5 cmbs by a trowel test. Feature 1 retains some subsurface integrity and likely has sequestered datable carbon deposits.

Figure 4-45. LA 203097, F 1, FCR Concentration, facing east (Roll 80772, Frame T18-8261).

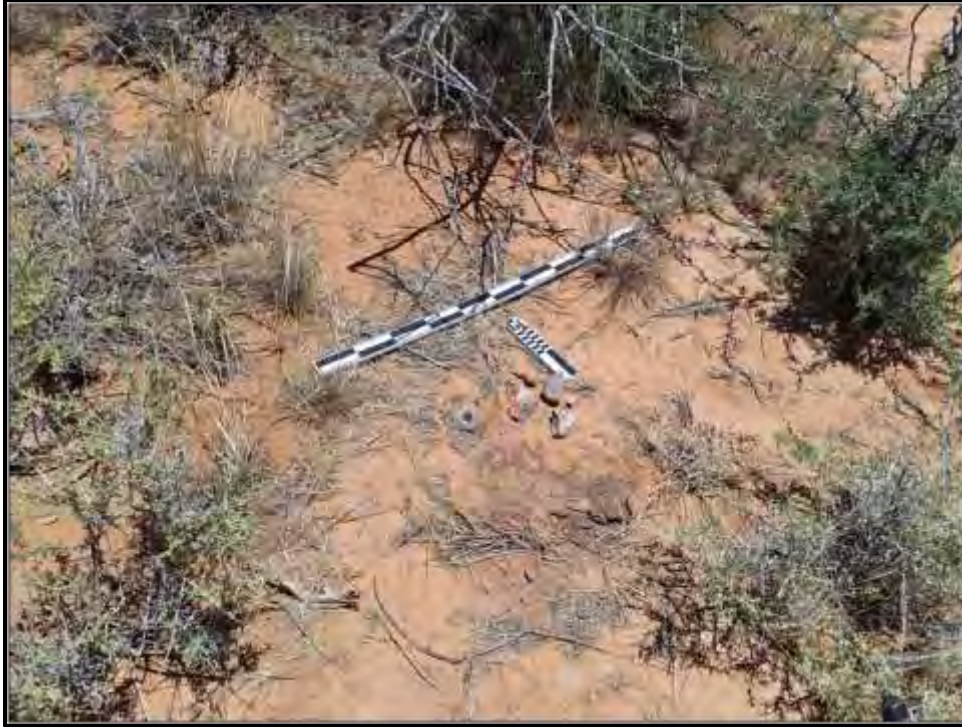
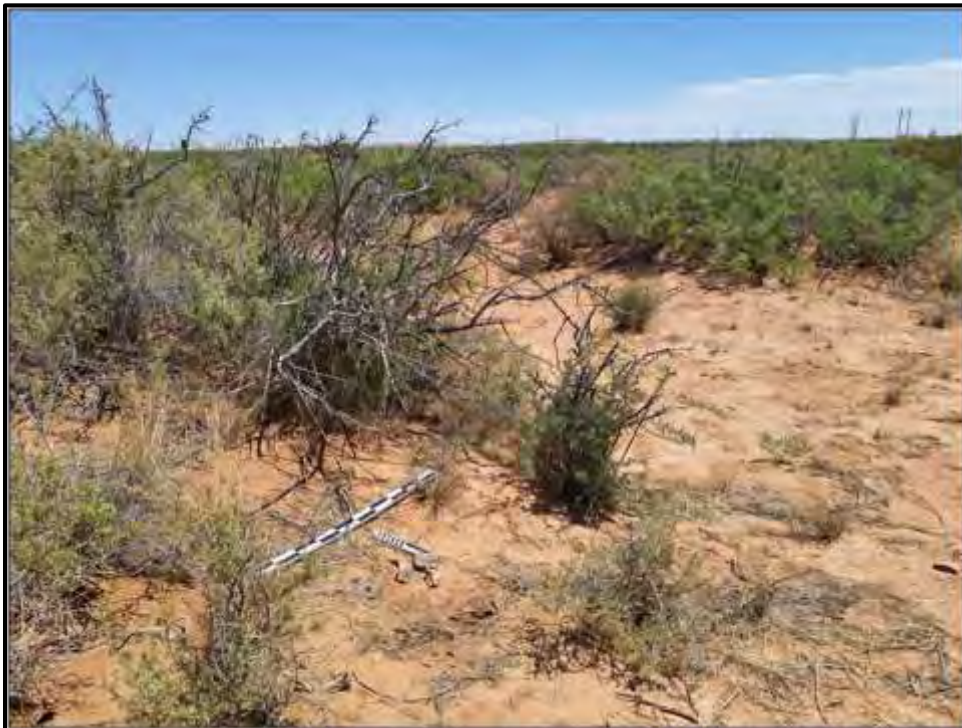
One ash stain (F1) and one burned rock midden (F2) were observed and recorded at the site. F1 measured 0.3 m (north-south) \times 0.24 m (east-west) in diameter. The ash stain was observed eroding from the base of a dune. There were five pieces of FCR associated with the 10-cm-diameter ash stain. A trowel test (TT 1) was conducted and found buried ash up to 3 cmbs (Figure 4-55 and Figure 4-56).

Figure 4-55. LA 203098, F1, exposed ash stain with FCR, facing northeast (Roll 80772, Frame T18-3392).

Figure 4-56. LA 203098, F1, ash stain with a few FCR, exposed near base of sand dune. Overview showing dune field, facing northeast (Roll 80772, Frame T18-3429).

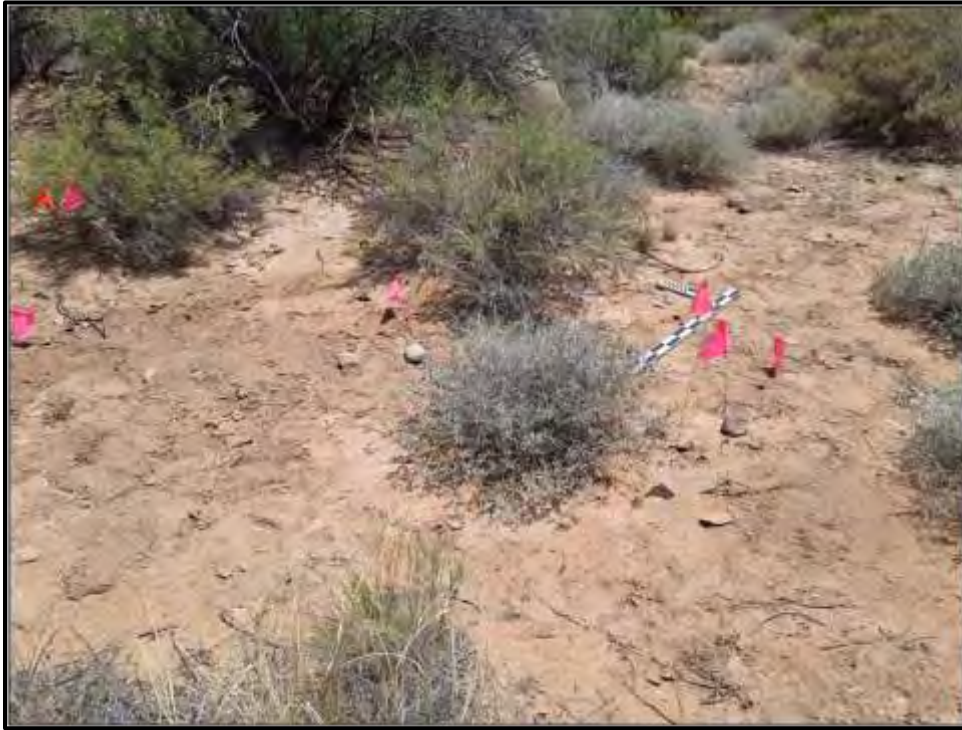
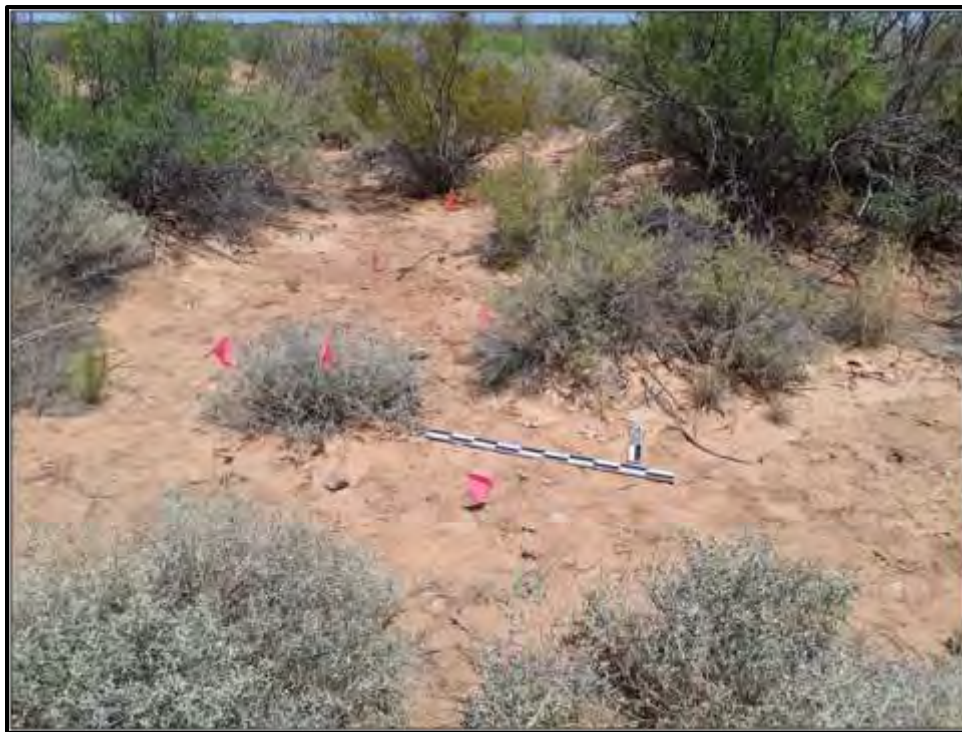
F2, a burned rock midden (Figure 4-57 and Figure 4-58), measures approximately 7.3 m (north-south) × 4.2 m (east-west). The rock midden is heavily deflated; however, there appears to be subsurface integrity defined by artifacts, such as a flaked debitage, core, and ground stone fragments (Table 4-19 through Table 4-21). A trowel scrape (TT 2) was conducted within the feature. Approximately 30 pieces of residual FCR, with an average diameter of 10 to 15 cm each, were identified within the feature. A total of four ground stone tool fragments, 17 flaked debitage, and one multidirectional core were associated with the feature.

Figure 4-57. LA 203098, F2, burned rock midden, deflated, facing east (Roll 80772, Frame T18-9397).

Figure 4-58. LA 203098, F2, burned rock midden, facing north (Frame -1483).

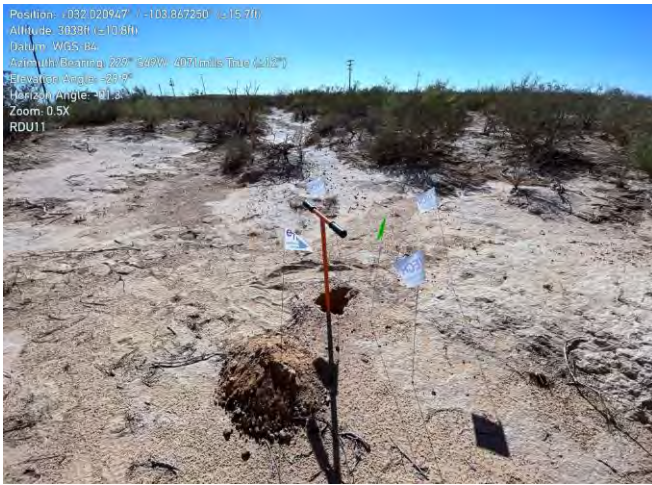
**Photograph 1****Date: 10/30/2023**

Description: Southwestern view of delineation activities.

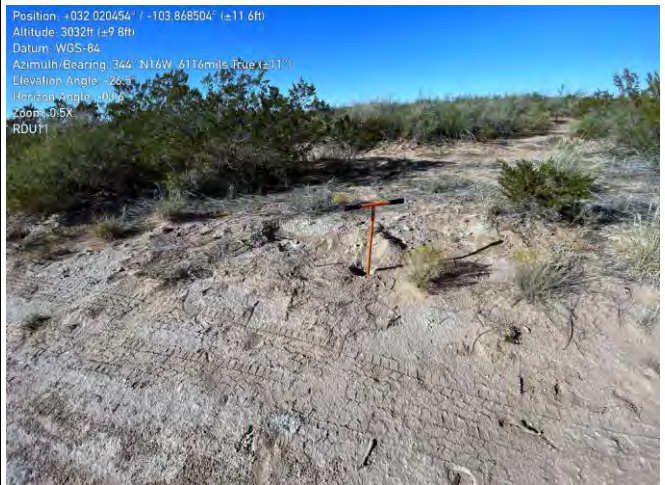
**Photograph 2****Date: 10/30/2023**

Description: Northwestern view of delineation activities.

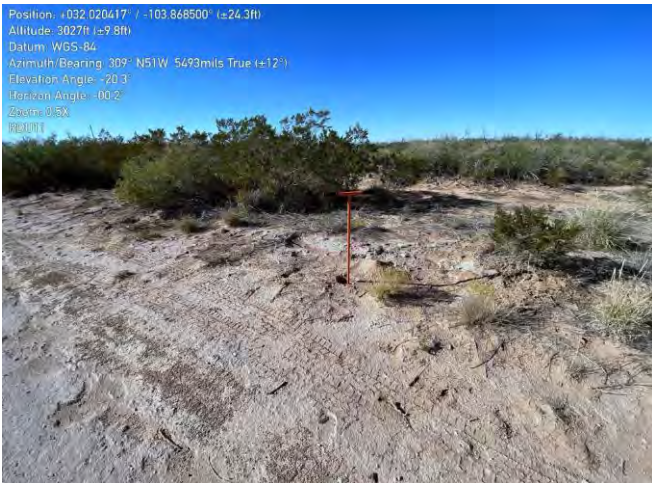
**Photograph 3****Date: 10/30/2023**

Description: Northwestern view of delineation activities.

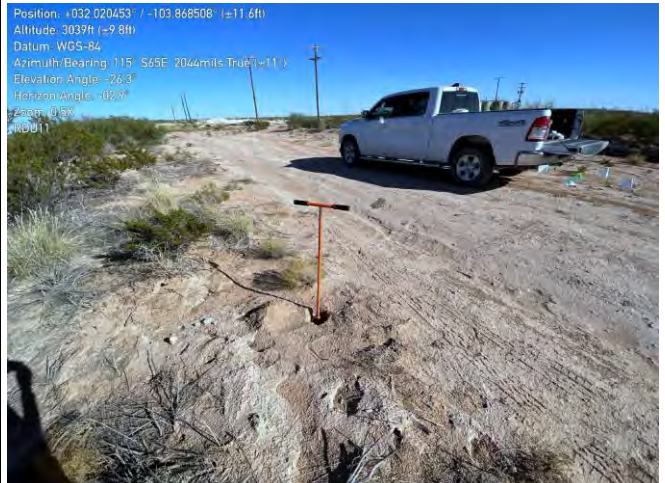
**Photograph 4****Date: 10/30/2023**

Description: Southeastern view of delineation activities.

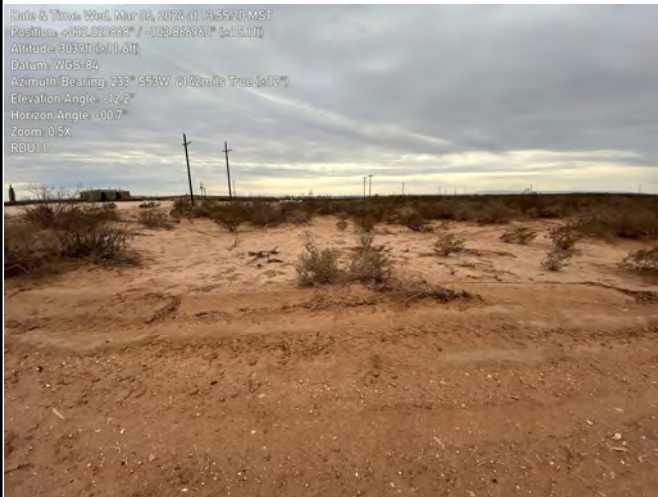
**Photograph 5****Date: 03/06/2024**

Description: Southwestern view of vegetation along path of investigation.

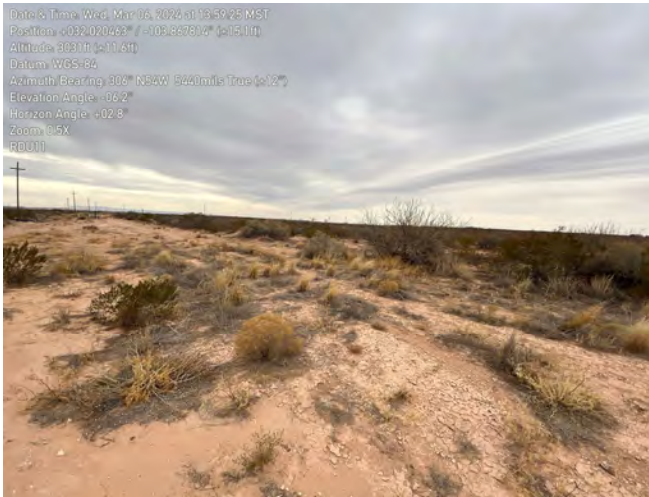
**Photograph 6****Date: 03/06/2024**

Description: Northwestern view of vegetation along path of investigation.

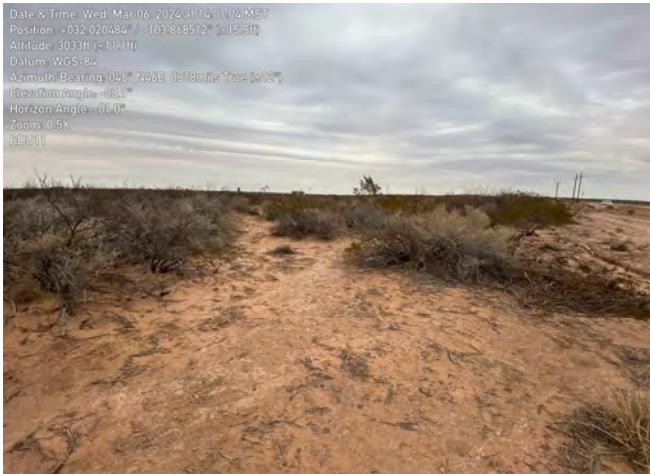
**Photograph 7****Date: 03/06/2024**

Description: Northeastern view of vegetation along path of investigation.

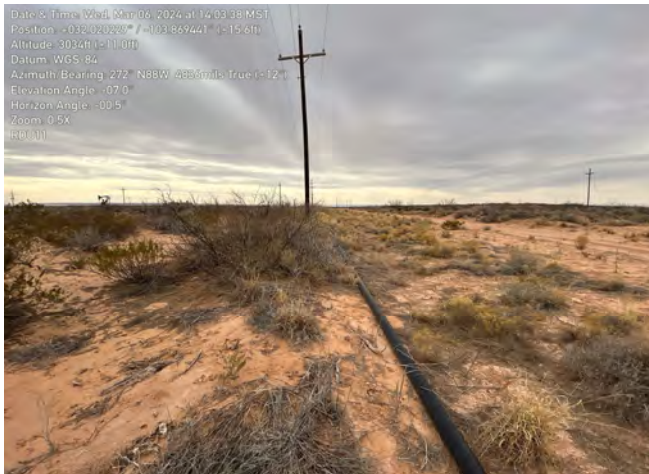
**Photograph 8****Date: 03/06/2024**

Description: Northwestern view of vegetation along path of investigation.

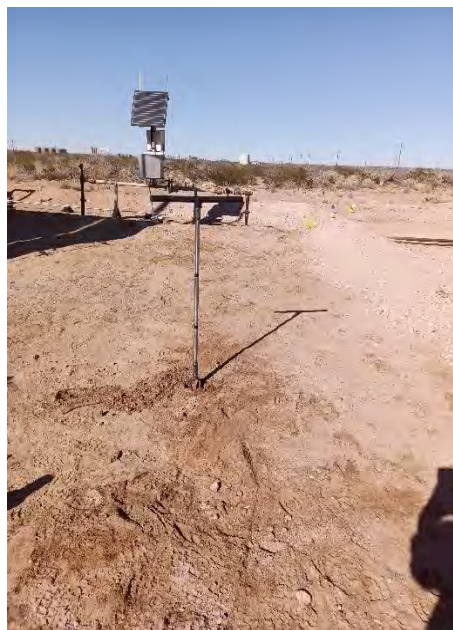
**Photograph 2**

Description: View of the Site during delineation activities

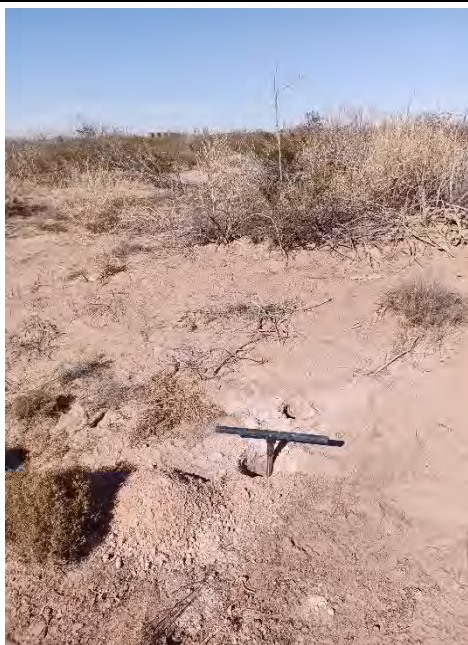
**Photograph 3**

Description: View of the Site during delineation

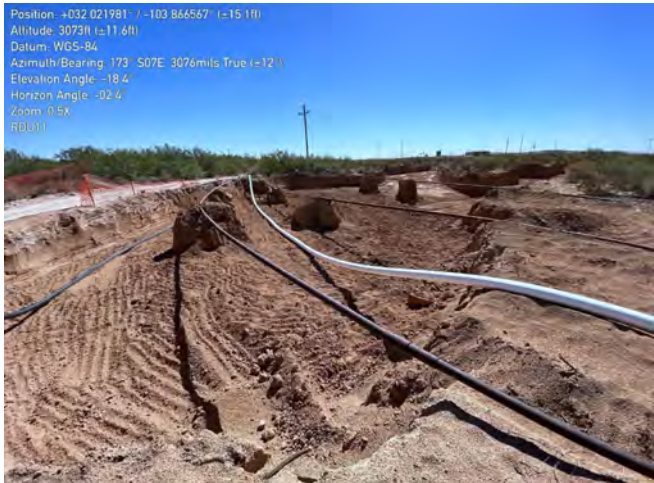
**Photograph 1****Date: 10/26/2023**

Description: Southeastern view of excavation activities from the southern excavation.

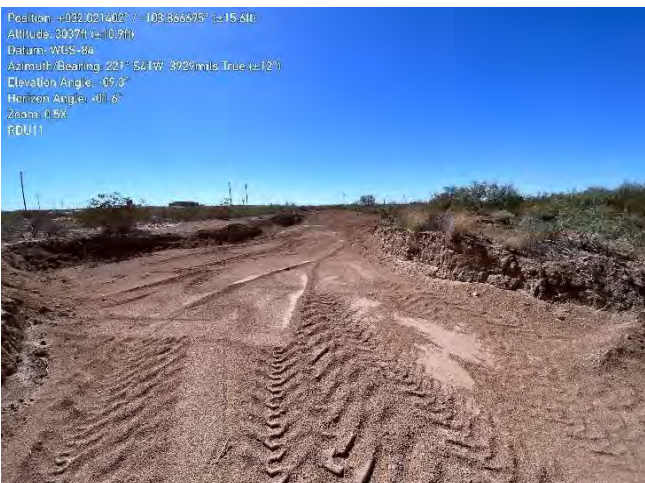
**Photograph 2****Date: 10/26/2023**

Description: Southwestern view of excavation activities from the southern excavation.

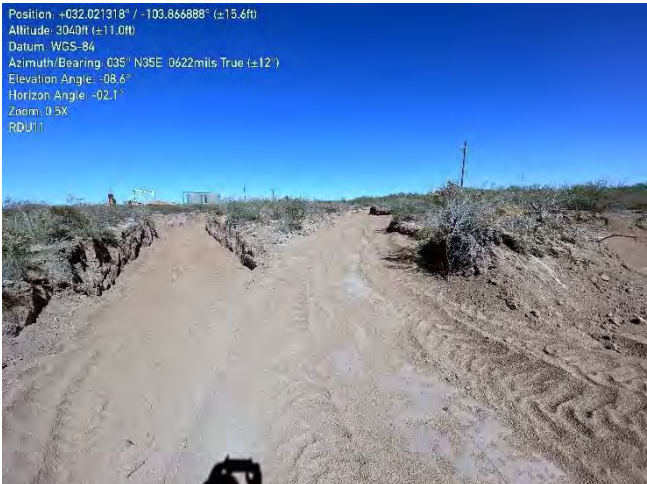
**Photograph 3****Date: 10/26/2023**

Description: Northeastern view of excavation activities from the southern excavation.

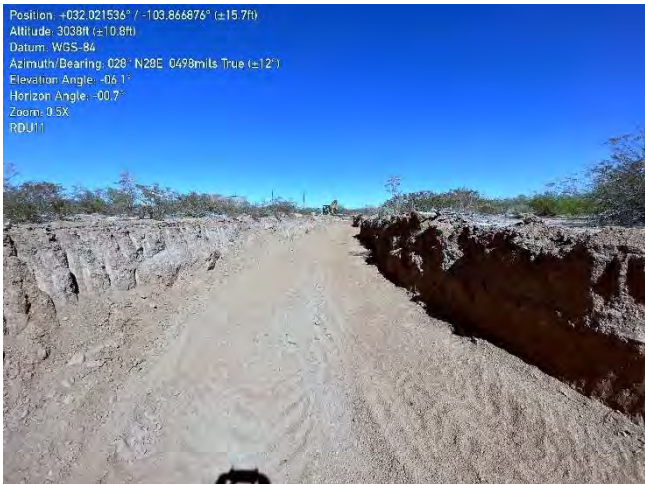
**Photograph 4****Date: 10/26/2023**

Description: Northeastern view of excavation activities from the southern excavation.

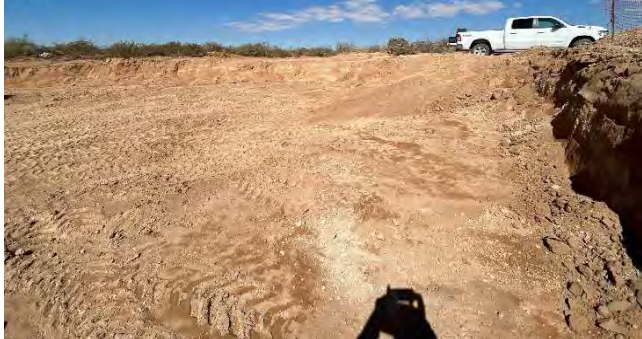
**Photograph 1****Date: 10/30/2023**

Description: Northwestern view of excavation activities from the northern excavation.

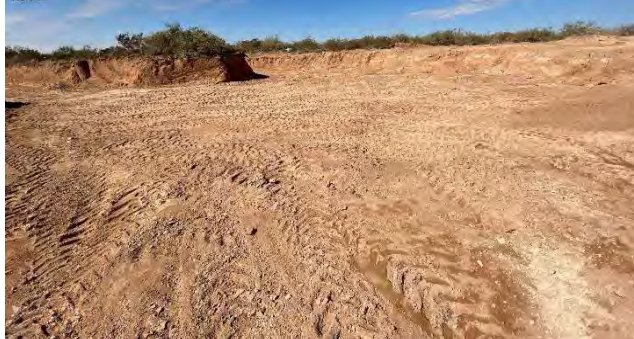
**Photograph 2****Date: 10/30/2023**

Description: Northwestern view of excavation activities from the northern excavation.

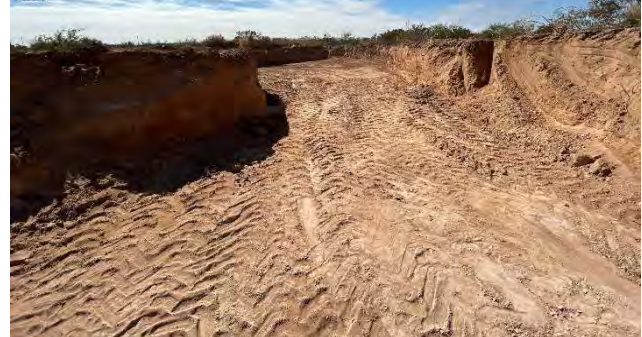
**Photograph 3****Date: 10/30/2023**

Description: Southwestern view of excavation activities from the northern excavation.

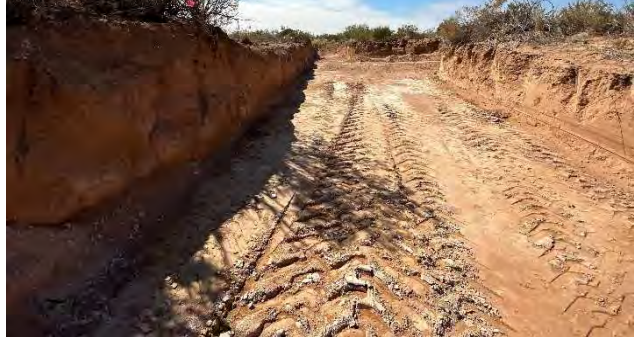
**Photograph 4****Date: 10/30/2023**

Description: Southwestern view of excavation activities from the northern excavation.

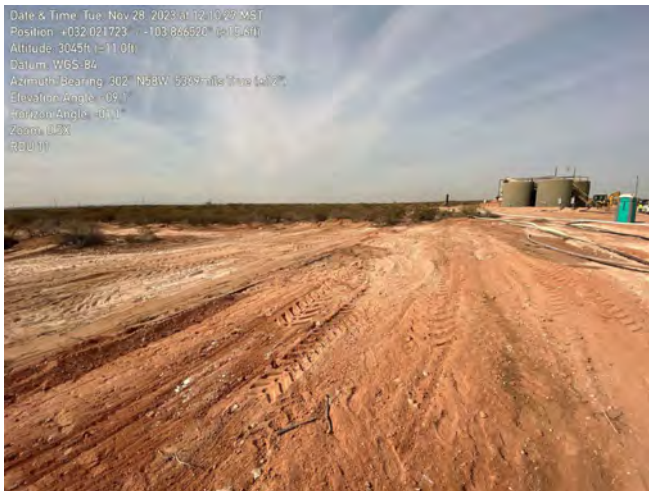
**Photograph 5****Date: 11/28/2023**

Description: Northwestern view of restoration activities of the southern excavation.

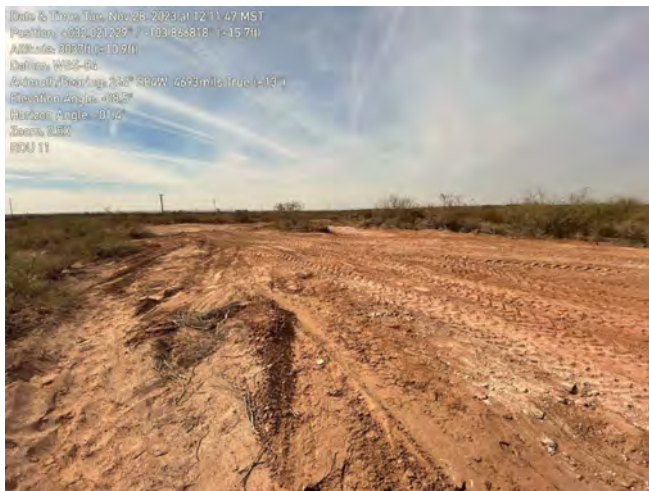
**Photograph 6****Date: 11/28/2023**

Description: Southwestern view of restoration activities of the southern excavation.

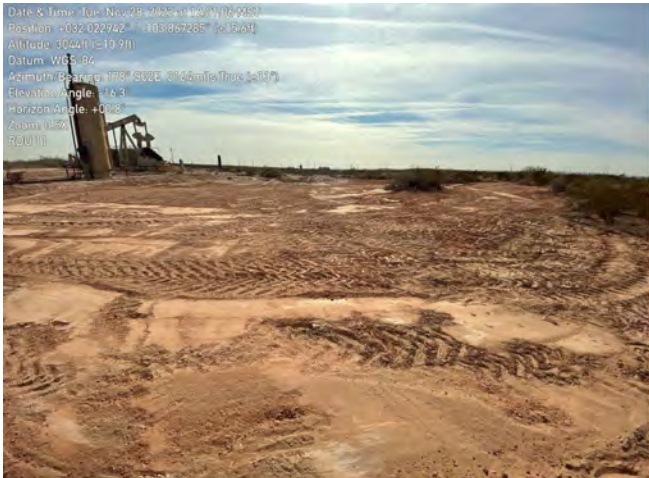
**Photograph 7****Date: 11/28/2023**

Description: Southeast view of restoration activities of the northern excavation.

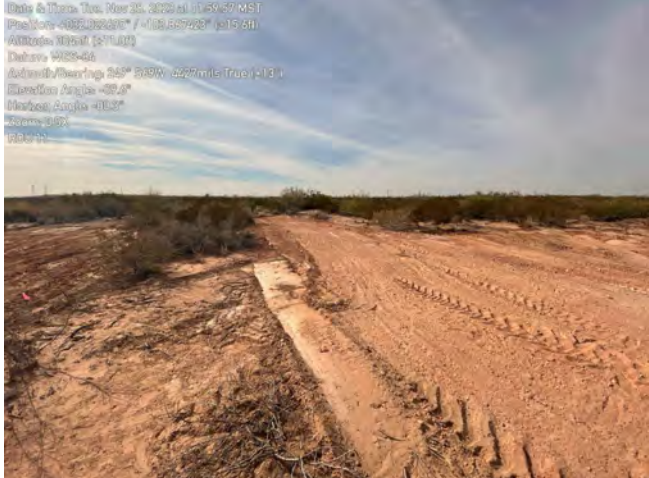
**Photograph 8****Date: 11/28/2023**

Description: Southwest view of restoration activities of the northern excavation.

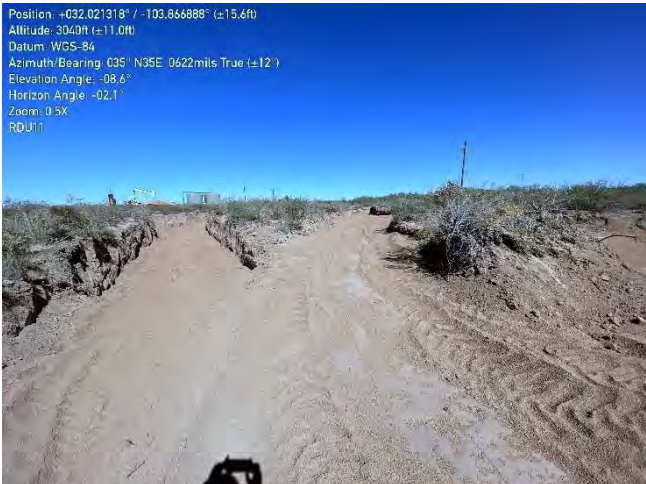
**Photograph 3****Date: 10/26/2023**

Description: Northeastern view of excavation activities from the southern excavation.

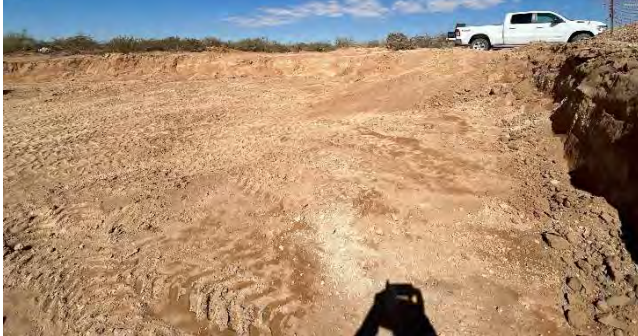
**Photograph 1****Date: 10/30/2023**

Description: Northwestern view of excavation activities from the northern excavation.

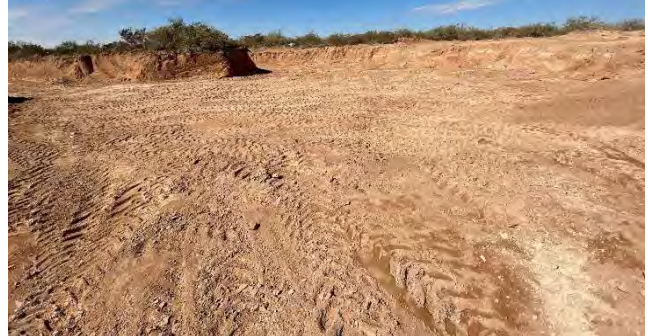
**Photograph 2****Date: 10/30/2023**

Description: Northwestern view of excavation activities from the northern excavation.

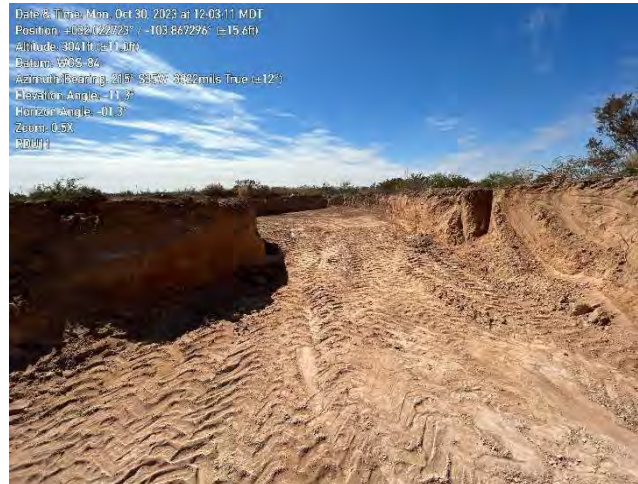
**Photograph 3****Date: 10/30/2023**

Description: Southwestern view of excavation activities from the northern excavation.

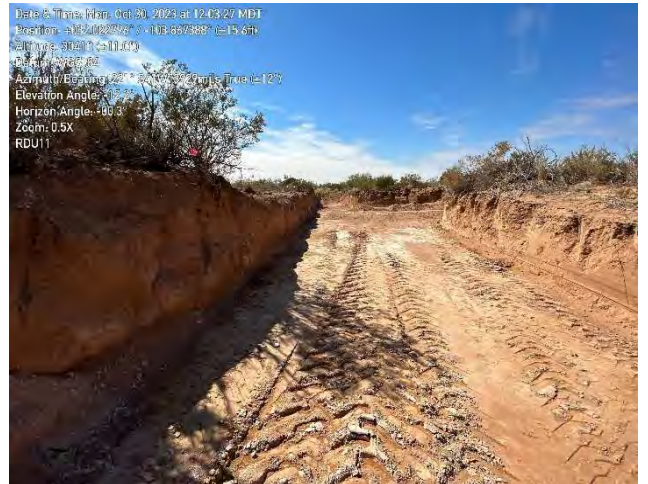
**Photograph 4****Date: 10/30/2023**

Description: Southwestern view of excavation activities from the northern excavation.

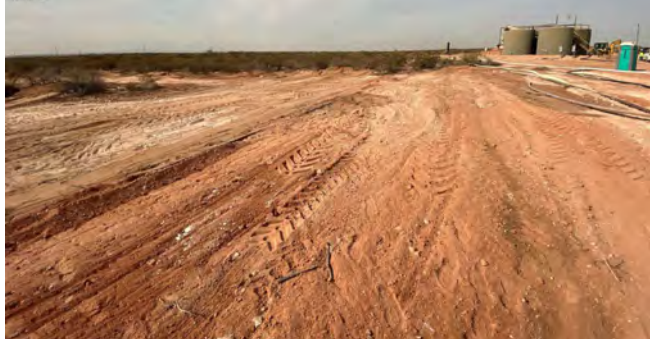
**Photograph 5****Date: 11/28/2023**

Description: Northwestern view of restoration activities of the southern excavation.

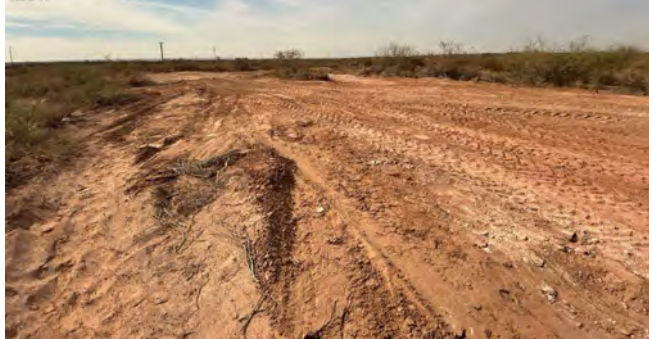
**Photograph 6****Date: 11/28/2023**

Description: Southwestern view of restoration activities of the southern excavation.

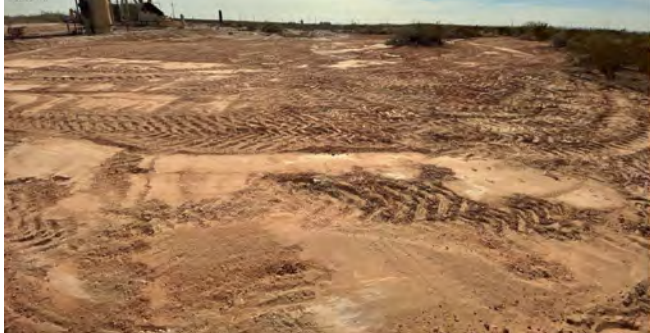
**Photograph 7****Date: 11/28/2023**

Description: Southeast view of restoration activities of the northern excavation.

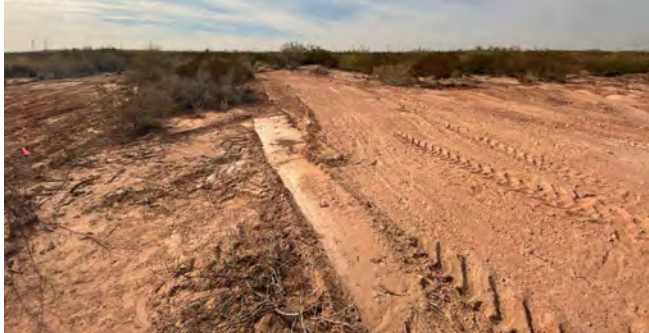
**Photograph 8****Date: 11/28/2023**

Description: Southwest view of restoration activities of the northern excavation.
