**Re: Closure Request  
Mesa 8105-JV-P 004H  
Incident Number nOY1831160155  
Lea County, New Mexico**

Ensolum, LLC (Ensolum), on behalf of BTA Oil Producers, LLC (BTA), has prepared this *Closure Request* to document delineation, excavation, and soil sampling activities performed at the Mesa 8105-JV-P 004H (Site), in accordance with an approved *Remediation Work Plan (Work Plan)* submitted June 9, 2023. The *Work Plan* proposed lateral and vertical delineation of the release. Based on the delineation activities completed and laboratory analytical results from the soil sampling events in accordance with the *Work Plan*, BTA is submitting this *Closure Request*, describing remediation that has occurred and requesting closure for Incident Number nOY1831160155.

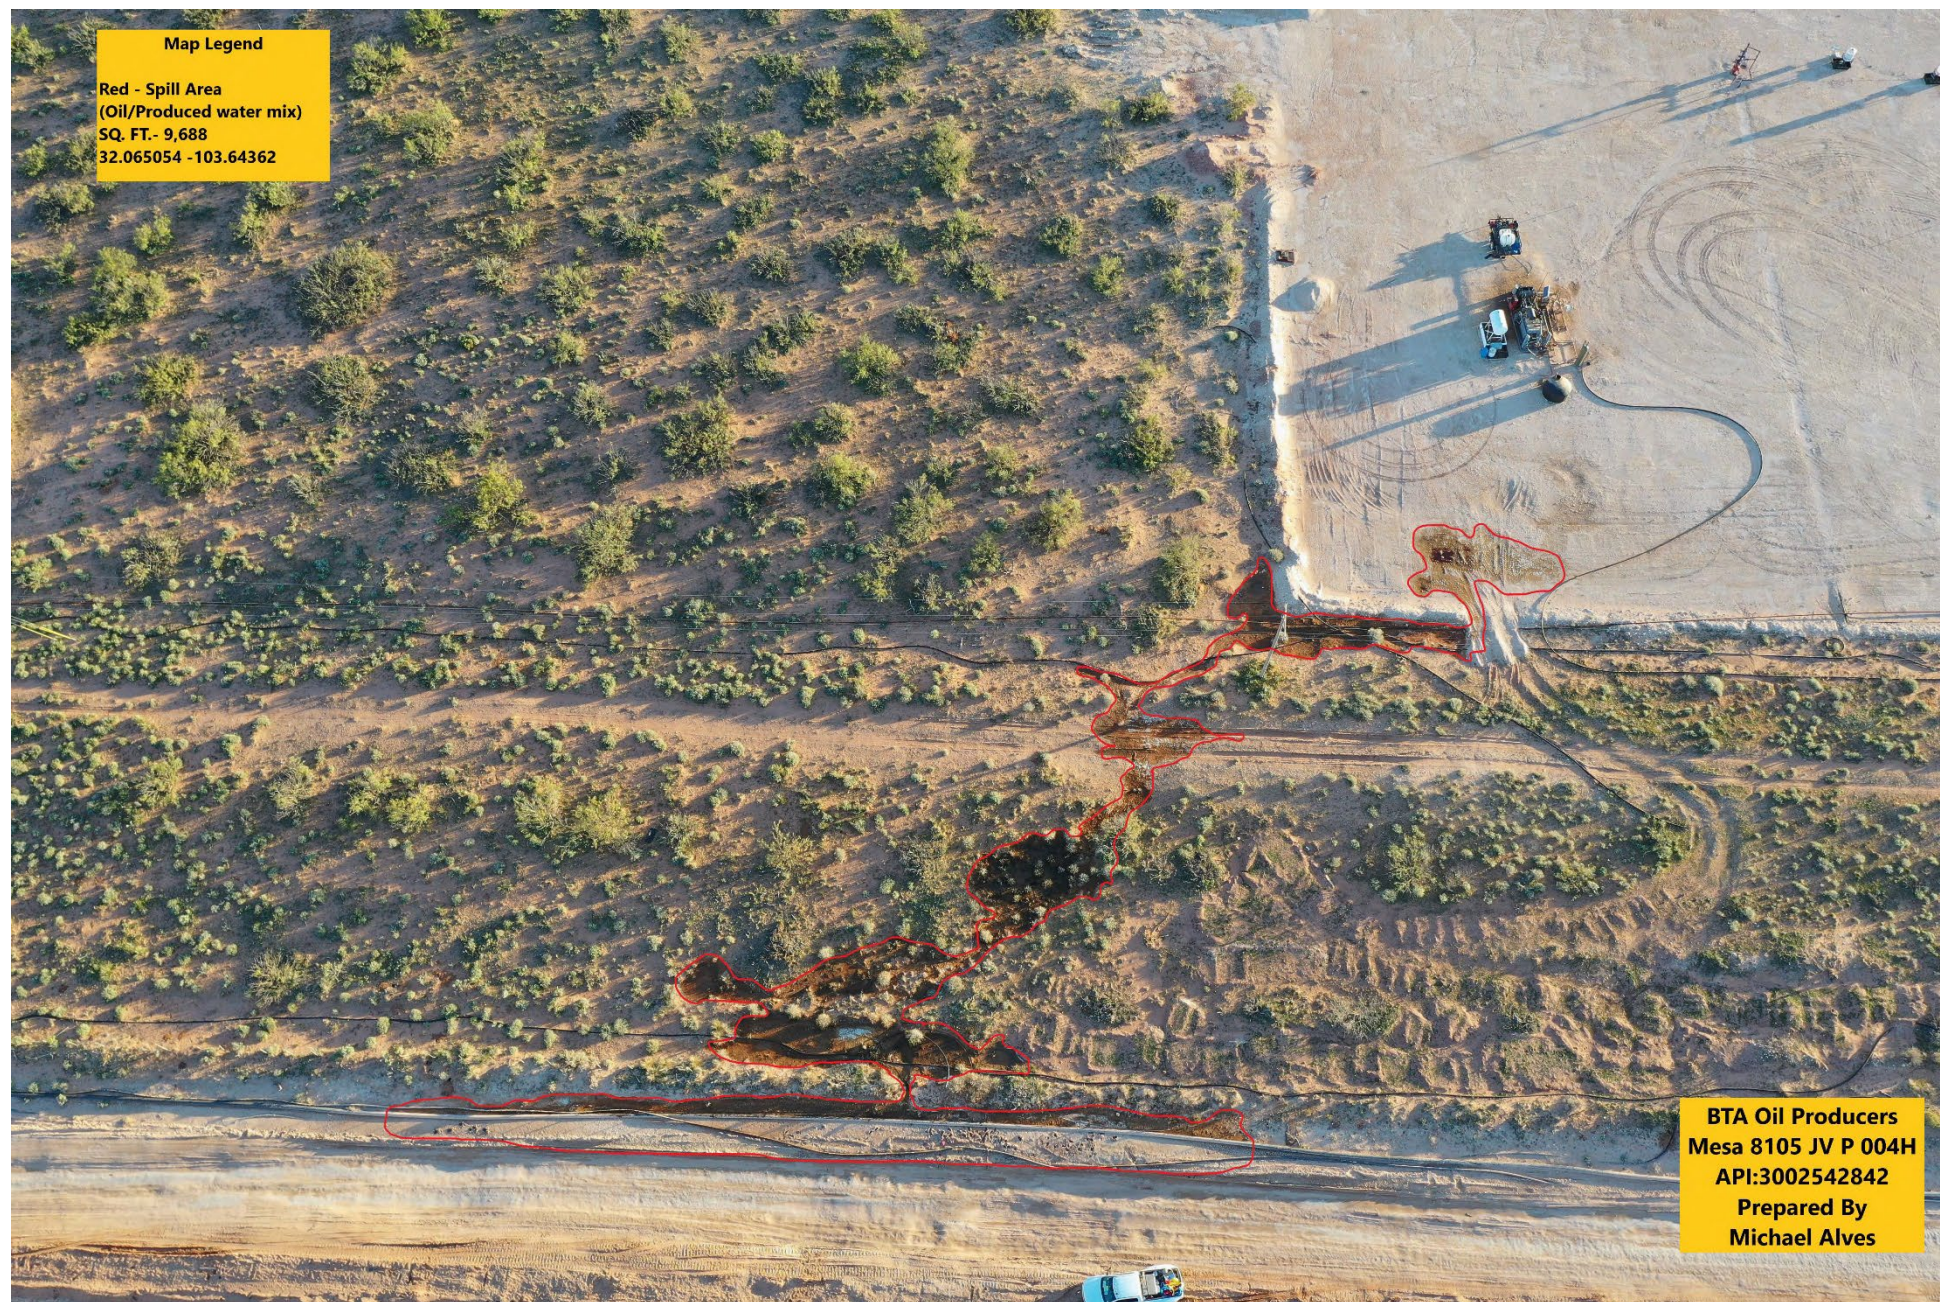
Figure 2  
Documented Release Extent (October 2018)

Release Extent

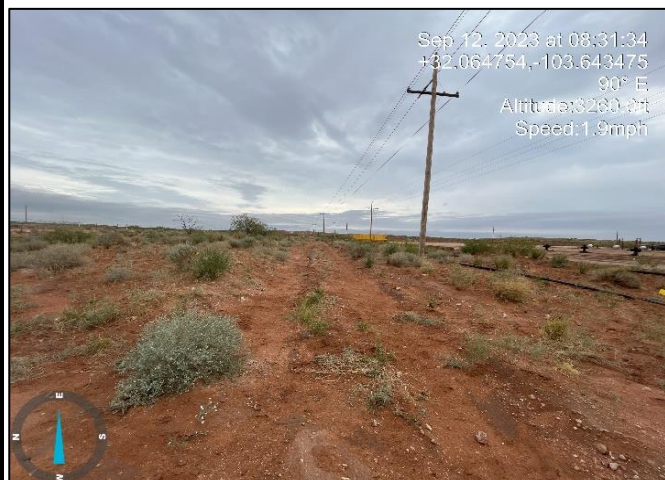
Photograph: 1  
Description: Delineation activities  
View: East

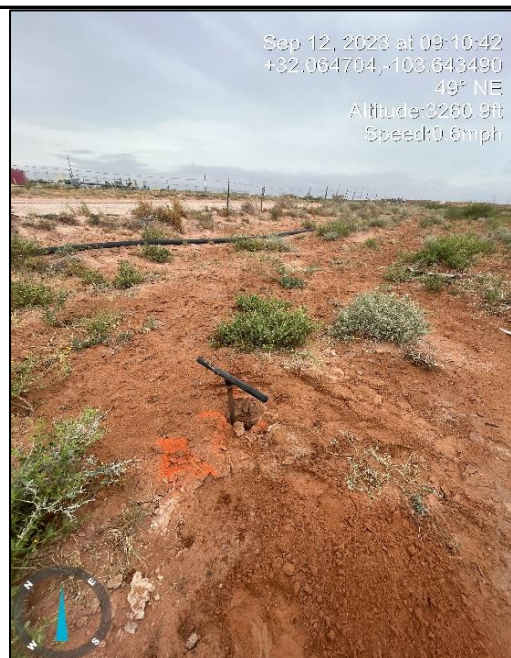
Photograph: 2  
Description: Delineation activities  
View: Northeast

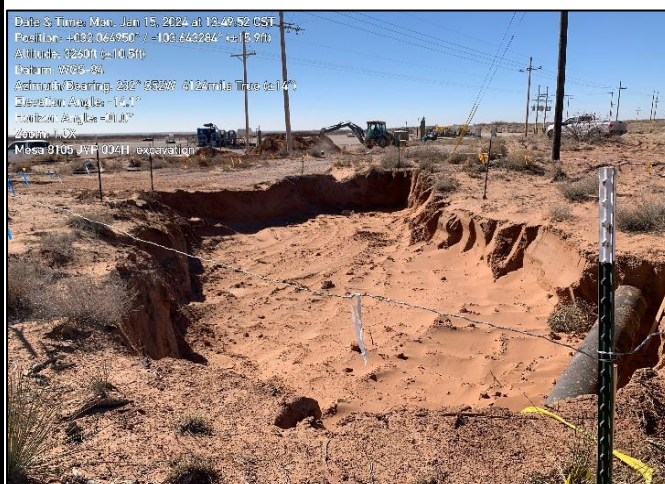
Photograph: 3  
Description: Excavation activities  
View: Southwest

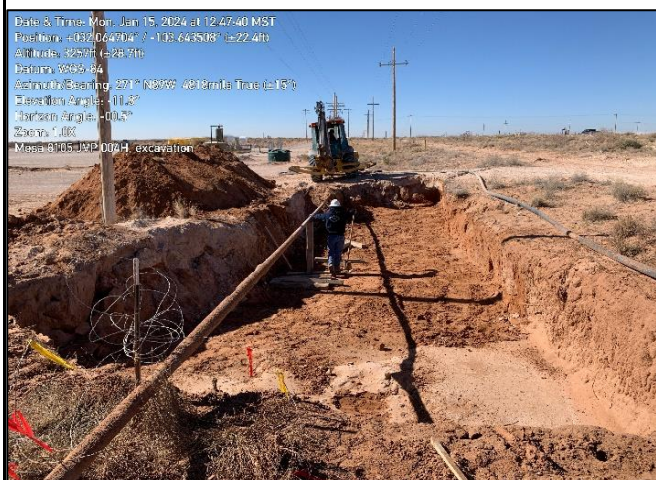
Photograph: 4  
Description: Excavation activities  
View: Northwest
