DEFERRAL REQUEST REPORT

RDx Federal 21 #031

Eddy County, New Mexico

Incident Number nAPP2326847671

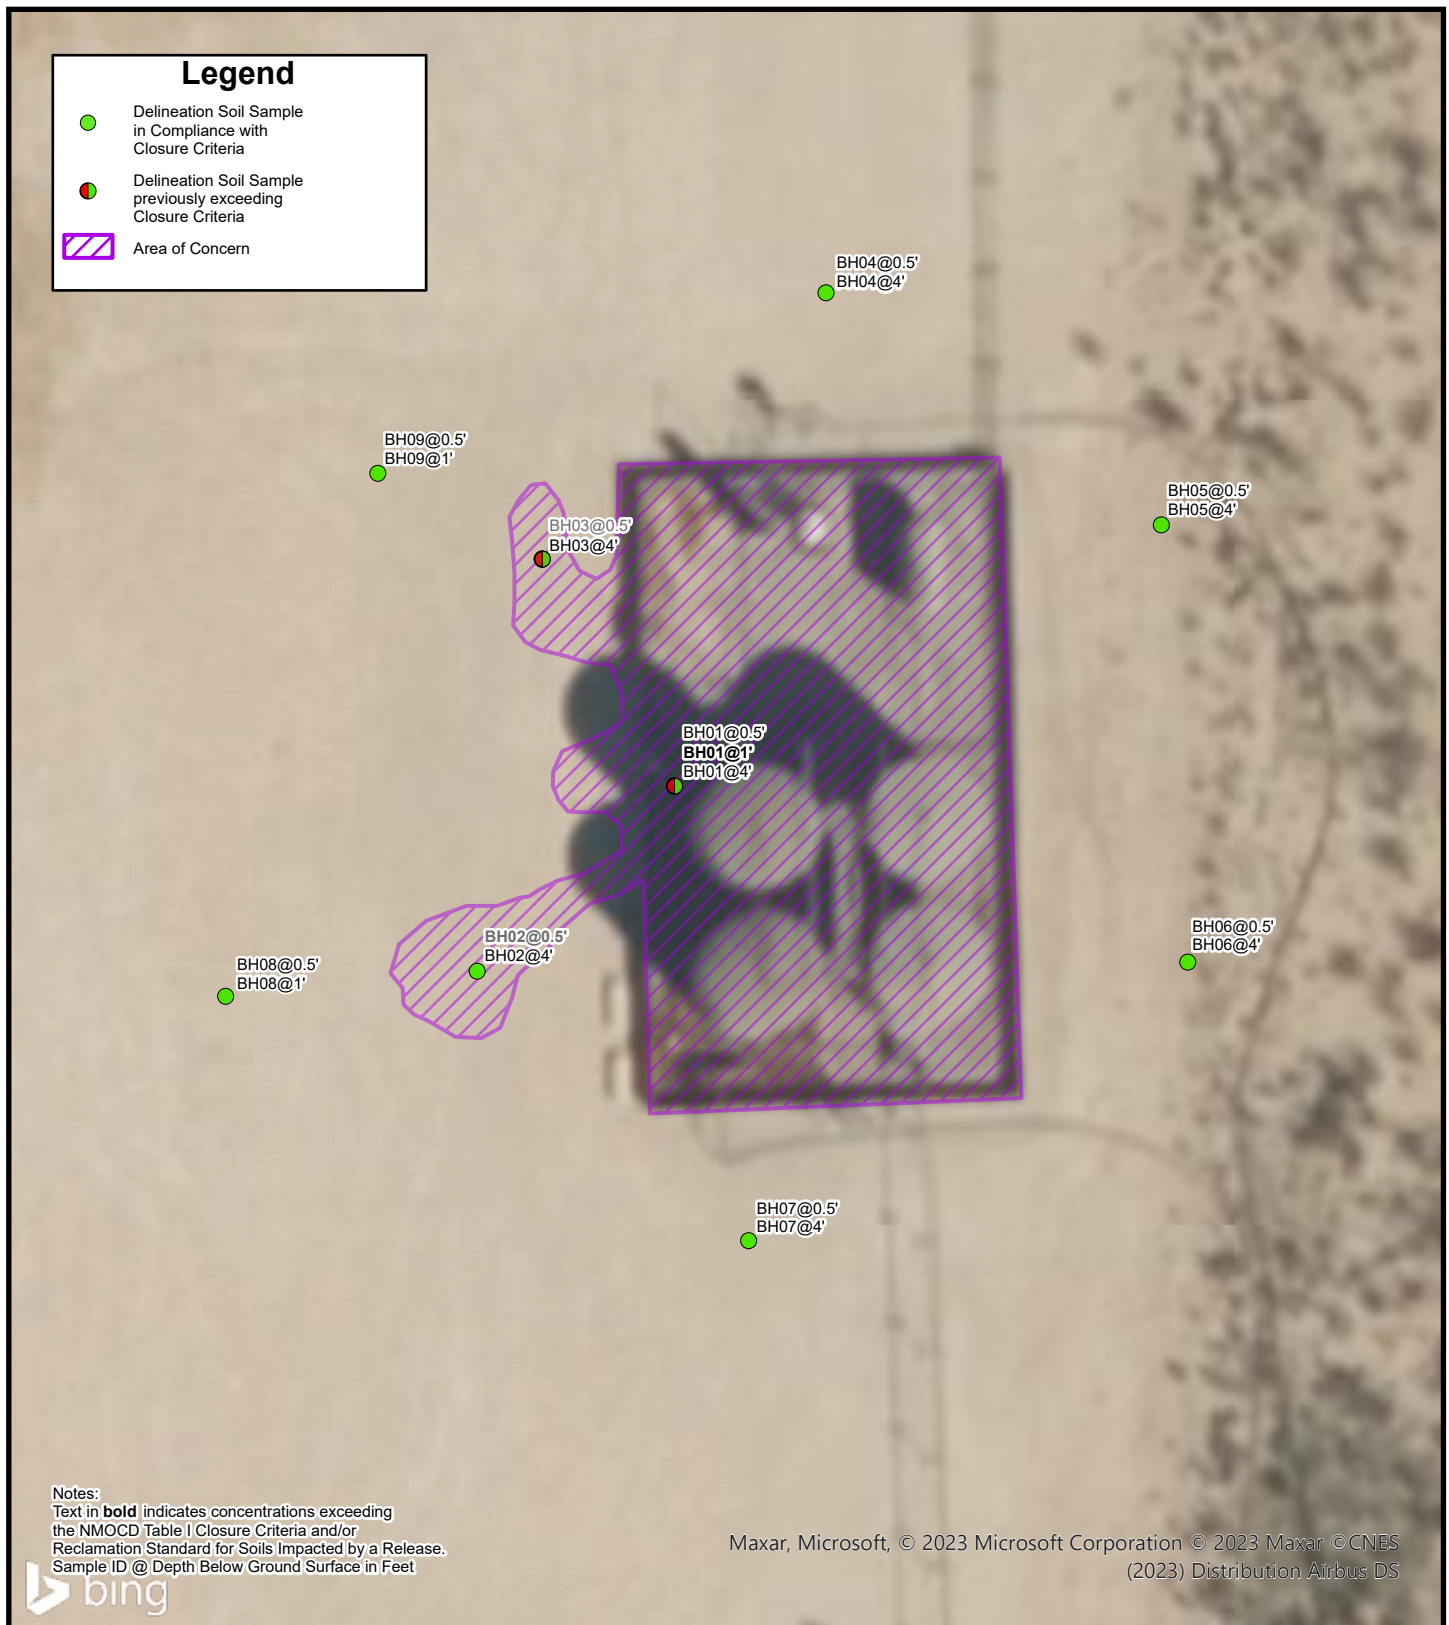
FIGURE 2

On September 25, 2023, Etech conducted initial site assessment activities which included mapping the observed release footprint, hereafter referred to as the Area of Concern (AOC). **Figure 2 in Appendix A** depicts the AOC. Following the removal of fluids and cleaning of the tank battery containment, on October 17, 2023, Etech conducted a liner inspection following a 48-hour notice to the NMOCD and determined the integrity of the liner was compromised. Continued corrective actions, which include summaries of excavation activities, sampling events, and laboratory analytical results are described below.

Laboratory analytical results for delineation soil samples collected within the AOC indicated one or more of the concentrations of the COCs exceeded the Site Closure Criteria. Laboratory analytical results are summarized in **Table 1** included in **Appendix E**. The executed chain-of-custody forms and laboratory analytical reports are provided in **Appendix F**.

Delineation Soil Sample Locations

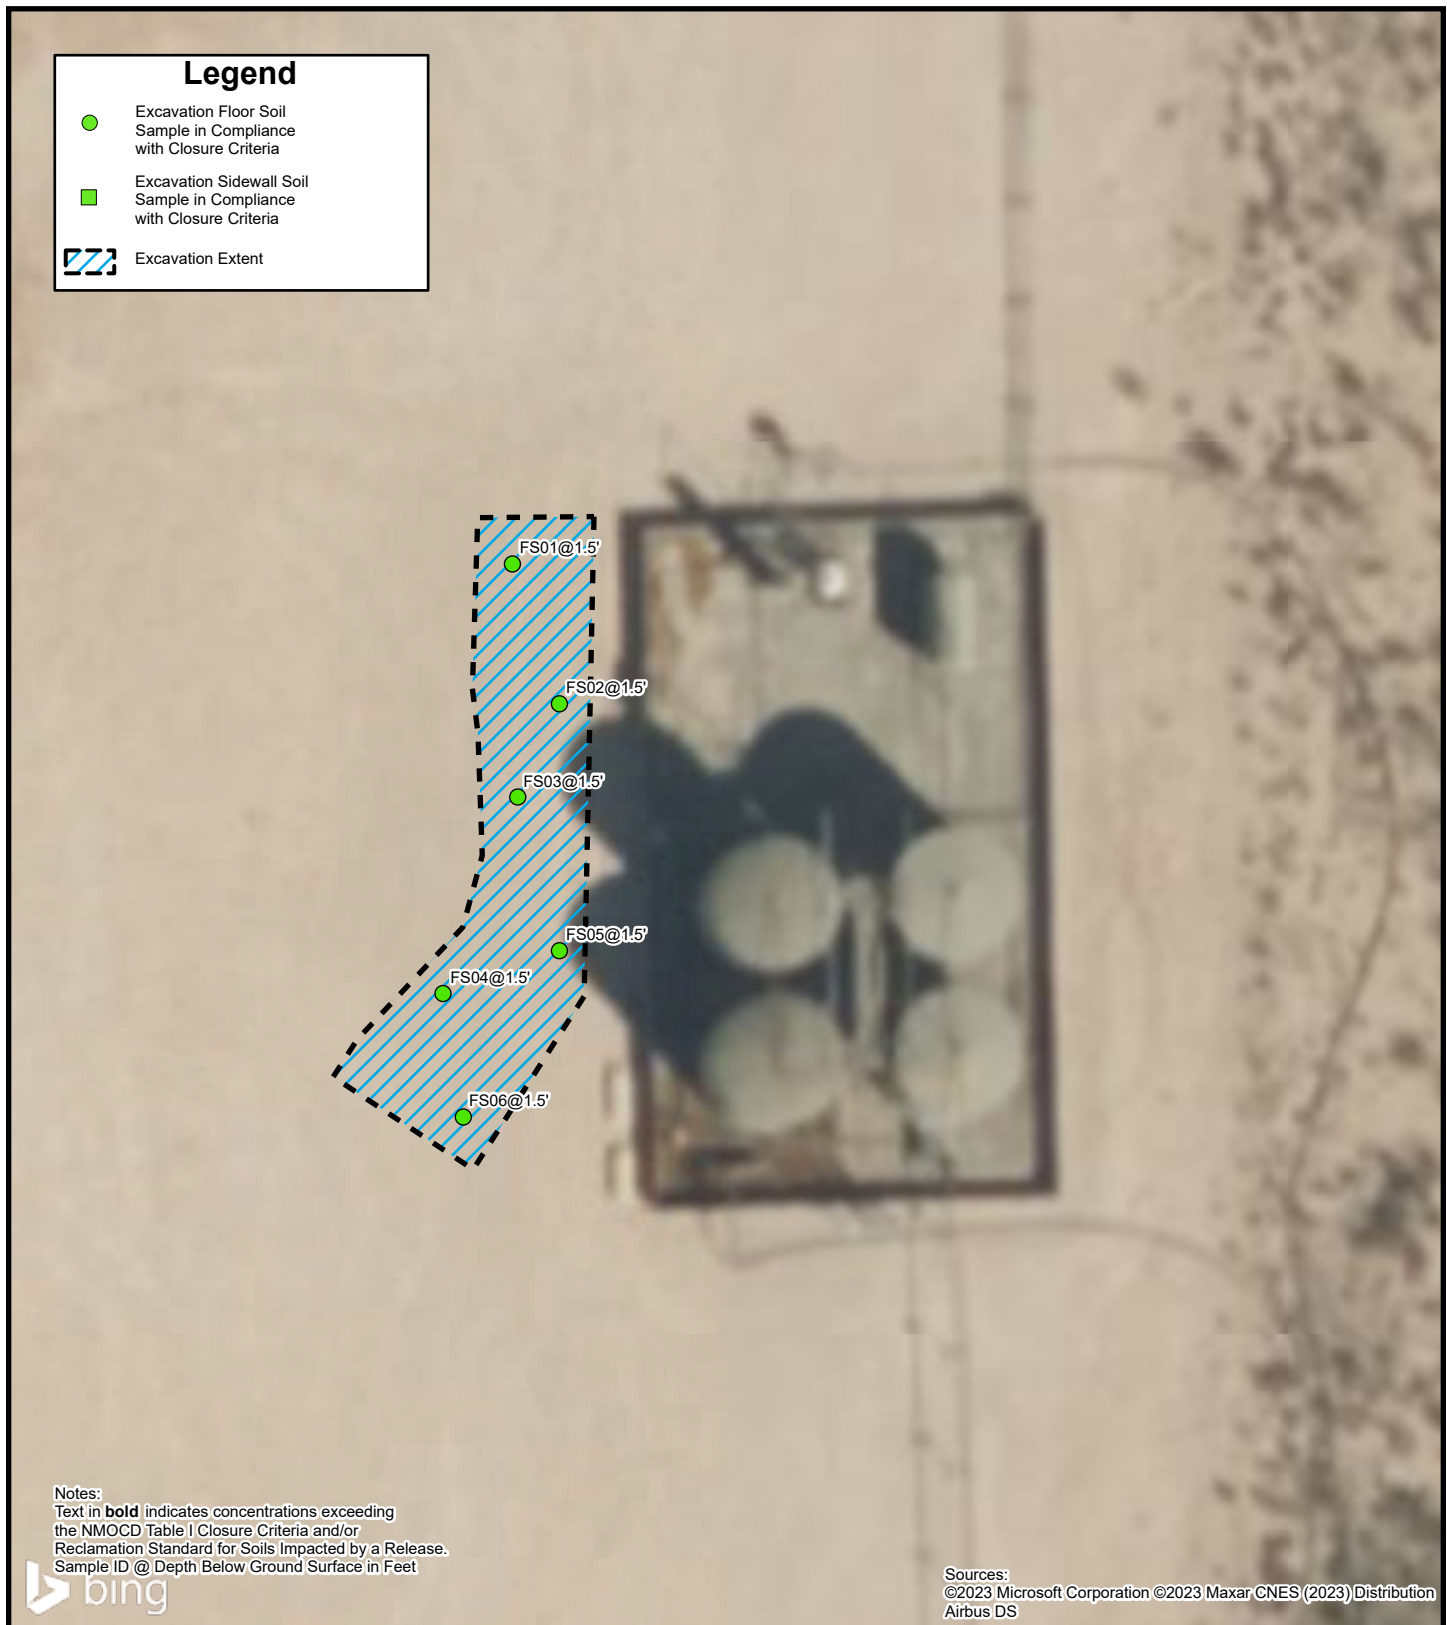
FIGURE 3

Following the removal of impacted soil, Etech collected 5-point composite confirmation soil samples at a frequency no greater than 200 square feet from the excavation. Due to the shallow depth of the excavation, soil from the excavation sidewalls were included in floor samples (FS01 through FS06). The 5-point composite soil samples were comprised of five equivalent aliquots homogenized in a 1-gallon, resealable plastic bag. Excavation confirmation soil samples were handled and analyzed as previously described. The locations of the excavation confirmation soil samples are shown in **Figure 3** in **Appendix A**.

Laboratory analytical results for all excavation confirmation soil samples collected indicated all concentrations of the COCs were below the Site Closure Criteria and/or reclamation standard. Laboratory analytical results are summarized in **Table 1** included in **Appendix E**. The executed chain-of-custody forms and laboratory analytical reports are provided in **Appendix F**.

Excavation Soil Sample Locations

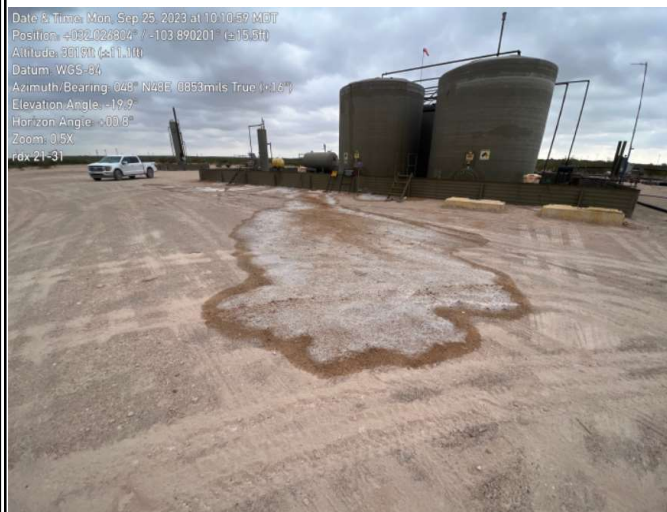
**Photograph 1****Date: 09/25/2023**

On September 23, 2023, an equipment malfunction caused a produced water tank to overflow and release approximately 10 barrels (bbls) of crude oil and 195 bbls of produced water into a tank battery lined containment. Approximately 5 bbls of fluids breached the containment and escaped to the pad surface. Vacuum trucks were immediately dispatched and recovered approximately 10 bbls of crude oil and 190 bbls of produced water. Immediate notice was given via email to the New Mexico Oil Conservation Division (NMOCD) via email on September 24, 2023. WPX reported the release to the NMOCD on a Corrective Action Form C-141 (Form C-141), which was received by the NMOCD on September 25, 2023, and was subsequently assigned Incident Number nAPP2326847671.

Description: Northeastern view of release prior to remediation activities.

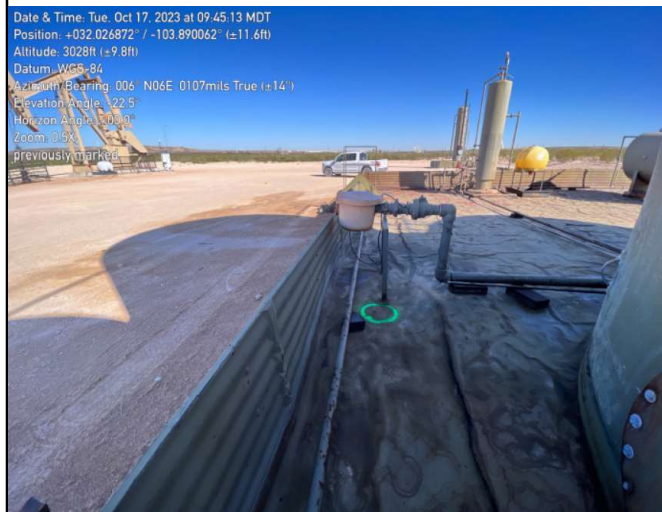
**Photograph 2****Date: 10/17/2023**

Description: Northern view of liner inspection activities, liner breach circled in green.

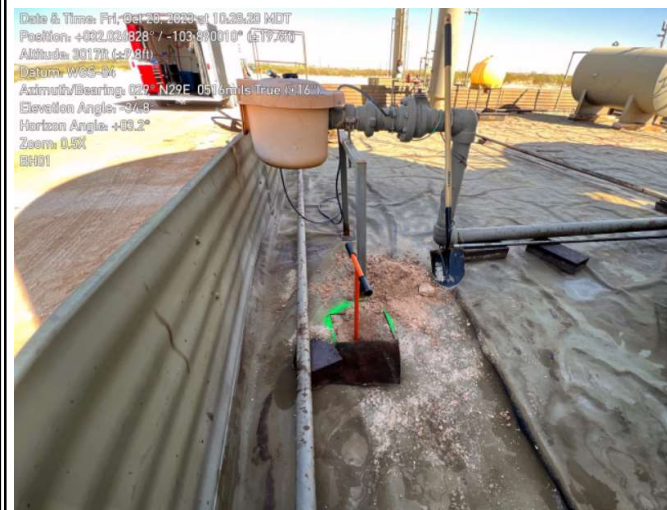
**Photograph 3****Date: 10/20/2023**

Description: Northern view of delineation activities.

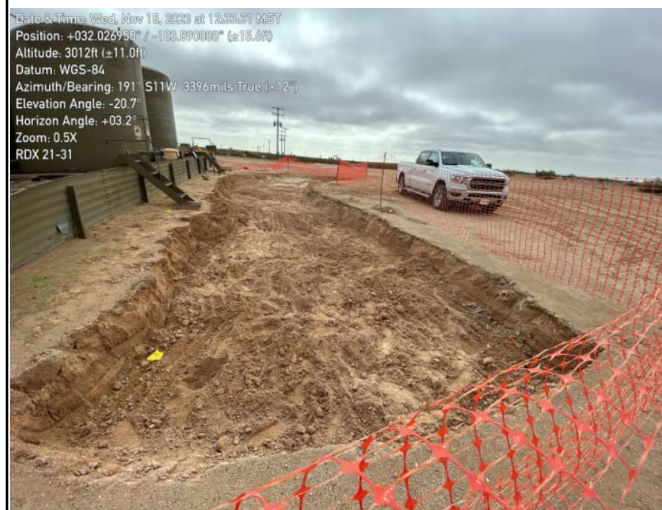
**Photograph 4****Date: 11/15/2023**

Description: Southern view of excavation activities.

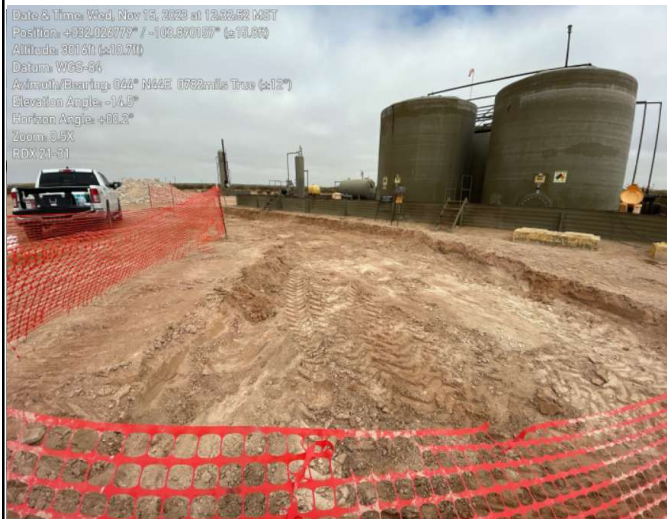
Photograph 5

Description: Northeastern view of excavation activities.

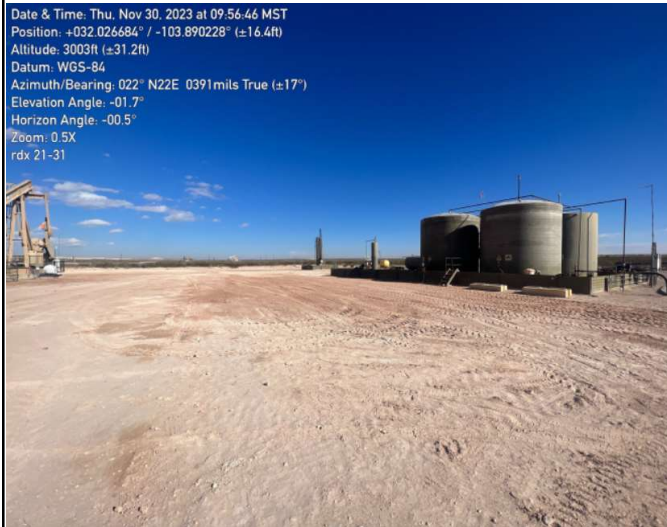
Photograph 7

Description: Northeastern view of restoration activities.
