Remediation Summary and Closure Request

BTA Oil Producers, LLC

Rojo 10-13

NMOCD Incident # nAPP2324131406

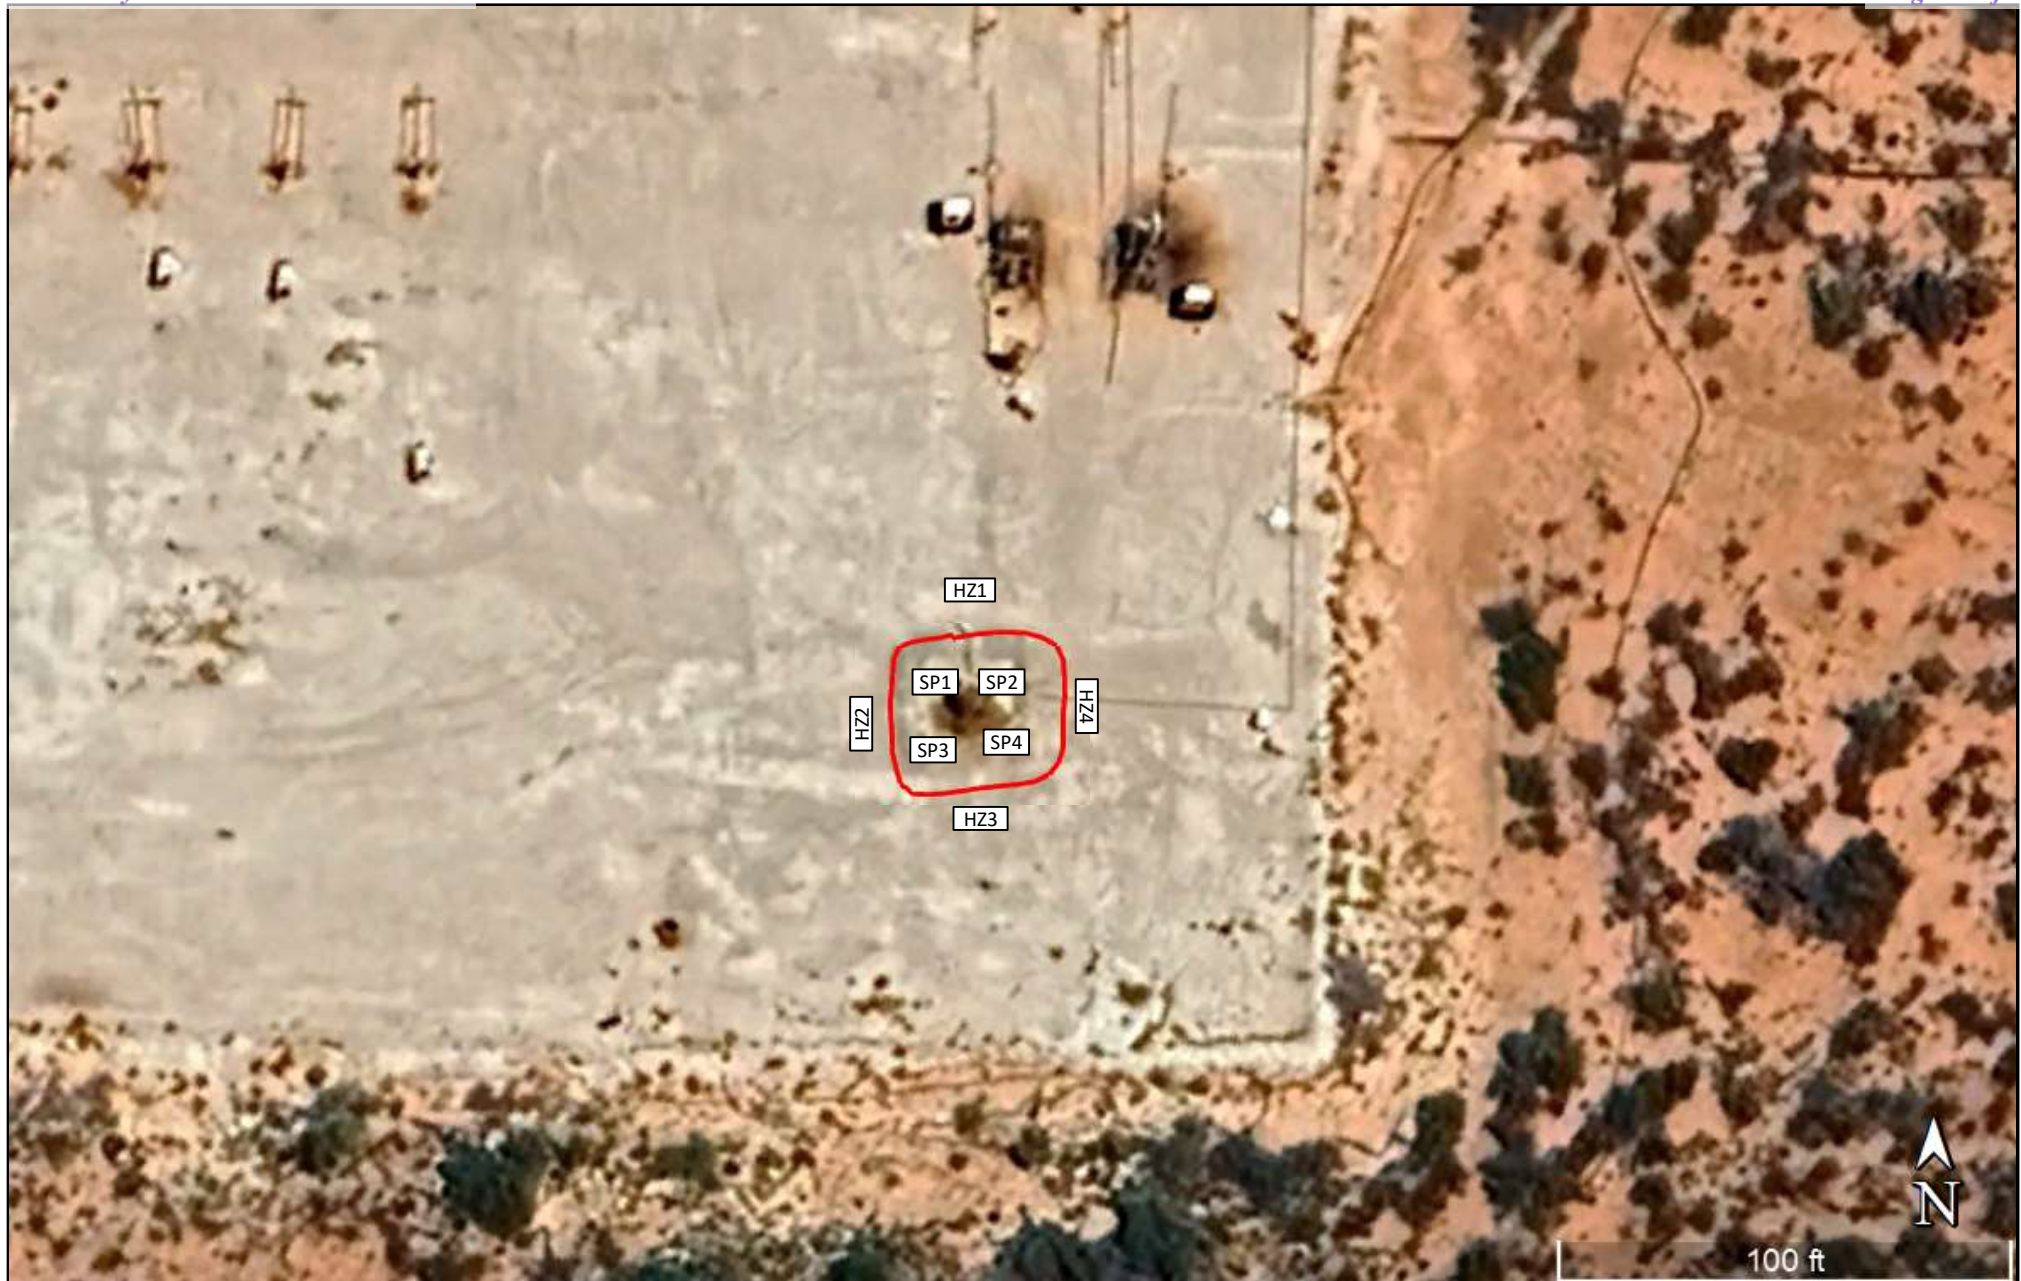
**Figure 4**

Delineation Sample Map
BTA Oil Producers, LLC
Rojo 10-13
GPS: 32.107294, -103.555319
Lea County

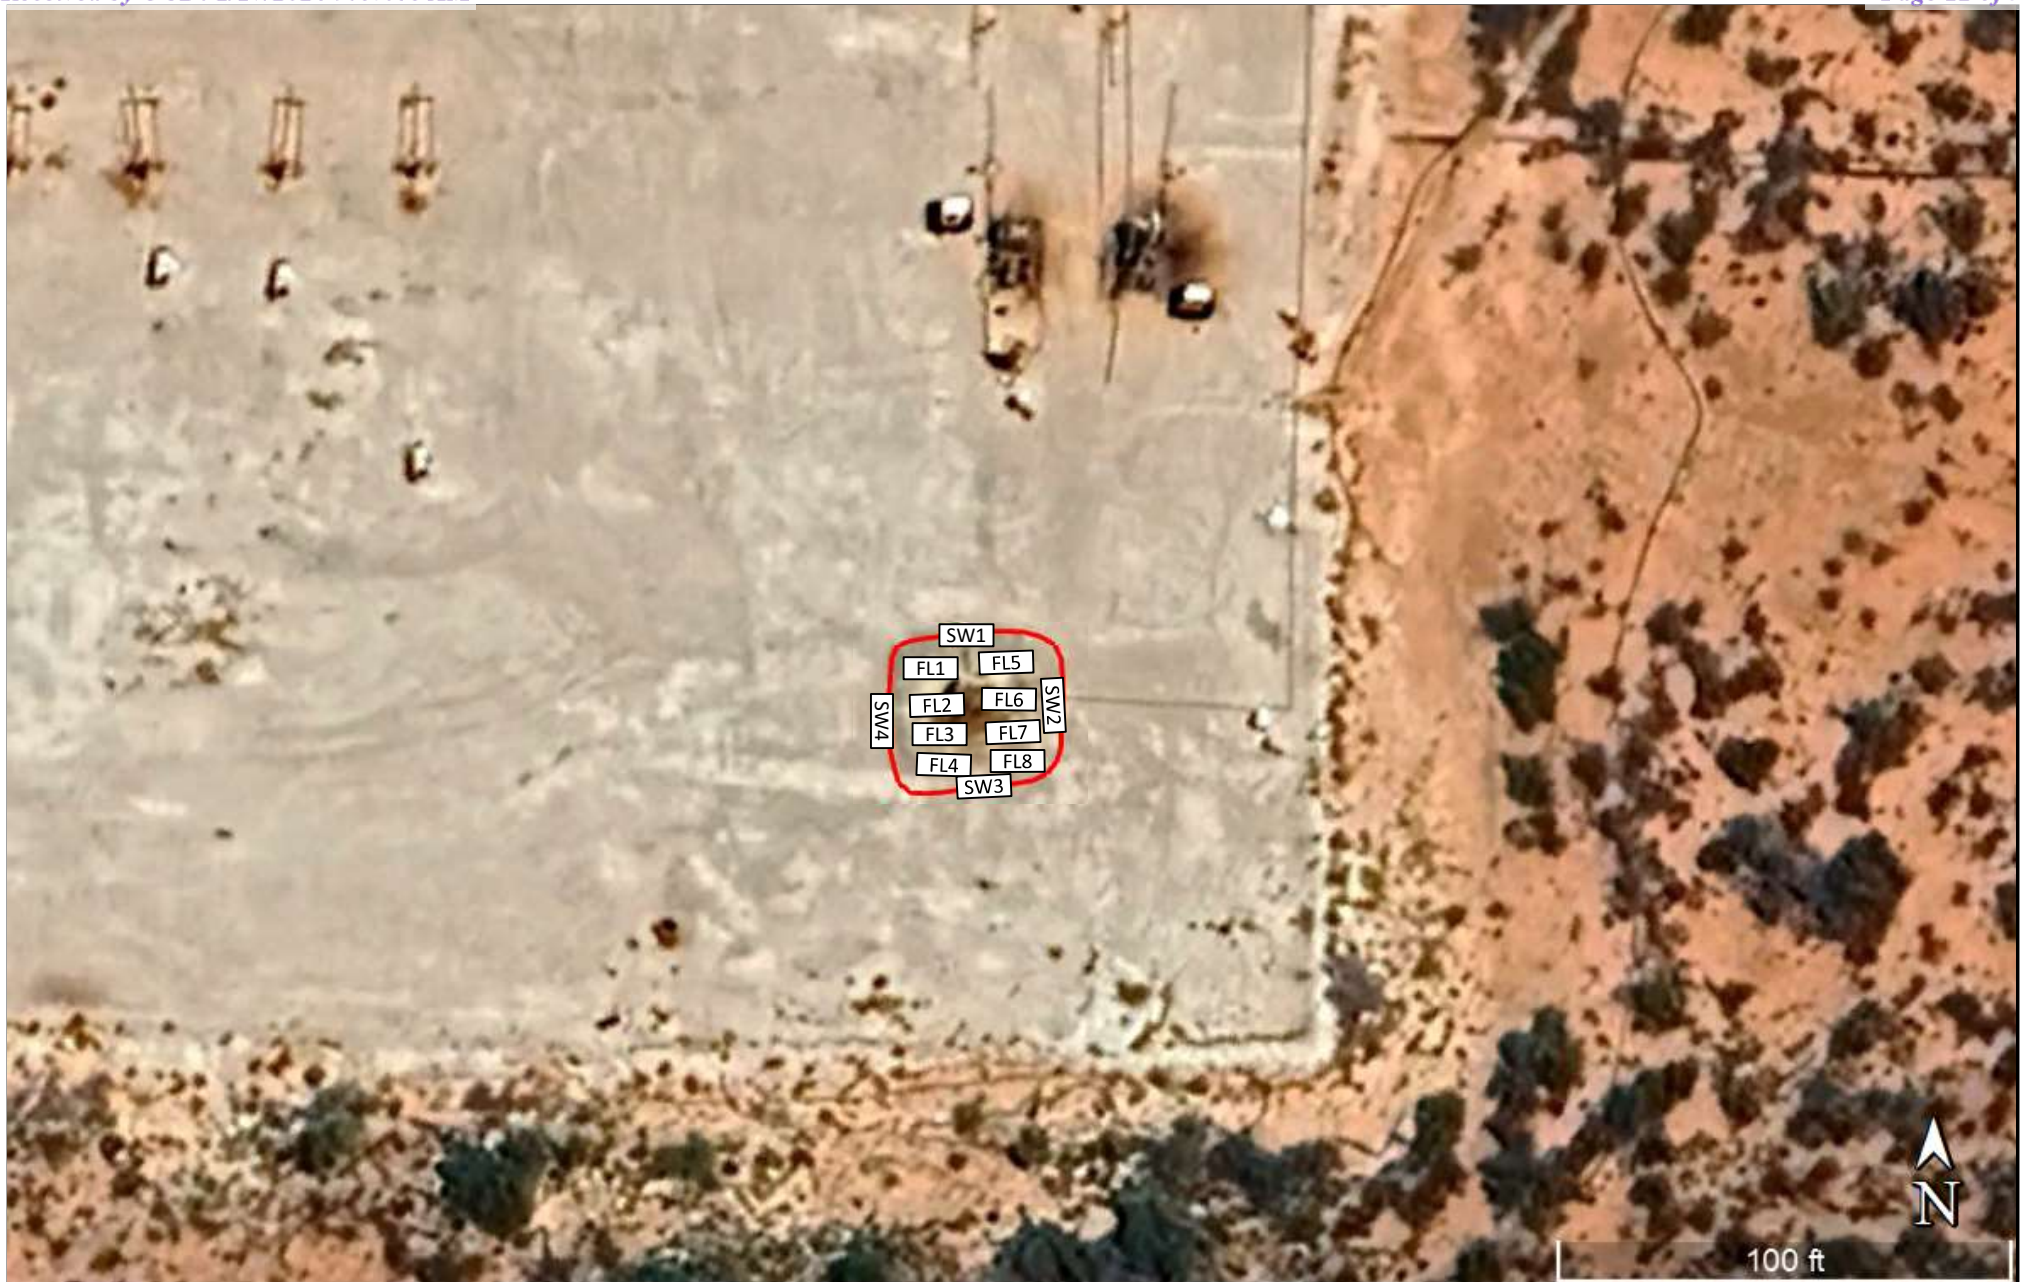
**Figure 5**

Excavation Sample Map
