RE: Liner Inspection and Closure Report
Halberd 27 State 3H Battery
API No. N/A
GPS: Latitude 32.80720 Longitude -104.15500
UL- E, Section 26, Township 17S, Range 28E
NMOCD Reference No. NAPP2330733832

Spur Energy Partners (Spur) has contracted Pima Environmental Services, LLC (Pima) to perform a liner inspection and prepare this closure report for the release of produced water that happened on the Halberd 27 State 3H Battery (Halberd). An initial C-141 was submitted on November 3, 2023, and can be found in Appendix B. This incident was assigned Incident ID NAPP2330733832, by the New Mexico Oil Conservation Division (NMOCD).

SITE PHOTOGRAPHS
SPUR ENERGY PARTNERS
Halberd 27 State 3H Battery

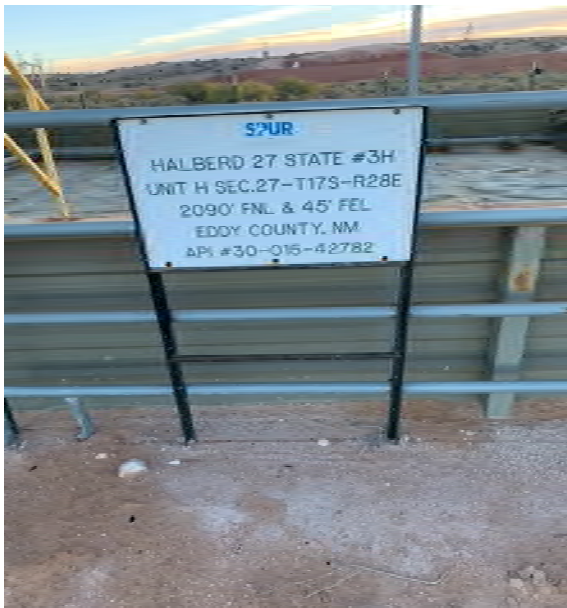
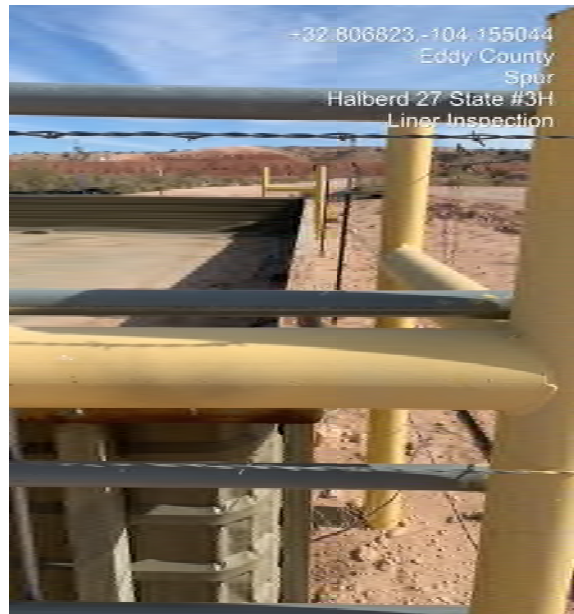
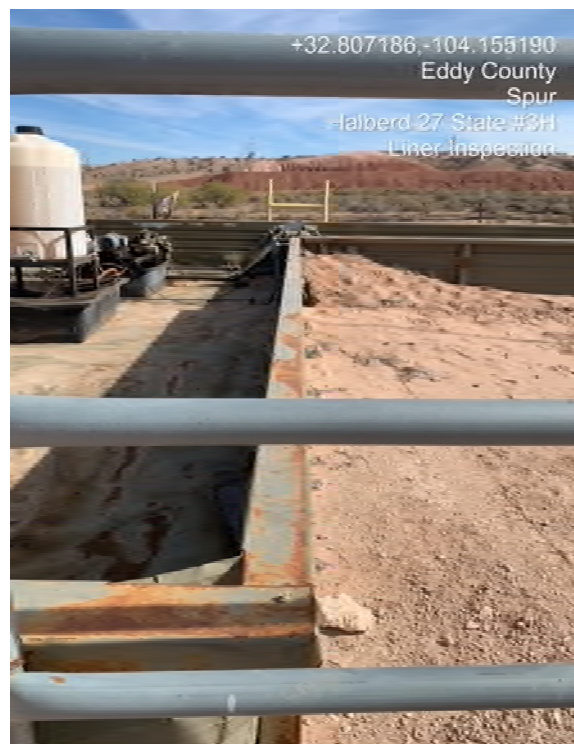
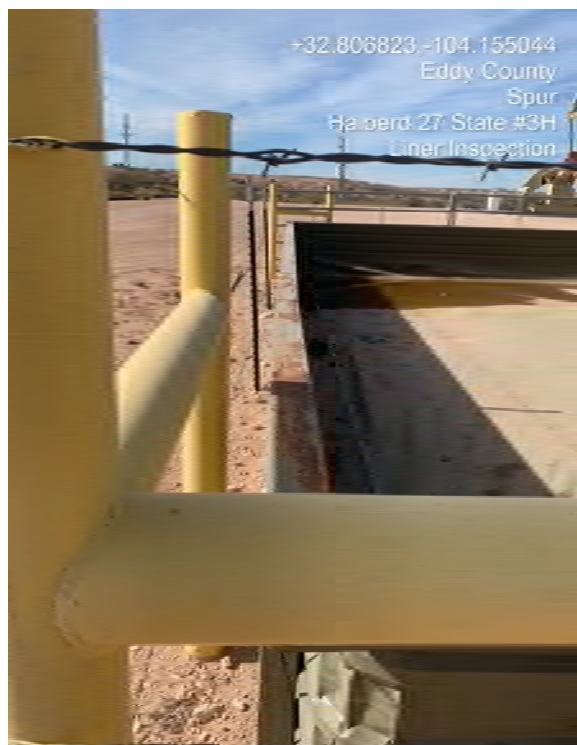
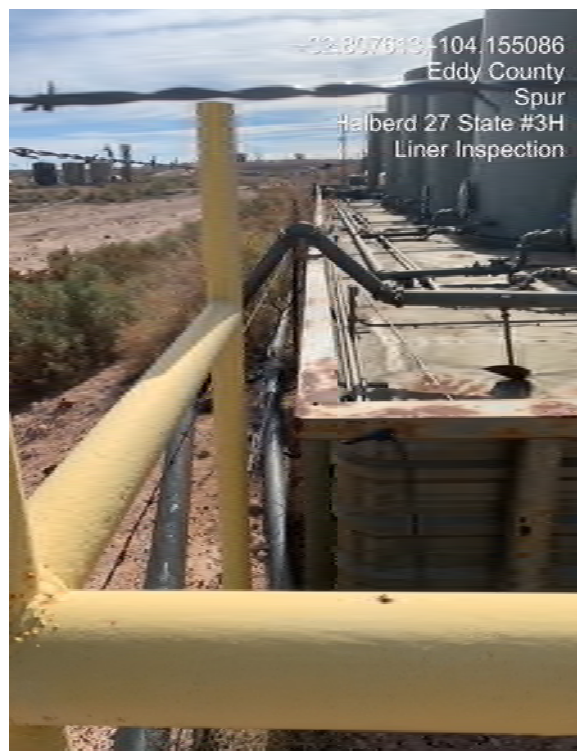
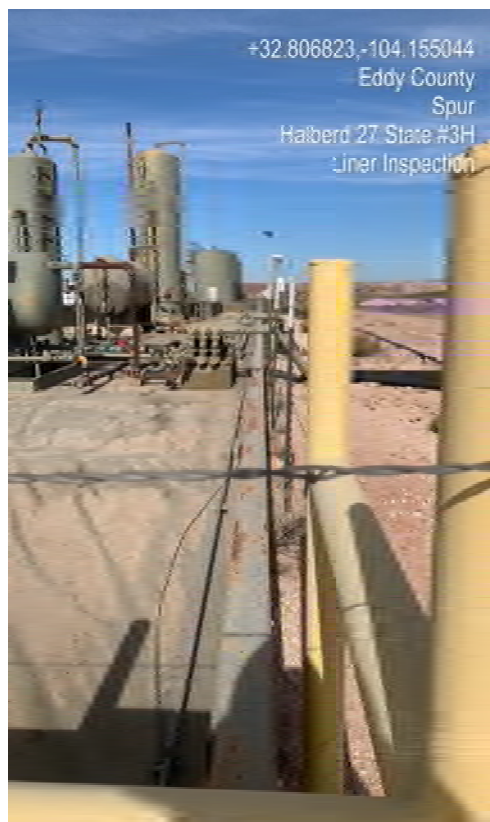
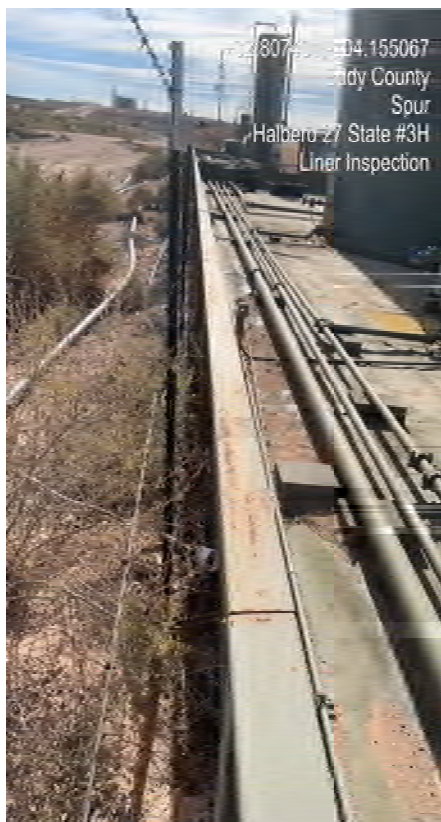
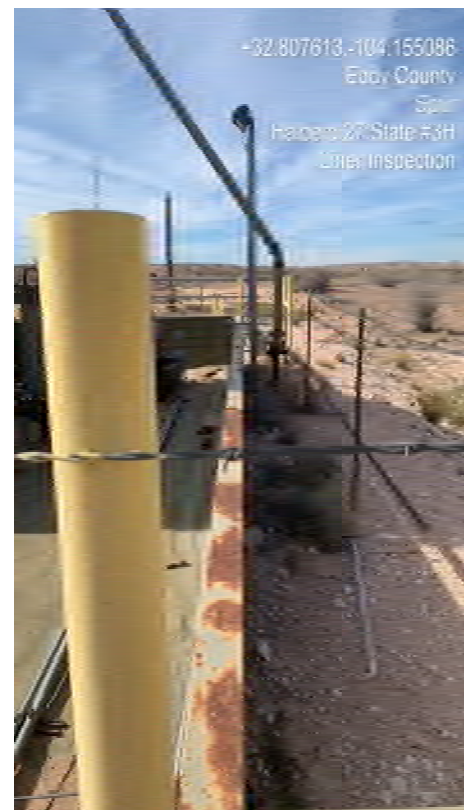
Liner Inspection:

On November 30, 2023, after sending the 48-hour notification via email, Pima Environmental conducted a liner inspection at this location. We concluded that this liner and containment maintained its integrity and was able to retain the fluids. The liner inspection form and photographic documentation can be found in Appendix C.

Visualization	Yes	No	Comments
Is there a tear in the liner?		X	
Are there holes in the liner?		X	
Is the liner retaining any fluids?	X		The inspection images of the liner reveal residual fluid resulting from the remediation event involving power washing.
Does the liner have integrity to contain a leak?	X

On November 28, 2023, the Pima personnel conducted a thorough cleaning of the lined containment by utilizing pressure washing techniques. Additionally, any remaining standing fluid was effectively removed using a vacuum truck.
