Site Assessment/Characterization

Remediation Plan

Durango Midstream, LLC
Hnulik 6 Lateral #1
32.80236°, -104.3429°
NMOCD Reference # nAPP2214534062
Terracon Project # AR227115

RE: Release Investigation and Remedial Action Plan
Hnulik 6 Lateral #1
Unit M, Section 25, Township 17 South, Range 26 East
32.80236°, -104.3429°
Eddy County, New Mexico
Terracon Project No. AR227115

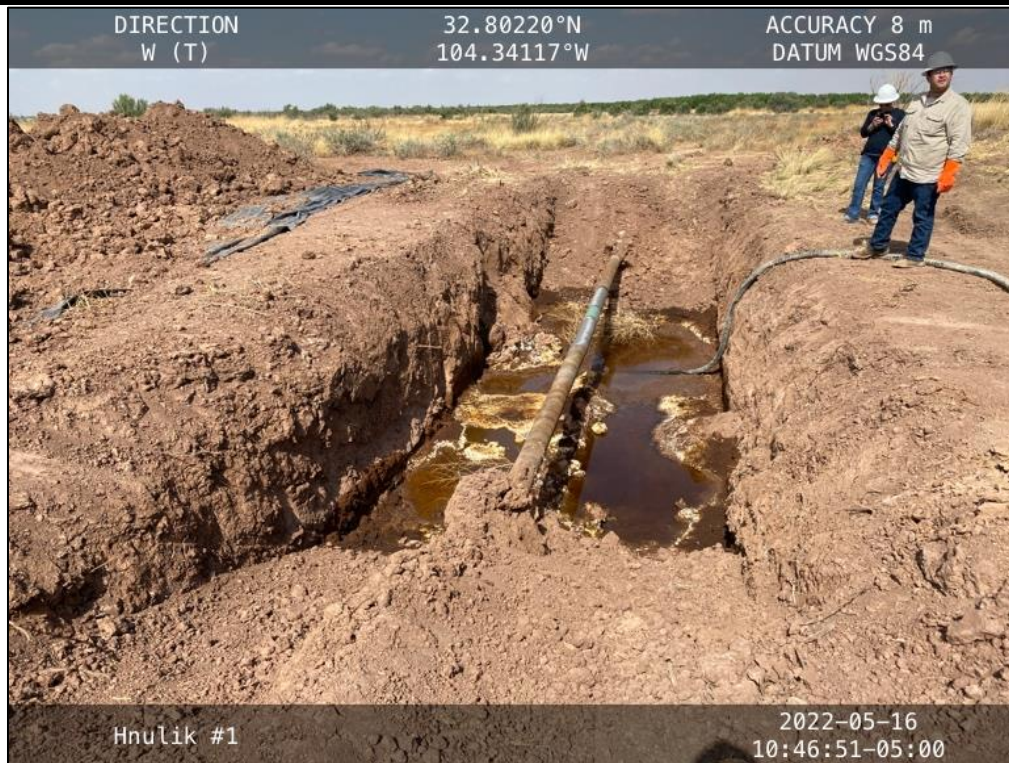
PHOTO 1: View of area prior to Excavation from the East.

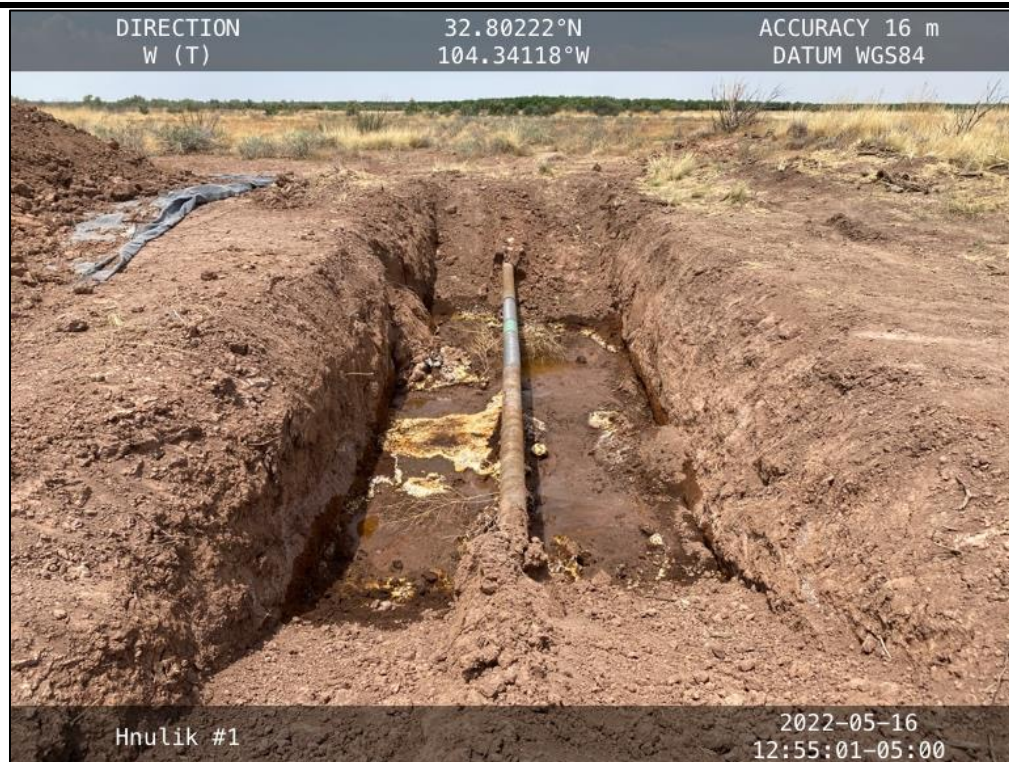
PHOTO 2: View of area prior Excavation from the East.

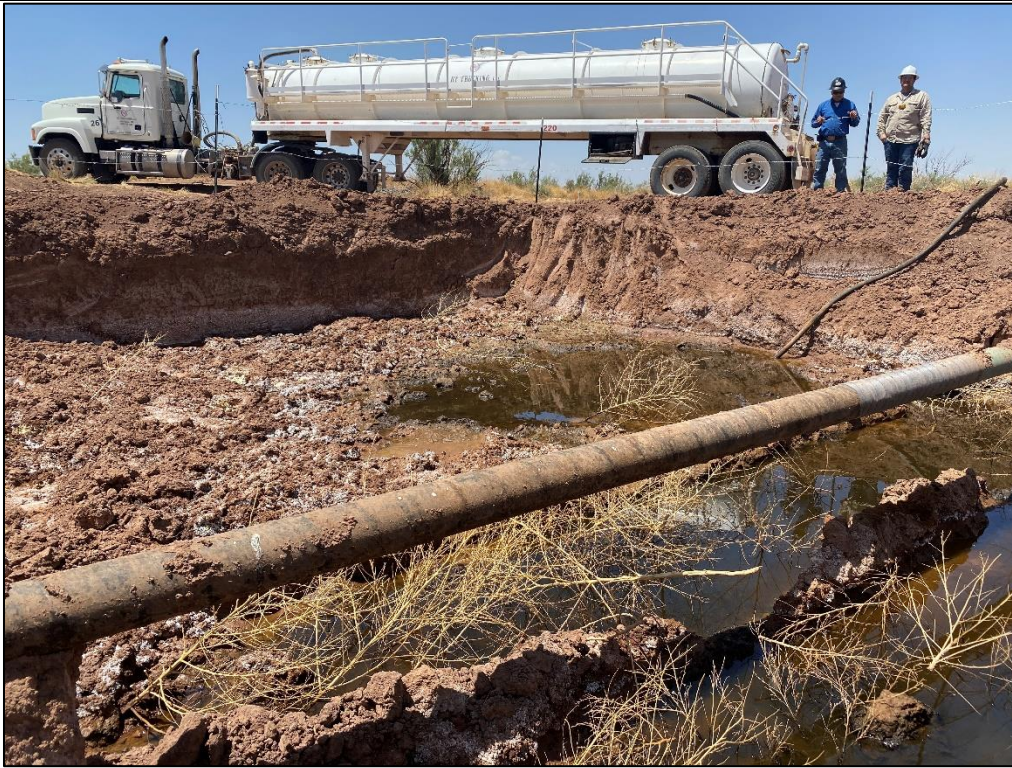
During soil excavation activities on May 16, 2022, perched alluvial water began infilling the excavation. The water recharge into the excavation observed periodically and was removed via trash pump into a water tank vessel for characterization prior to disposal. On July 12 and 13, 2022, field personnel returned to the project site to pump water from the excavation bottom resulting in the removal of approximately 525 bbls of liquid which was subsequently transported from site for disposal. On July 27, 2022, field personnel returned to the project site to pump additional liquid from the excavation bottom and removed approximately 480 bbls of water at this time and which was also stored in the on-site container for disposal. On August 2, 2022, additional liquid was removed from the excavation area and on this date 125 bbls of liquid were removed and containerized for disposal. In total, approximately 1,130 bbls of liquid was removed from the excavation area and transported to an approved disposal facility. Liquid removal activities will continue until background levels are reached.

PHOTO 3: View of open excavation, and removal of water.

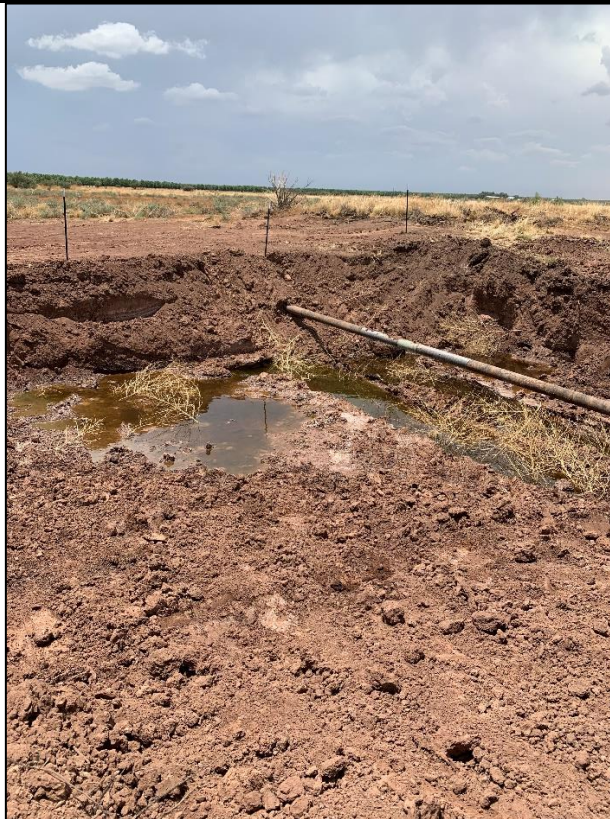
PHOTO 4: View of final Excavation, after trench dewatering and pipe repair.

- 1) The line failure has been repaired and the release has ceased.
- 2) Terracon conducted a background evaluation of soils present outside of the release margins to establish chloride background levels at the site. Chloride concentrations appear to be naturally elevated due to the natural accumulation of soil salinity resulting from the wetting and dry of chlorides within the Pecos River and from the rising and falling of the alluvial perched water. Based on the evaluation of the detected chloride concentrations evaluated utilizing the EPAs ProUCL calculator to determine 95% Upper Confidence Limit (UCL), the background chloride concentration for the site is calculated to be 22,389 milligrams per kilogram (mg/kg).
