**RE: Liner Inspection and Closure Report**  
**Arkansas State 23 Tank Battery**  
**API No. 30-015-40192**  
**GPS: Latitude 32.64745 Longitude -104.46073**  
**UL- E, Section 23, Township 19S, Range 25E**  
**NMOCD Reference No. NAPP2331331325**

**SITE PHOTOGRAPHS**  
**Spur Energy Partners**  
**Arkansas State 23 Tank**  
**Battery**

**Liner Inspection**

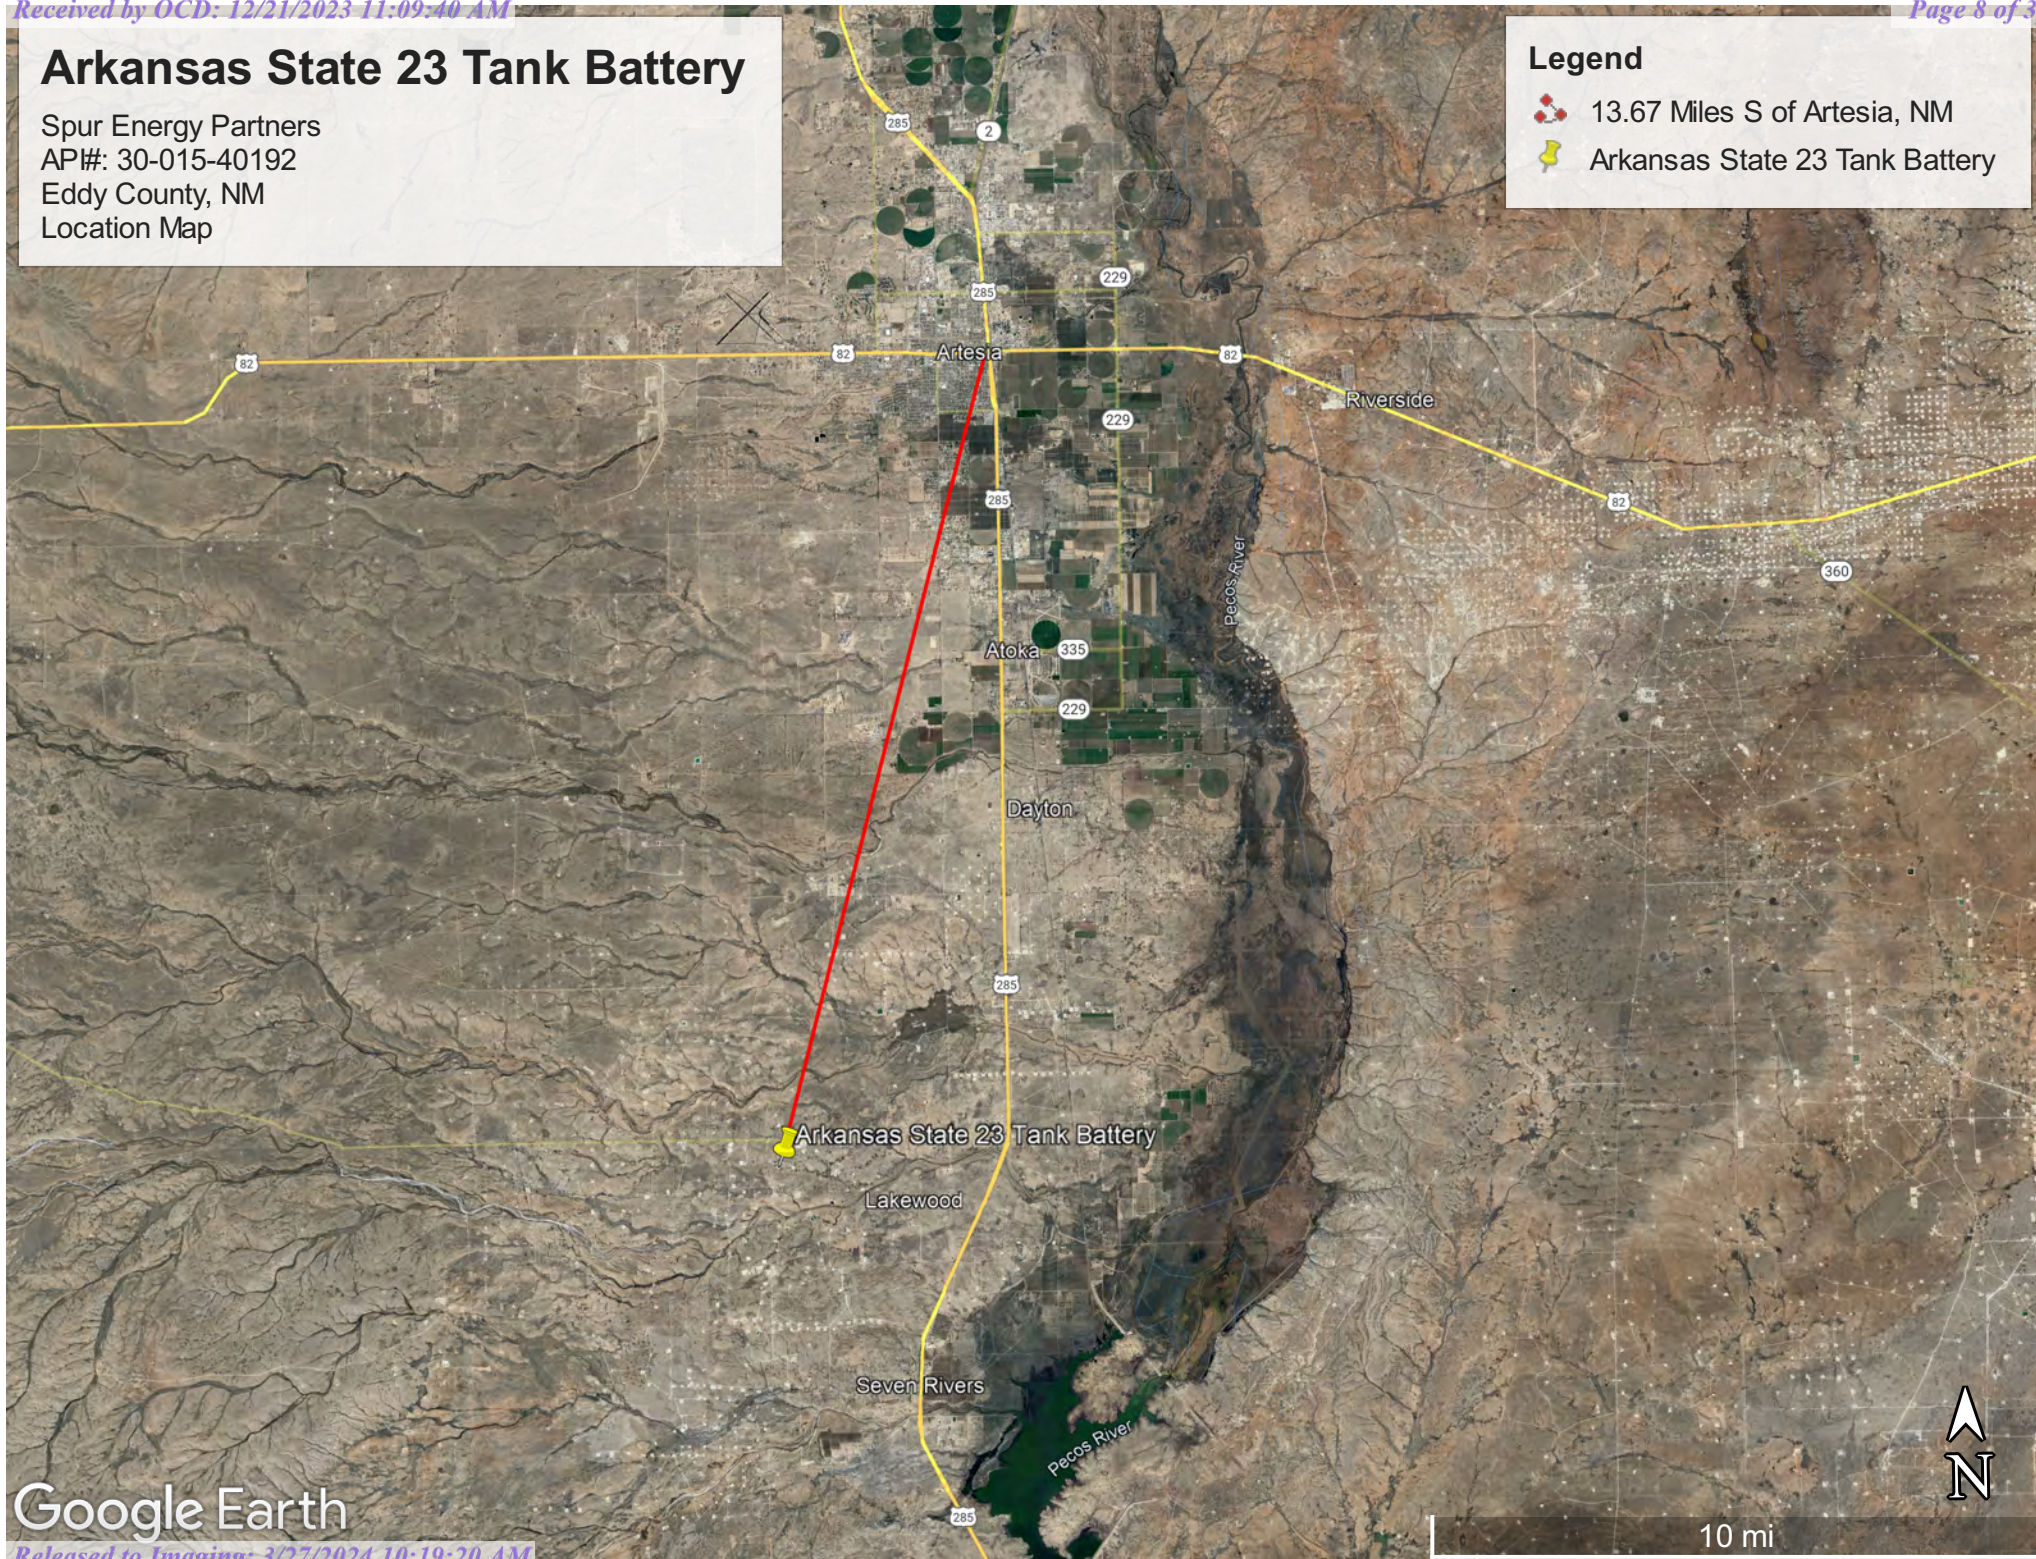
Spur Energy Partners  
API#: 30-015-40192  
Eddy County, NM  
Location Map

The Arkansas is located approximately 13.67 miles southwest of Artesia, NM. This spill site is in Unit E, Section 23, Township 19S, Range 25E, Latitude 32.64745 Longitude -104.46073, Eddy County, NM. A Location Map can be found in Figure 1.

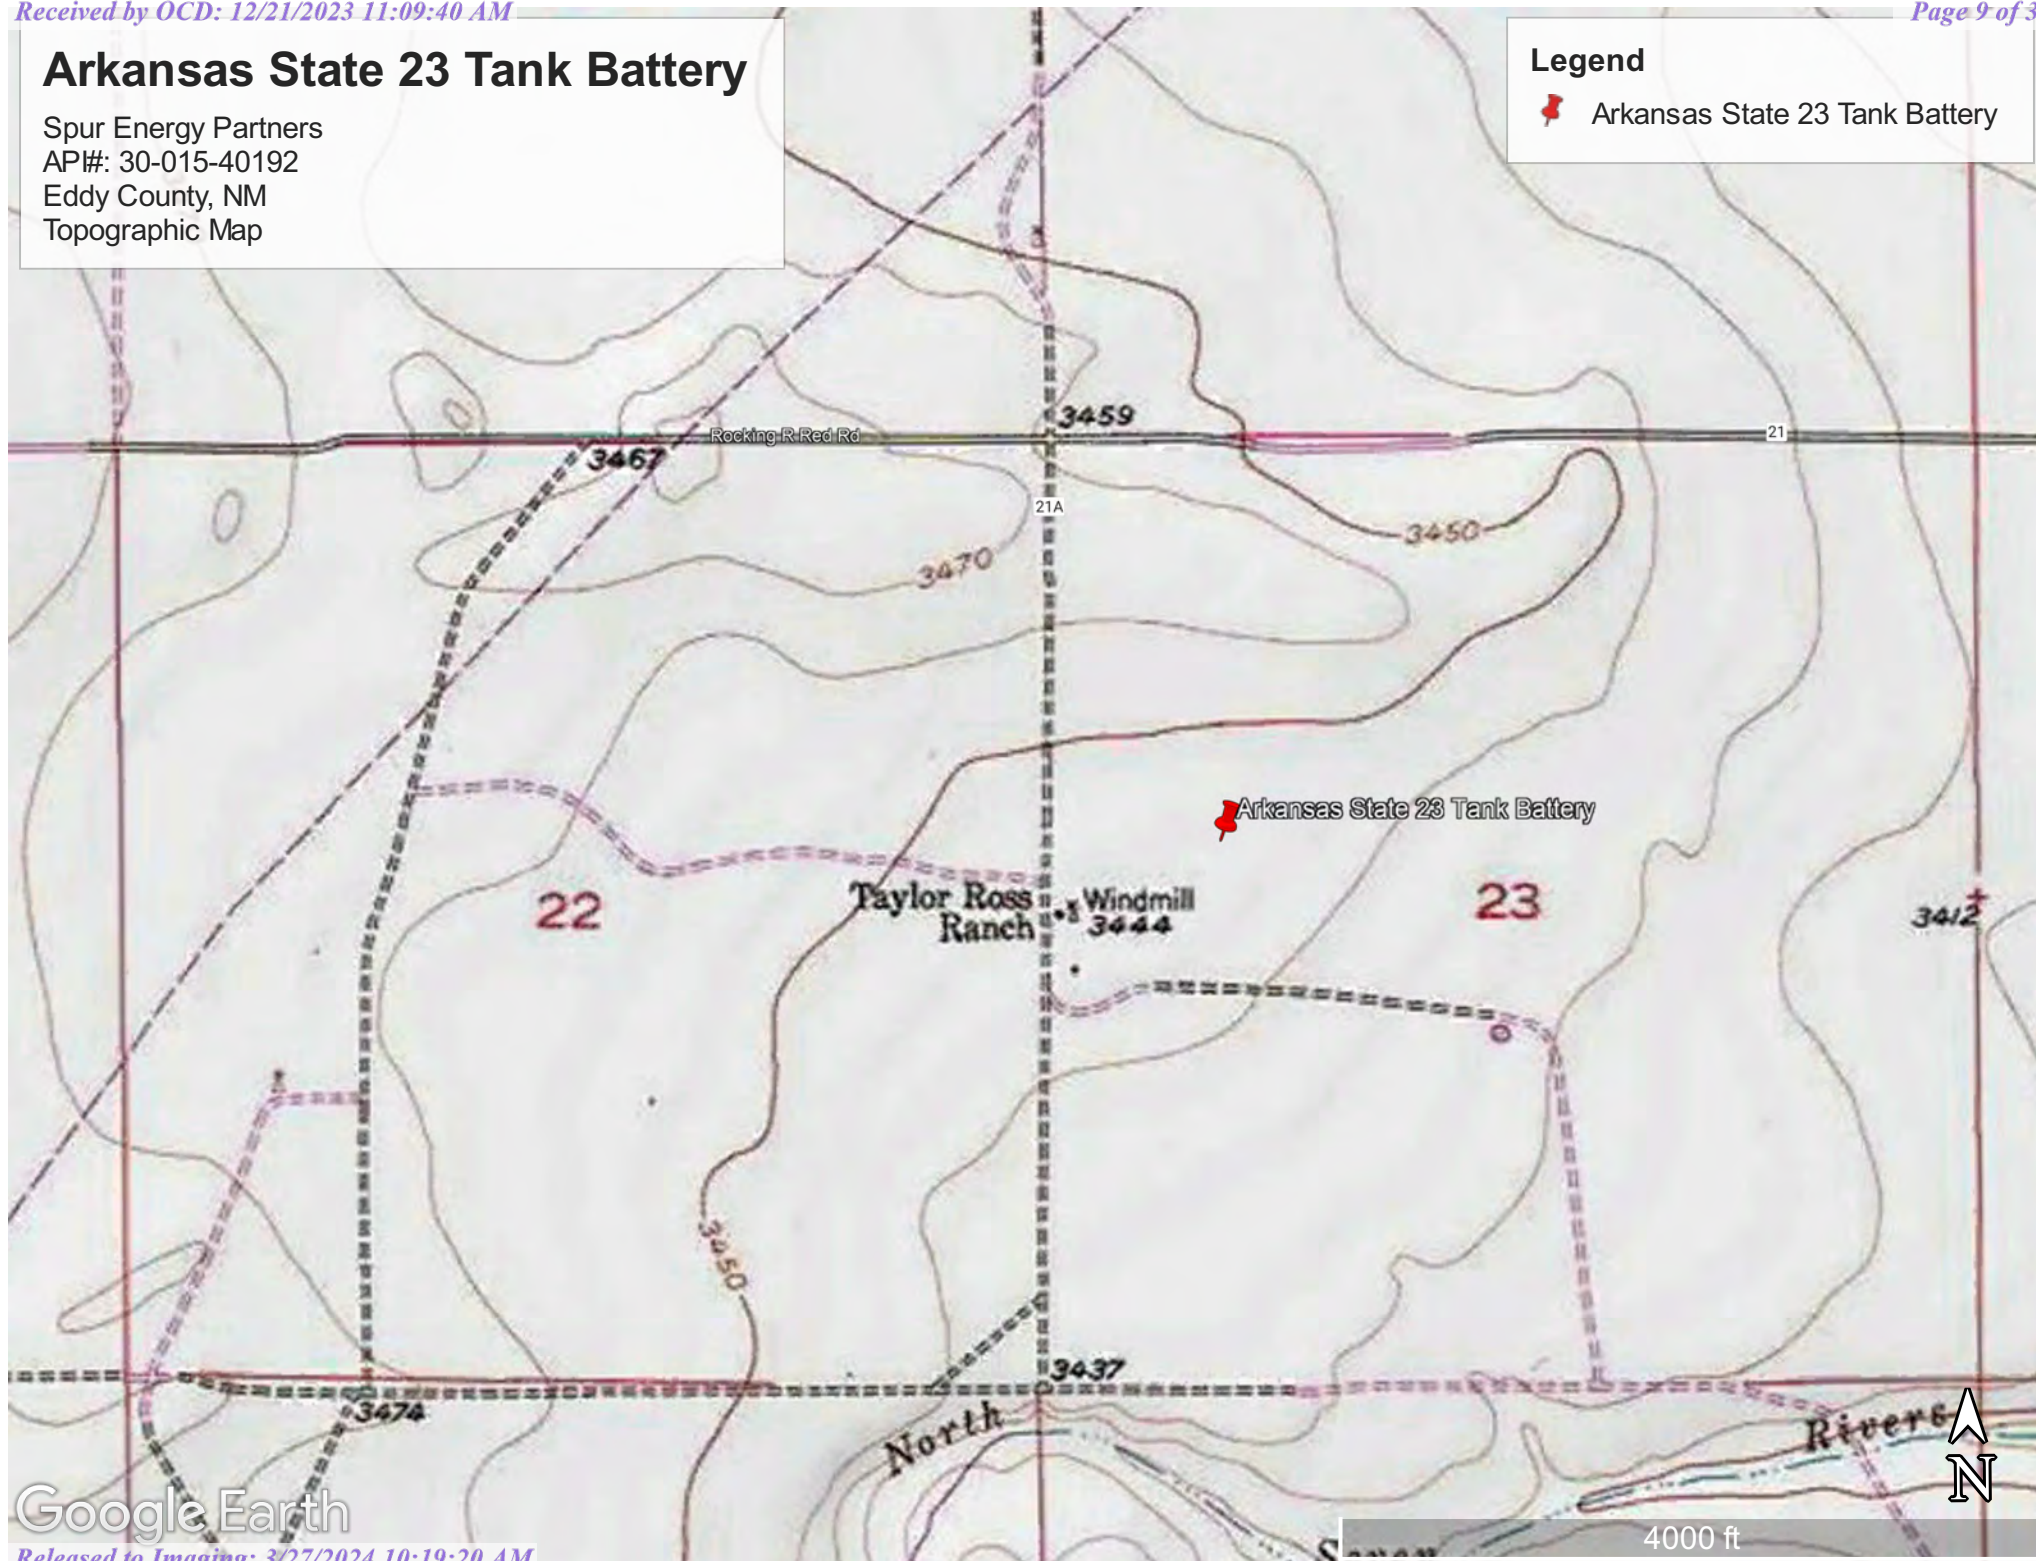
Spur Energy Partners  
AP#: 30-015-40192  
Eddy County, NM  
Topographic Map

Based on the well water data from the New Mexico Office of the State Engineer, the depth to the nearest groundwater in this vicinity measures 82 feet below grade surface (BGS), positioned roughly 0.69 miles away from the Arkansas, drilled on July 12, 2023. Conversely, as per the United States Geological Survey well water data, the nearest groundwater depth in this region is recorded at 122.43 feet BGS, situated approximately 0.88 miles away from the Arkansas, with the last gauge conducted on January 13, 2015. For detailed references to water surveys and the precise locations of water wells, please refer to Appendix A, inclusive of the relevant maps. Notably, the Arkansas is situated within an area with a medium potential for karst, as illustrated in Figure 3. Additionally, a comprehensive Topographic Map is available for reference in Figure 2.

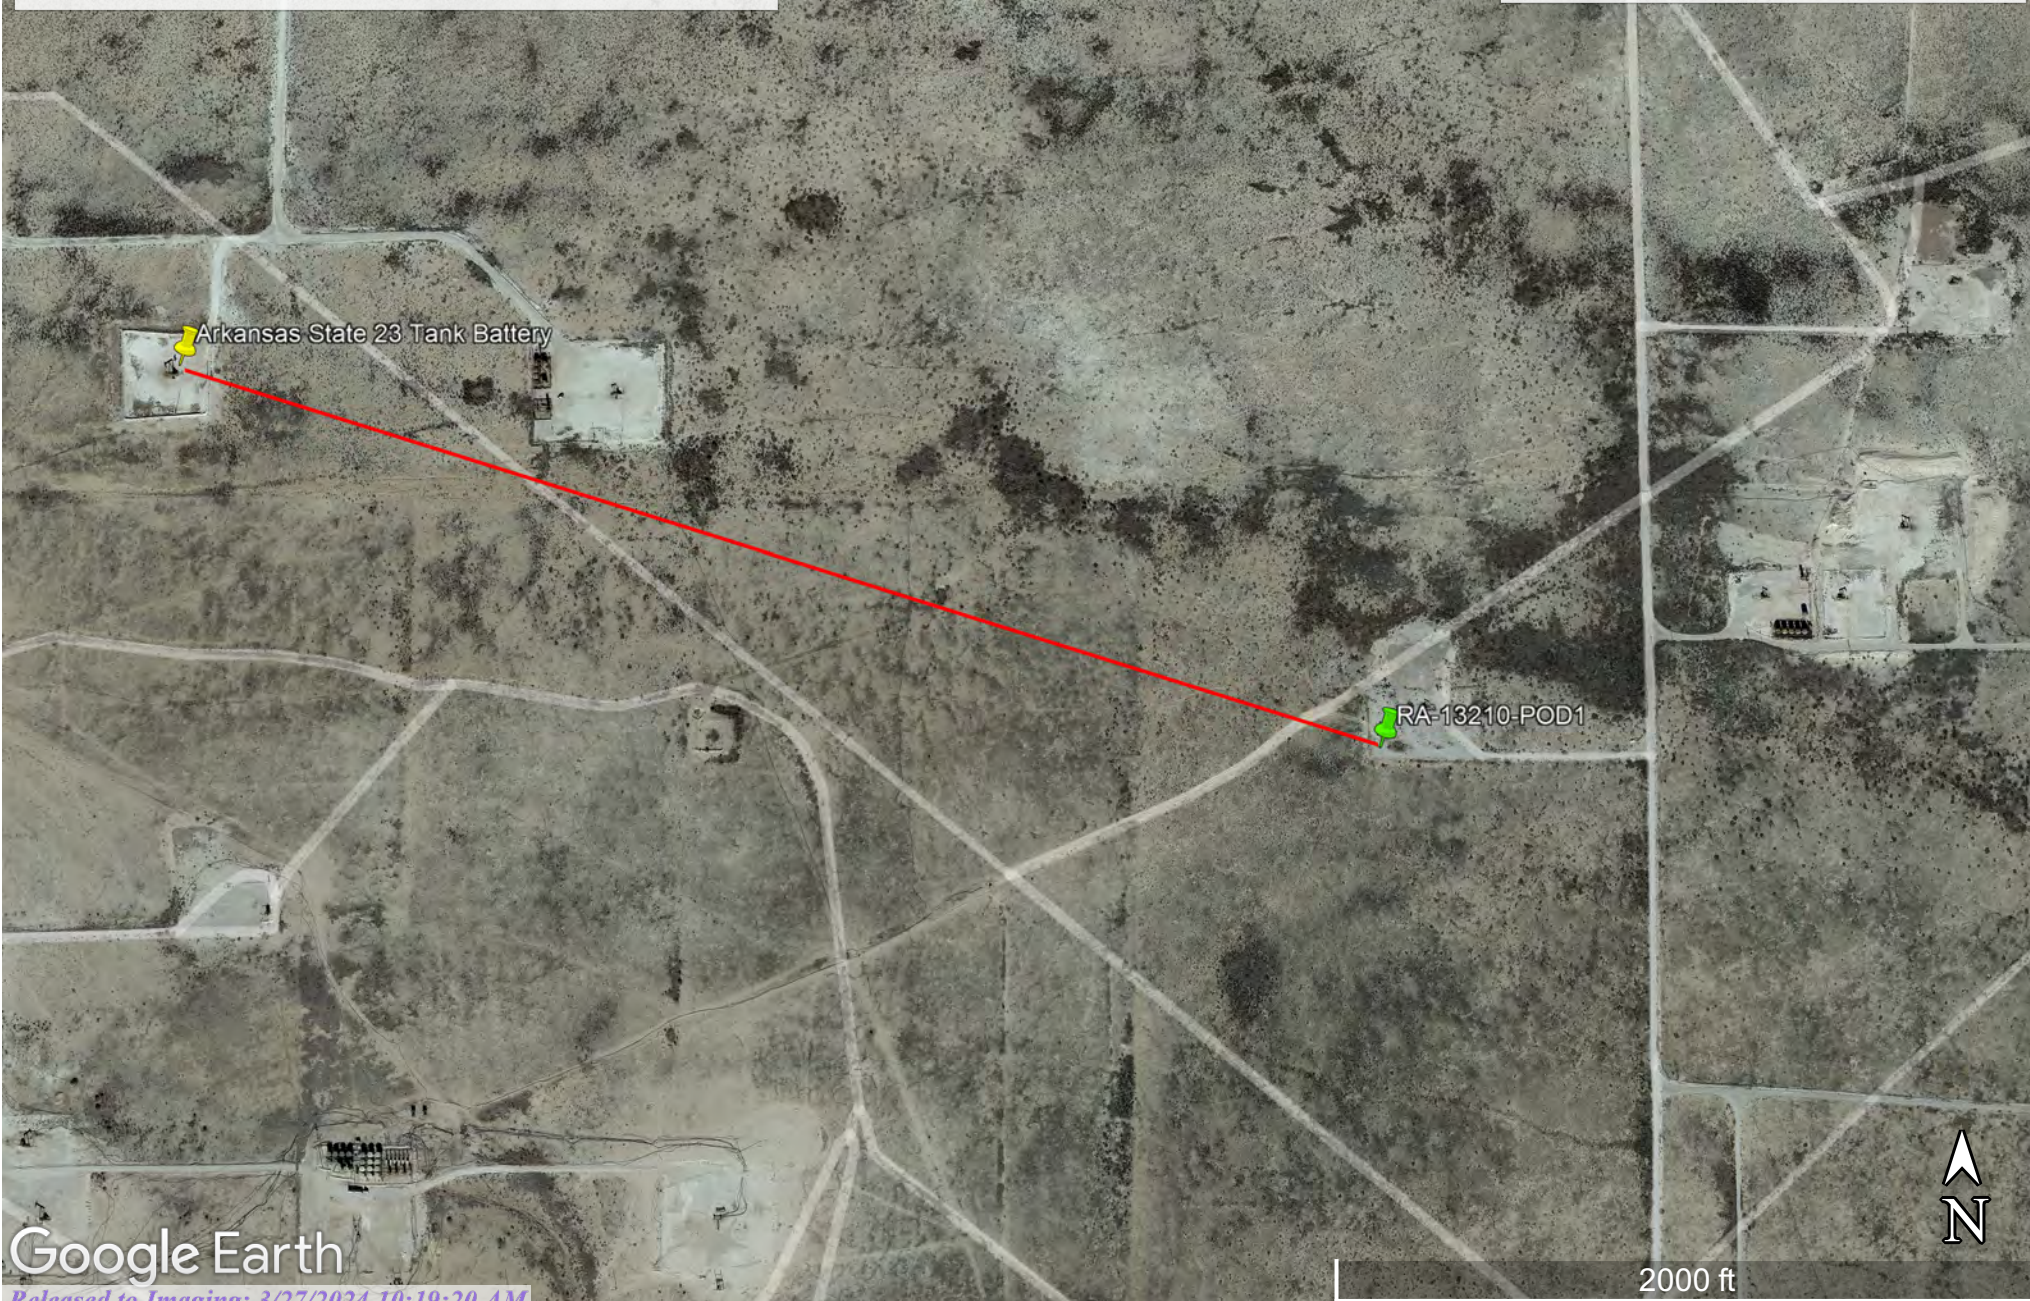
Spur Energy Partners  
API#: 30-015-40192  
Eddy County, NM  
POD- RA-13210 Map

RA-13210-POD1-0.69 of a mile

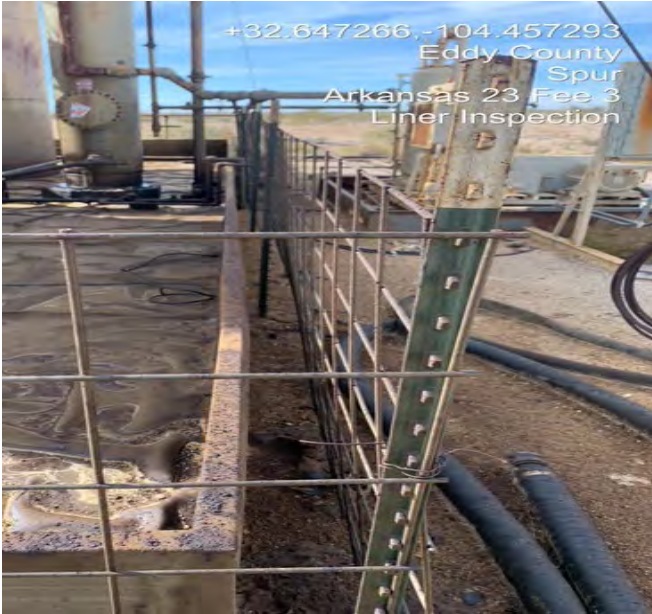
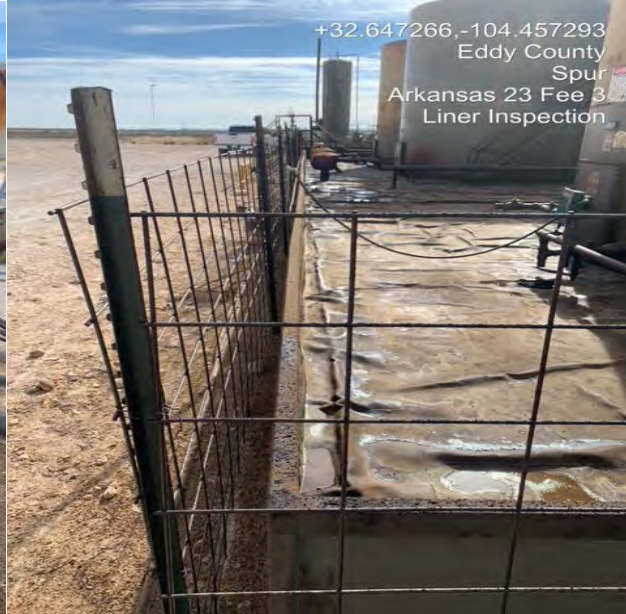
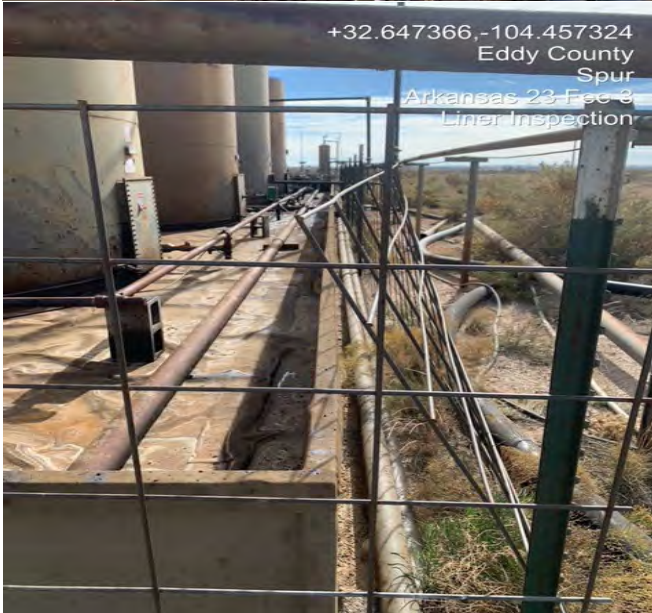
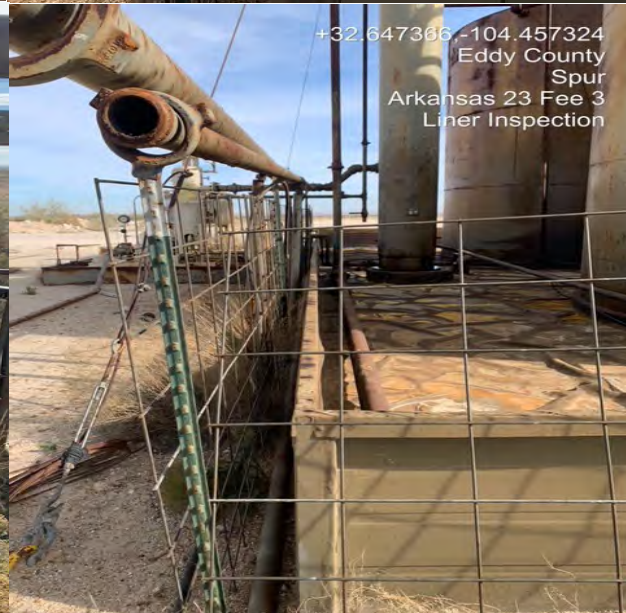
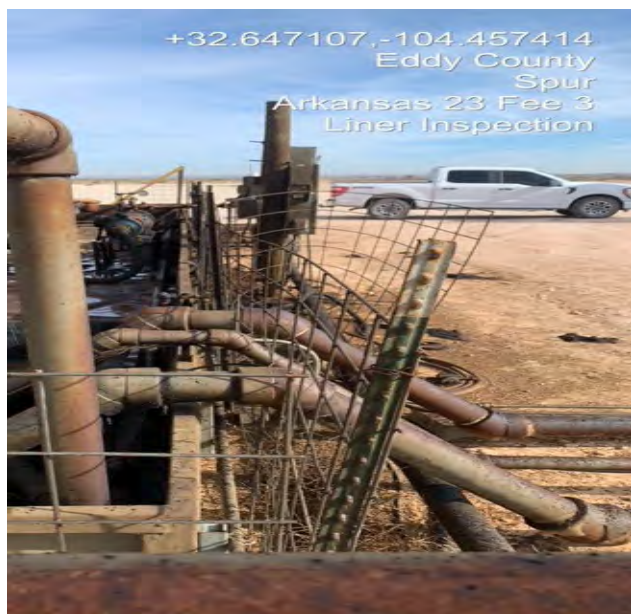
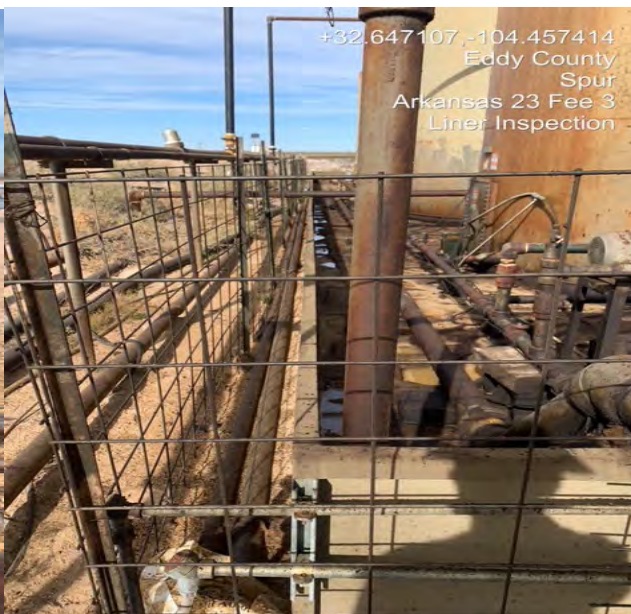
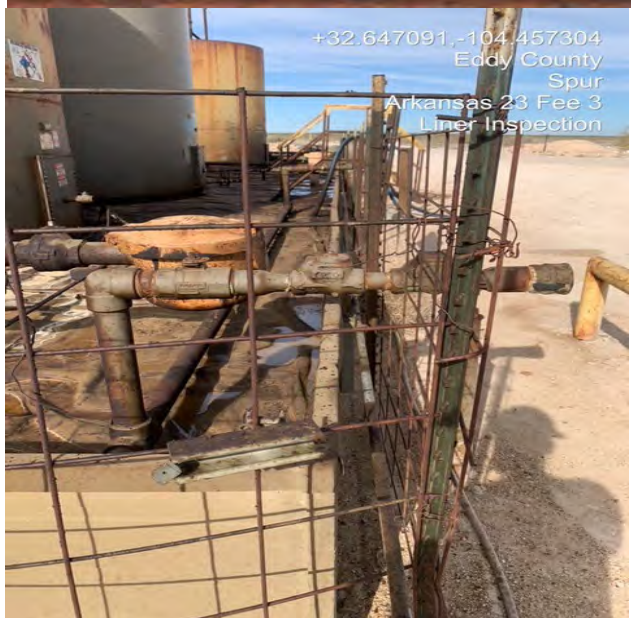
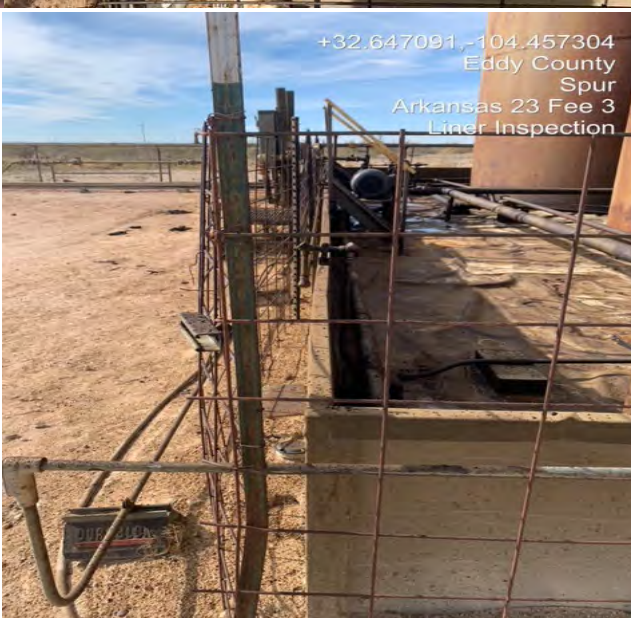
On November 30, 2023, after sending the 48-hour notification via email, Pima Environmental conducted a liner inspection at this location. We concluded that this liner and containment maintained its integrity and was able to retain the fluids. The liner inspection form and photographic documentation can be found in Appendix C.

Visualization	Yes	No	Comments
Is there a tear in the liner?		X	
Are there holes in the liner?		X	
Is the liner retaining any fluids?	X		The inspection images of the liner reveal residual fluid resulting from the remediation event involving power washing.
Does the liner have integrity to contain a leak?	X
