**Re: Closure Request  
PLU 29-20 Big Sinks 108H  
Incident Number NAPP2328644007  
Eddy County, New Mexico**

Ensolum, LLC (Ensolum), on behalf of XTO Energy, Inc. (XTO), has prepared this *Closure Request* to document site assessment, excavation, and soil sampling activities performed at the PLU 29-20 Big Sinks 108H (Site). The purpose of the site assessment, excavation, and soil sampling activities was to address impacts to soil following a release of crude oil and produced water at the Site. Based on excavation activities and soil sample laboratory analytical results, XTO is submitting this *Closure Request*, describing remediation that has occurred and requesting no further action for Incident Number NAPP2328644007.

XTO Energy, Inc  
Closure Request  
PLU 29-20 Big Sinks 108H

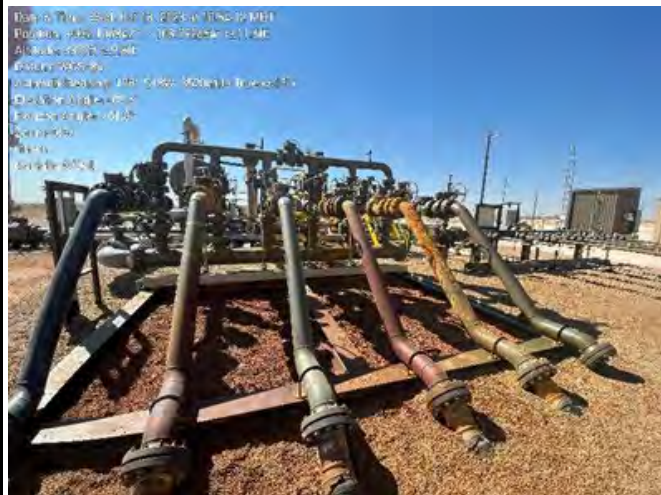
Photograph 1

Description: Site assessment activities, release point.

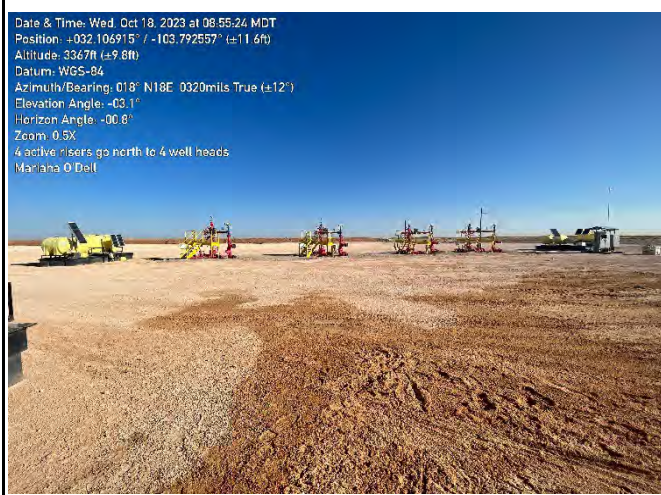
Photograph 2

Description: Site assessment activities, release extent.

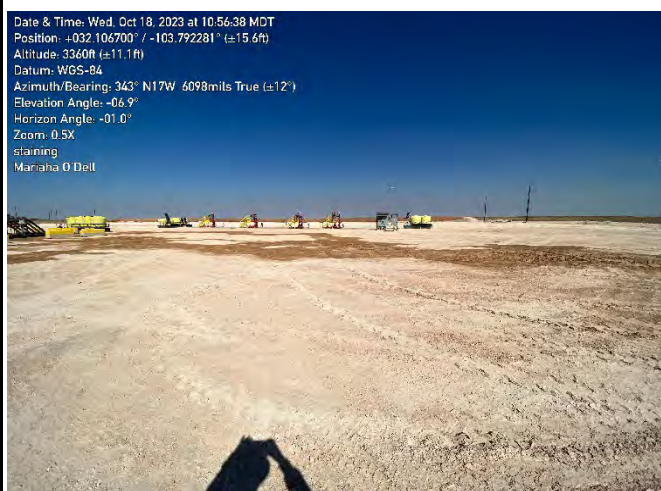
Photograph 3

Description: Site assessment activities, release extent.

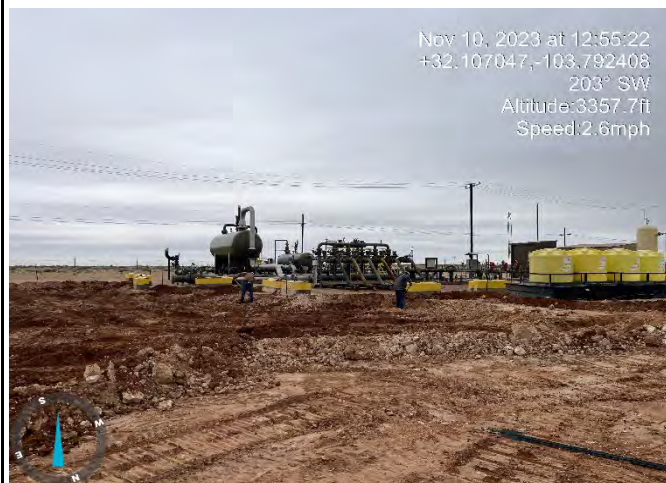
Photograph 5 Date: 11/10/2023  
Description: Excavation near production equipment.  
View: Southwest

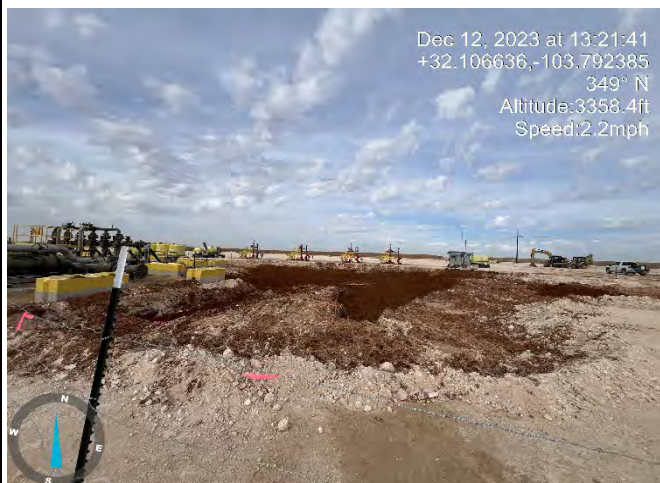
Photograph 6 Date: 12/12/2023  
Description: Excavation extent.  
View: North

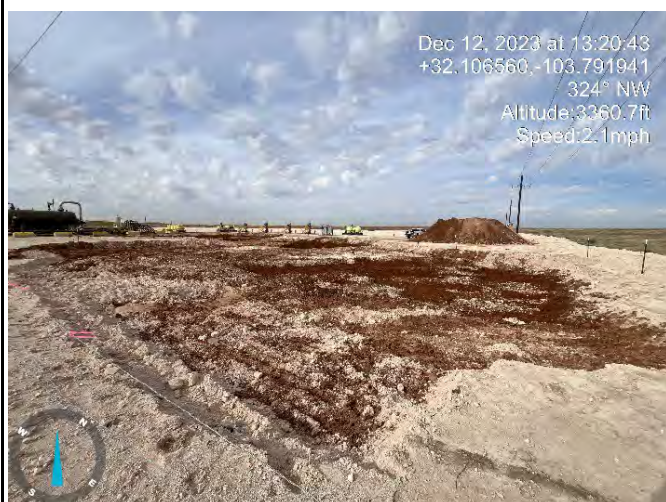
Photograph 7 Date: 12/12/2023  
Description: Excavation extent.  
View: Northwest

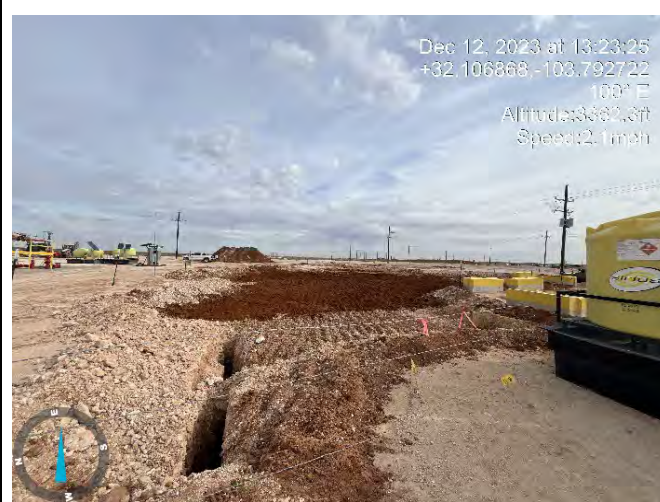
Photograph 8 Date: 12/12/2023  
Description: Excavation extent.  
View: East
