**Re: Liner Inspection and Closure Request
ConocoPhillips
Airacuda 31 Federal 2H Release
Unit Letter B, Section 31, Township 25 South, Range 33 East
Lea County, New Mexico
Incident ID# NAPP2402939826**

Release Characterization, Remediation and Closure Report
March 14, 2024

Liner Inspection and Closure Report
March 12, 2024

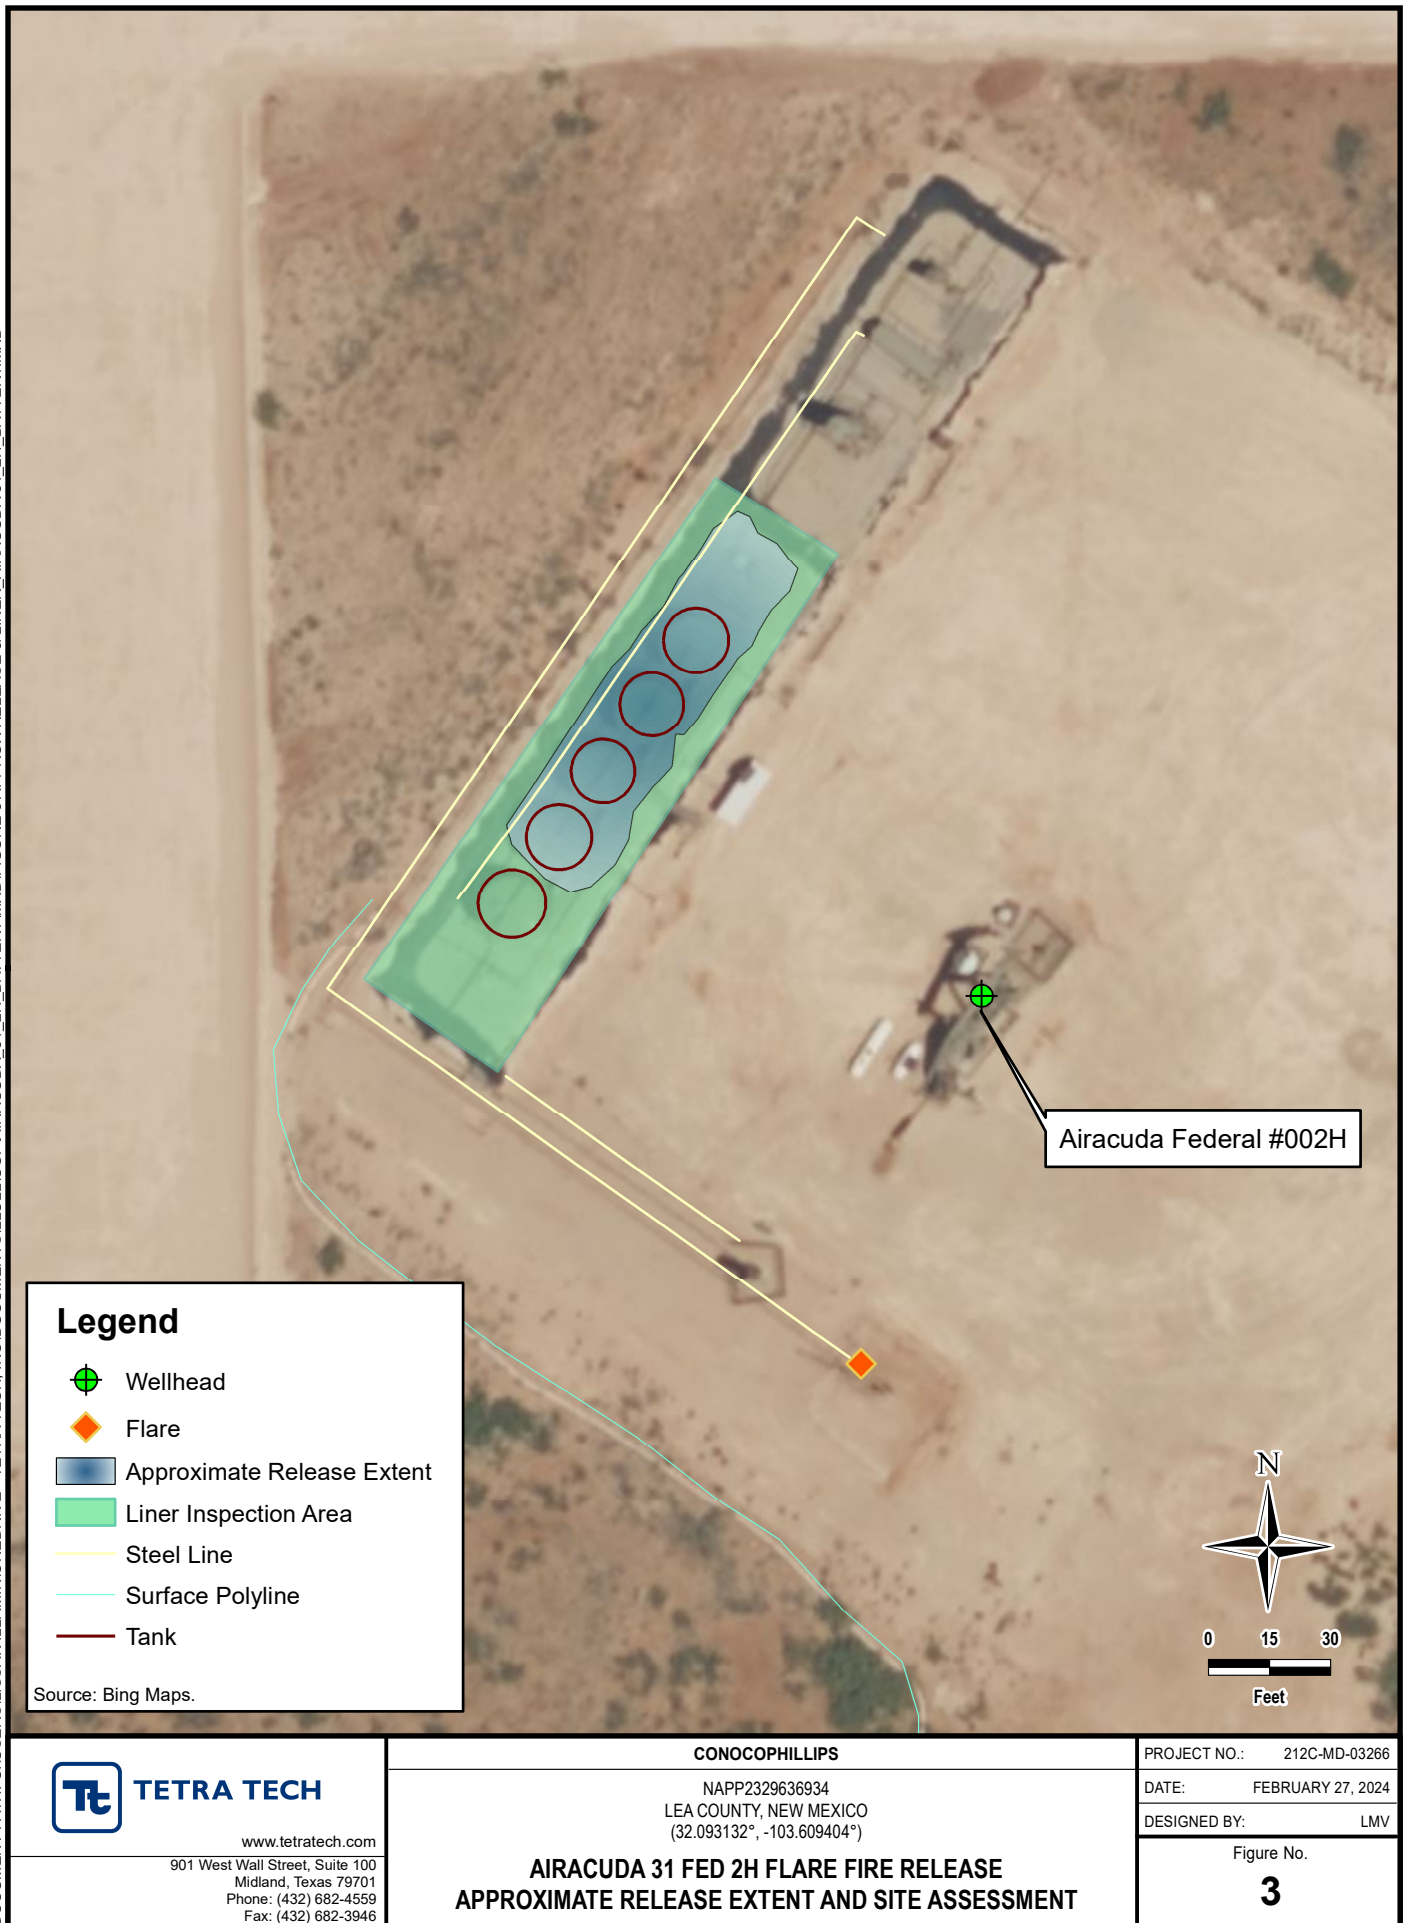
- Figure 1 – Overview Map
- Figure 2 – Topographic Map
- Figure 3 – Approximate Release Extent and Liner Inspection

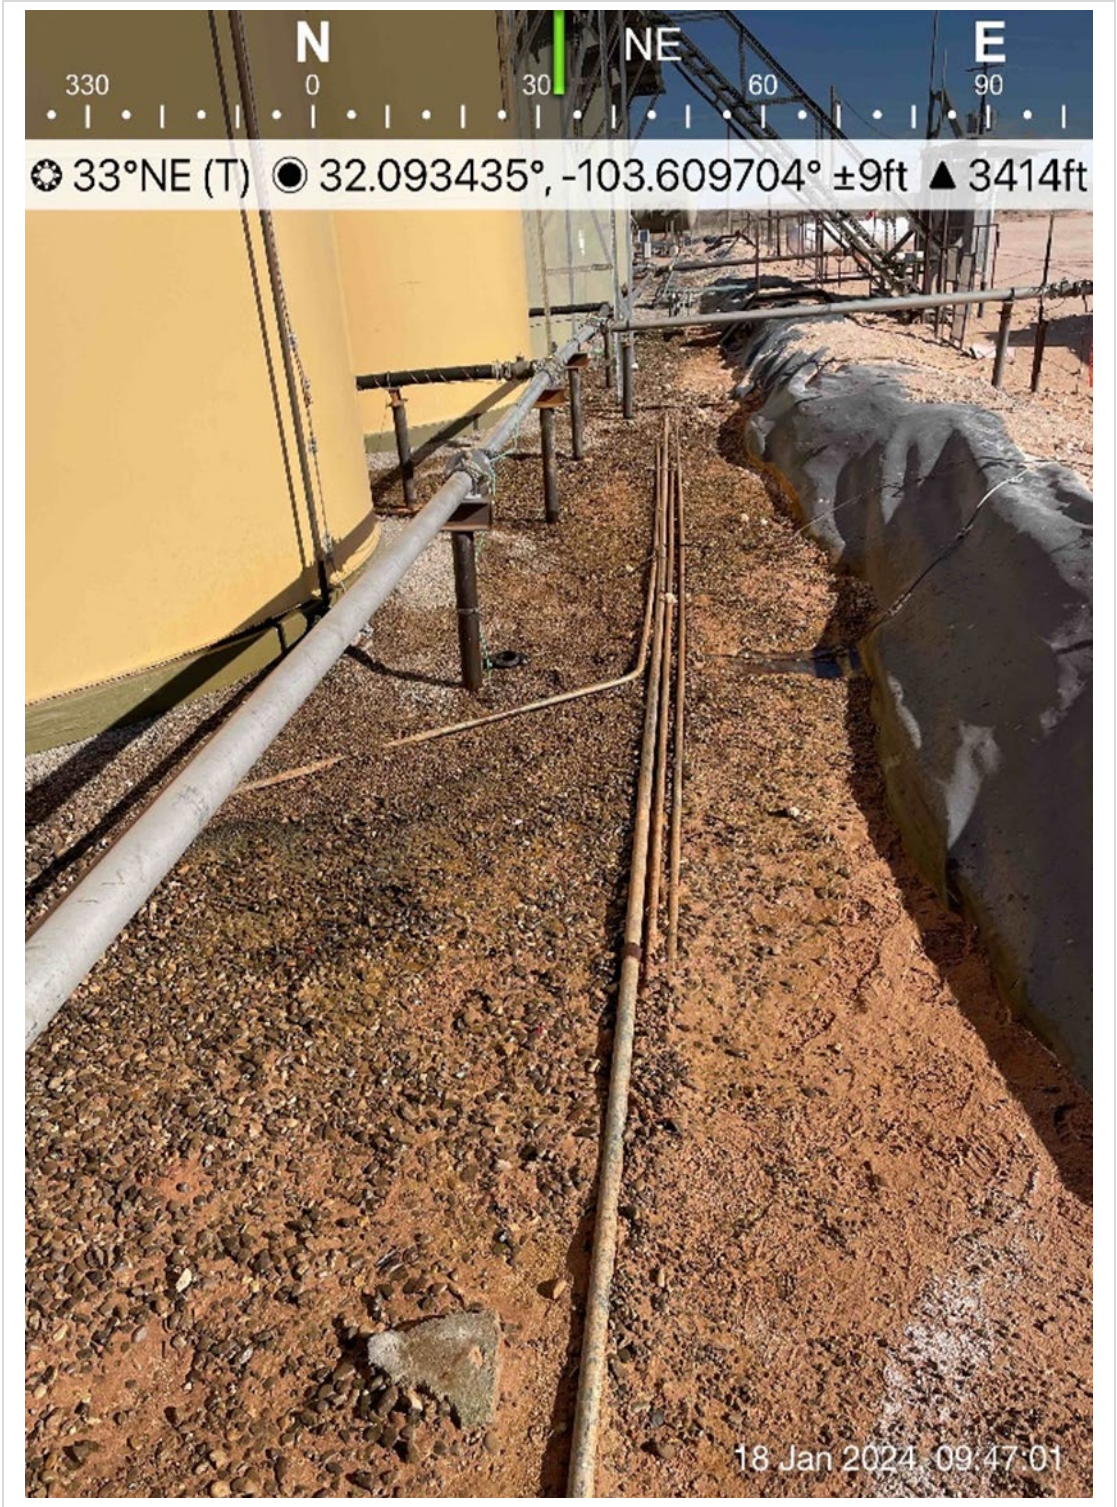
TETRA TECH, INC. PROJECT NO. 212C-MD-03358	DESCRIPTION	View northwest. Approximate release extent prior to liner inspection.	1
	SITE NAME	Airacuda 31 Federal 2H Release	1/18/2024

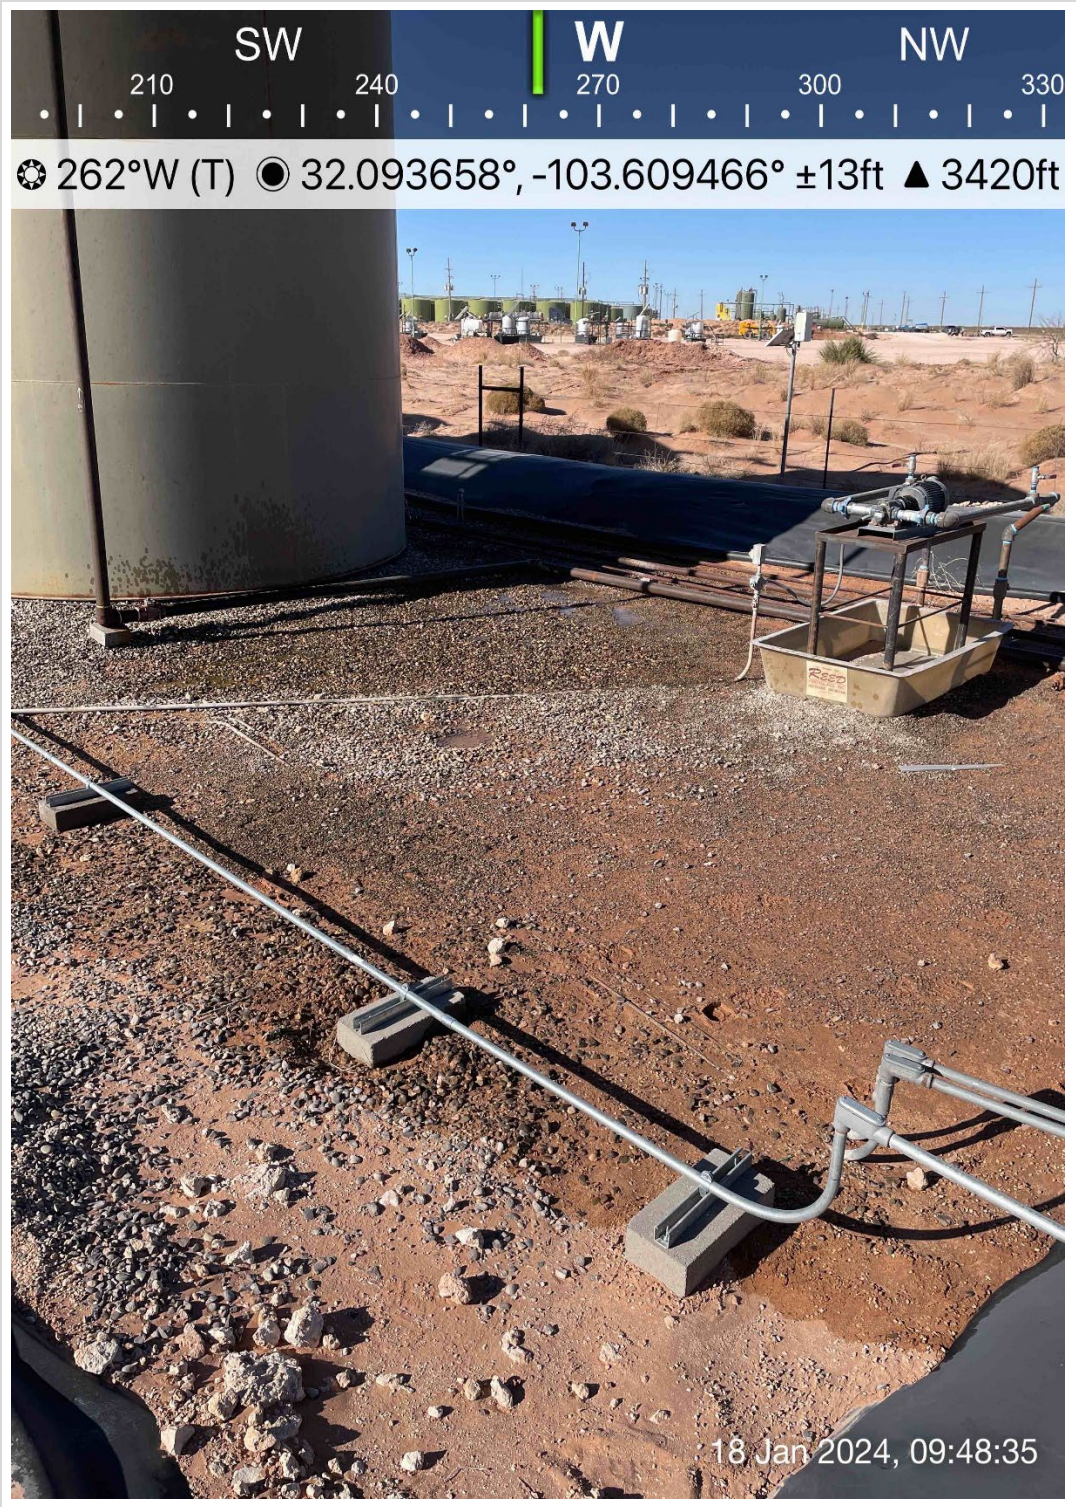
TETRA TECH, INC. PROJECT NO. 212C-MD-03358	DESCRIPTION	View west. Approximate release extent prior to liner inspection.	2
	SITE NAME	Airacuda 31 Federal 2H Release	1/8/2024

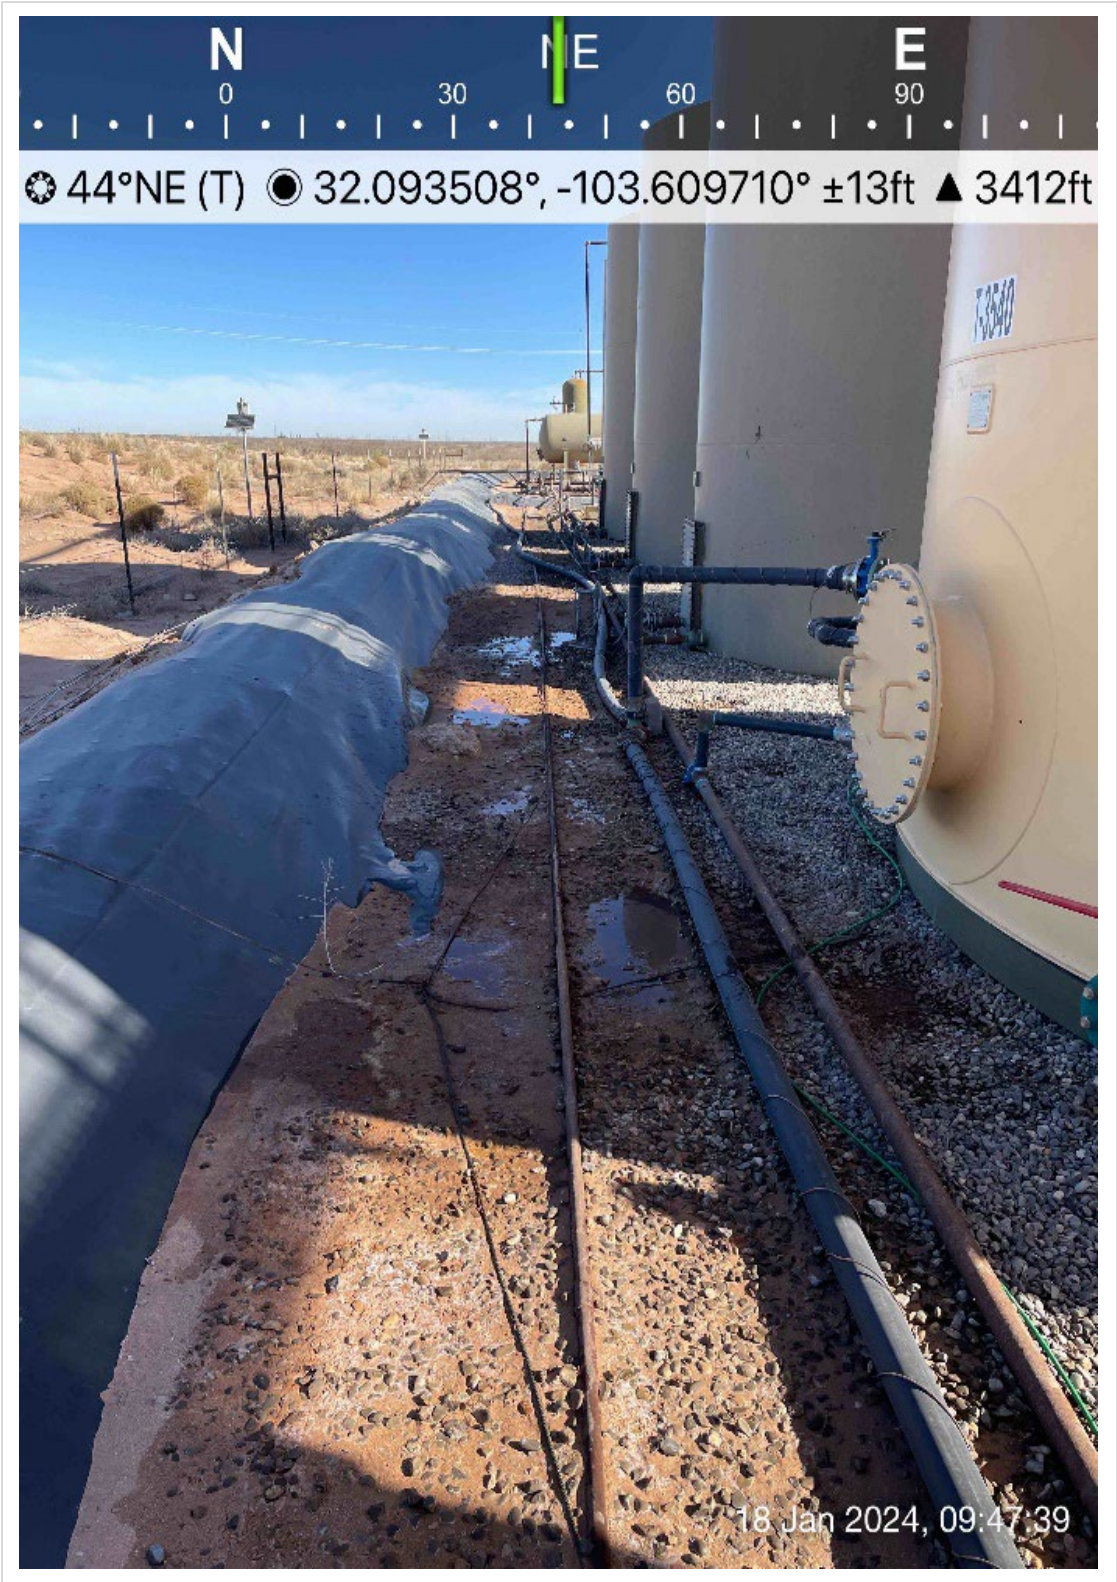
TETRA TECH, INC. PROJECT NO. 212C-MD-03358	DESCRIPTION	View northeast. Approximate release extent prior to liner inspection.	3
	SITE NAME	Airacuda 31 Federal 2H Release	1/18/2024

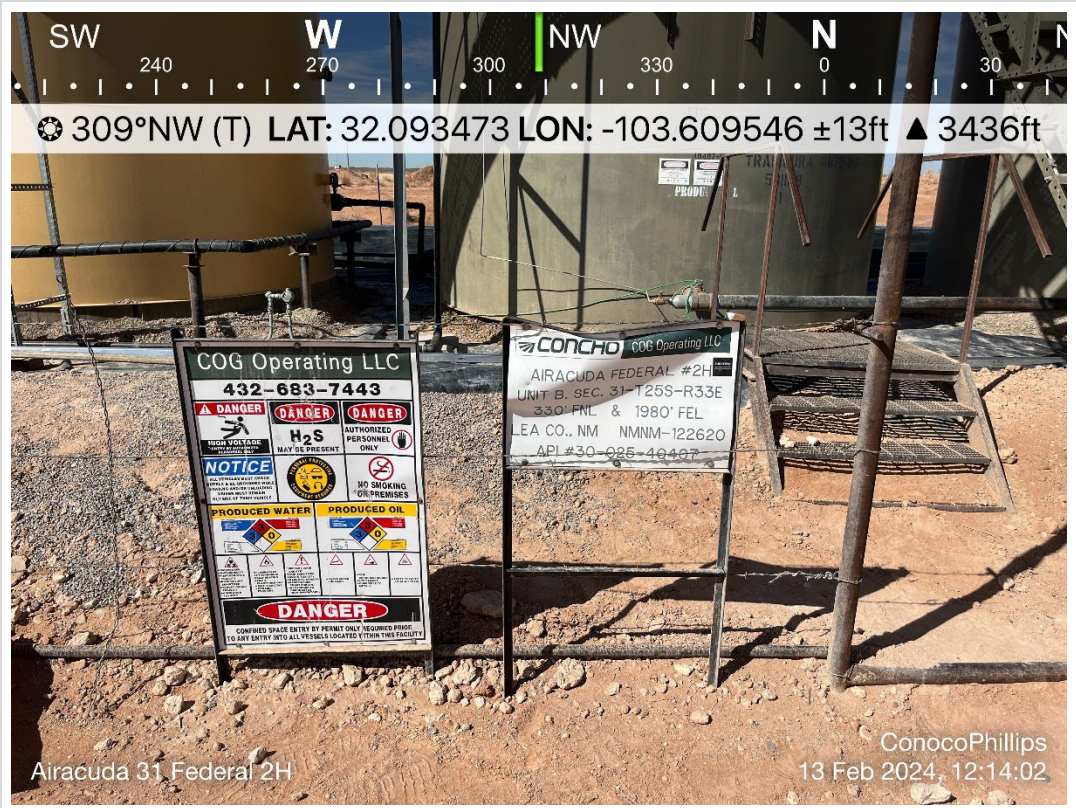
TETRA TECH, INC. PROJECT NO. 212C-MD-03358	DESCRIPTION	View northwest. View of site signage.	4
	SITE NAME	Airacuda 31 Federal 2H Release	2/13/2024

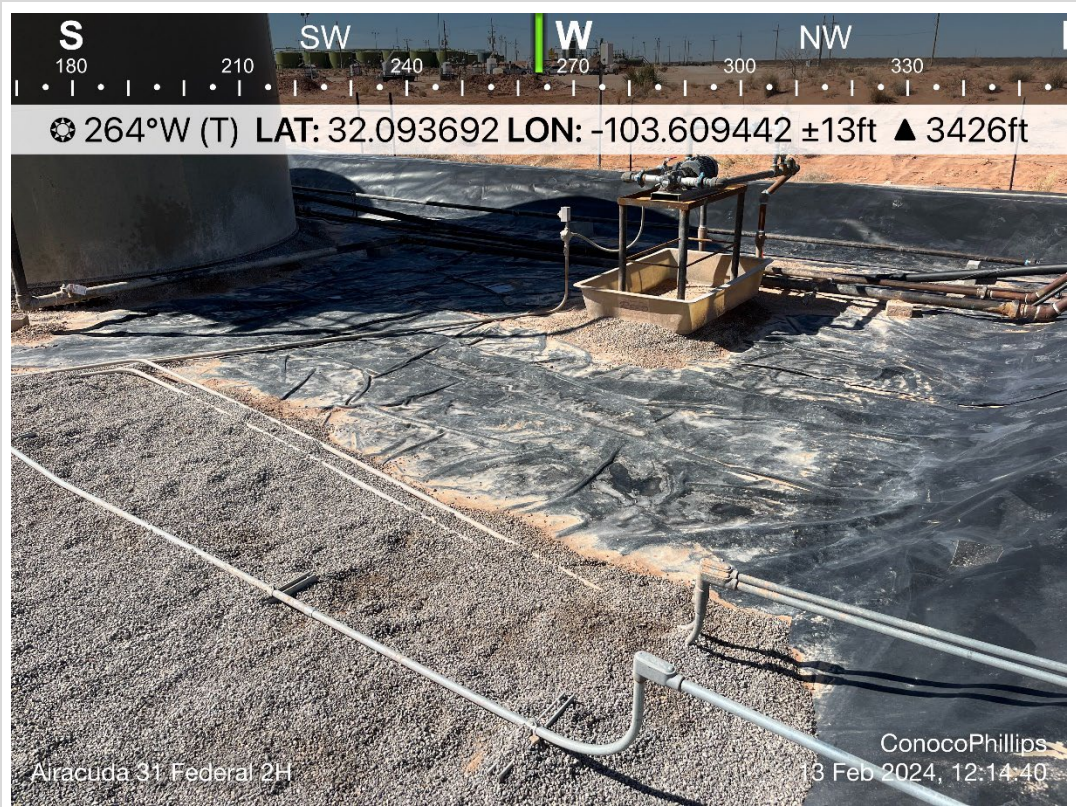
On February 13, 2024, Tetra Tech personnel performed an inspection of the liner within the containment area of the Airacuda 31 Federal 2H Tank Battery. This work was completed to verify the integrity of the liner. The liner was observed to underlie the entirety of the tank battery containment area. The liner was intact with no visible rips or tears. At the time of the inspection, the liner was intact and had the ability to contain the documented release. The potentially impacted material was removed and will be replaced with the new course material on site by COP Operations. Photographic documentation of the liner inspection is included in Appendix D.

TETRA TECH, INC. PROJECT NO. 212C-MD-03358	DESCRIPTION	View west. View of exposed liner. No rips or tears observed. Liner integrity intact.	5
	SITE NAME	Airacuda 31 Federal 2H Release	2/13/2024

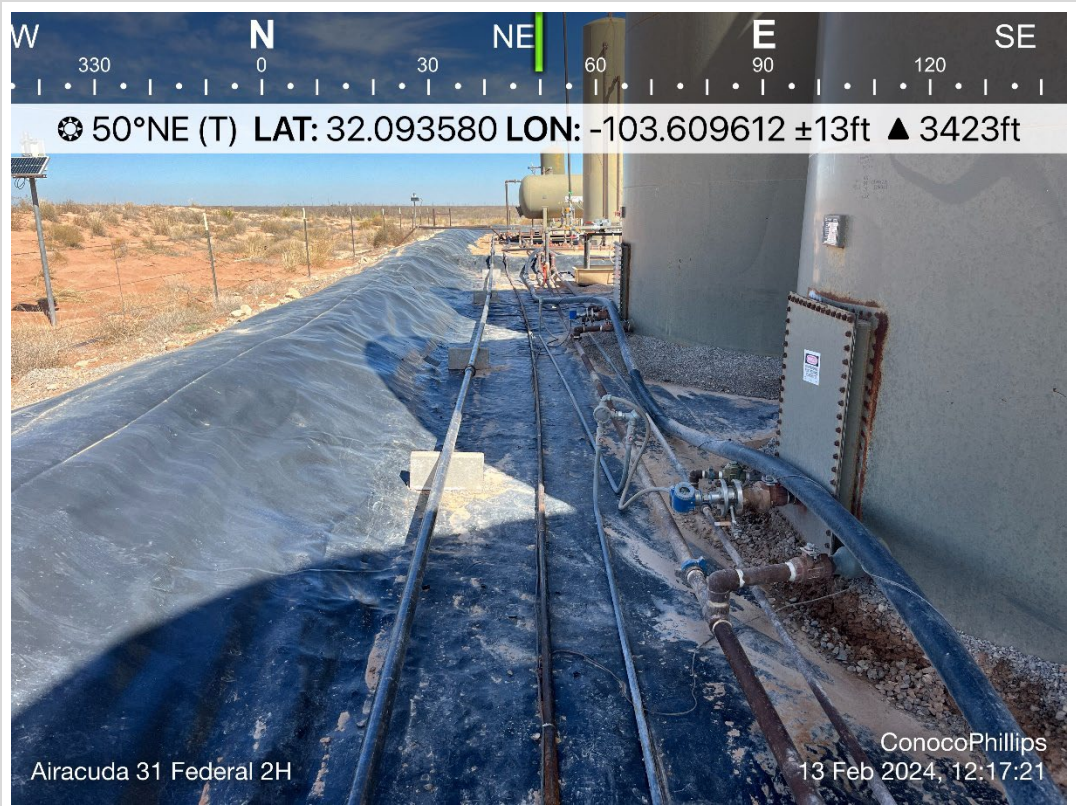
TETRA TECH, INC. PROJECT NO. 212C-MD-03358	DESCRIPTION	View northeast. View of exposed liner. No rips or tears observed. Liner integrity intact.	6
	SITE NAME	Airacuda 31 Federal 2H Release	2/13/2024

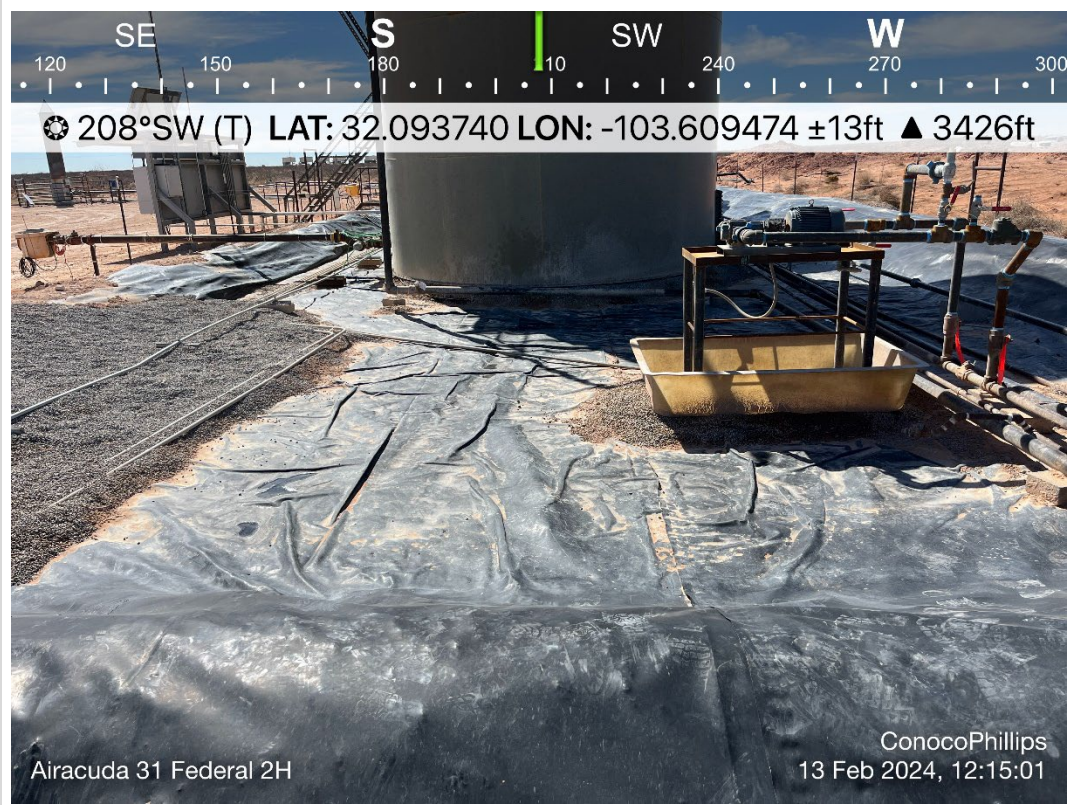
TETRA TECH, INC. PROJECT NO. 212C-MD-03358	DESCRIPTION	View south. View of exposed liner. No rips or tears observed. Liner integrity intact.	7
	SITE NAME	Airacuda 31 Federal 2H Release	2/13/2024

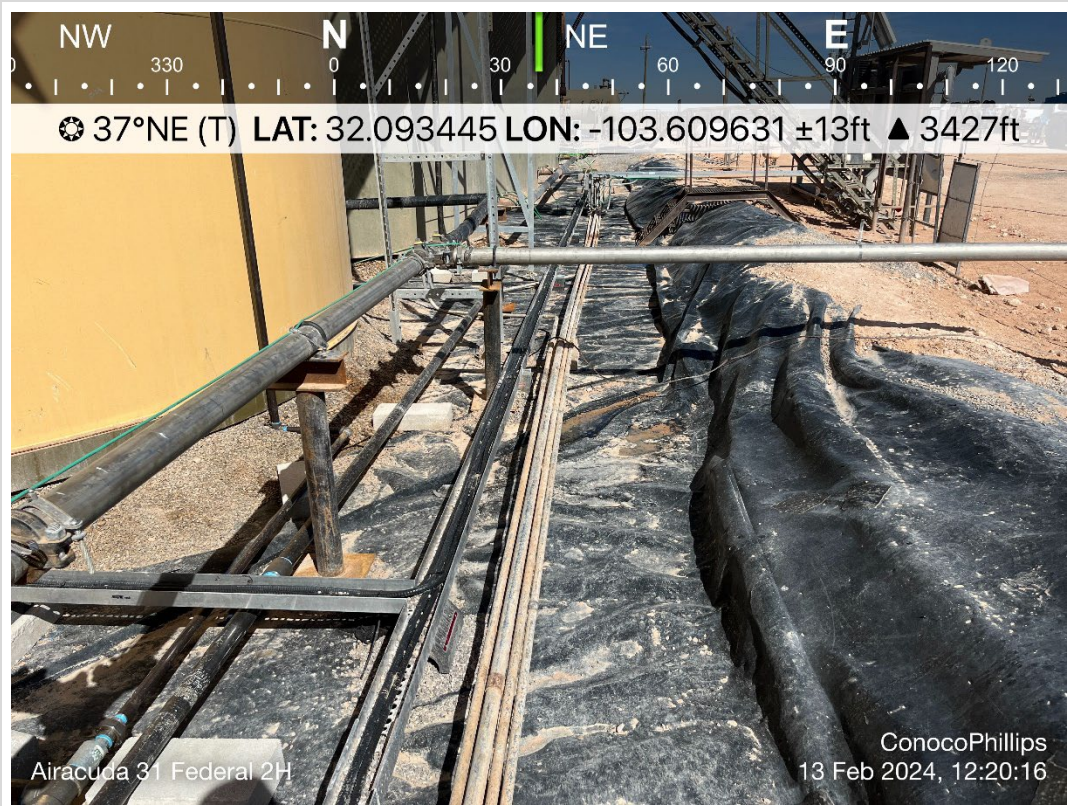
TETRA TECH, INC. PROJECT NO. 212C-MD-03358	DESCRIPTION	View northeast. View of exposed liner. No rips or tears observed. Liner integrity intact.	10
	SITE NAME	Airacuda 31 Federal 2H Release	2/13/2024

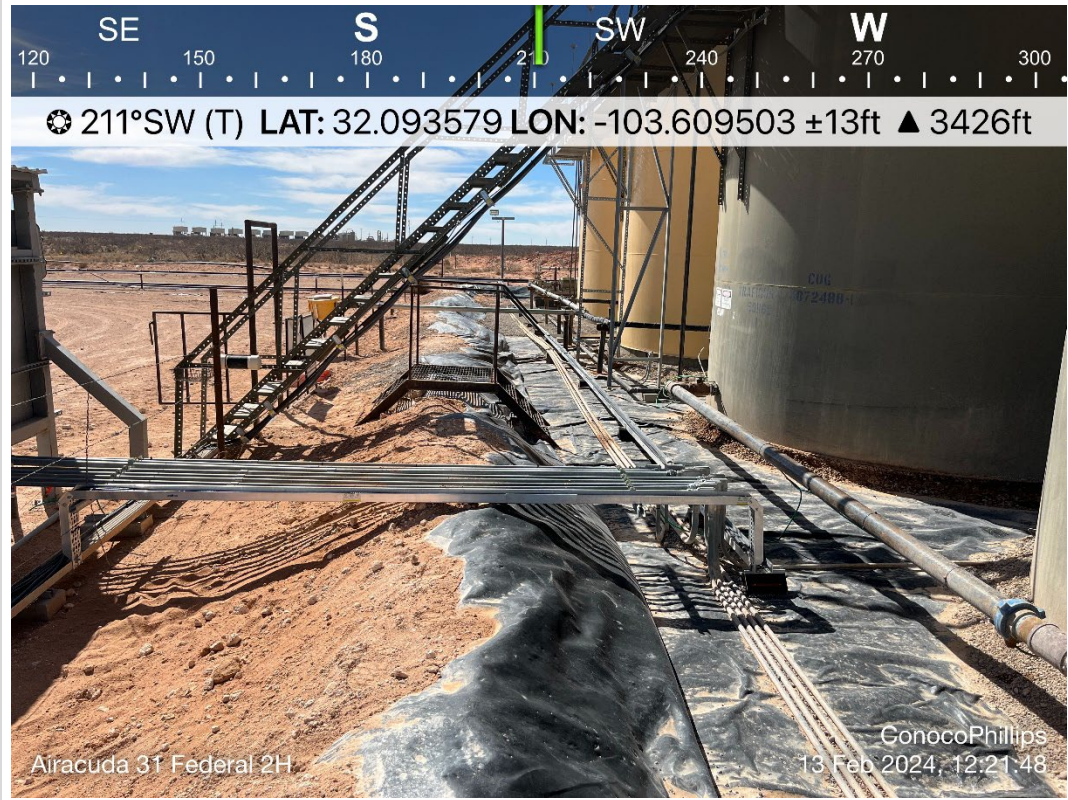
TETRA TECH, INC. PROJECT NO. 212C-MD-03358	DESCRIPTION	View south. View of exposed liner. No rips or tears observed. Liner integrity intact.	11
	SITE NAME	Airacuda 31 Federal 2H Release	2/13/2024
