Mr. Mike Bratcher  
New Mexico Oil Conservation Division  
811 South First Street  
Artesia, New Mexico 88210**RE: Closure Request  
Ross Draw Unit #041  
Remediation Permit Number 2RP-5654  
Eddy County, New Mexico**

LT Environmental, Inc. (LTE), on behalf of WPX Energy Permian, Inc. (WPX), presents the following Closure Request detailing soil sampling and excavation activities at the Ross Draw Unit #041 (Site) in Unit L, Section 22, Township 26 South, Range 30 East, in Eddy County, New Mexico (Figure 1). The purpose of the soil sampling and excavation activities was to address impacts to soil following a produced water and crude oil release at the Site. Based on the excavation activities and results of the soil sampling events, WPX is submitting this Closure Request, describing remediation that has occurred and requesting no further action for this release event.

FIGURE 2  
SITE MAP  
ROSS DRAW UNIT #041  
UNIT L SEC 22 T26S R30E  
EDDY COUNTY, NEW MEXICO  
WPX ENERGY PERMIAN, LLC.

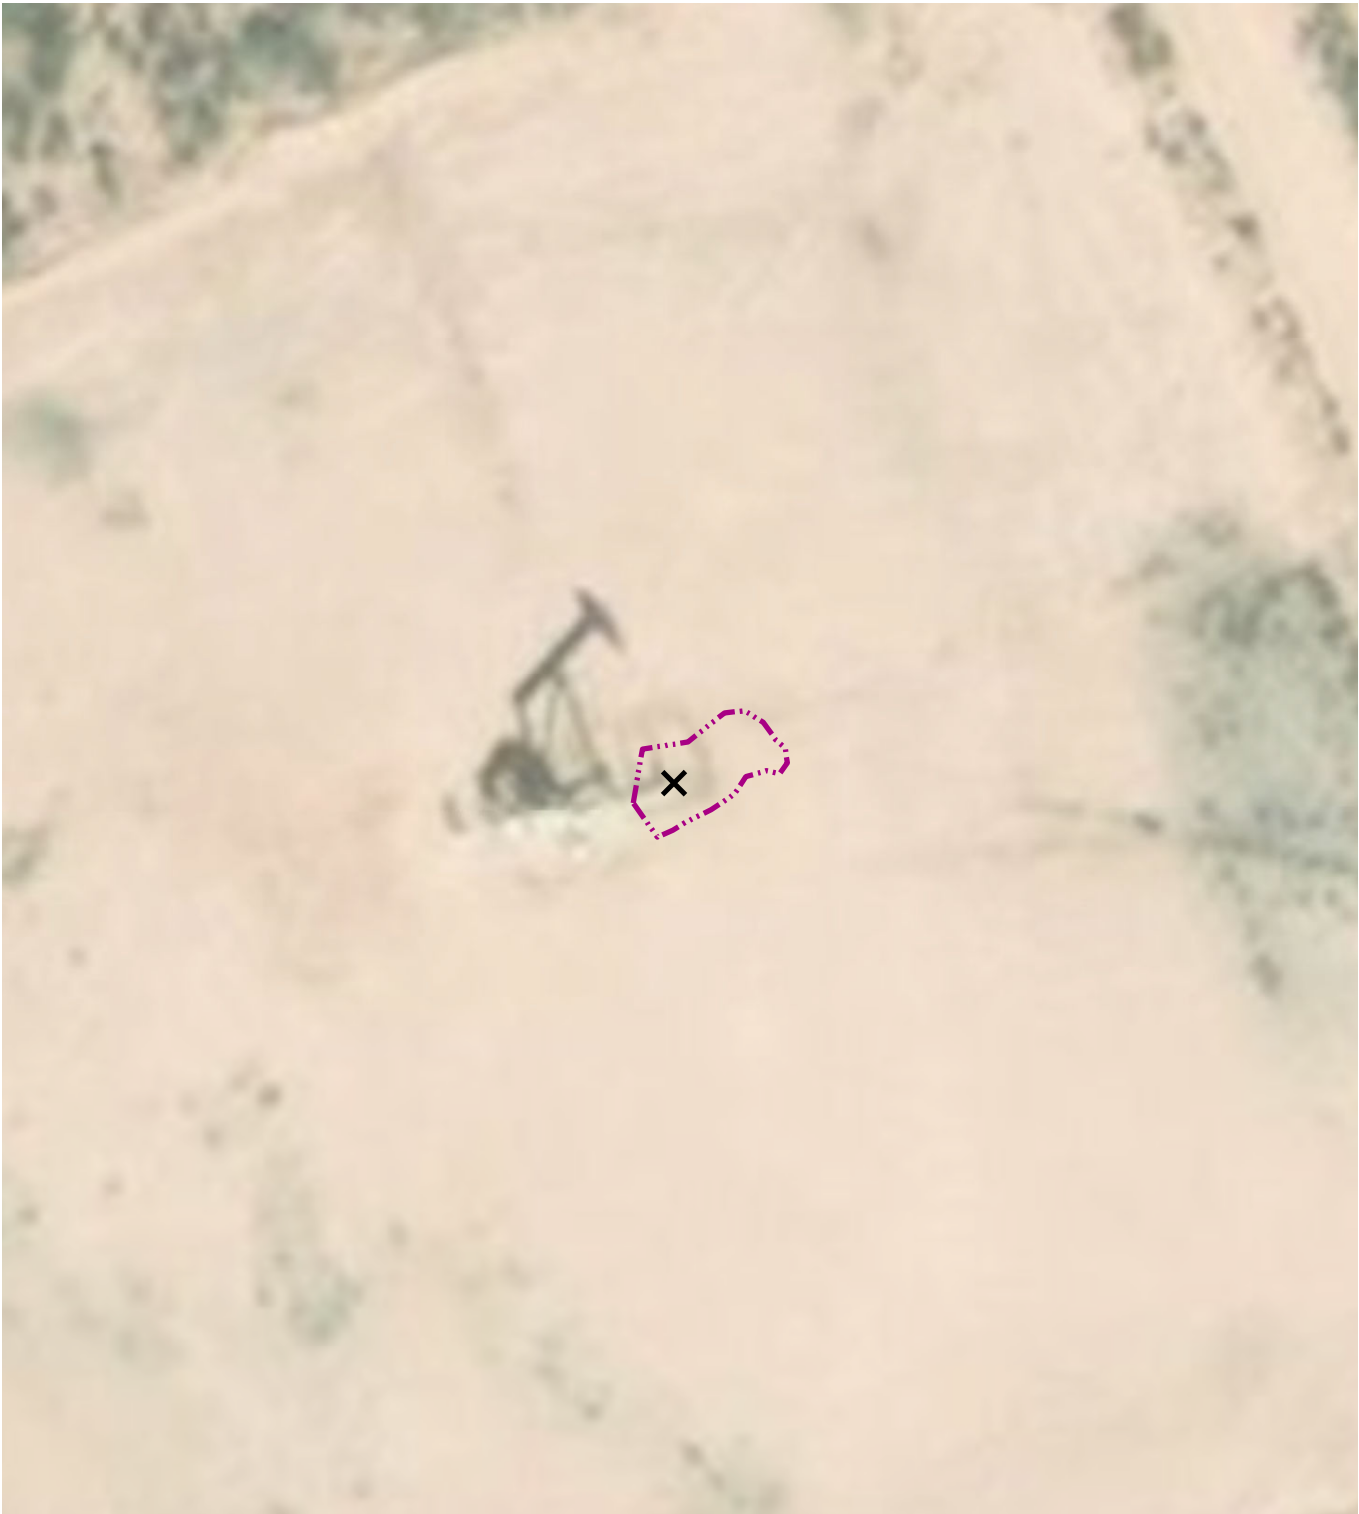
RELEASE LOCATION
-

RELEASE EXTENT (490 SQUARE FEET)

On September 25, 2019, LTE personnel inspected the Site to evaluate the release extent. WPX had conducted preliminary excavation activities prior to the visit. The release extent and excavation area were mapped utilizing a handheld Global Positioning System (GPS) unit and are depicted on Figure 2. Preliminary field screening and observations within the excavation area indicated impacts to soil and that further excavation was warranted. Photographic documentation was conducted during the Site visit. Photographs are included in Attachment 2.

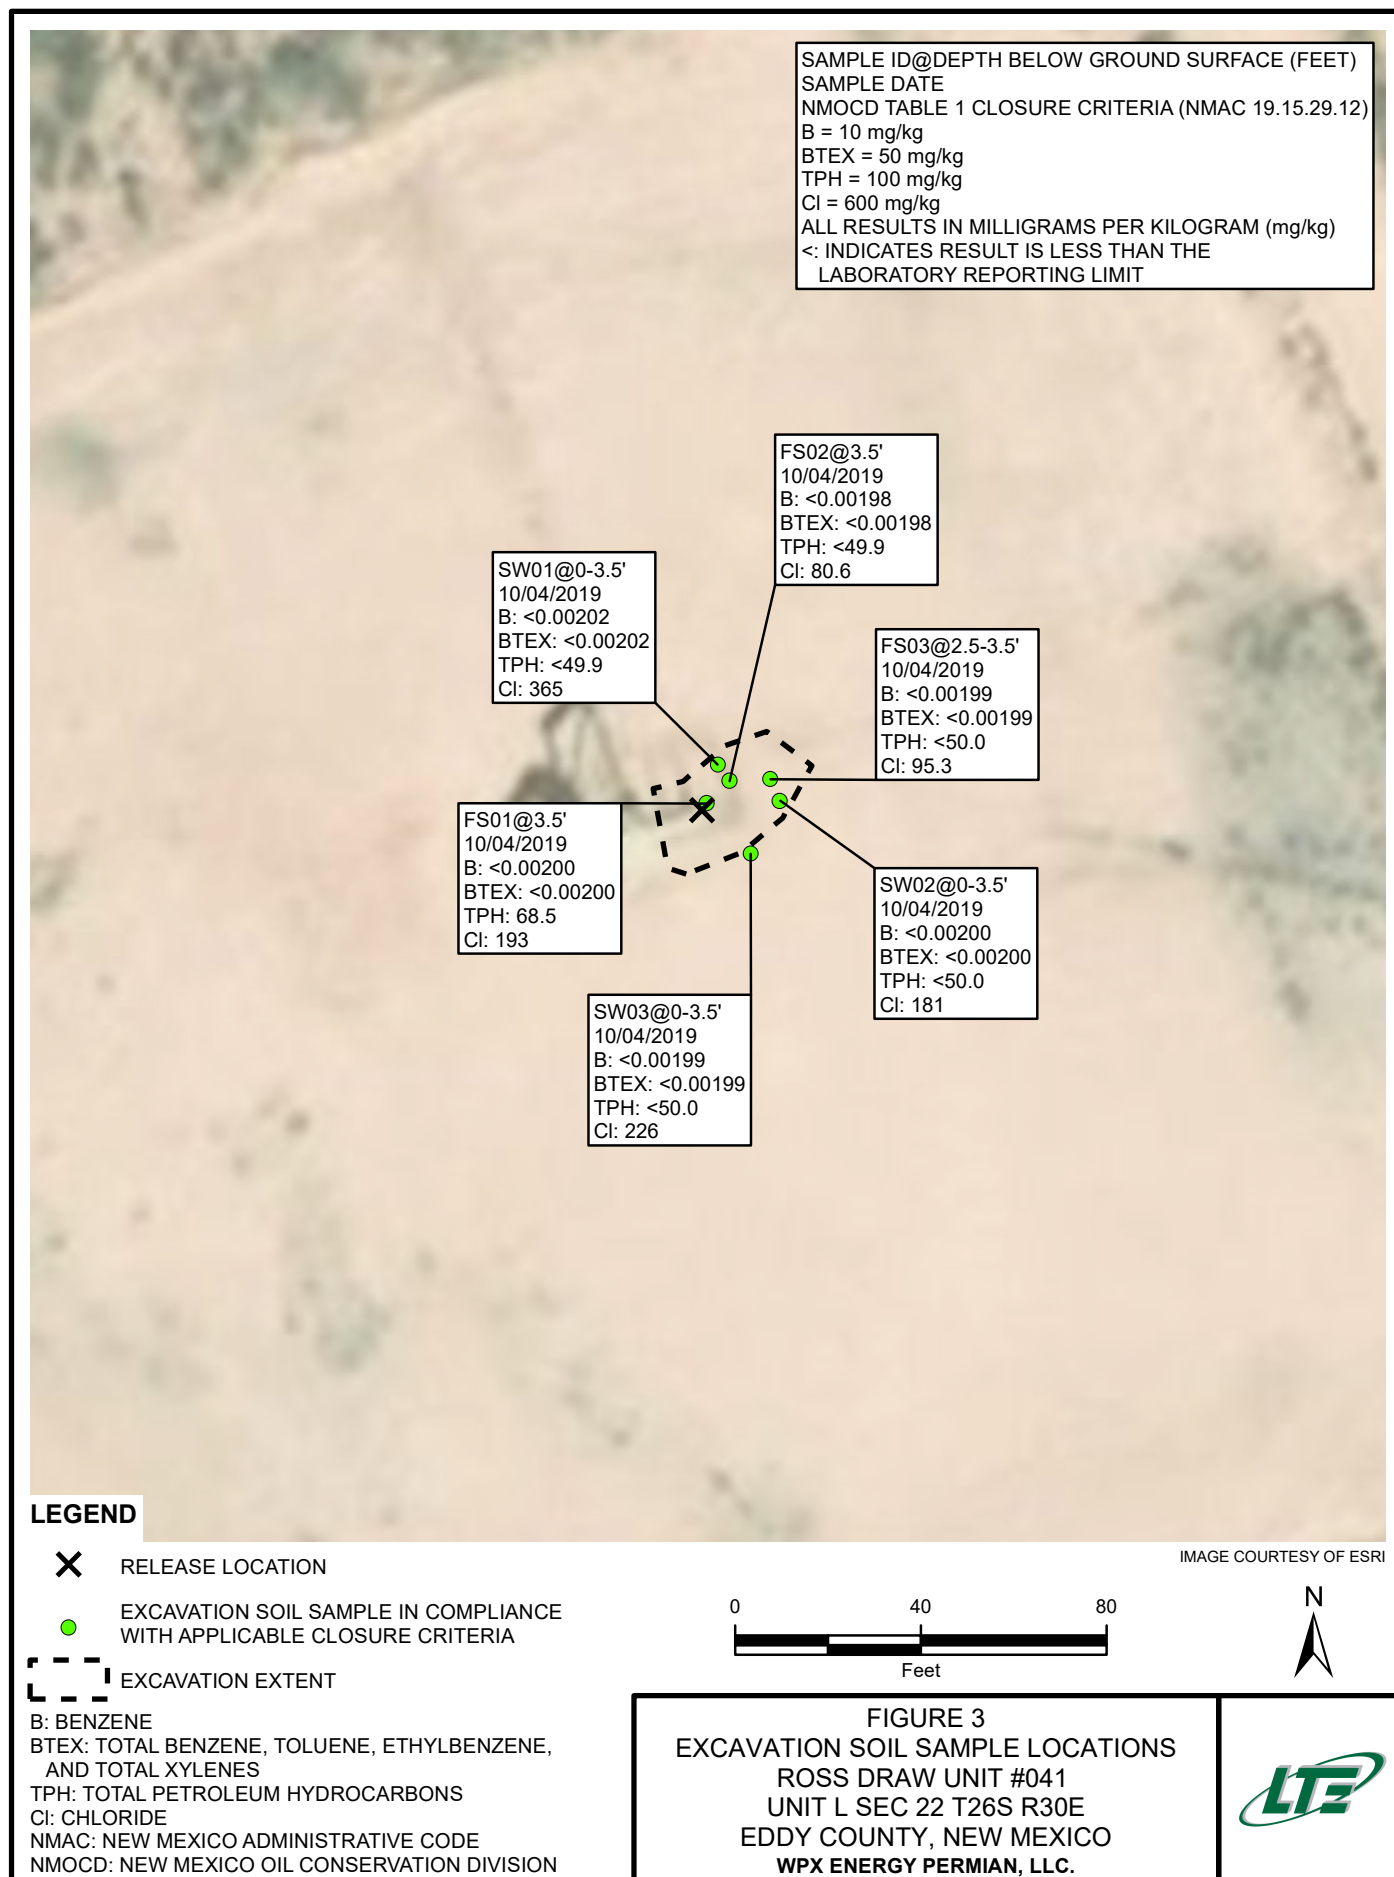
On October 2, 2019, LTE was on site to oversee excavation activities within the release area. Excavation activities were directed by field screening soil samples for volatile aromatic hydrocarbons using a PID and chloride using Hach® chloride QuanTab® test strips. Following completion of excavation activities, 5-point composite confirmation soil samples were collected from the floor (samples labeled as "FS") and sidewalls (samples labeled as "SW") of the excavation area. Each soil sample represented at most 200 square feet. The soil samples placed directly into a pre-cleaned glass jar, labeled with the location, date, time, sampler name, method of analysis, and immediately placed on ice. The soil samples were shipped at or below 4 degrees Celsius (°C) under strict chain-of-custody (COC) procedures to Xenco Laboratories (Xenco) in Midland, Texas, for analysis of chloride following United States Environmental Protection Agency (USEPA) Method 300.0. Approximately 60 cubic yards of impacted soil were removed from the excavation area and transported to the R360 Red Bluff Facility in Orla, Texas for disposal. The excavation area measured approximately 1,200 square feet in area and 3.5 feet bgs in depth. The excavation area and soil sample locations are depicted on Figure 3.

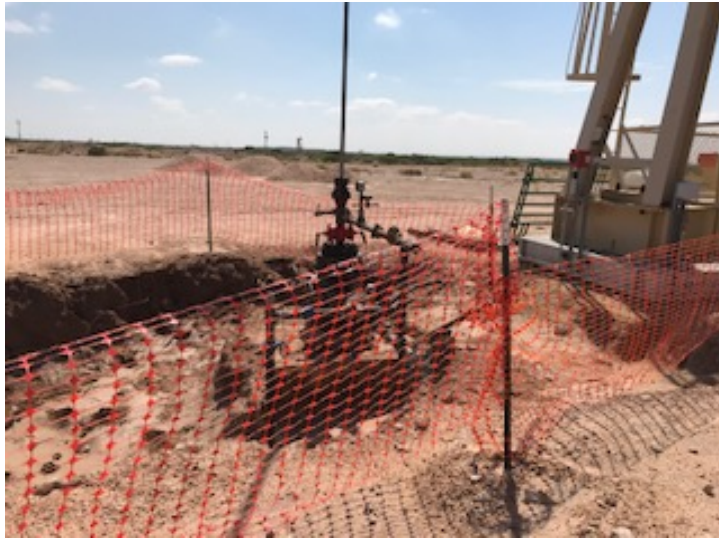
**Photograph 1:** View south of excavation.

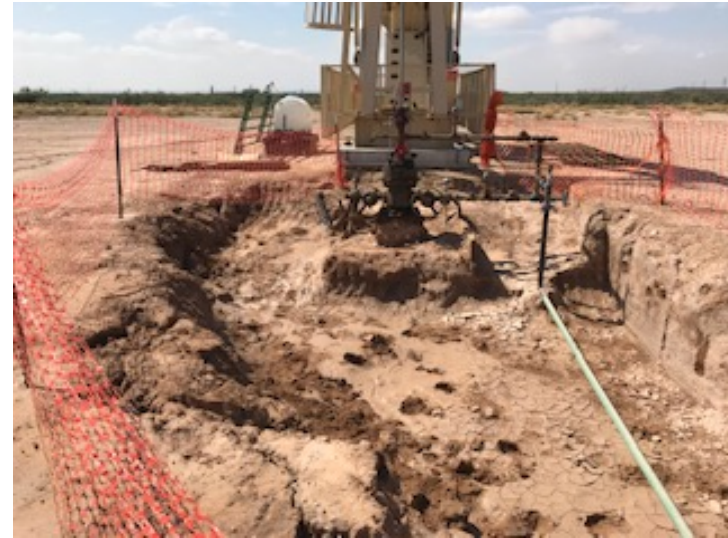
**Photograph 2:** View west of excavation.

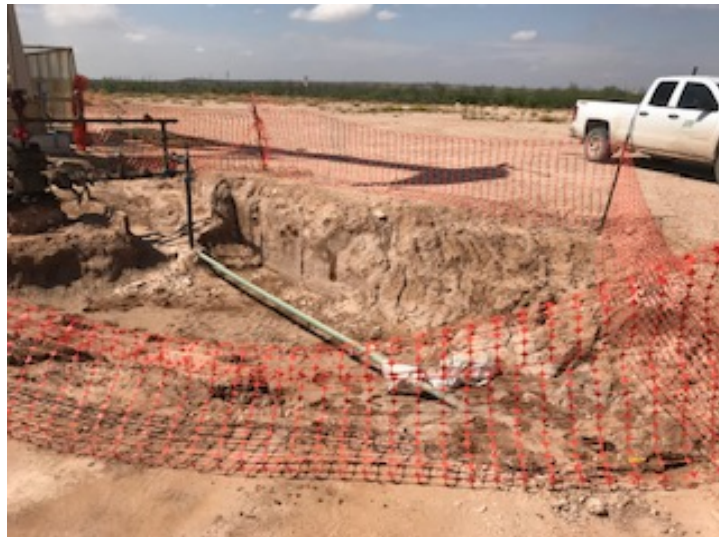
**Photograph 3:** View northwest of excavation.

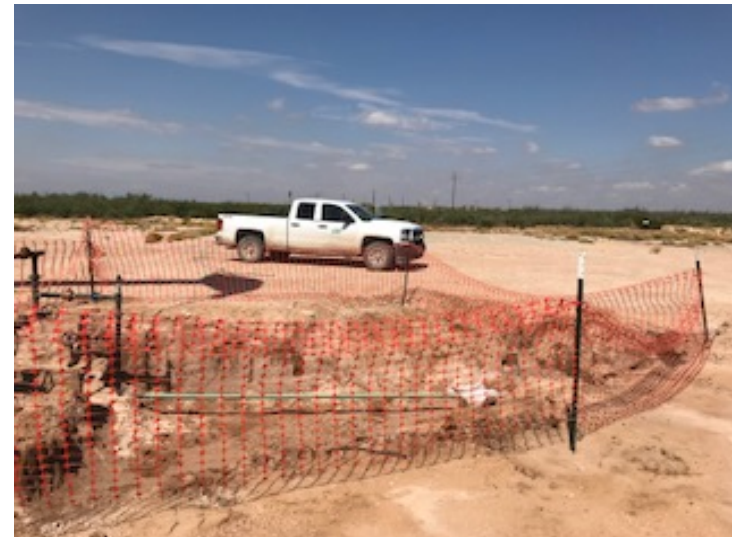
**Photograph 4:** View north of excavation.
