Release Assessment and Closure

Harroun Ranch West Battery

Vertex File Number: 23E-05202

BTA Oil Producers, LLC

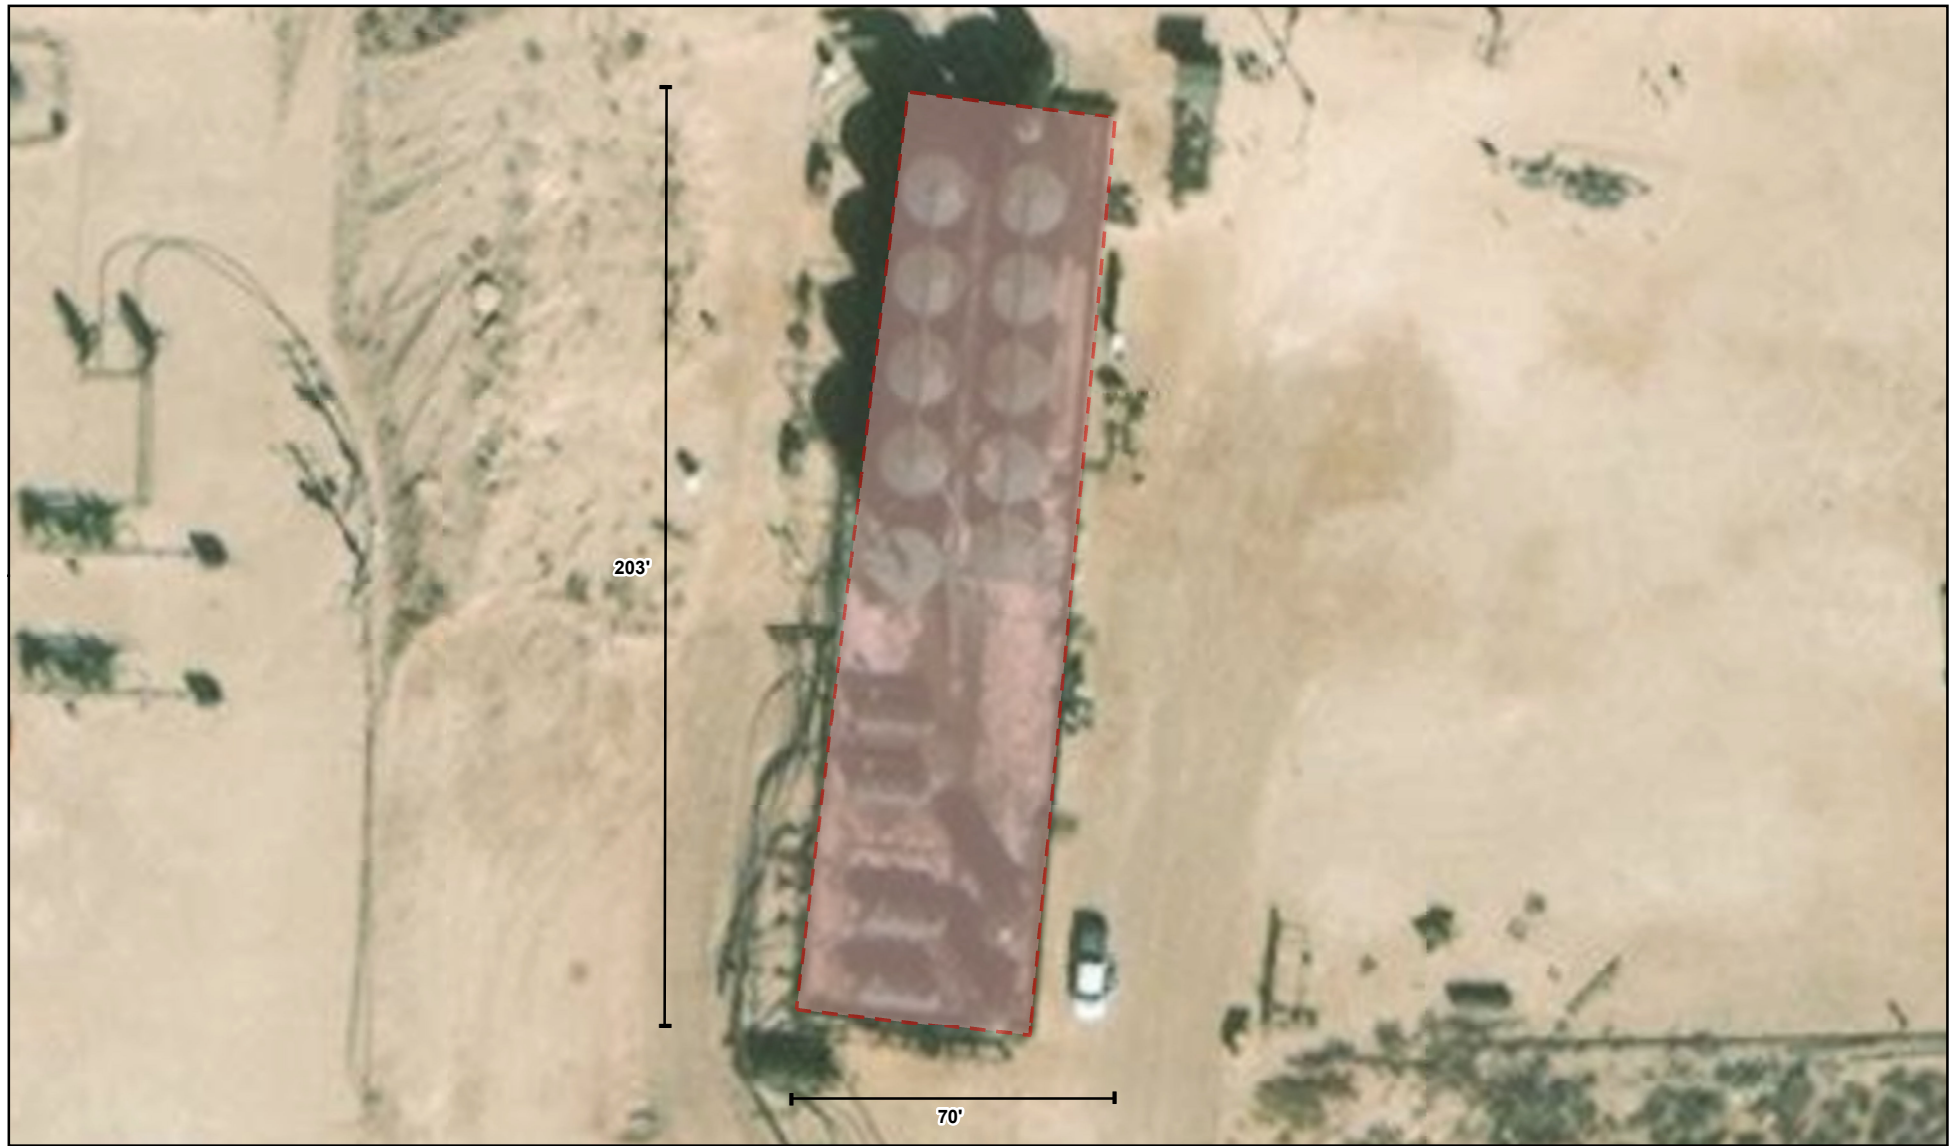
Release Area in Containment (~9,619 sq.ft.)

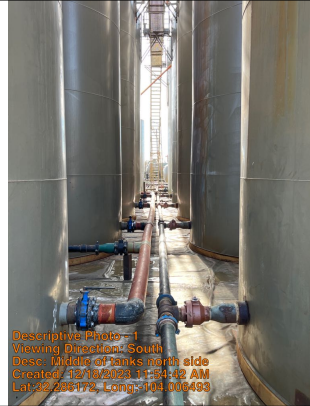
Descriptive Photo - 1
Viewing Direction: South
Desc: Middle of tanks north side
Created: 12/18/2023 11:54:02 AM
Lat:32.285175, Long:-104.006463

Middle of tanks north side

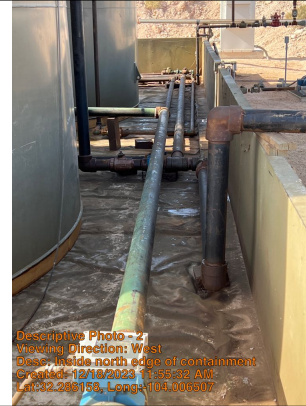
Descriptive Photo - 2
Viewing Direction: West
Desc: Inside north edge of containment
Created: 12/18/2023 11:55:30 AM
Lat:32.285175, Long:-104.006507

Inside north edge of containment

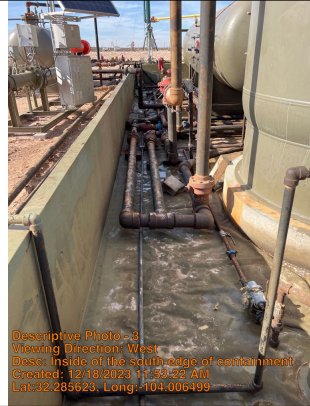
Descriptive Photo - 3
Viewing Direction: West
Desc: Inside of the south edge of containment
Created: 12/18/2023 11:53:32 AM
Lat:32.285623, Long:-104.006499

Inside of the south edge of containment

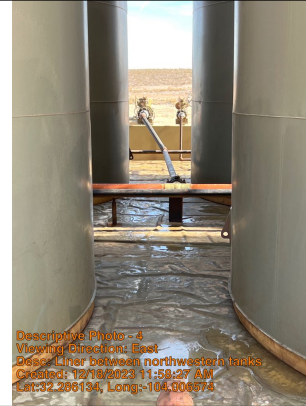
Descriptive Photo - 4
Viewing Direction: East
Desc: Liner between northwest tanks
Created: 12/18/2023 11:58:27 AM
Lat:32.285134, Long:-104.006574

Liner between northwest tanks

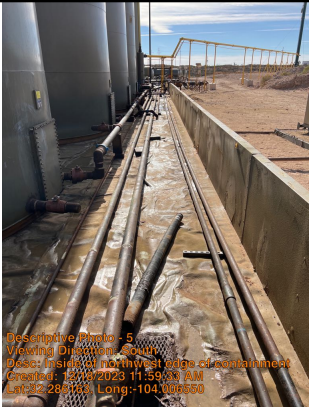
<p><small>Descriptive Photo - 5 Viewing Direction: South Desc: Inside of northwest edge of containment Created: 12/18/2023 11:59:38 AM Lat:32.286921, Long:-104.006550</small></p>	<p>Viewing Direction: East</p>

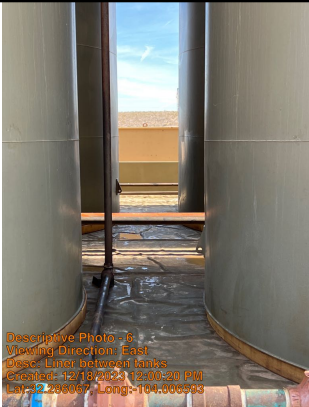
<p><small>Descriptive Photo - 6 Viewing Direction: East Desc: Liner between tanks Created: 12/18/2023 12:00:20 PM Lat:32.286921, Long:-104.006550</small></p>
<p>Inside of northwest edge of containment</p>	<p>Liner between tanks</p>
<p>Viewing Direction: East</p>

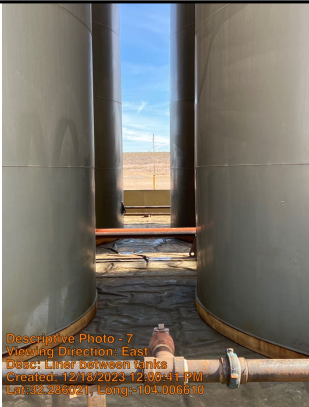
<p><small>Descriptive Photo - 7 Viewing Direction: East Desc: Liner between tanks Created: 12/18/2023 12:00:41 PM Lat:32.286921, Long:-104.006550</small></p>	<p>Viewing Direction: East</p>

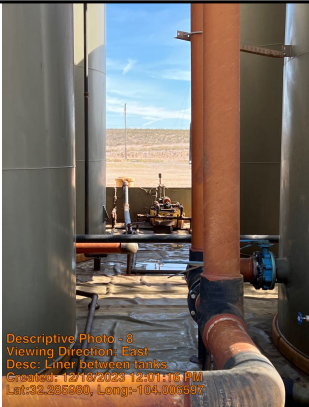
<p><small>Descriptive Photo - 8 Viewing Direction: East Desc: Liner between tanks Created: 12/18/2023 12:01:18 PM Lat:32.286921, Long:-104.006550</small></p>
<p>Liner between tanks</p>	<p>Liner between tanks</p>

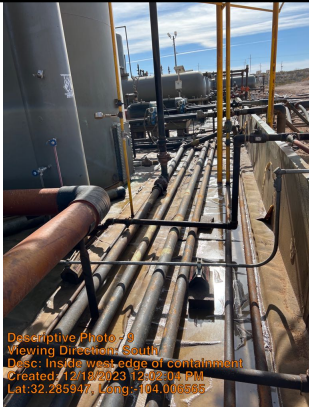
<p><small>Descriptive Photo - 9 Viewing Direction: South Desc: Inside west edge of containment Created: 12/18/2023 12:02:08 PM Lat:32.285947, Long:-104.006665</small></p>	<p>Viewing Direction: South</p>   <p><small>Descriptive Photo - 10 Viewing Direction: South Desc: Inside of southwest edge of containment Created: 12/18/2023 12:03:05 PM Lat:32.285747, Long:-104.006812</small></p>
Inside of west edge of containment	Inside of southwest edge of containment
<p>Viewing Direction: Northwest</p>

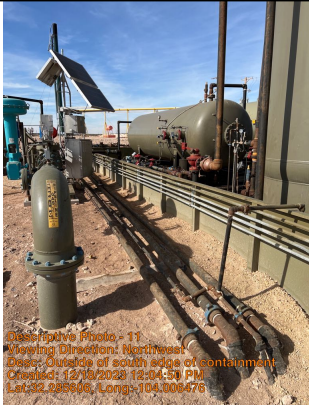
<p><small>Descriptive Photo - 11 Viewing Direction: Northwest Desc: Outside of south edge of containment Created: 12/18/2023 12:04:58 PM Lat:32.285806, Long:-104.006476</small></p>	<p>Viewing Direction: North</p>

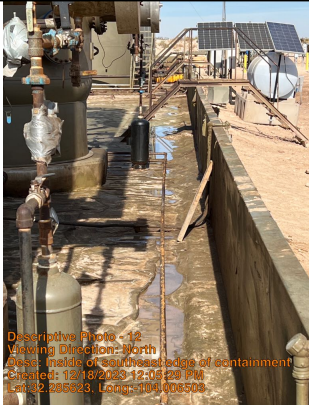
<p><small>Descriptive Photo - 12 Viewing Direction: North Desc: Inside of southeast edge of containment Created: 12/18/2023 12:04:22 PM Lat:32.285823, Long:-104.006508</small></p>

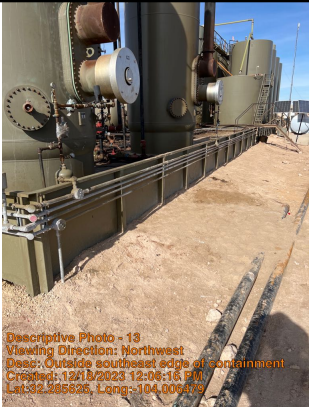
<p>Descriptive Photo - 13 Viewing Direction: Northwest Desc: Outside southeast edge of containment Created: 12/18/2023 12:06:16 PM Lat:32.285625, Long:-104.006673</p>	<p>Viewing Direction: Northeast</p>

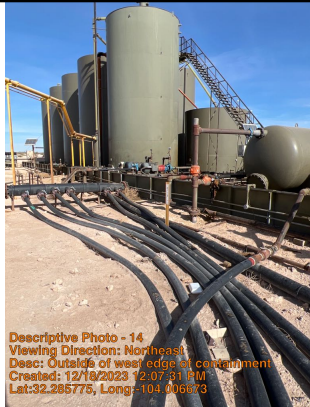
<p>Descriptive Photo - 14 Viewing Direction: Northeast Desc: Outside of west edge of containment Created: 12/18/2023 12:07:31 PM Lat:32.285775, Long:-104.006673</p>
Outside of southeast edge of containment	Outside of west edge of containment
<p>Viewing Direction: Northeast</p>

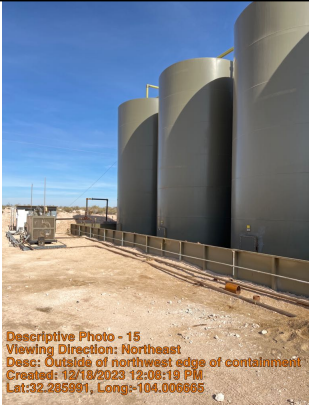
<p>Descriptive Photo - 15 Viewing Direction: Northeast Desc: Outside of northwest edge of containment Created: 12/18/2023 12:08:18 PM Lat:32.285991, Long:-104.006665</p>	<p>Viewing Direction: Southeast</p>

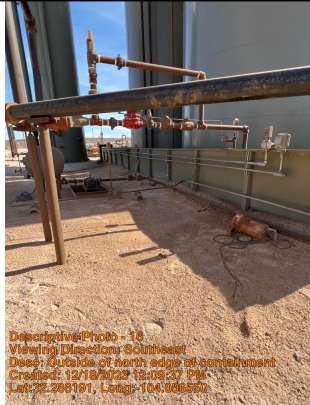
<p>Descriptive Photo - 16 Viewing Direction: Southeast Desc: Outside of north edge of containment Created: 12/18/2023 12:08:37 PM Lat:32.286191, Long:-104.006500</p>

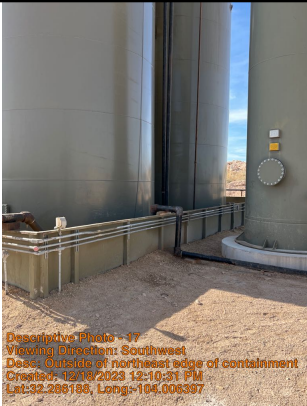
<p><small>Description Photo - 37 Viewing Direction: Southwest Desc: Outside of northeast edge of containment Created: 12/18/2023 12:10:31 PM Lat:32.288186, Long:-104.006397</small></p>	<p>Viewing Direction: Southwest</p>

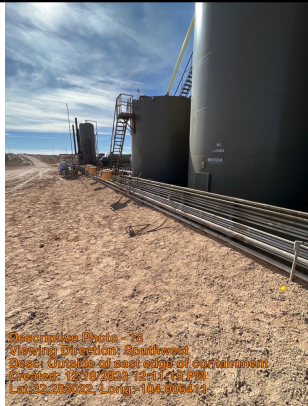
<p><small>Description Photo - 38 Viewing Direction: Southwest Desc: Outside of east edge of containment Created: 12/18/2023 12:11:18 PM Lat:32.288022, Long:-104.006411</small></p>
Outside of northeast edge of containment	Outside of east edge of containment
<p>Viewing Direction: West</p>

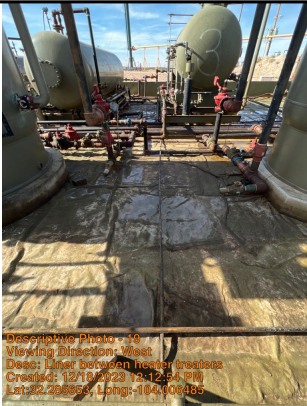
<p><small>Description Photo - 39 Viewing Direction: West Desc: Liner between heater treaters Created: 12/18/2023 12:12:54 PM Lat:32.288555, Long:-104.006485</small></p>	<p>Viewing Direction: North</p>

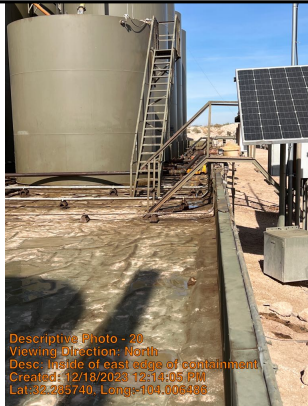
<p><small>Description Photo - 40 Viewing Direction: North Desc: Inside of east edge of containment Created: 12/18/2023 12:14:05 PM Lat:32.288740, Long:-104.006408</small></p>

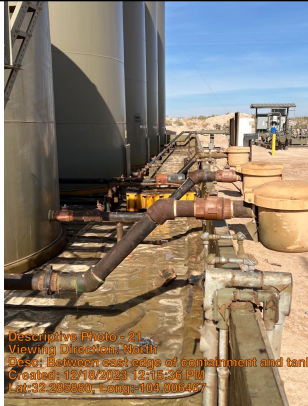
Between east edge of containment and tanks

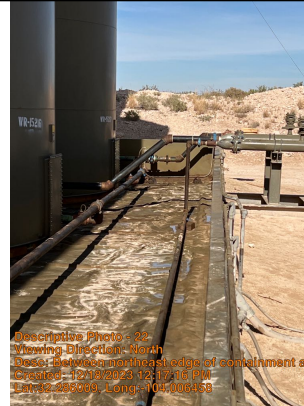
Between northeast edge of containment and tanks

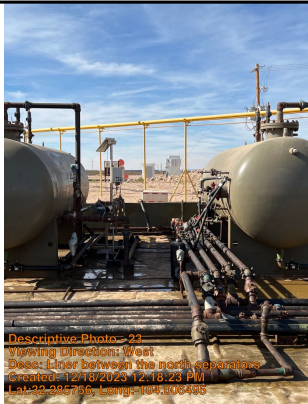
Liner between the north separators

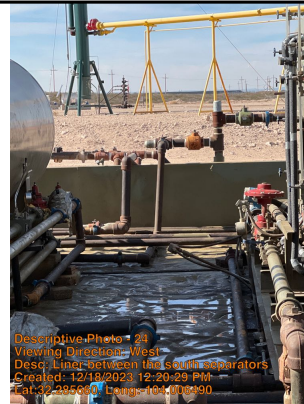
Liner between the south separators

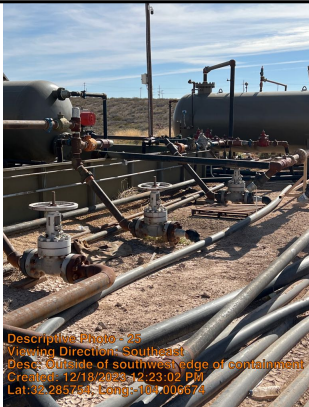
<p>Description: Photo - 25 Viewing Direction: Southeast Desc: Outside of southwest edge of containment Created: 12/18/2023 12:23:02 PM Lat: 32.285705, Long: -104.006674</p>

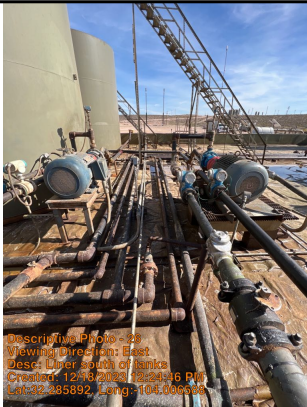
<p>Description: Photo - 26 Viewing Direction: East Desc: Liner south of tanks Created: 12/18/2023 12:24:36 PM Lat: 32.285892, Long: -104.006668</p>
Outside of southwest edge of containment	Liner south of tanks
