Re: Fourth Quarter 2023 – SVE System Update

Scott 4M
San Juan County, New Mexico
Hilcorp Energy Company
NMOCD Incident Number: NCE2003650476

Ensolum, LLC (Ensolum), on behalf of Hilcorp Energy Company (Hilcorp), presents this *Fourth Quarter 2023 – SVE System Update* report summarizing the soil vapor extraction (SVE) system performance at the Scott 4M natural gas production well (Site), located in Section 17, Township 31 North, and Range 10 West in San Juan County (Figure 1). The SVE system has operated since January 2021 to remediate subsurface soil impacts resulting from approximately 42 barrels (bbls) of natural gas condensate released from an aboveground storage tank. This report summarizes Site activities performed in October, November, and December of 2023.

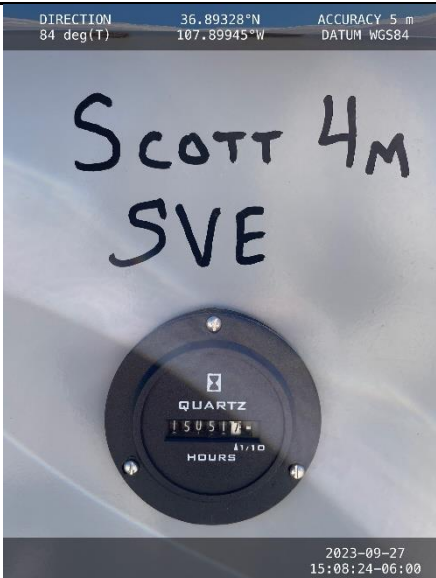
<p>Photograph 1</p> <p>Runtime meter taken on September 27, 2023 at 3:08 PM Hours = 15,051.7</p>

During the fourth quarter of 2023, Ensolum and Hilcorp personnel performed bi-weekly operation and maintenance (O&M) visits to ensure the system was operating as designed and to perform any required maintenance. Field notes taken during O&M visits are presented in Appendix A. During the fourth quarter of 2023, vacuum was applied to SVE wells SVE01 through SVE05 in order to induce flow in impacted soil zones. Between September 27 and December 20, 2023, the SVE system operated for 2,014.7 hours for a runtime efficiency of 100 percent (%). Photographs

of the runtime meter for calculating the fourth quarter runtime efficiency are presented as Appendix B. The SVE system operational hours and calculated percent runtime are presented in Table 1.

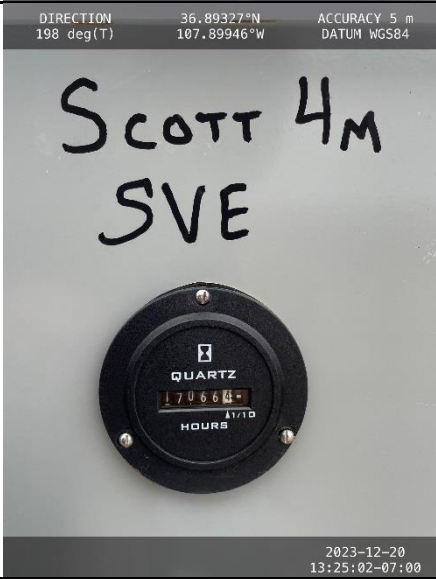
<p>Photograph 2</p> <p>Runtime meter taken on December 20, 2023 at 1:25 PM Hours = 17,066.4</p>
