Incident Number: nAPP2402219489

Release Assessment and Closure

Mesa Bronco CTB

Vertex Resource Services Inc.

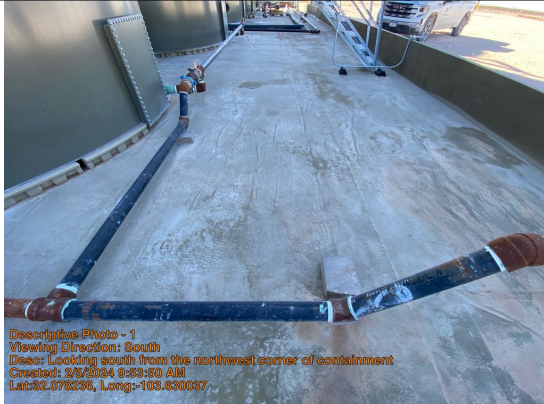
Descriptive Photo - 1
Viewing Direction: South
Desc: Looking south from the northwest corner of containment
Created: 2/5/2024 9:53:50 AM
Lat:32.078236, Long:-103.630037

Looking south from the northwest corner of containment

10:32 No issues were found. Liner looks good throughout entire containment.

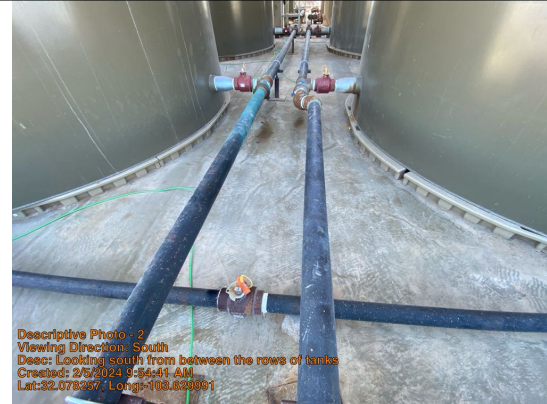
Descriptive Photo - 2
Viewing Direction: South
Desc: Looking south from between the rows of tanks
Created: 2/5/2024 9:54:41 AM
Lat:32.078237, Long:-103.630031

Looking south from between the rows of tanks against the north wall

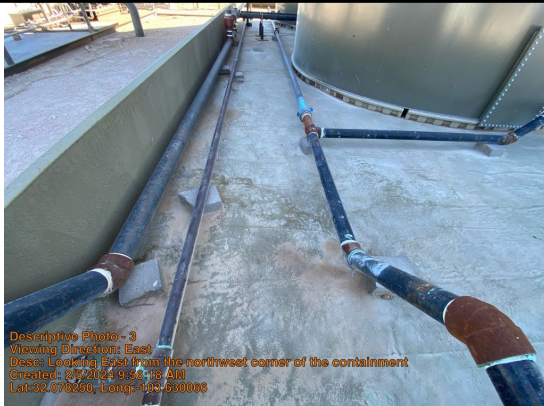
Descriptive Photo - 3
Viewing Direction: East
Desc: Looking East from the northwest corner of the containment
Created: 2/5/2024 9:56:18 AM
Lat:32.078236, Long:-103.630035

Looking East from the northwest corner of the containment

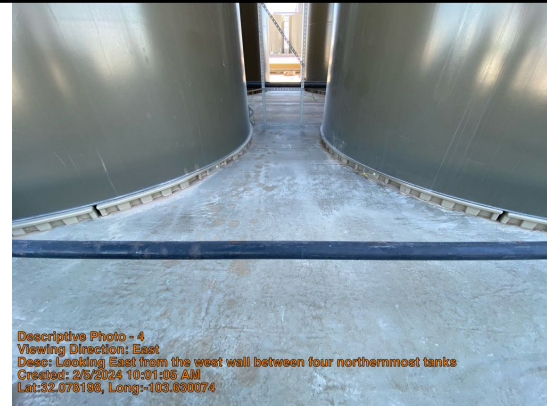
Descriptive Photo - 4
Viewing Direction: East
Desc: Looking East from the west wall between four northernmost tanks
Created: 2/5/2024 10:01:08 AM
Lat:32.078196, Long:-103.630074

Looking East from the west wall between four northernmost tanks

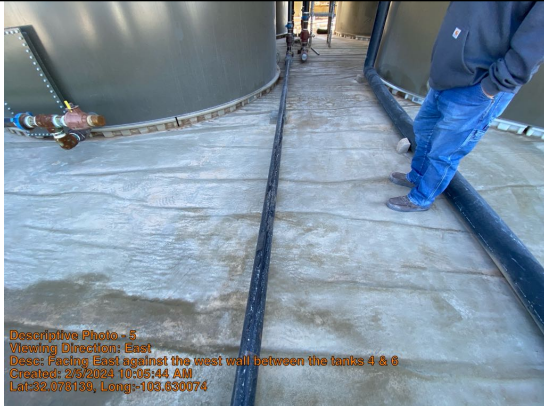
Descriptive Photo - 5
Viewing Direction: East
Desc: Facing East against the west wall between the tanks 4 & 6
Created: 2/5/2024 10:06:44 AM
Lat:32.078133, Long:-103.630074

Facing East against the west wall between the tanks 4 & 6

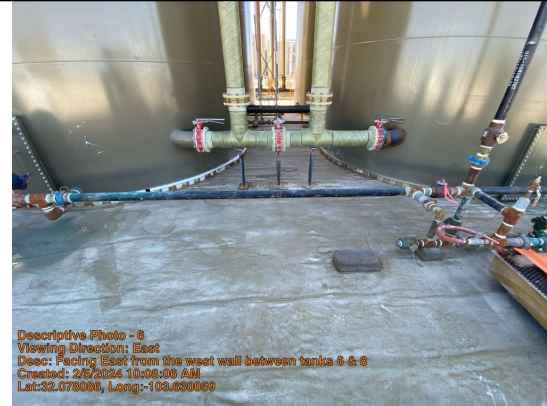
Descriptive Photo - 6
Viewing Direction: East
Desc: Facing East from the west wall between tanks 6 & 8
Created: 2/5/2024 10:06:06 AM
Lat:32.078066, Long:-103.630059

Facing East from the west wall between tanks 6 & 8

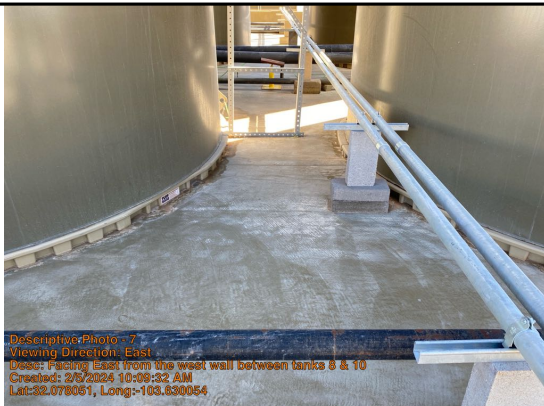
Descriptive Photo - 7
Viewing Direction: East
Desc: Facing East from the west wall between tanks 8 & 10
Created: 2/5/2024 10:09:32 AM
Lat:32.078061, Long:-103.630054

Facing East from the west wall between tanks 8 & 10

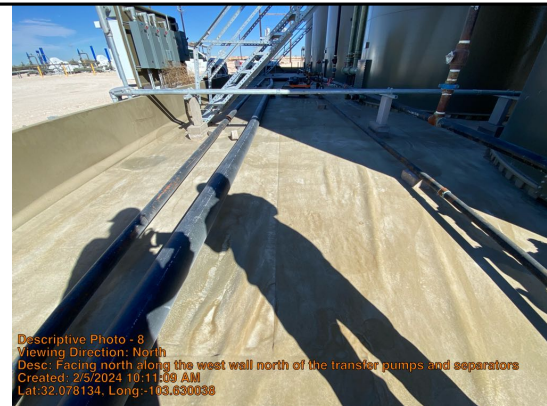
Descriptive Photo - 8
Viewing Direction: North
Desc: Facing north along the west wall north of the transfer pumps and separators
Created: 2/5/2024 10:11:09 AM
Lat:32.078134, Long:-103.630038

Facing north along the west wall north of the transfer pumps and separators

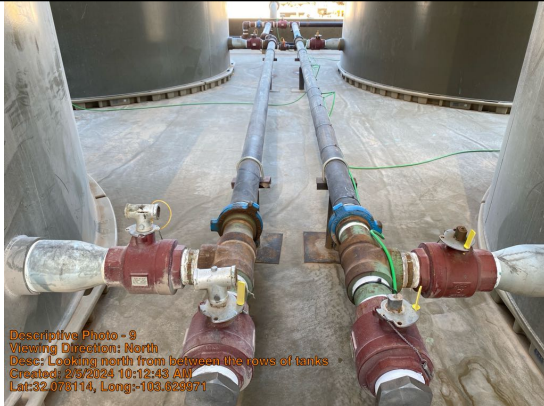
Descriptive Photo - 9
Viewing Direction: North
Desc: Looking north from between the rows of tanks
Created: 2/5/2024 10:12:43 AM
Lat:32.076114, Long:-103.629871

Looking north from the midpoint between the rows of tanks

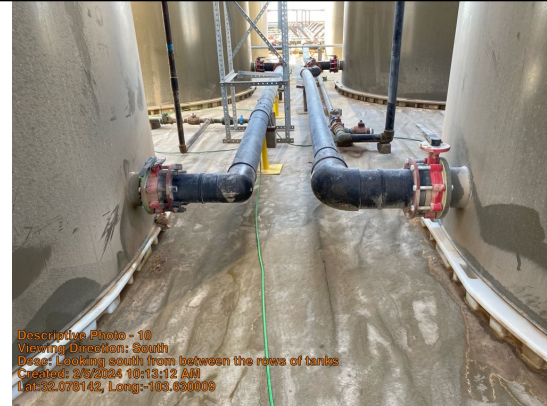
Descriptive Photo - 10
Viewing Direction: South
Desc: Looking south from between the rows of tanks
Created: 2/5/2024 10:13:12 AM
Lat:32.076142, Long:-103.630006

Looking south from the midpoint between the rows of tanks

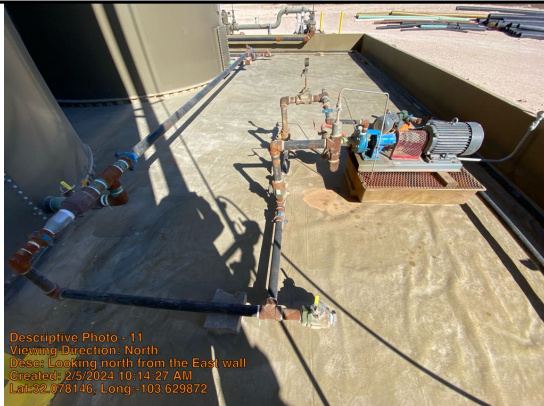
Descriptive Photo - 11
Viewing Direction: North
Desc: Looking north from the East wall
Created: 2/5/2024 10:14:27 AM
Lat:32.076116, Long:-103.629872

Looking north from the midpoint along the East wall

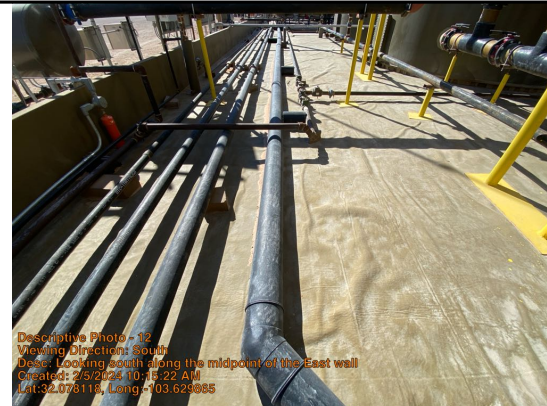
Descriptive Photo - 12
Viewing Direction: South
Desc: Looking south along the midpoint of the East wall
Created: 2/5/2024 10:15:22 AM
Lat:32.076115, Long:-103.629885

Looking south along the midpoint of the East wall

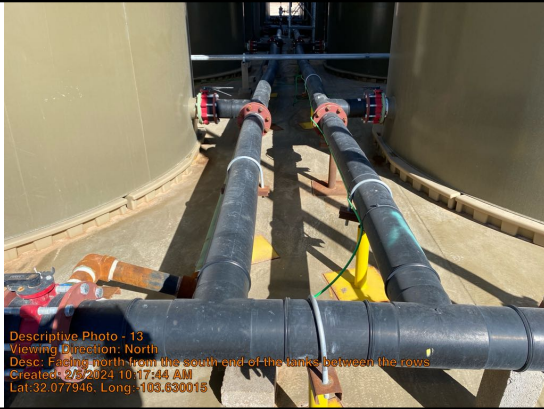
Viewing Direction: North

Facing north from the south end of the tanks between the rows

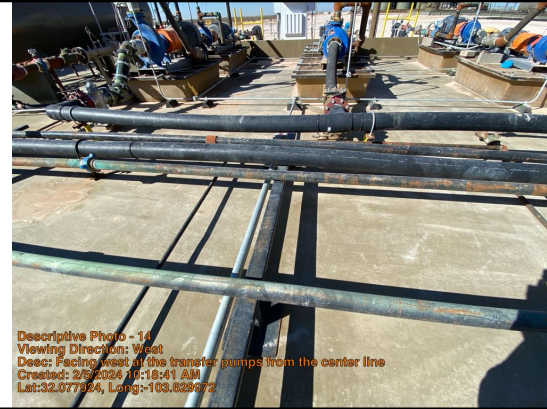
Viewing Direction: West

Facing west at the transfer pumps from the center line

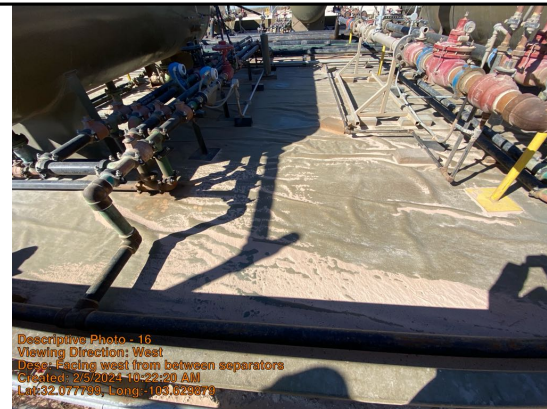
Viewing Direction: West

Facing west from between separators

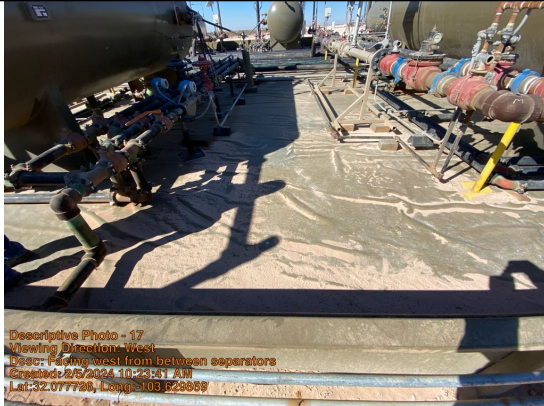
Descriptive Photo - 17
Viewing Direction: West
Desc: Facing west from between separators
Created: 2/5/2024 10:23:41 AM
Lat:32.077726, Long:-103.629889

Facing west from between separators

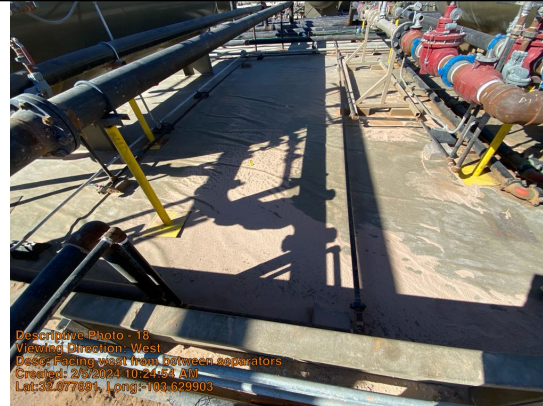
Descriptive Photo - 18
Viewing Direction: West
Desc: Facing west from between separators
Created: 2/5/2024 10:24:54 AM
Lat:32.077523, Long:-103.629903

Facing west from between separators

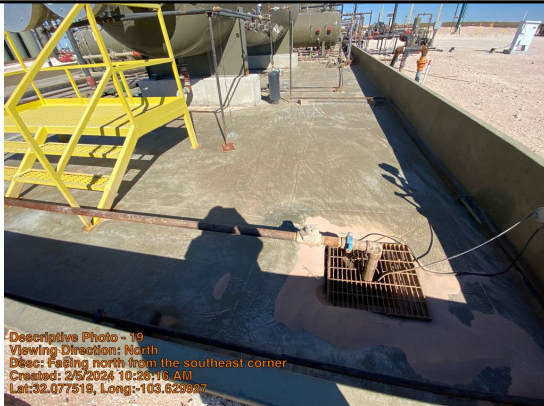
Descriptive Photo - 19
Viewing Direction: North
Desc: Facing north from the southeast corner
Created: 2/5/2024 10:28:16 AM
Lat:32.077519, Long:-103.629922

Facing north from the southeast corner

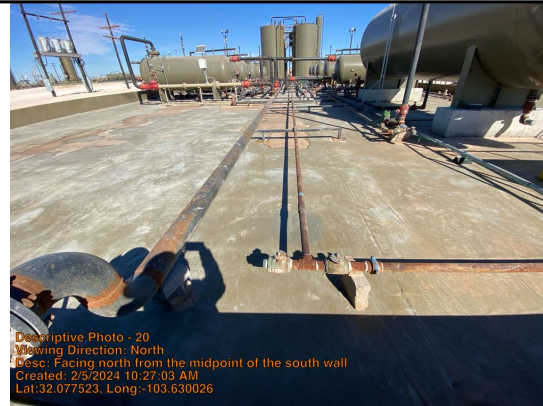
Descriptive Photo - 20
Viewing Direction: North
Desc: Facing north from the midpoint of the south wall
Created: 2/5/2024 10:27:03 AM
Lat:32.077523, Long:-103.630026

Facing north from the midpoint of the south wall

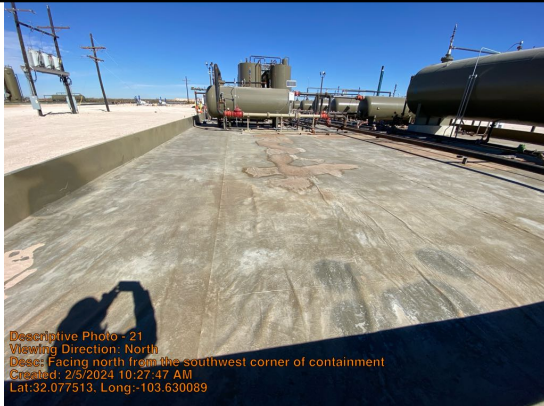
Viewing Direction: North

Facing north from the southwest corner of containment

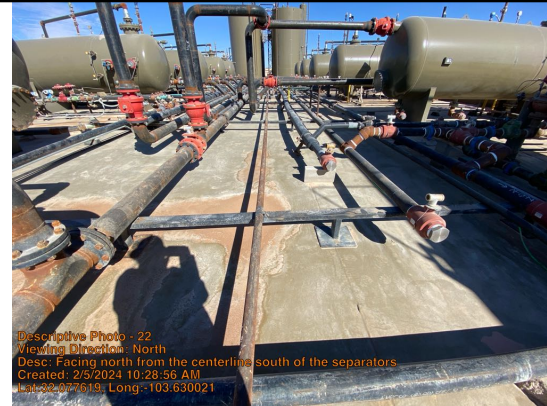
Viewing Direction: North

Facing north from the centerline south of the separators
