**Re: Closure Request
EVGSAU 2437-001
Incident Numbers NAPP2303273838 and NAPP2334650001
Lea County, New Mexico**

Maverick Permian, LLC
Closure Request
EVGSAU 2437-001

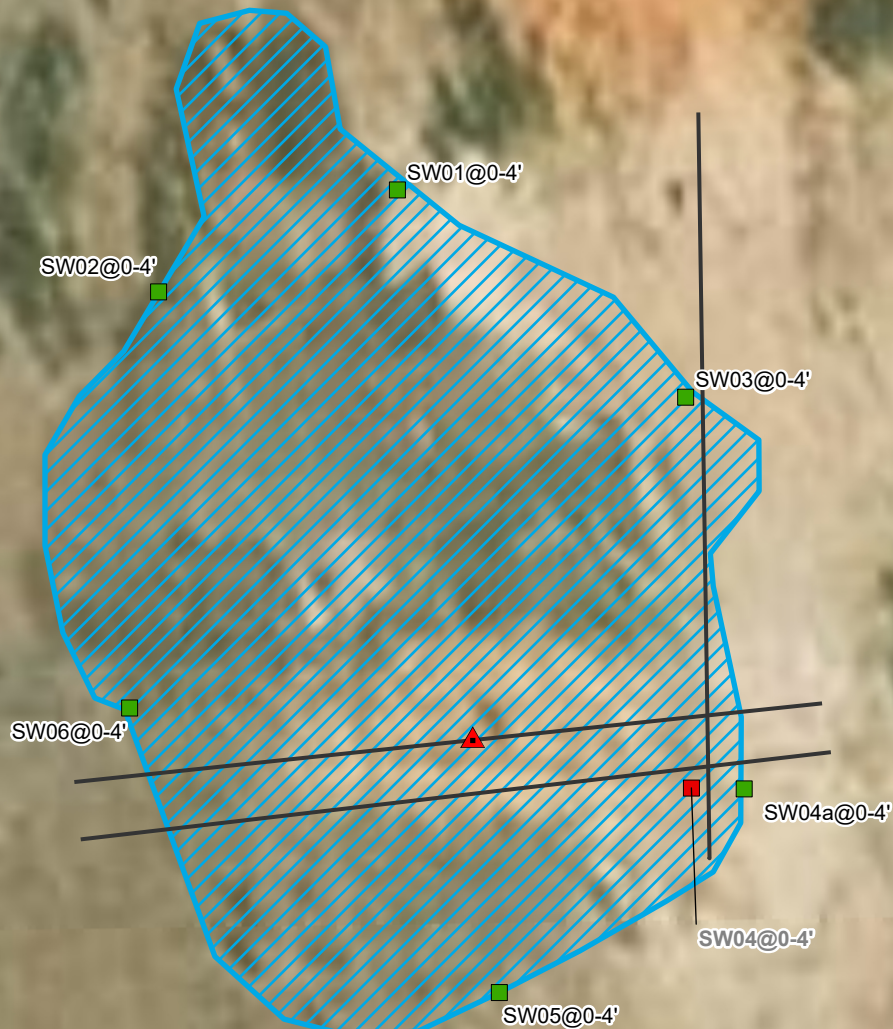
Delineation Soil Sample Locations

Notes:
 Sample ID @ Depth Below Ground Surface
 Samples in **bold** indicates sample exceeded applicable
 closure criteria
 Samples in grey indicate samples were removed during
 excavation activities

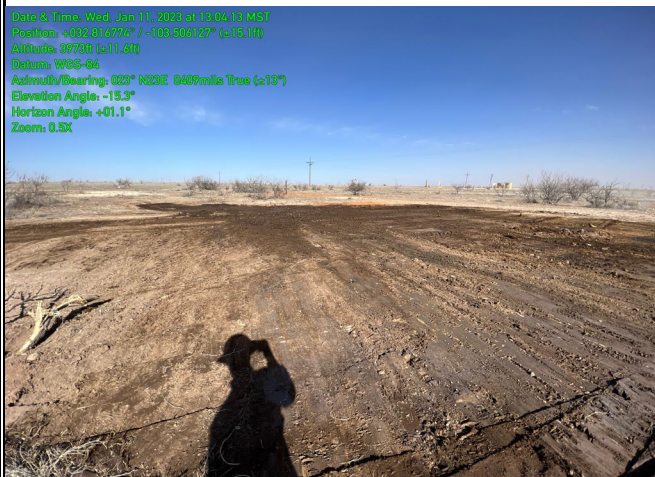
Photograph 1

Description: Soil staining in release footprint

View: Northeast

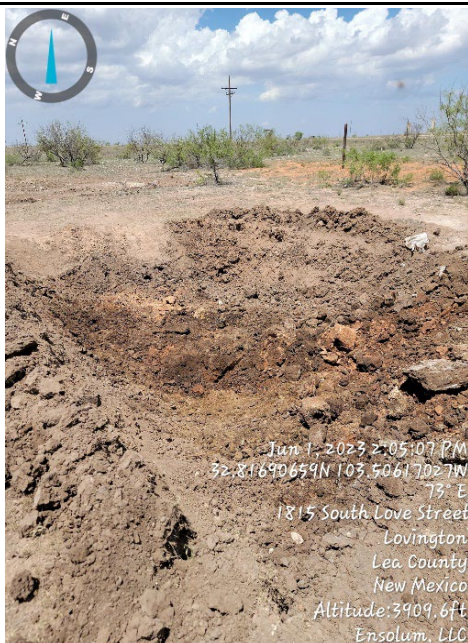
Photograph 3

Description: Historical pit

View: East
